**National Register of Historic Places
Inventory—Nomination Form**

historic HUILUA FISHPOND NATIONAL HISTORIC LANDMARK

street & number Kamehameha Highway (State Highway 83) not for publication

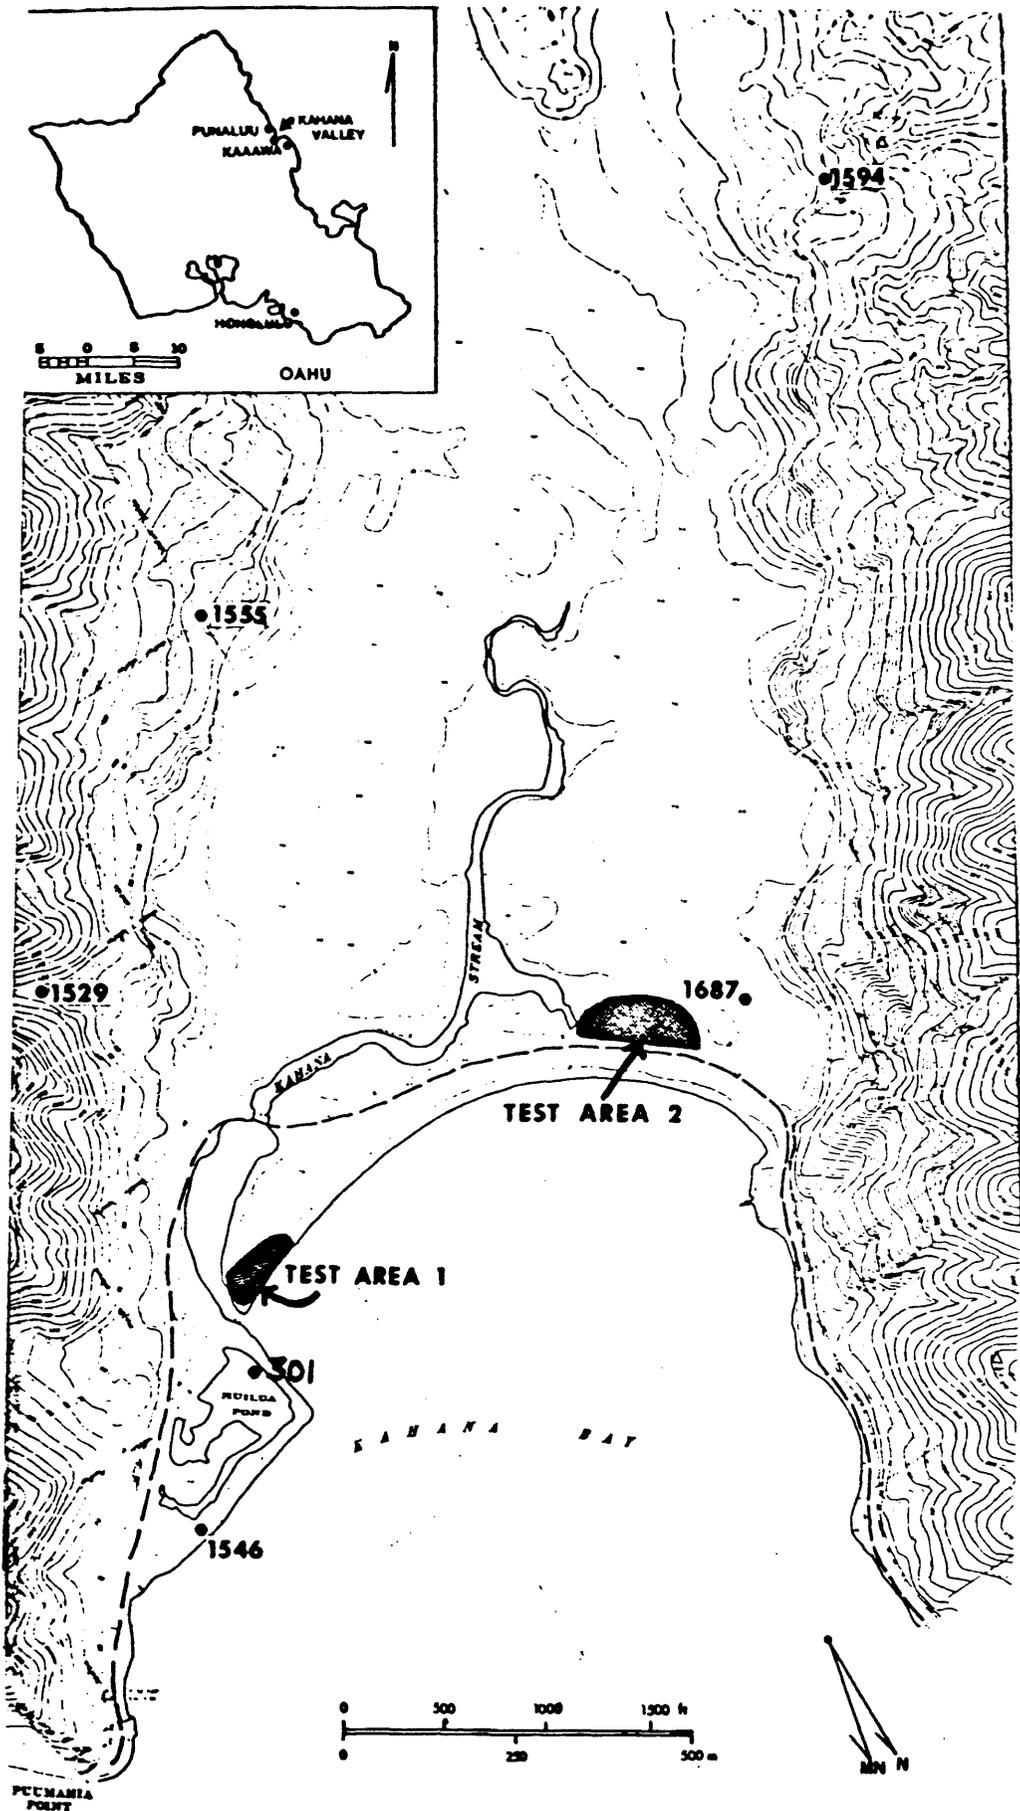
Figure 1: Map of lower Kahana Valley showing Huilua Fishpond and locations of excavated sites and auger test areas. (Source: Hommon and Bevaqua 1973:2, Fig.1)

Huilua is the only fishpond that has been declared a National Historic Landmark as a single structural entity, although several other Hawaiian NHLs include a fishpond as one component of a larger complex. At the time of its designation in 1962, Huilua Pond possessed exceptional scenic and considerable structural integrity; moreover, it was one of the few fishponds still in operation in the Hawaiian Islands. It still possesses a scenic integrity and charm that typifies rural Hawaii and is the most arresting feature of the Kahana Valley (Figure 1).

Archeological survey and test excavations in the vicinity of Huilua Fishpond (Homan and Bevaqua 1973) identified four additional archeological properties (see Figure 1):

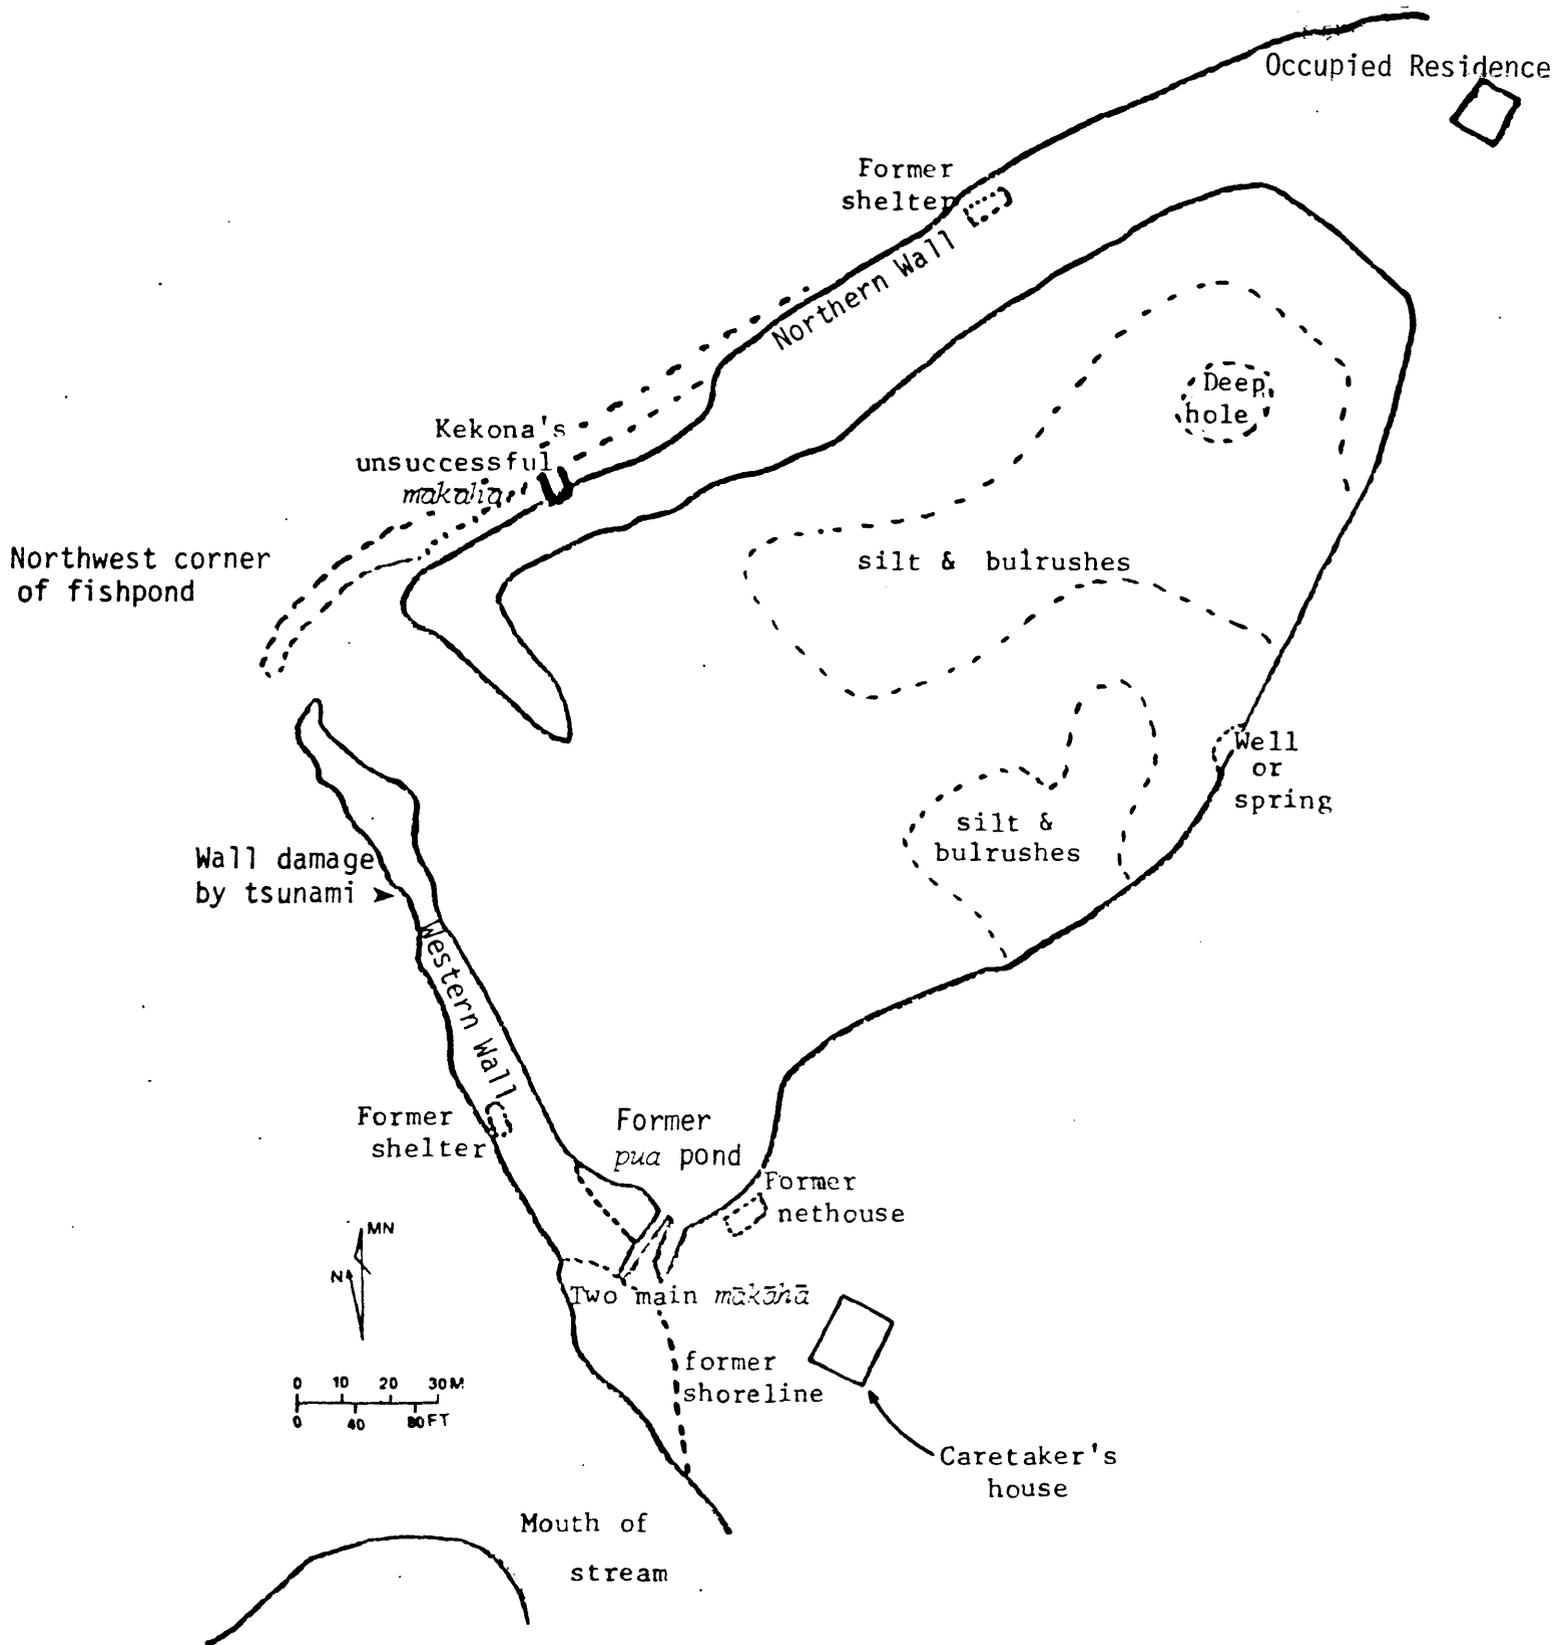
Figure 2:

Outline sketch of Huilua Fishpond showing former structures, well, deep hole, and a third and unsuccessful *makaha*. All positions of sites are approximate. (After Hommon and Bevacqua 1973:39, fig. 22).

It is not clear on surface evidence if the walled pua (pond for fry), the location of which is indicated in Figure 2, has been submerged by sand or destroyed. Kelly notes that dragline excavation of the pond after the 1957 tsunami redeposited spoils in the area obliterating the pua pond (1980:15). Sinoto believes the pua walls may have been destroyed by the same dredging (1980:7), although none of his test trenches appear to have probed that location. It is also possible that the pua may have been constructed in late historic or early modern times for none of the early sketches show it. Jackson's 1884 map (Figure 7) does not depict an interior pond; and the earliest known illustration of it appears in a 1936 Army Air Corps aerial photograph (Sinoto 1980:7).

No surface evidence remains of the former net house or other temporary shelters that may have been associated with the pond and its maintenance in prehistoric or historic times (see Figure 2). The caretaker's house, no longer extant, overlooked the makaha. This structure dated from the historic period. Archeological tests in the vicinity might well establish the location of earlier caretakers' huts, net houses or other structures, and the ko'a fish shrine. Several residences (occupied under State Parks permits) are presently located on the far eastern end of the stabilized dune that forms the eastern portion of the northern seawall. This area has not been archeologically surveyed but has the potential for containing significant prehistoric and historic archeological deposits.

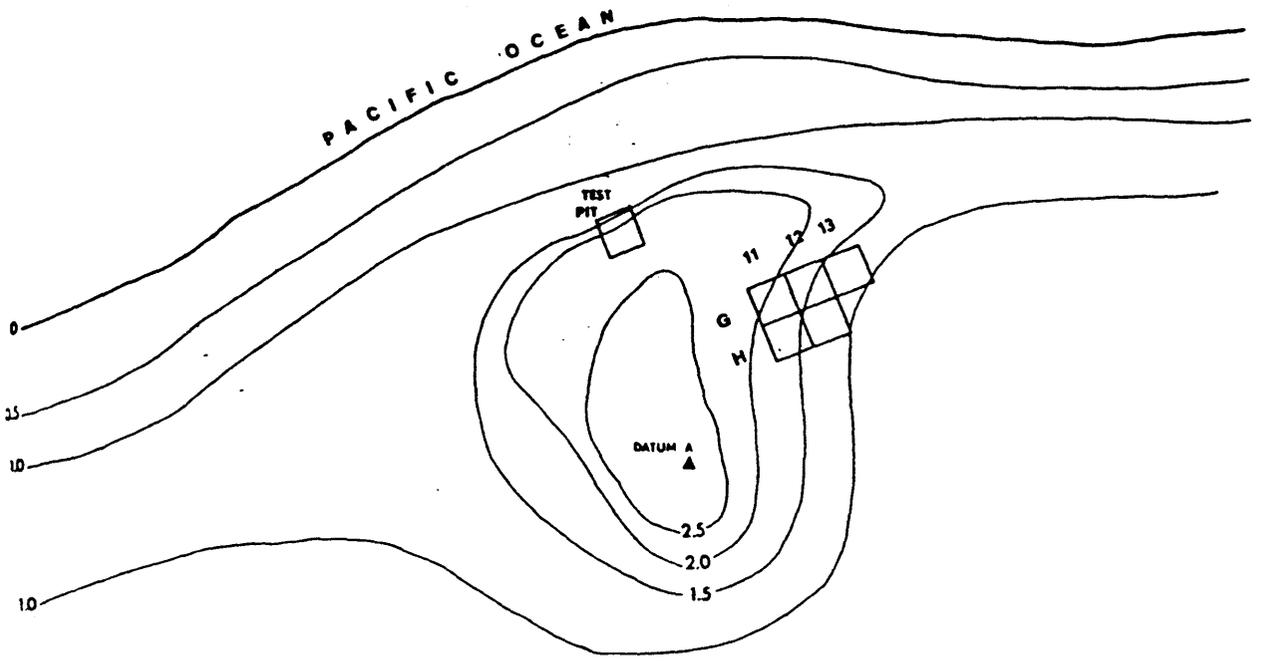
Figure 3: MAP OF SITE 1546, SHOWING EXCAVATED AREAS.
Map taken from Hommon & Bevacqua, 1973:24.

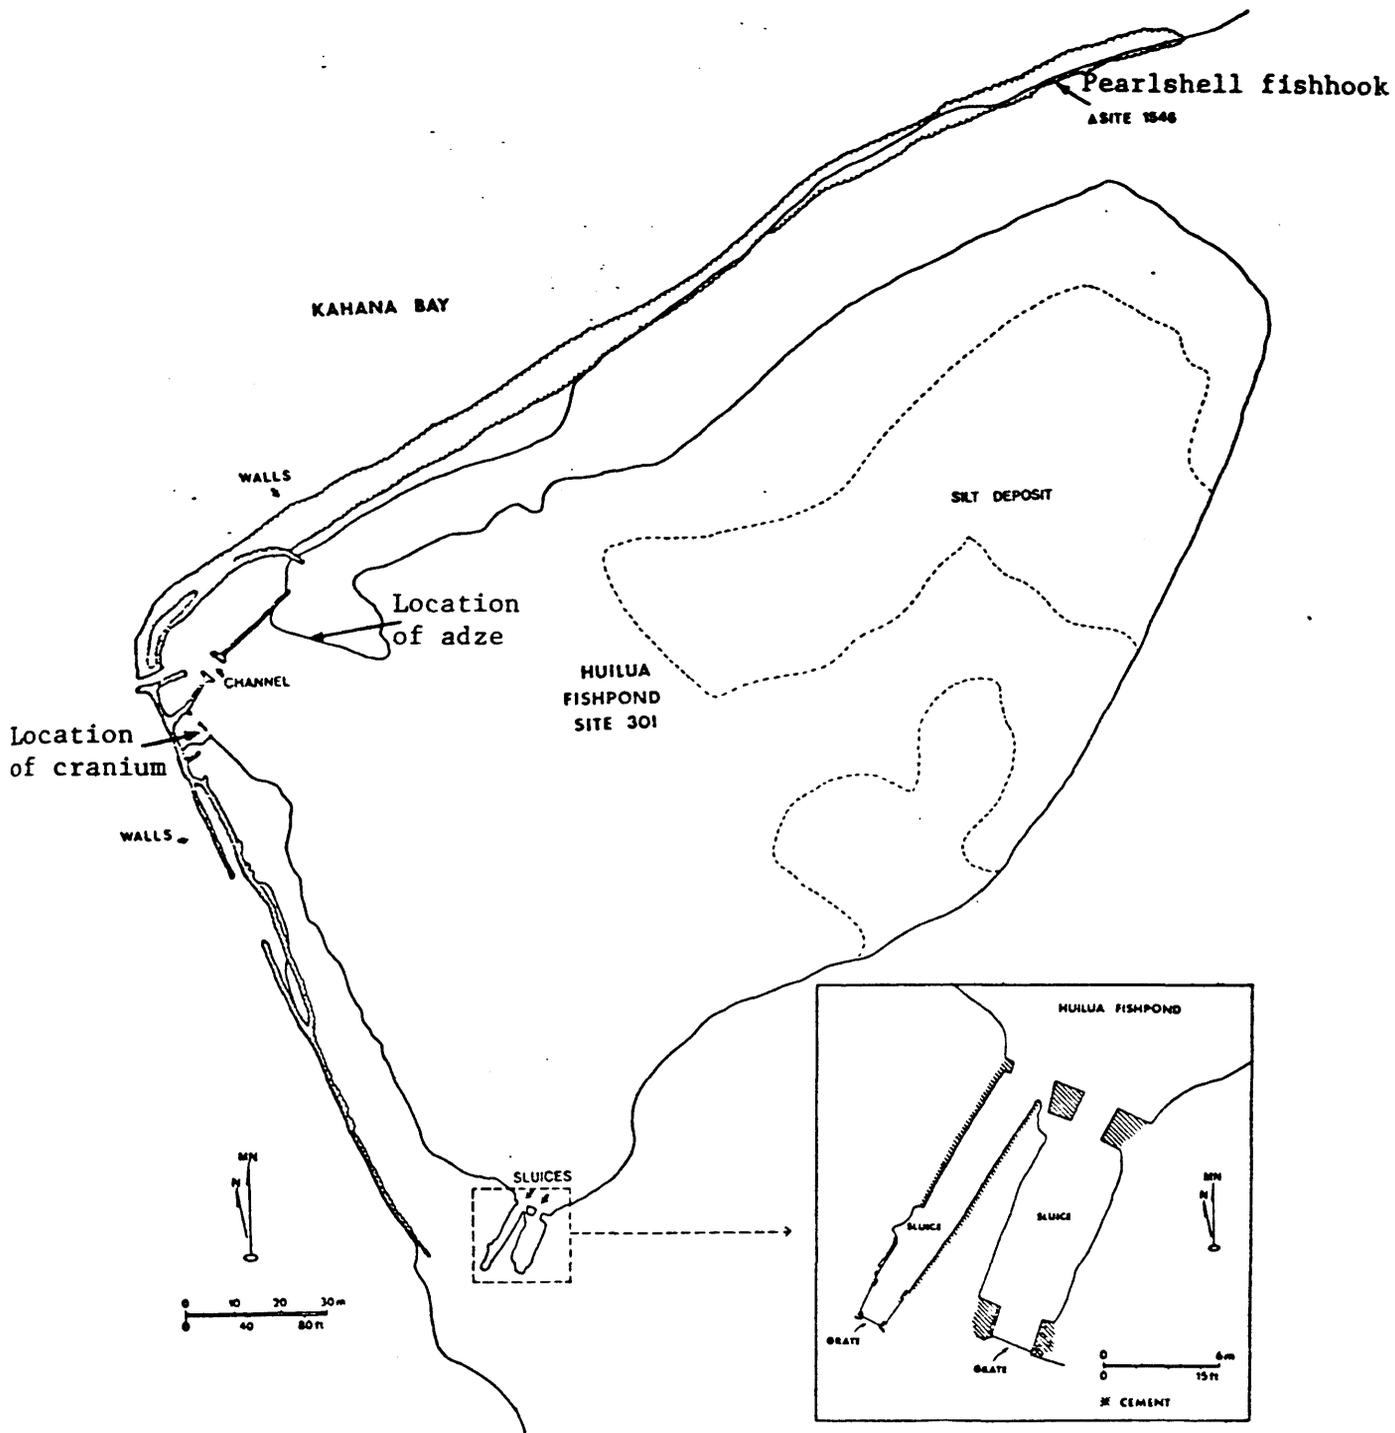
Figure 4:

**MAP OF HUILUA FISHPOND (SITE 301).
INSET SHOWS SLUICES AT SW CORNER.**

Location of human remains and recovered cultural materials - cranium location taken from Kam and Ota (1981).

(Map taken from Hommon & Bevacqua, 1973:39)

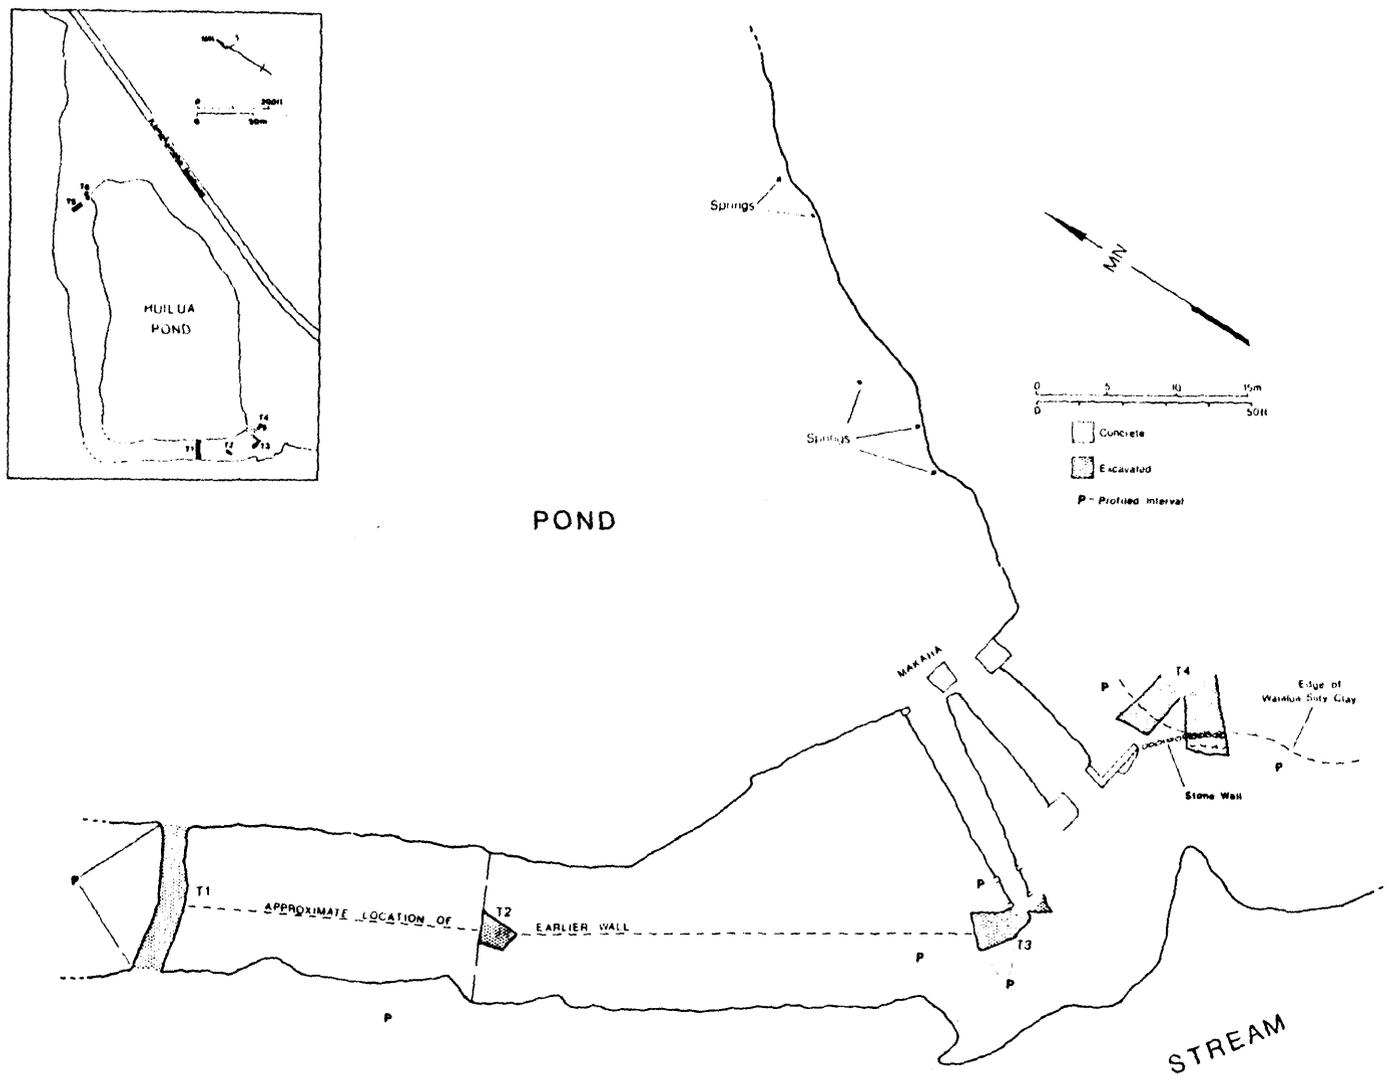
Figure 5: Location of archeological pre-stabilization trenches at Huilua Fishpond. (Source: Sinoto 1980:Fig. 1).

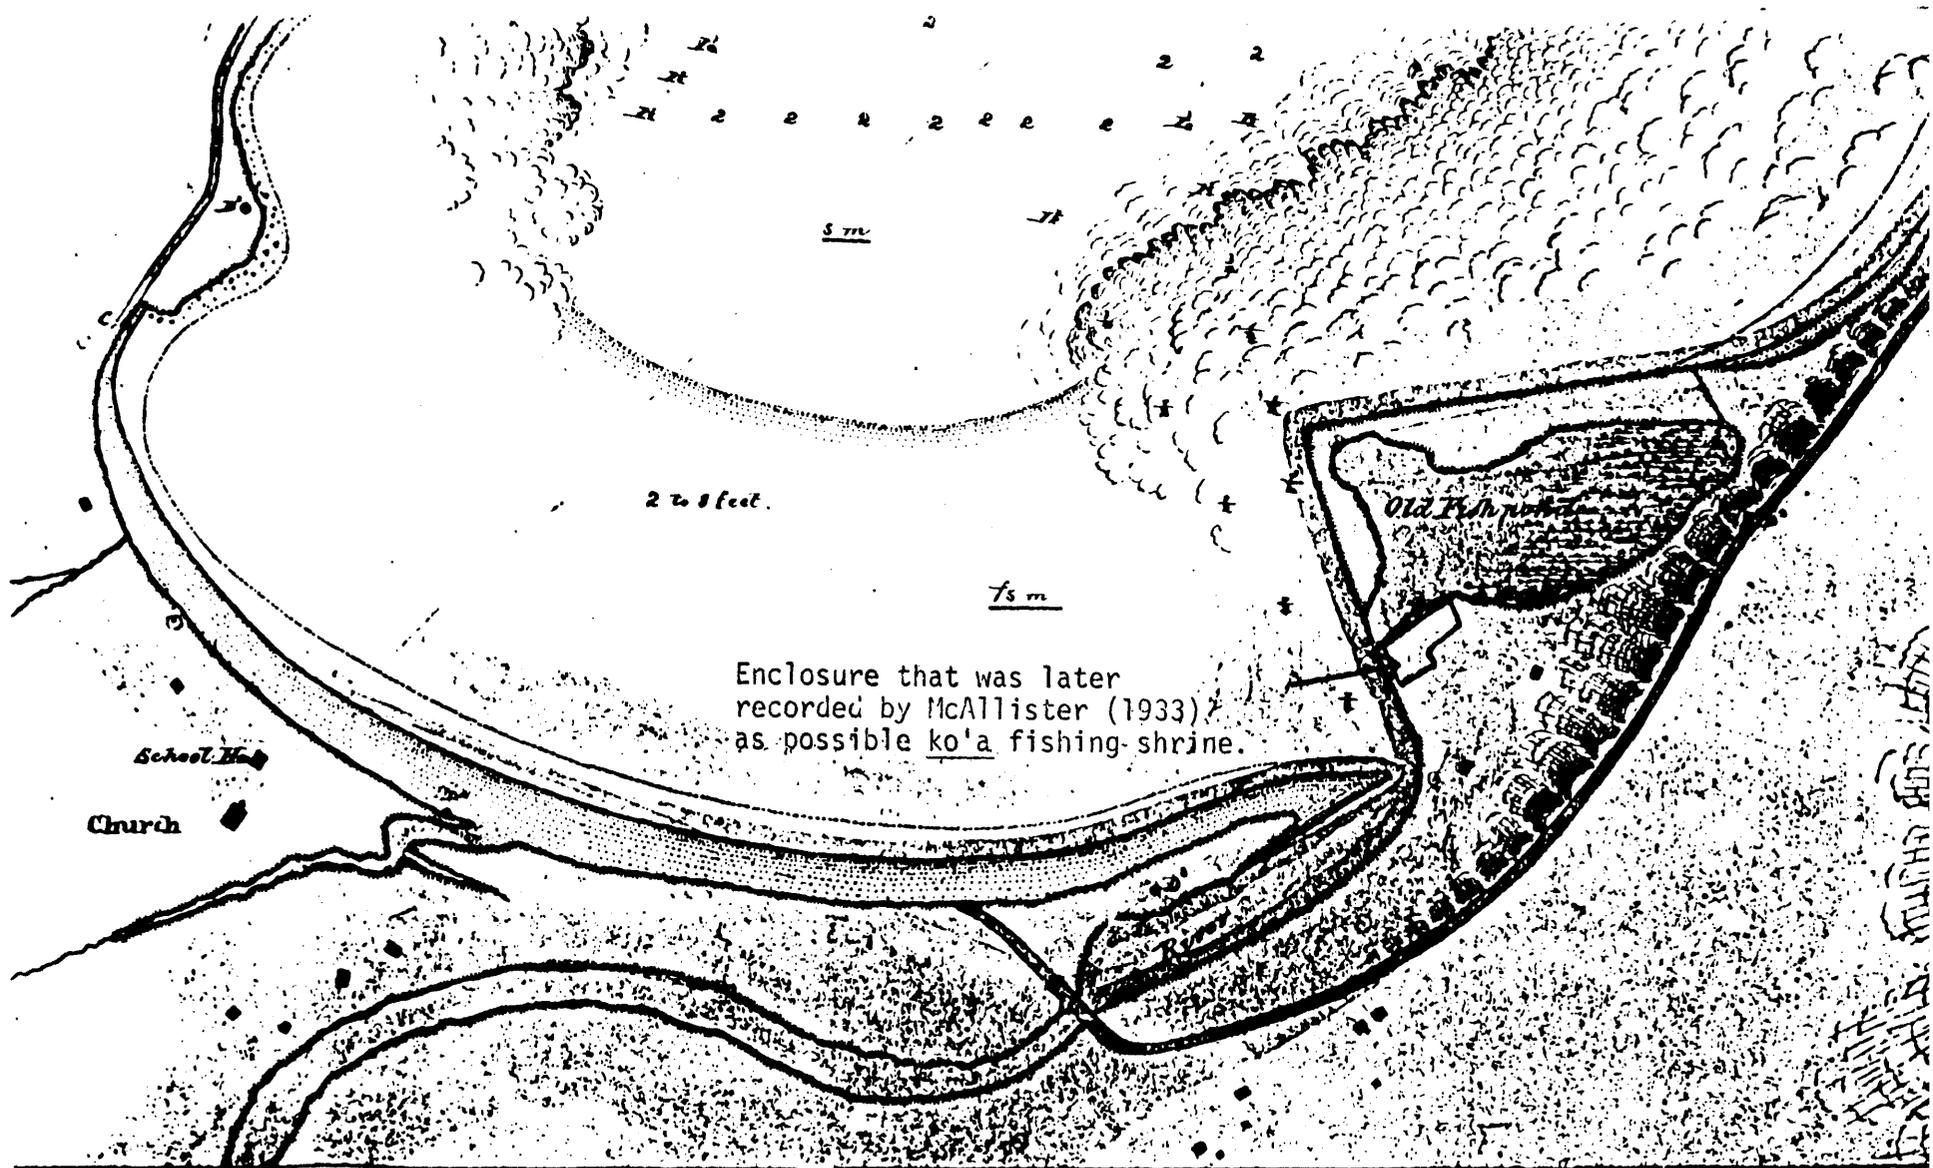
Figure 7: Portion of Hawaiian Government Survey Map (1884) showing Huilua Fishpond at Kahana Bay. Note stone-wall enclosure at southern end of fishpond. From map and survey done by George E. Gresley-Jackson, May 1884, Scale 300' = 1 inch (1/3600). Reg. Map No. 1350, State Surveyor's Office.

Reproduced from Kelly 1980:7.

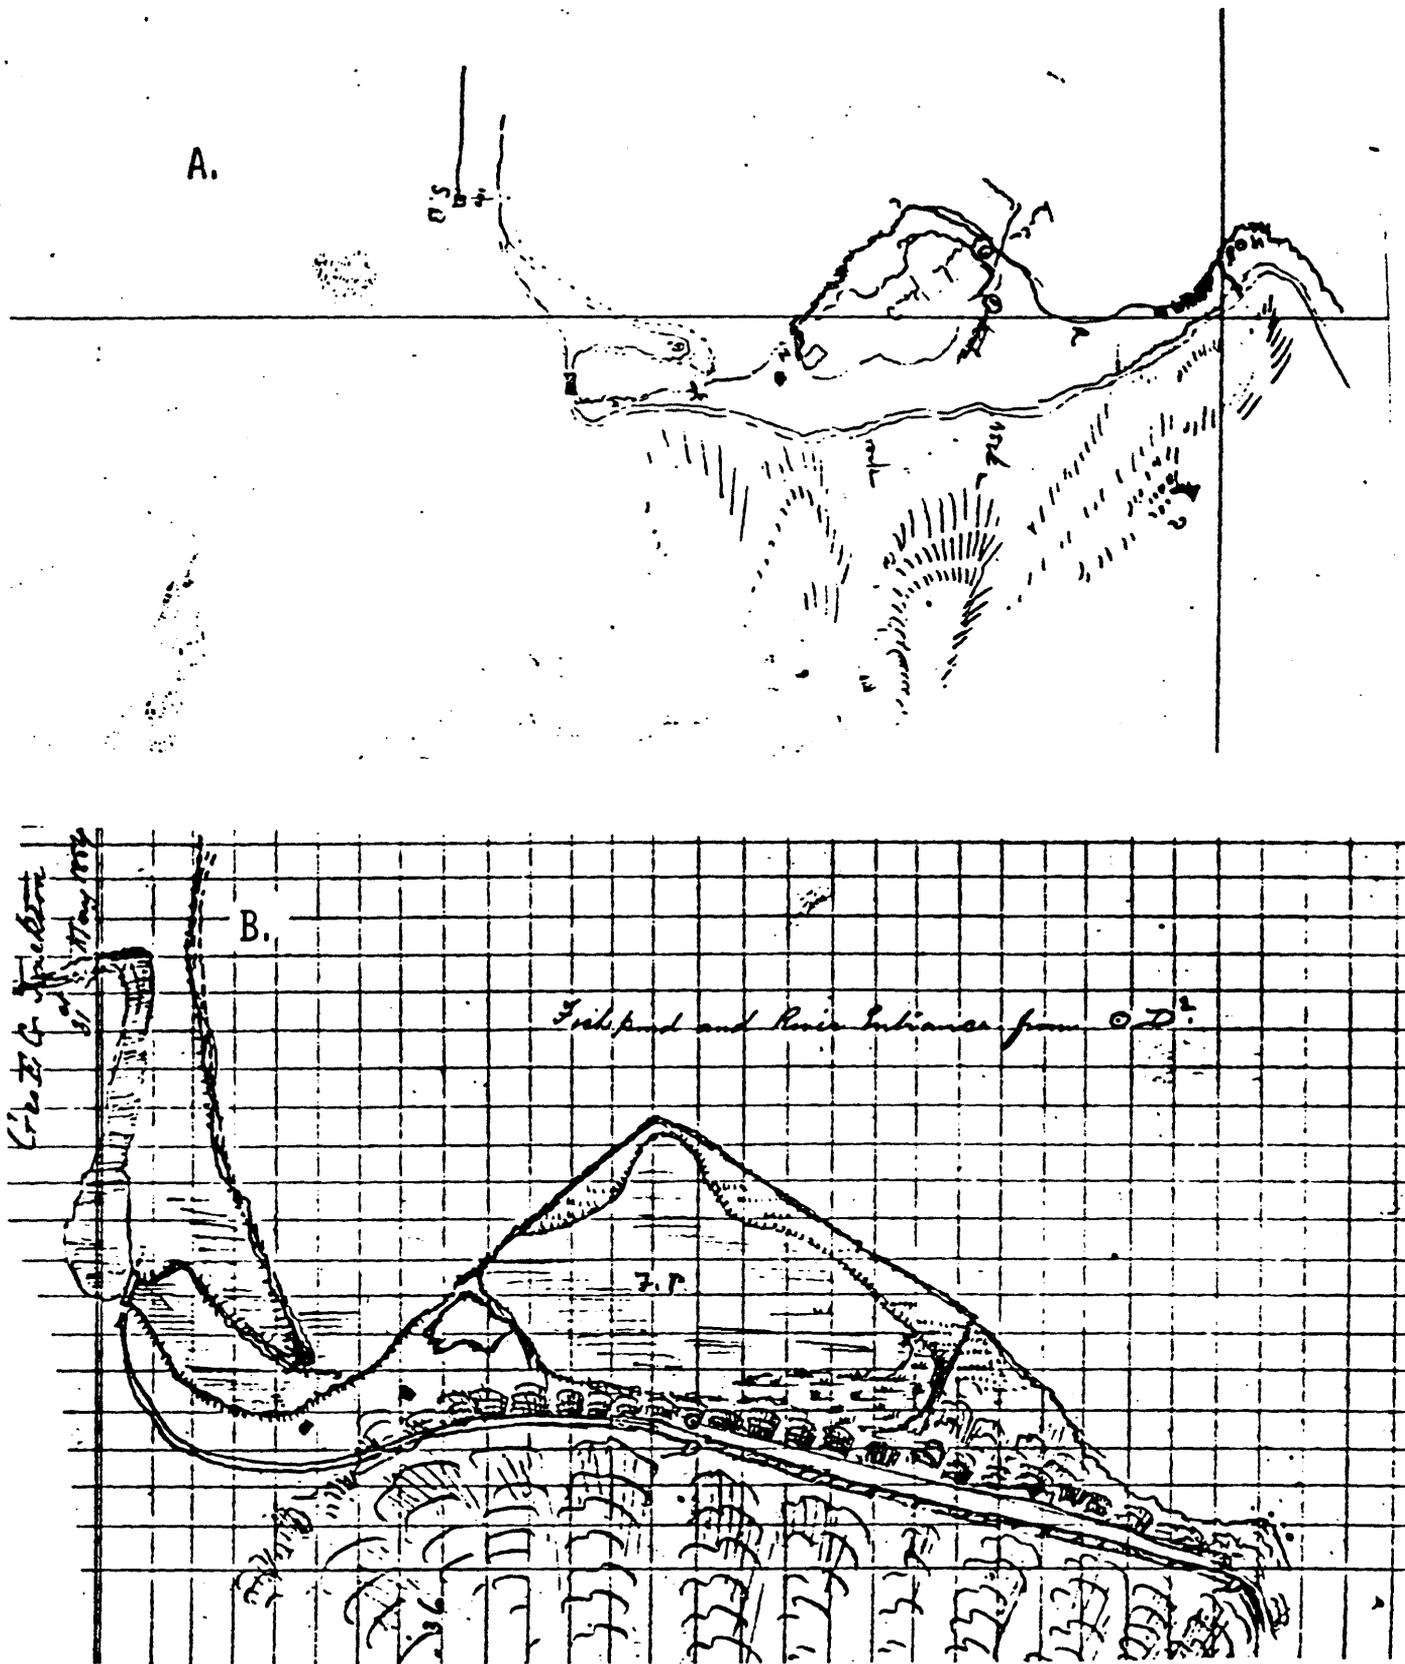
Figure 8: Early sketches of Huilua Fishpond, Kahana Bay, O'ahu from surveyors' field records:

- By J. F. Brown, June 19, 1879 (Field Book Reg. No. 173:95);
- By Geo. E. G. Jackson, May 31, 1884. Fishpond and River Entrance (Field Book Reg. No. 247:13). In these early years the government road around the bay was on the sand beach.
