National Register of Historic Places Registration Form

Resting in 130 feet of water five miles southeast of Port Washington, the schooner *Northerner* represents a rare example of a once common class of vessels on the Great Lakes, the lakeshoring schooner. Built in 1850 by the well-known shipwright John Oades at Clayton, New York, the 81-foot schooner was lost in 1868 off Port Ulao, Wisconsin, while under tow to Milwaukee for repairs. Representative of a relatively undocumented vessel type and trade, the *Northerner* provides historians and archaeologists the rare opportunity to study Great Lakes lakeshoring schooner construction and use. Once common on the Great Lakes, these small schooners occupied a special niche in the Great Lake's regional economy, providing important economic and cultural links between frontier coastal communities. Their operation and use was largely undocumented during the nineteenth century, however, and today the lakeshoring schooner is one of the least understood vessel classes to have sailed the Great Lakes.

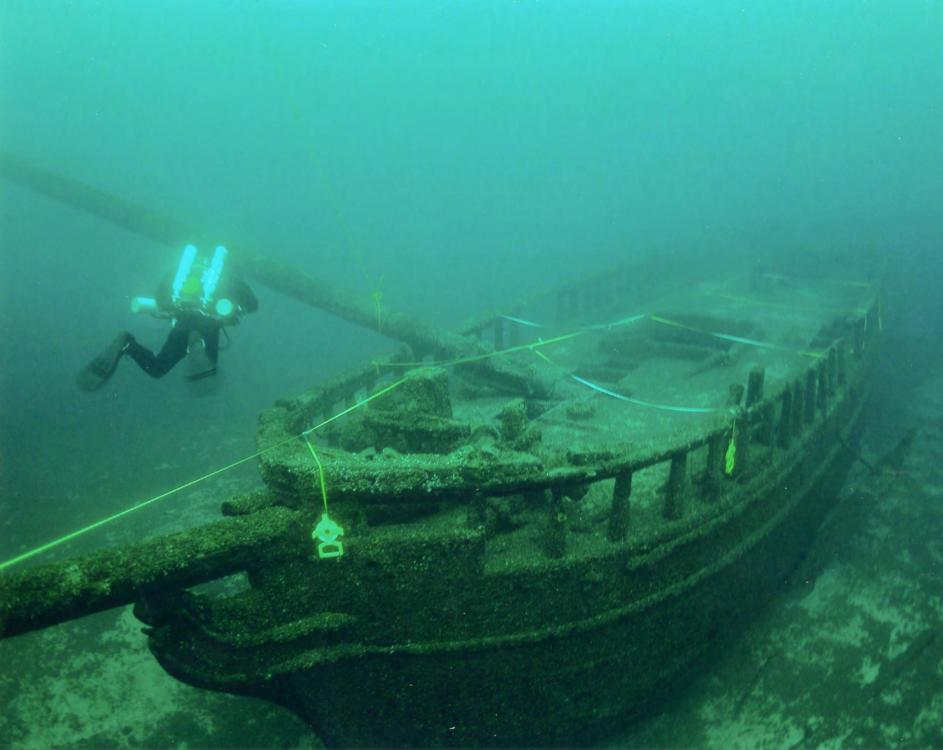
Ozaukee County, Wisconsin Photo 1 of

"Northerner" Shipwreck (Schouner)
