**National Register of Historic Places
Registration Form**

historic name Cape Hinchinbrook Light Station

other names/site number Cape Hinchinbrook Lighthouse (AHR Site No. COR-095)

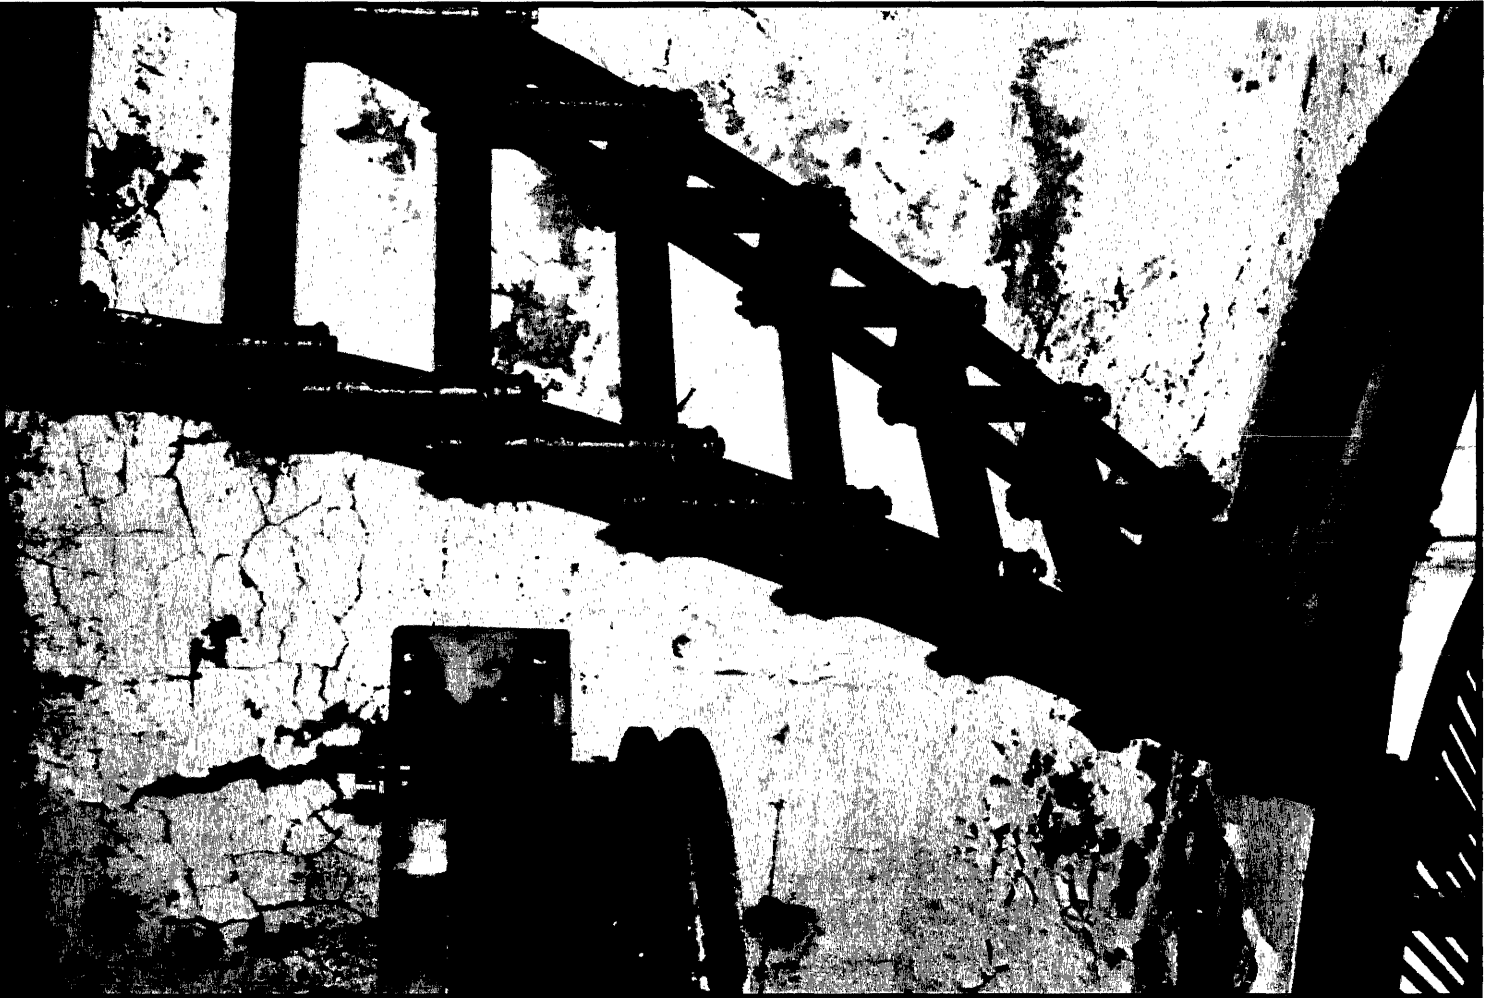
Lantern House Stairs

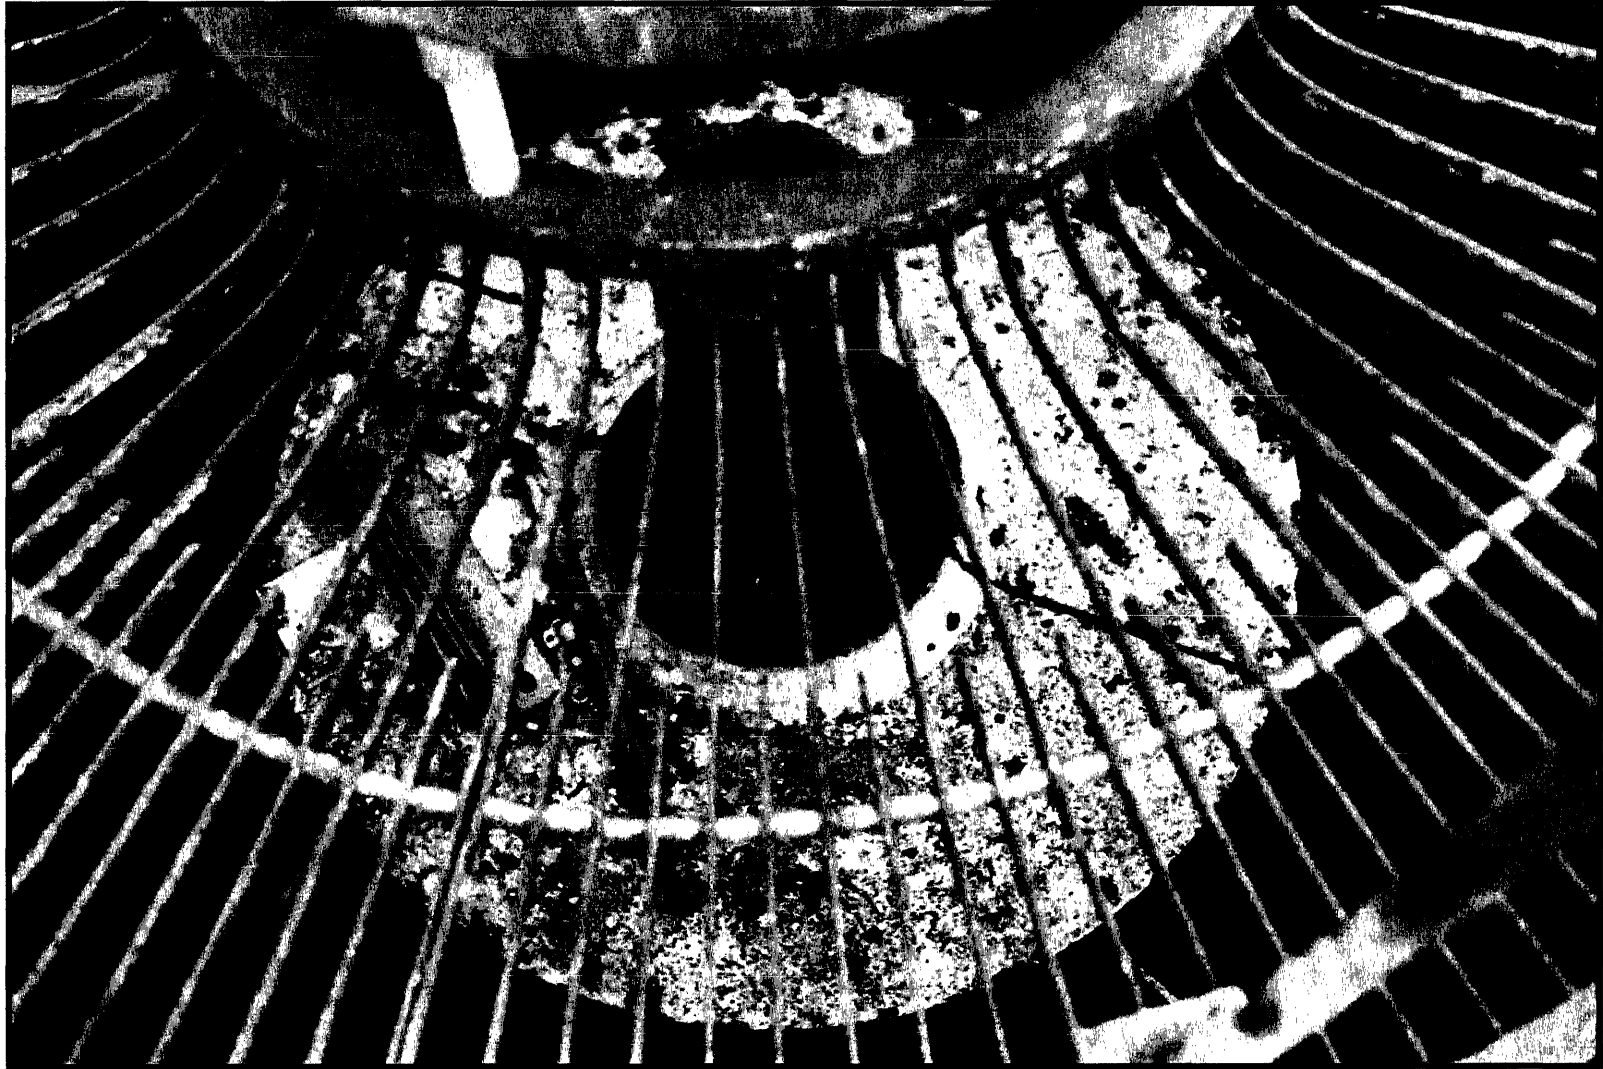
Grate between Lamp and Rotating Machinery

The lighthouse originally was equipped with a third-order fresnel lens manufactured by Barber Bernard & Turenne in Paris, France. The unit reportedly was modified to provide first-order capabilities with a rating of 20,000 candlepower. When installed in the current tower, the light was electrified with a 200,000 candlepower rating. Capacity was upped with a 1,000-watt bulb in 1960, which increased the rating to 3,500,000 candlepower. The original fresnel lens remained in use until 1971 when it was replaced with a DCB-224 beacon. Between 1994 and 1998, the lamp was a 250 mm CG-181 unit that had originally served as an emergency light on top of the roof. The lantern house currently protects a VEGA VRB 25 solar-powered light. The focal plane height for the tower is 235 feet above the water, and 52 feet above adjacent grade.

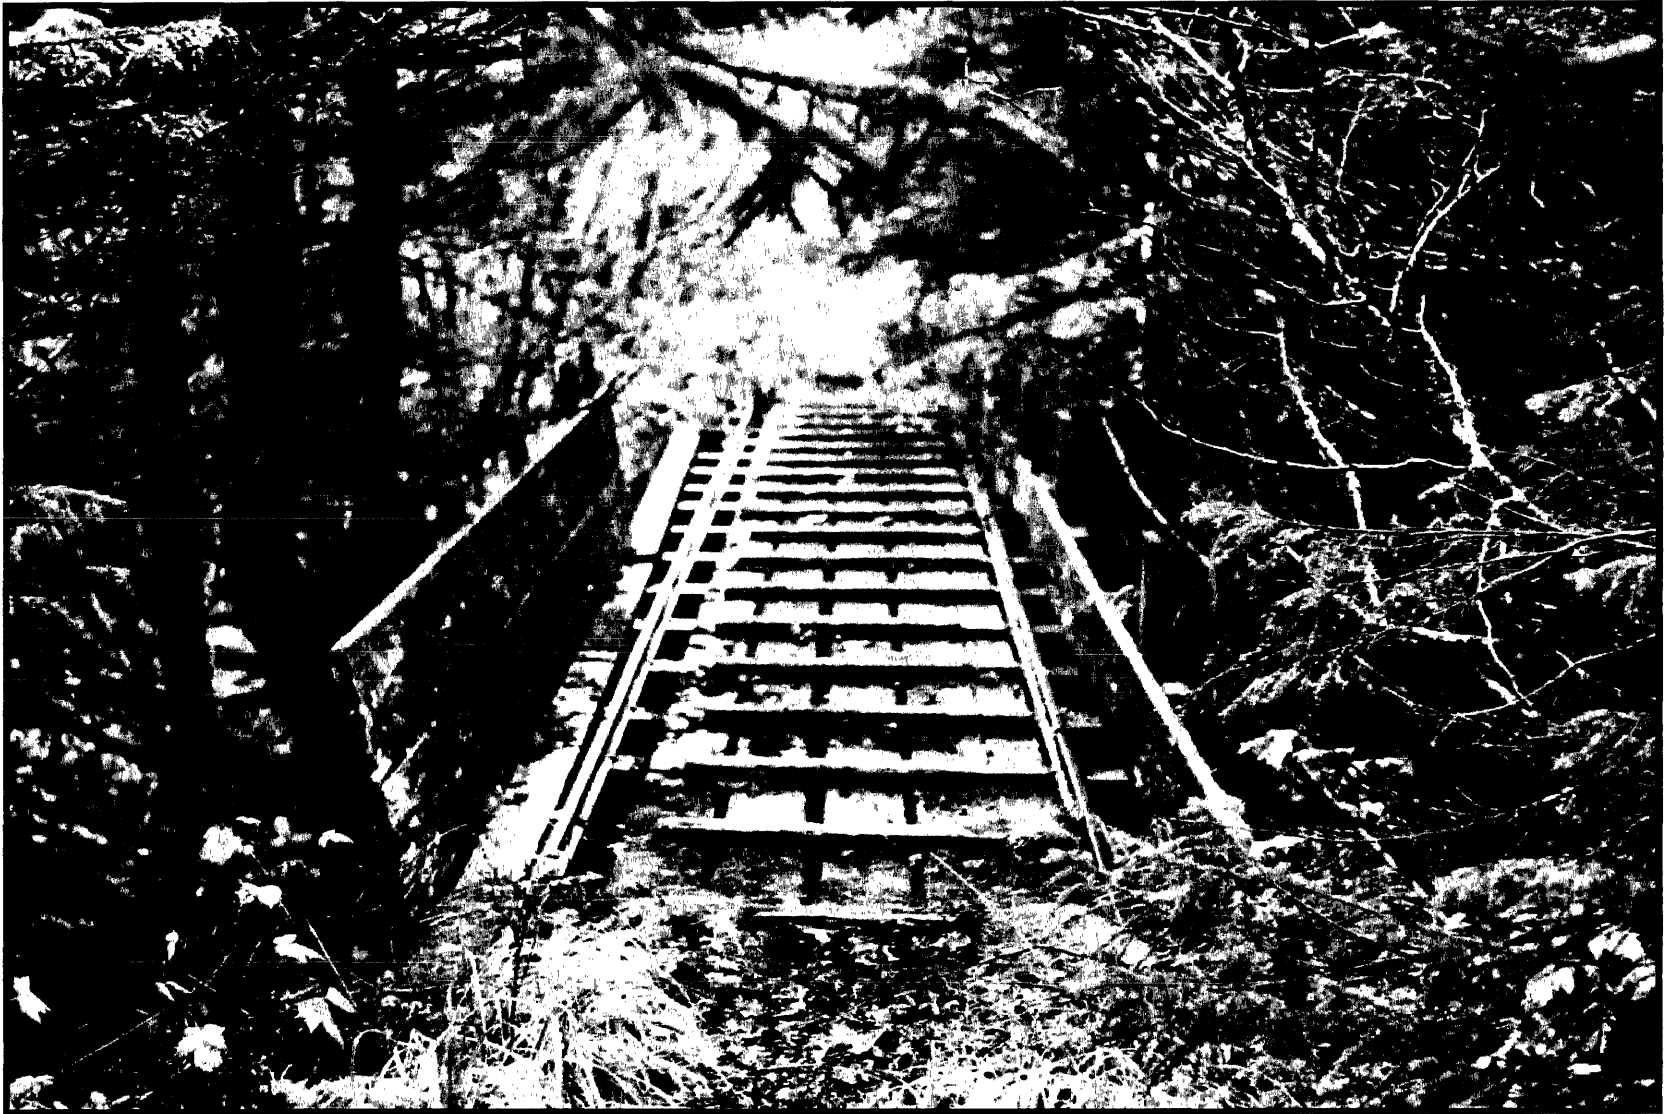
Lower Tramway Trestle
