KENTUCKY HISTORIC RESOURCES
Individual Inventory Form

Resource # 201
Shelby County

1. Name of Resource:
Pemberton Farm

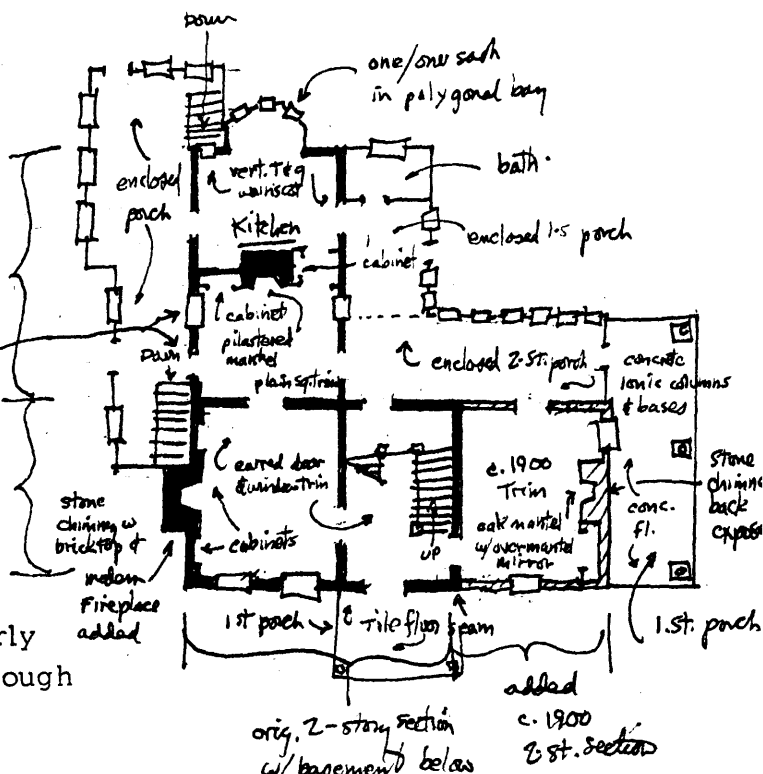
45 Description and House Plan: (continued)

it is conceivable that the vergeboards are an original feature merely duplicated and extended in the ca. 1900 additions. Also in ca. 1900 a polygonal bay window was added to the north end of the ell. At the same time window sash throughout the house were replaced with one/one sash and the existing exterior blinds installed.

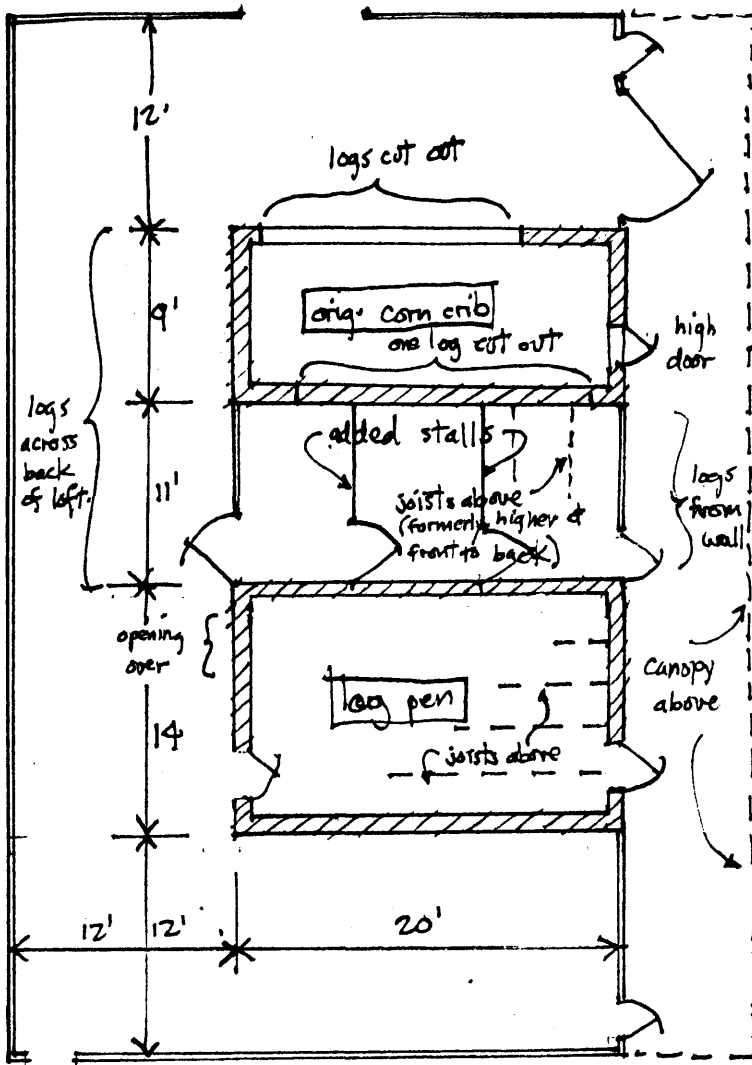
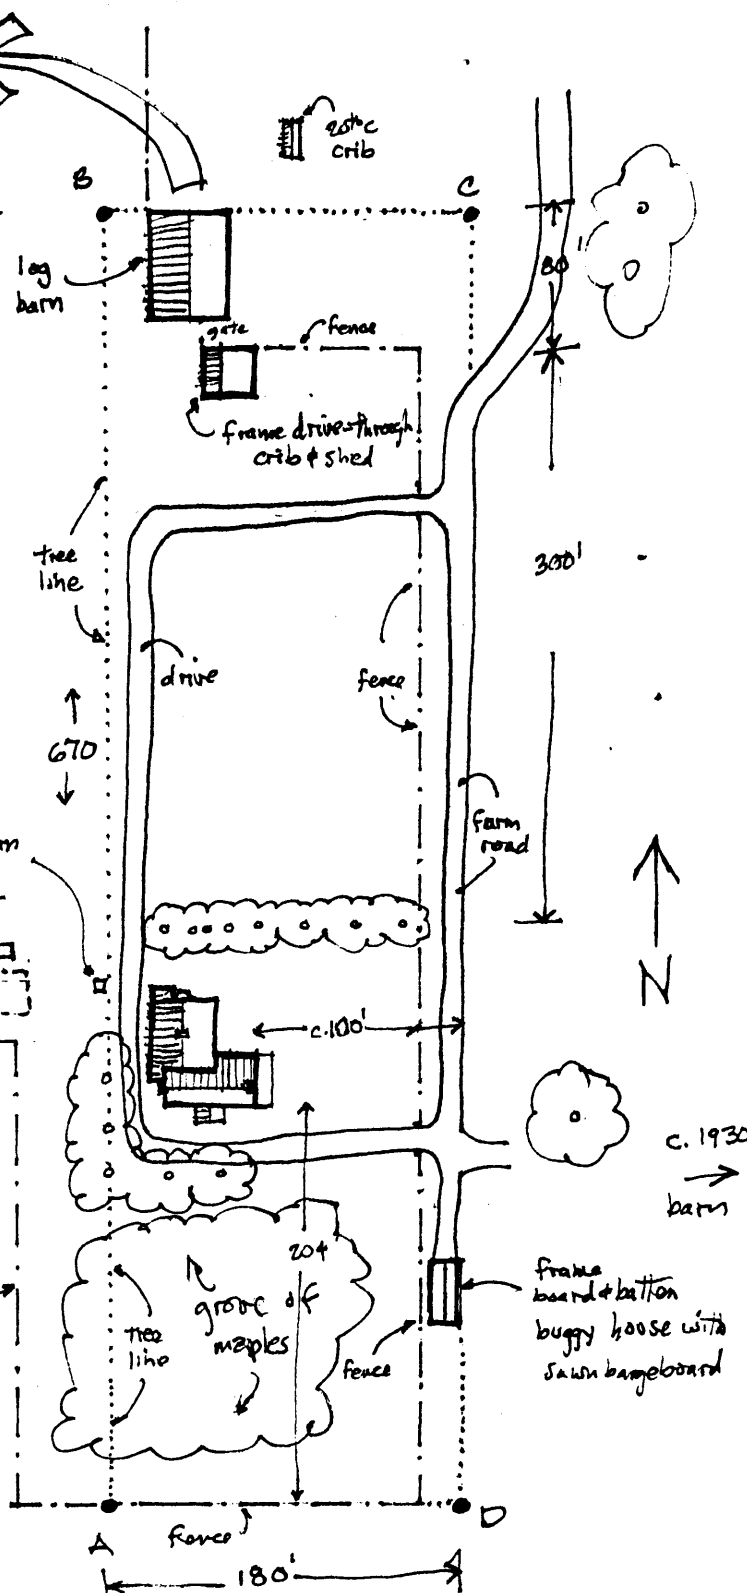
2h-201 Pemberton House
 site Plan
 all dimensions paced 1986
 NOT TO SCALE

Outbuildings: A double-crib log barn stands c.350 feet directly north of the house on a line with the end of the ell. The barn is unusual in its assymetry of plan: threshing floor/drivethrough is flanked by a 9'x20' corn crib on the north and a 14'x20' stall on the south. Threshing floor has been subdivided in this century for cattle or horse stalls. Loft above central space has been lowered. Low loft originally above 14'x20' pen. Logs whitewashed. Frame shed on north, west, and south, as well as a canopy on braces over east front, may be original, as are many such sheds, but shows no direct evidence of such, such as sharing continuous top plates with the log section. A nearby frame corn crib shares a gable roof with a drivethrough wagon shed. the early twentieth-century structure, which has a storage shed attached to the east on the opposite side of the drive-through from the crib, forms an L-shape with the barn. A frame buggy house with board-and-batten siding and decorative sawn vergeboards similar to those on the house, stands southeast of the house the the end of the entrance road. It is similar to a buggy house at the Pickett House (Sh-162)
