National Register of Historic Places
Registration Form

historic name "Ocean Wave" Shipwreck

city or town Lake Michigan

state Wisconsin code WI county Door

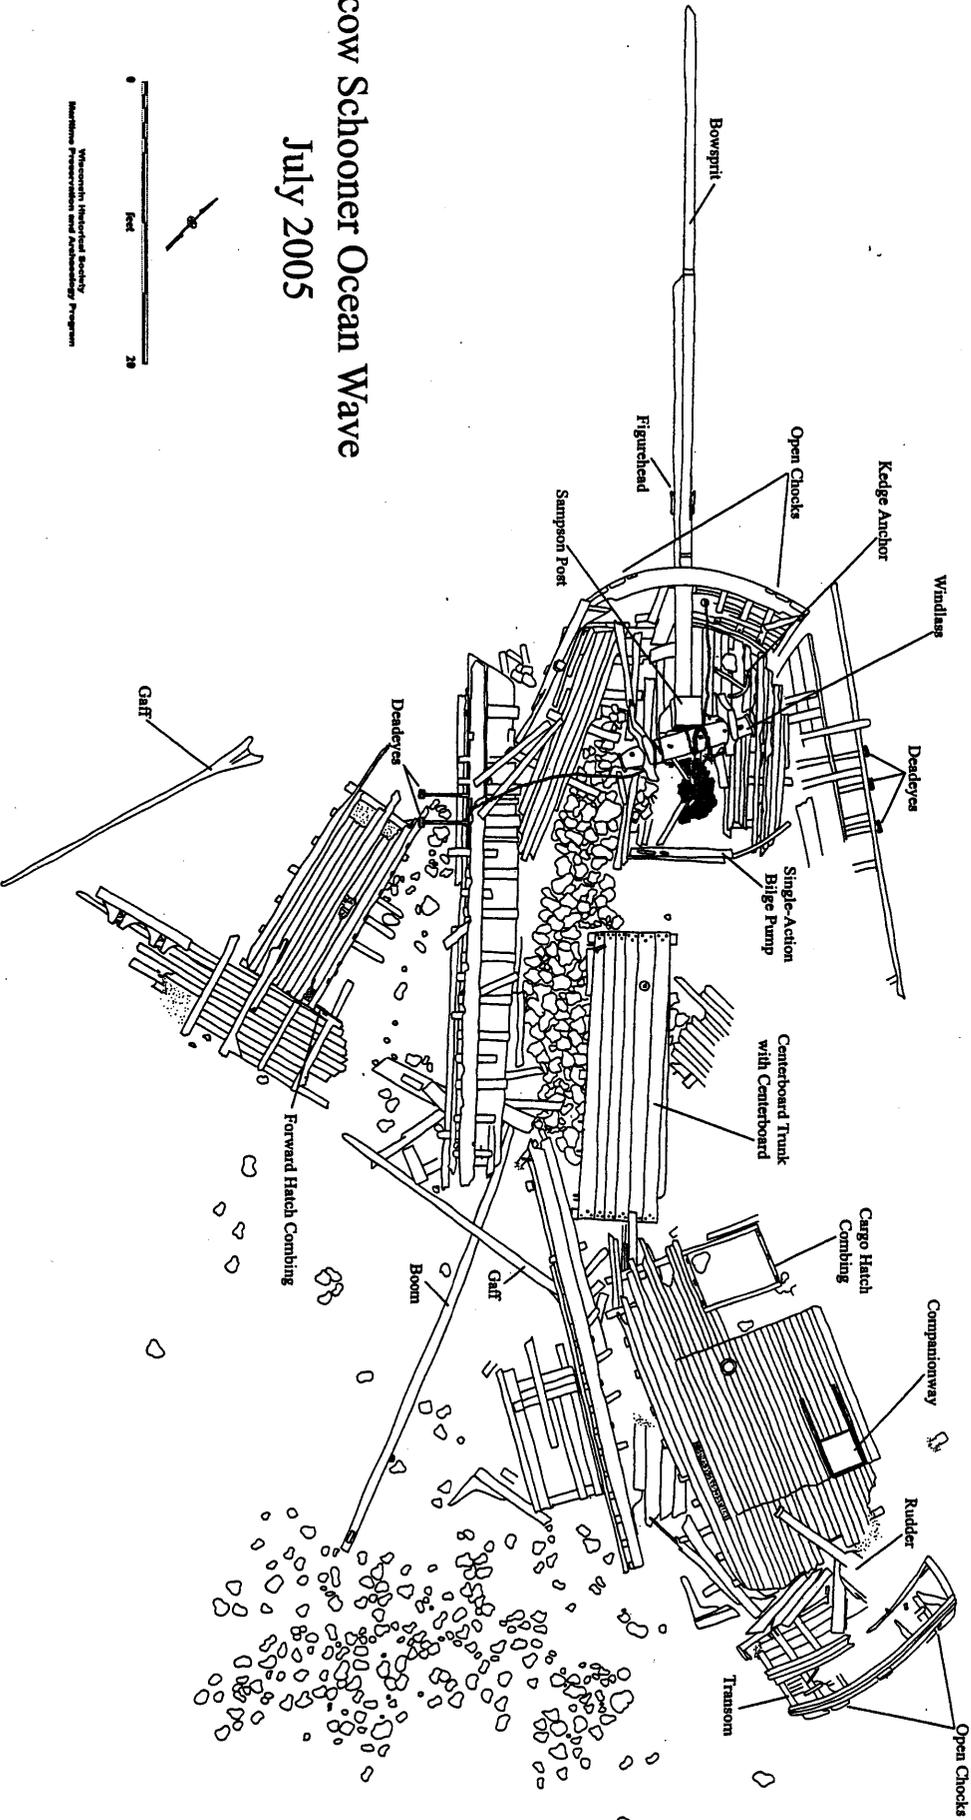
Scow Schooner Ocean Wave
July 2005

"Ocean Wave" Shipwreck
Lake Michigan
Door County, Wisconsin
