NATIONAL REGISTER OF HISTORIC PLACES  
INVENTORY - NOMINATION FORM

COMMON:  
**C & O CANAL**

CITY OR TOWN:  
**Washington, D.C. to Cumberland, Md. (Western Terminus)**

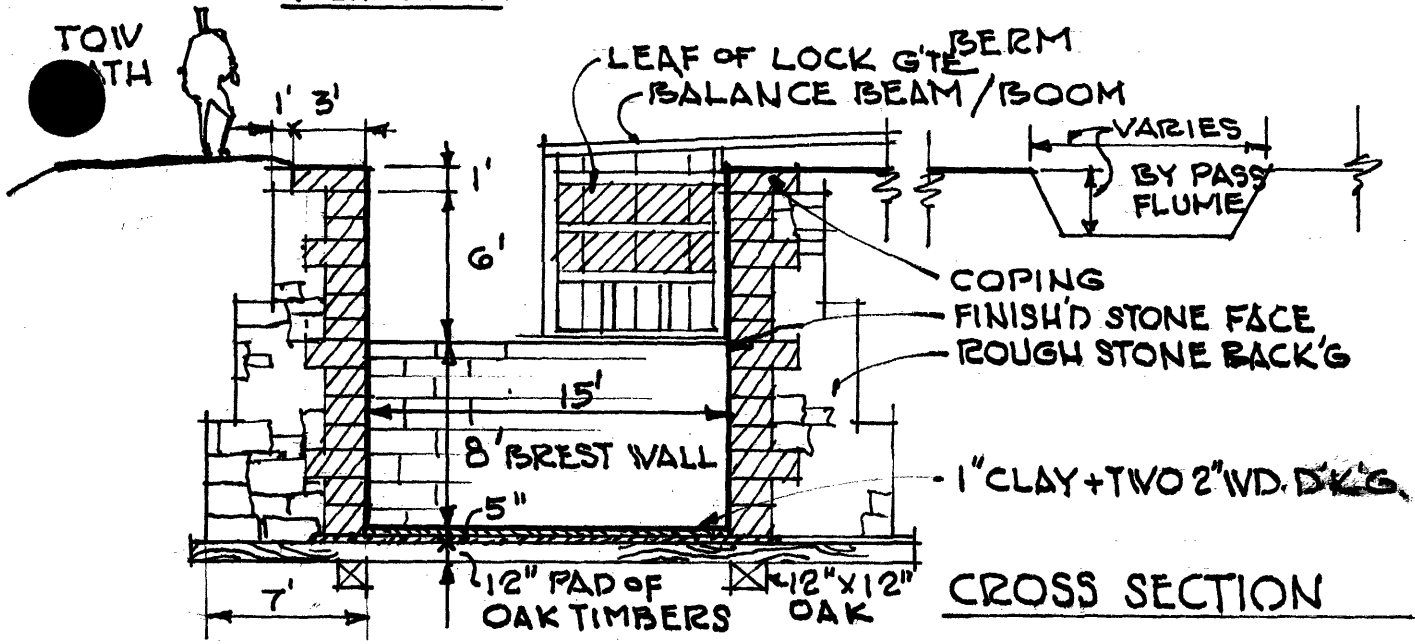
B. - Locks:

From the sea level elevation of zero feet for the Potomac at Georgetown, the river rises to the inland elevation of 605' at Cumberland. This change of elevation of 605' was divided up into 74 increments of change, thus giving the majority of locks an 8' vertical movement of water to be accomplished and accommodated. The use of the canal was totally dependent on the proper functioning of the locks. A standard plan was

developed and the written specifications required a wood foundation of oak timbers, stone of high quality, carefully cut and finished and properly laid in cement mortar. The workmanship was of high standards to be accepted. Minor variations in the locks were made at specific locations to suit existing local conditions, but the plans, and the specifications of 1829 and 1830 (which move the brest wall from the down edge to the up edge of the upper lock gate pocket thereby requiring two tall lock gates), held until the 1848-1850 period when restricted time and finances forced the Canal Company into many changes in the locks. The lock trench was dug or prepared to an exact surveyed depth. Unless solid rock was found at the proper depth, a bed was laid of 12" x 12" oak timbers, approximately 30' long, placed perpendicular to the run of the lock, and with their sides butted. This wood pad was underlaid by 12" x 12" timbers with their ends butted to give a continuous length of timber under the face of the two parallel lock walls. Three-inch thick plank sheet piling from the top of the pad to 5' below was placed at the up and down canal lock ends of the pad plus at two intermediate locations. Two-inch wood decking was placed over the timber pad and butt-laid perpendicular to it. The decking was laid to continue under the lock wall face stones. The lock walls were 15' apart and built of cut and finished stone with minimum dimensions of 2½' long, 1' high, and 18" thick, carefully set in cement mortar in regular courses. The walls were topped off with a coping stone of 12" height and 3' top exposed thickness with a minimum of 3' length. The top lock side edge of the coping stone was rounded with a 1" radius. Under the coping stone the face wall was backed up by a rough cut stone wall laid to give a total wall thickness of 4' at the top, increasing to 7' at the bottom in two equal steps. The height of the lock wall was dependent on the change of level of water to be accomplished in the lock, but a typical height of 15'-3" would include 2" finished decking butt laid crossways of the lock, 1" clay, 6' water level, 8' change of water level, plus 1' coping. The main body of the lock was approximately 92' long. At each end, each side of the main body walls a 10' long, 16" increase of width was laid to become a lock gate pocket. Typically the down canal edge of the upper lock gate pockets was the location of the 8' high stone, cross lock wall, known as the brest wall. It was here that the bottom of the lock moved up to the top of the brest wall for the remainder of the upper lock. It was the height of this brest wall that gave the lock the ability to change the water level more or less than 8'. Above the upper lock gate pockets the lock walls moved back to the 15' clear width and continued in straight run (known as extension wall) for approximately 7', at the end of which they curved out in a quarter of a circle to run about 12' perpendicular to the lock walls, (known as wingwalls) to either bank of the above canal. Immediately below the lower lock gate pockets the lower extension walls run for about 14', with a clear width of 15', curve out in a quarter circle and run for 12' plus as wingwalls perpendicular to the lock. Water ducts were placed at the bottom level of the walls in the upper pockets and main body of the lock. Water was controlled by iron wicket gates in the pocket wall that could be adjusted by iron stems that emerged through the coping stones. To fill the lock, when the top lock gates were in their normal closed position, the lower gates were closed, the upper water wickets opened, and the lock filled, then the upper gates could be opened, a
