National Register of Historic Places Registration Form

1. Name of Property			
		la Quebrada Manzana	
other names/site number Lo	s Tuneles de San Ge	ermán; Vaulted Brick	Tunnel Storm-
Se	wer System		
2. Location			
	rrocarril and Calle	e Esperanza	not for publication
city, town San Germán			violnity
etate Puerto Rico C	ode PR county Sa	an Germán cods PR	125 zip code 00753

Section number 7 Page 9 Vaulted Brick Tunnel Storm-Sewer System, San Germán, Puerto Rico

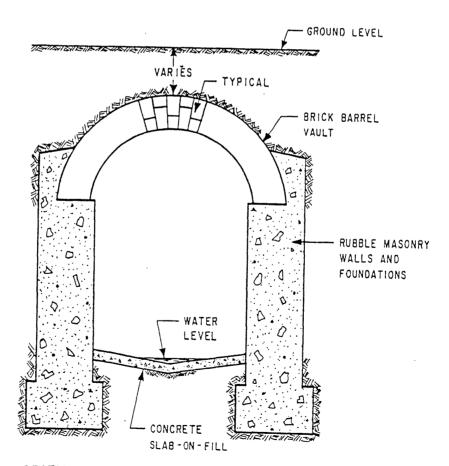
PARTIAL VAULT SECTIONS

SECTION OF TYPICAL 11/2 BRICK THICK RECESSED TUNNEL SEGMENT VAULT

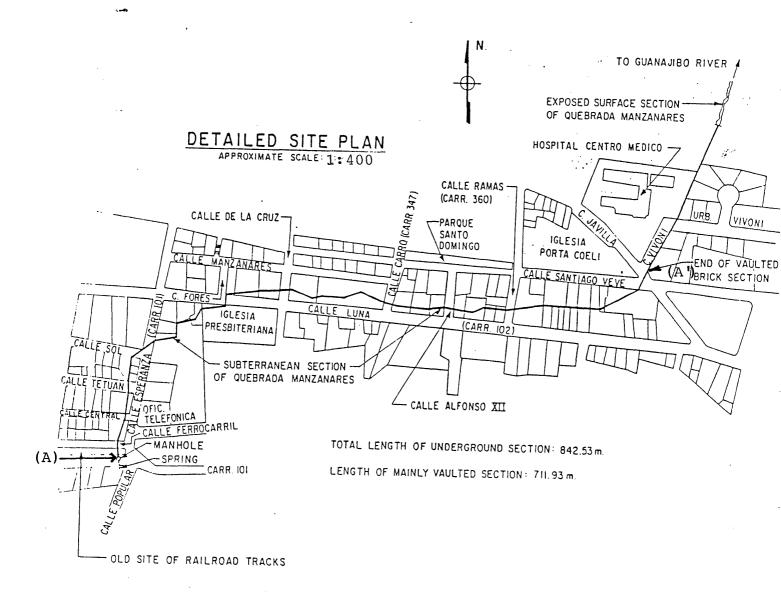
*Note: The property being nominated is limited to the line A-A'.
