BRIDGETON HISTORIC DISTRICT

PARKE COUNTY, INDIANA County and State

Bridgeton Historic District, Parke County, Indiana

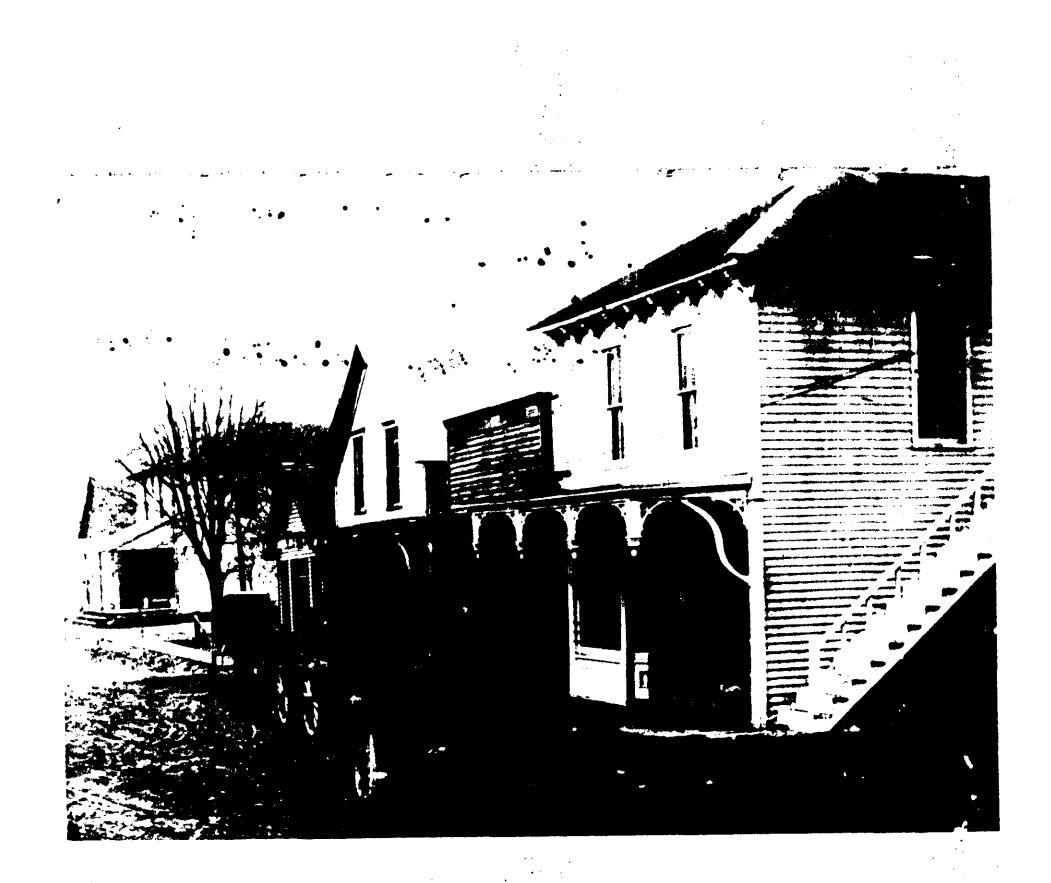
Historic Photograph-Bridgeton Historic District, Parke Co., IN Building to right with exterior stair is "Ye Olde Covered Bridge Shoppe" today.

Ye Olde Covered Bridge Shoppe, Photo 8, Building 3

This non-contributing building was originally quite similar to buildings 8 and 31, having a two-story, hip roofed appearance. At some point in the last thirty years, it was reduced to one story and the store front was changed (see historic photo). Apparently, the cornice and scroll brackets were salvaged from the demolished second story, cut and fitted to the present structure. Thus, the gable end has irregularly spaced brackets which are not raked.
