San Miguel Church Name of Property Socorro County, NM County and State

7. Description

Narrative Description

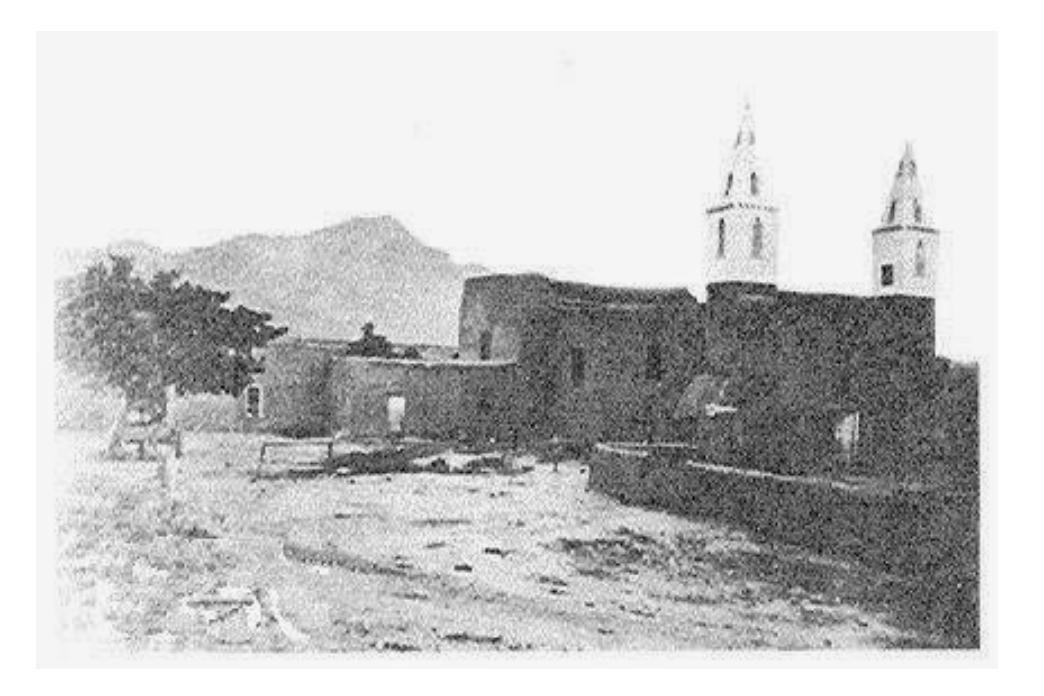
Figure 1. San Miguel Church, c.1880.

The Atchison, Topeka & Santa Fe Railway arrived in Socorro in 1880, bringing manufactured building supplies from the East. During the 1880s, gabled and hipped roofs were constructed over San Miguel's nave and apse. The wood-shingled roofs obscured the clerestory opening. The existing windows on the north and south sides were rebuilt as Gothic lancet windows. The four-over-four-light sash windows replaced smaller, higher window openings, which provided greater protection from raiding Indians. A square window was located above the entrance, which was sheltered by a wood semi-circular entrance porch.

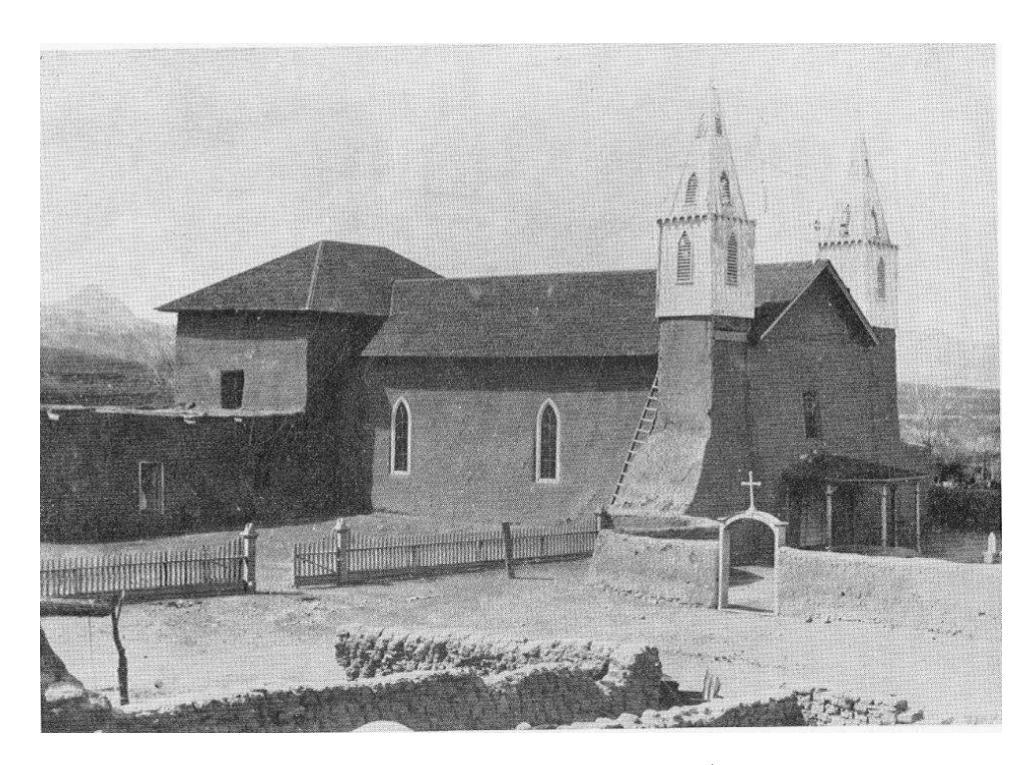
Figure 2. San Miguel Church, Late 19th century.

Late-19th-century photographs depict the small, flat-roofed sacristy on the south side of the sanctuary. A wooden picket fence enclosed the yard in front of the sacristy, its gate opposite the sacristy door. A mud-plastered adobe wall lined the three sides of the forecourt that included a campo santo. In the 1880s, the parish men, Los Caballeros Catolicos de San Miguel, or the Catholic Knights of Saint Michael, built the side chapel on the north side of the sanctuary by enlarging the north transept. The upper stage of the towers were remodeled a second time in the Gothic Revival style with Gothic-style pediments on all sides of the tower. The openings in the

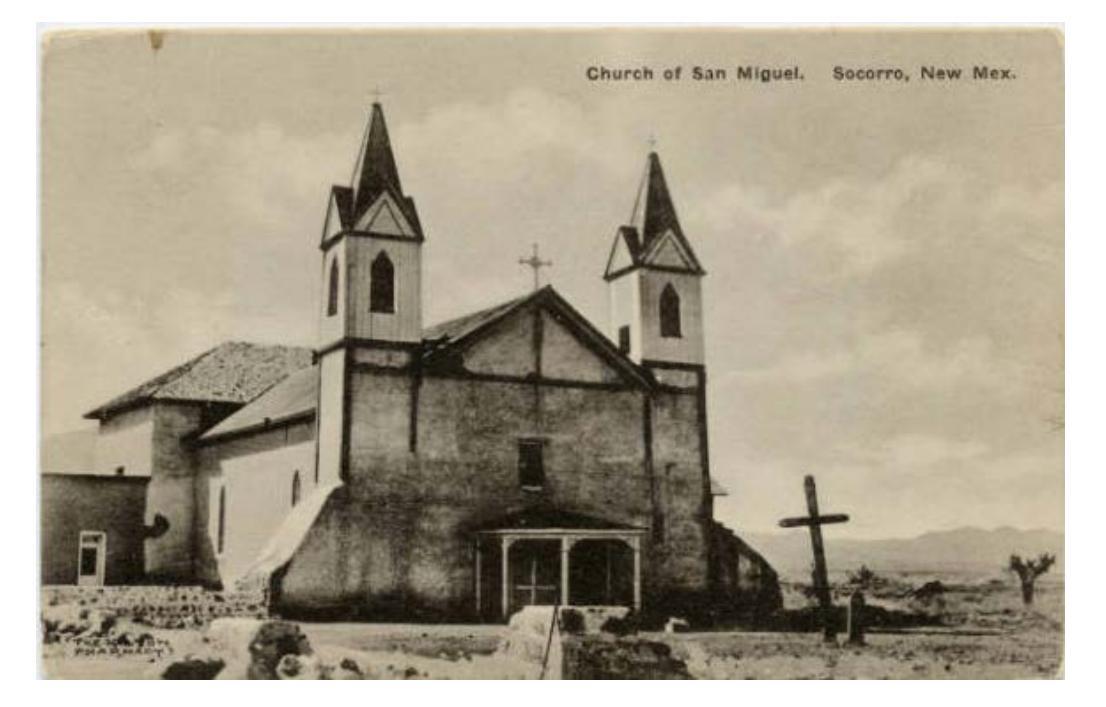
Figure 3. San Miguel Church, c.1900.

spires were removed. In 1902, the *Socorro Chieftain* reported that the "appearance of the church of San Miguel has just been much improved by the repairing of the cupolas."⁵

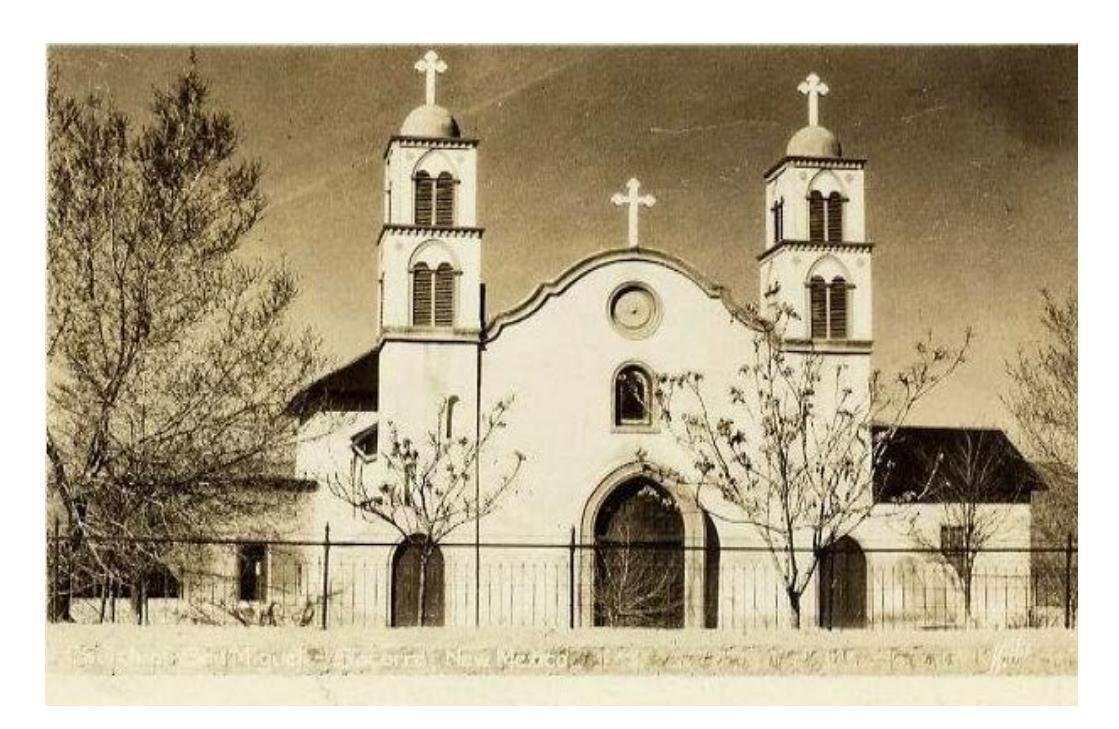
Figure 4. San Miguel Church, 1933.

The Gothic Revival style, which the congregation associated with French architecture, fell out of favor. In c.1930, Pastor Peter Pelzer rebuilt the towers and parapet in the Spanish Colonial Revival style. He also installed a bell in the north tower. The lancet windows along the nave were replaced with larger, round-headed windows. Pastor Joseph Mueller installed stained-glass windows between 1944 and 1949.

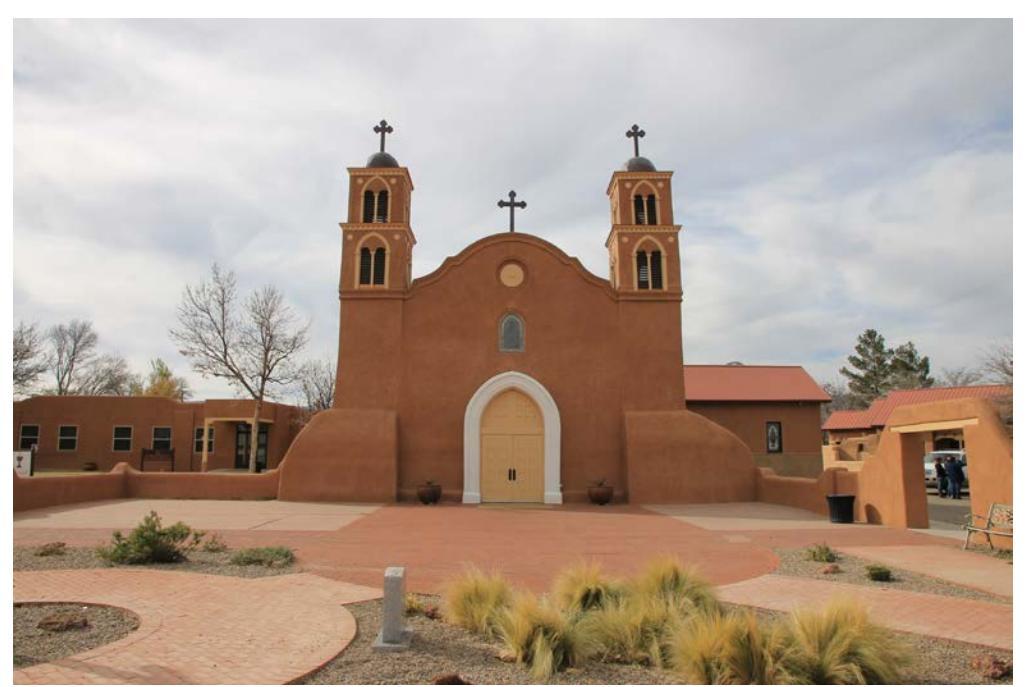
3 of 16. San Miguel Church, main façade, photographer facing west.

In c.1933, the Gothic Revival-style façade was rebuilt in the Spanish Colonial Revival style with an arched parapet and twin towers. The façade is balanced and symmetrical. The three-stage towers are square in plan and surmounted by domes topped with metal crosses. The towers feature decorative rosettes and copper louvres framed in molded Gothic arches. The Gothic-style entrance remains. An arched stained-glass window depicting the Archangel St. Michael is located above the entrance. A rondel with a sunburst motif is located in the parapet.

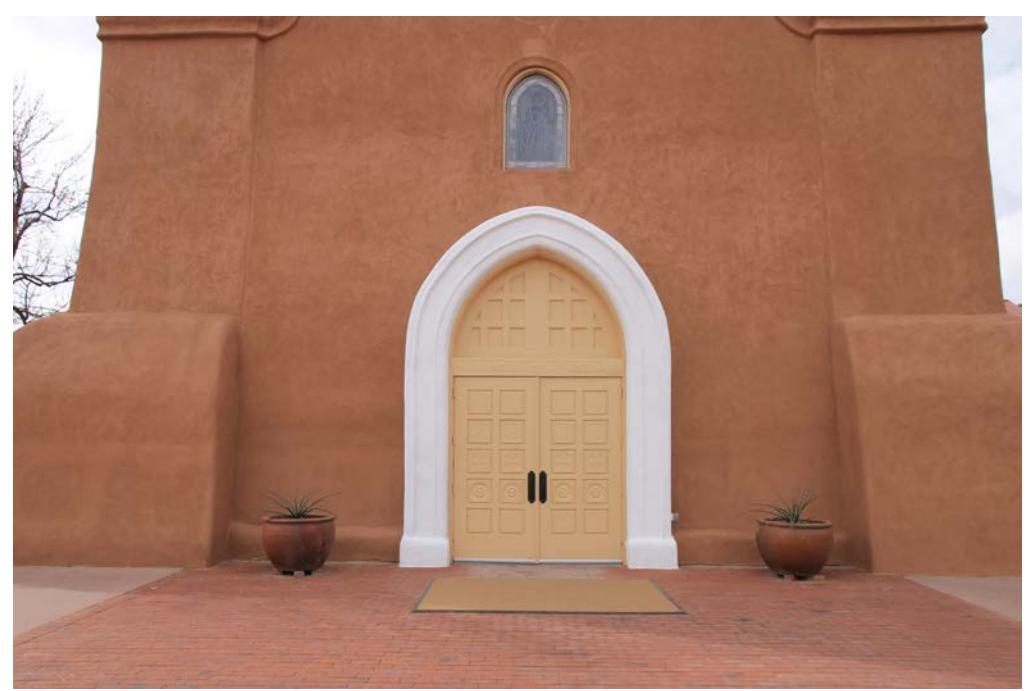
4 of 16. San Miguel Church, detail of entrance doors, buttresses, and San Miguel window, photographer facing west.

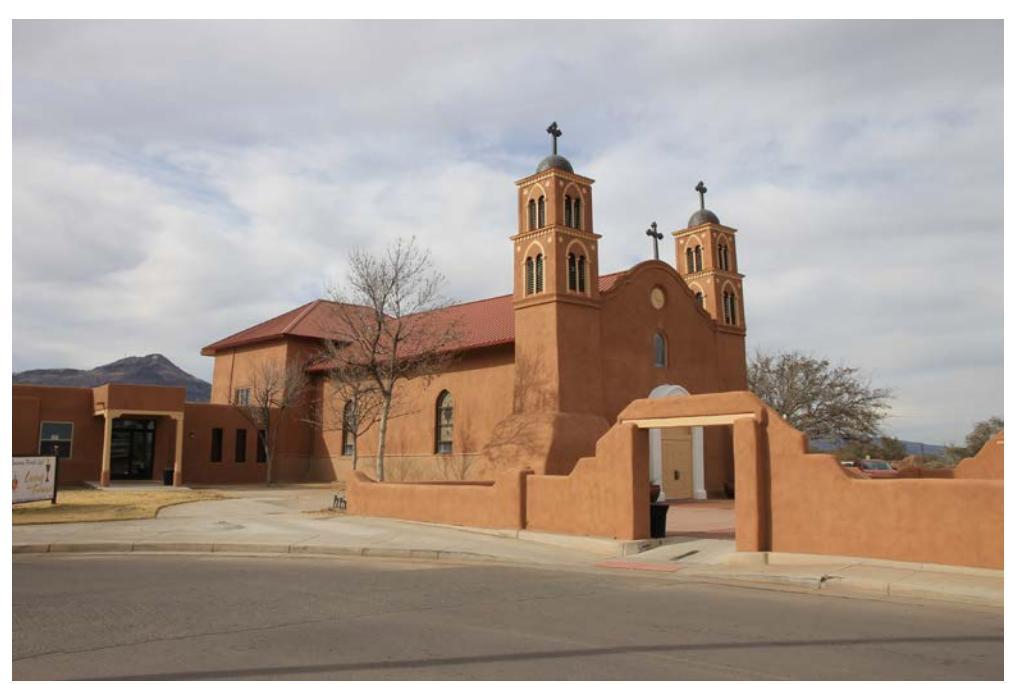
5 of 16. San Miguel Church, main façade and south side with sacristy (left), photographer facing northwest.

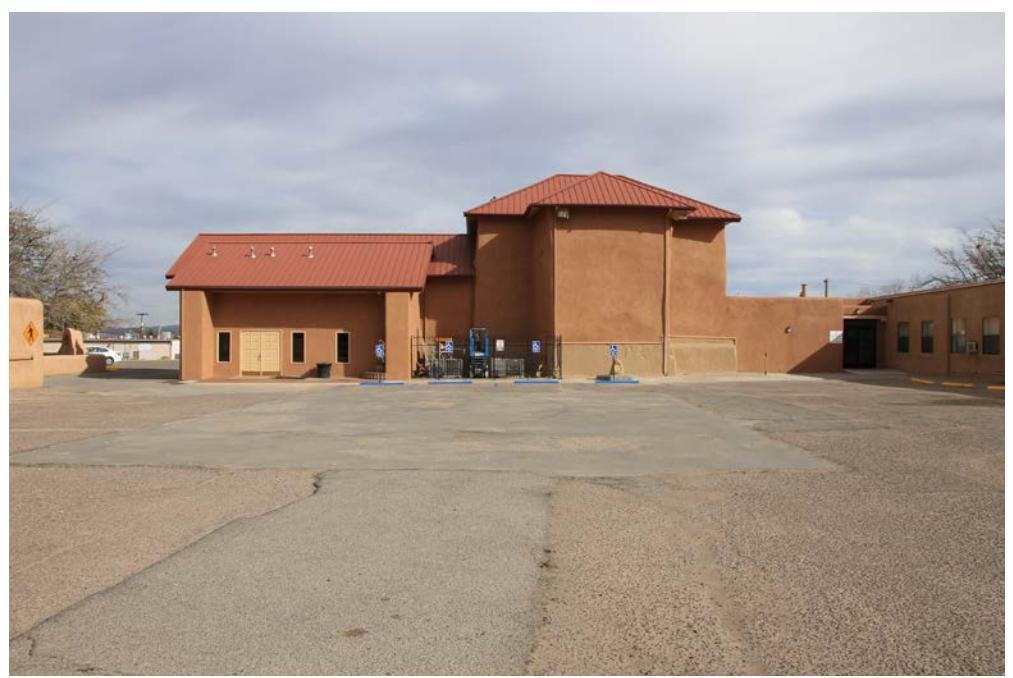
6 of 16. San Miguel Church, west (rear) elevation, with school at right, photographer facing east.

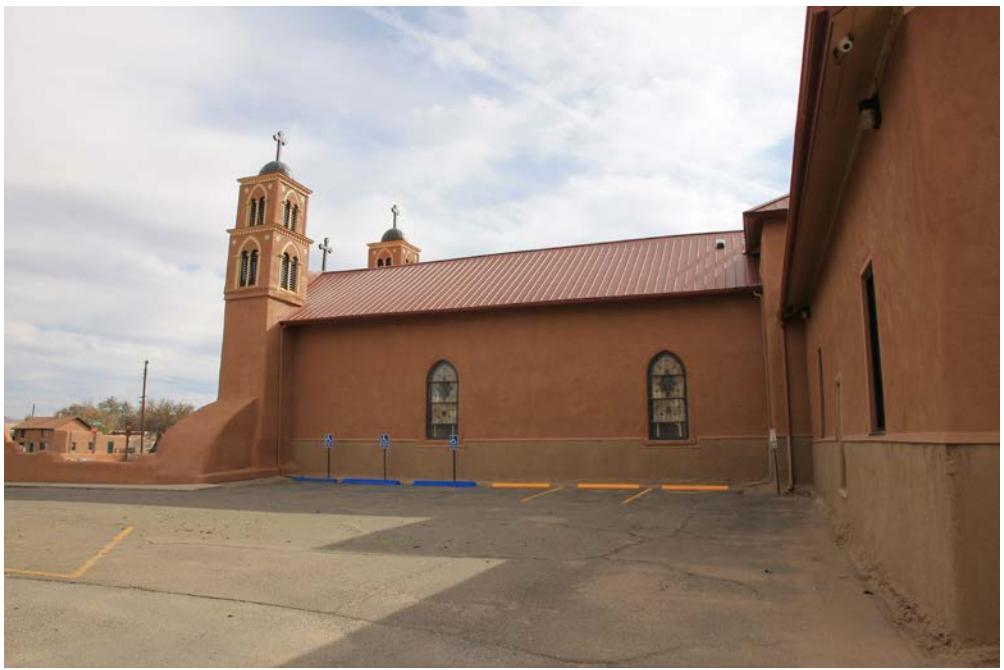
7 of 16. San Miguel Church, north side with side chapel (right), photographer facing southeast.

The north and south sides of the nave each include two, arched stained-glass windows. These are set in larger rectangular openings, which can be seen on the interior. The side chapel features square replacement windows. In 1974, a small, two-room addition was built on the west side (rear) of the side chapel to serve as a confessional and entrance foyer.

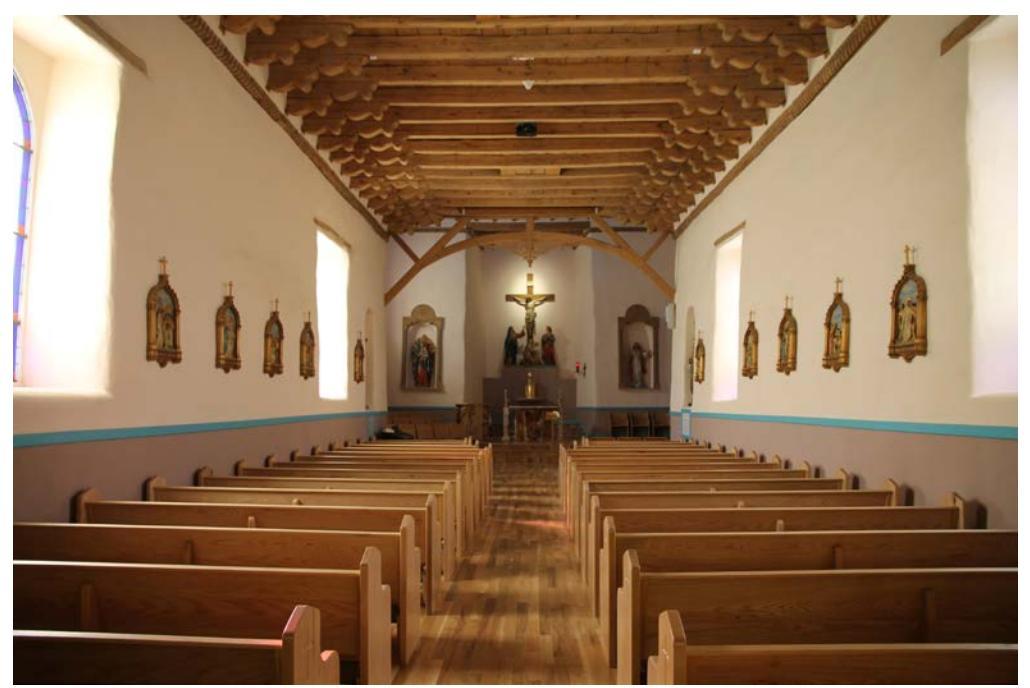
8 of 16. Interior, nave toward sanctuary and altar, photographer facing west.

The sanctuary is elevated above the nave by several steps. The pulpit faces the northeast to allow the clergy to address worshippers in the nave and side chapel. The altar features a sculpted crucifixion scene. The apse is flanked by rectangular nichos with newly installed, unpainted wood surrounds. The stylized surrounds are flanked by Solomonic columns and topped by sunbursts. The ceiling in the side chapel is supported by corbels and vigas. A doorway on the shallow south transept leads to the sacristy.

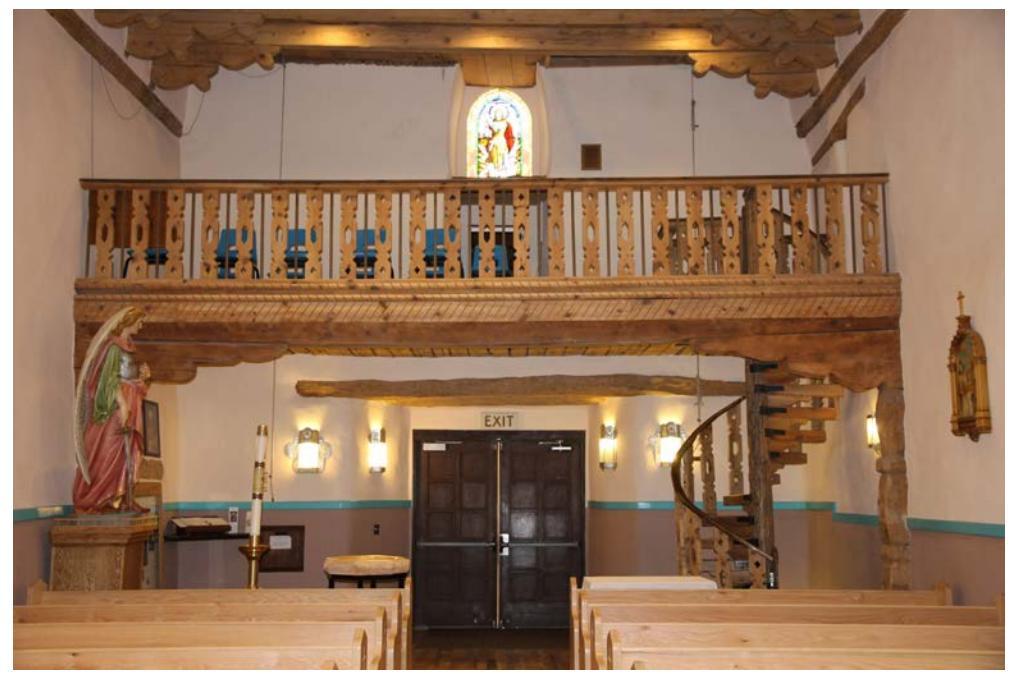
14 of 16. Interior, choir loft, photographer facing east.

The cruciform plan includes a shallow transept on the south side and an extended transept on the north that that forms the side chapel, which was built in the 1880s. Hand-carved wood pilasters, original to the church, support the choir loft. The circular wood staircase and choir loft balustrade were built during a renovation of the church in 1973 and 1974. The fifteen rows of wood pews seat 300 worshippers. The pews and wood were replaced. The renovation included replacing some deteriorated vigas and corbels in the nave and adding vigas and corbels to the plain ceiling of the side chapel. This renovation uncovered the wood lintels above the entrance and windows in the nave. The clerestory with four oculi illuminates the altar. The truss that spans the nave was likely installed to support the weight of the ceiling and clerestory.

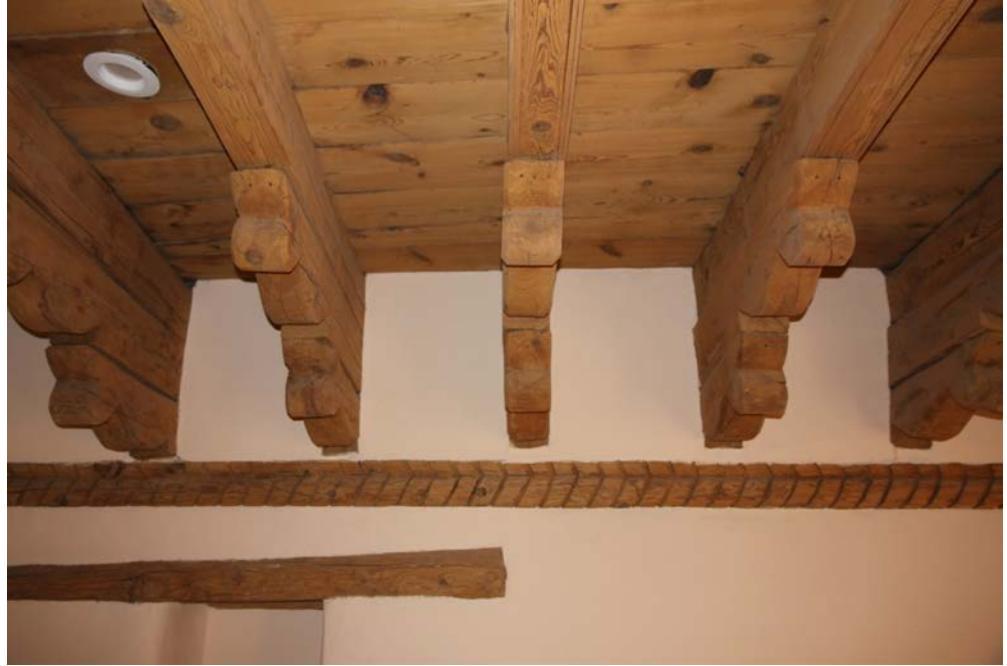
15 of 16. Interior, vigas and corbels above the choir loft, photographer facing south.

The design, materials, and workmanship are evident in the adobe structure and the wood structural elements, such as vigas and corbels that support the roof. The setting has been lost, except for its located along a paved section of El Camino Real de Tierra Adentro and the forecourt and campo santo. The forecourt and campo santo are characteristic of Spanish Colonial churches from the 17th and 18th centuries. San Miguel Church retains a high level of historic integrity.
