National Register of Historic Places Inventory—Nomination Form

historic	Bare Hills	House		· · · · · · · · · · · · · · · · · · ·		
and/or common						
2. Locat	ion N	I Balt	timere	at		
street & number	6222 Falls	V			not for publ	ication
city, town	Baltimore	mc' <u>X</u> vici	nity of	congressional district	Second	
state	Maryland c	ode 24	county	Baltimore	code	005

Bare Hills house Baltimore County CONTINUATION SHEET Maryland ITEM NUMBER 7 PAGE 1

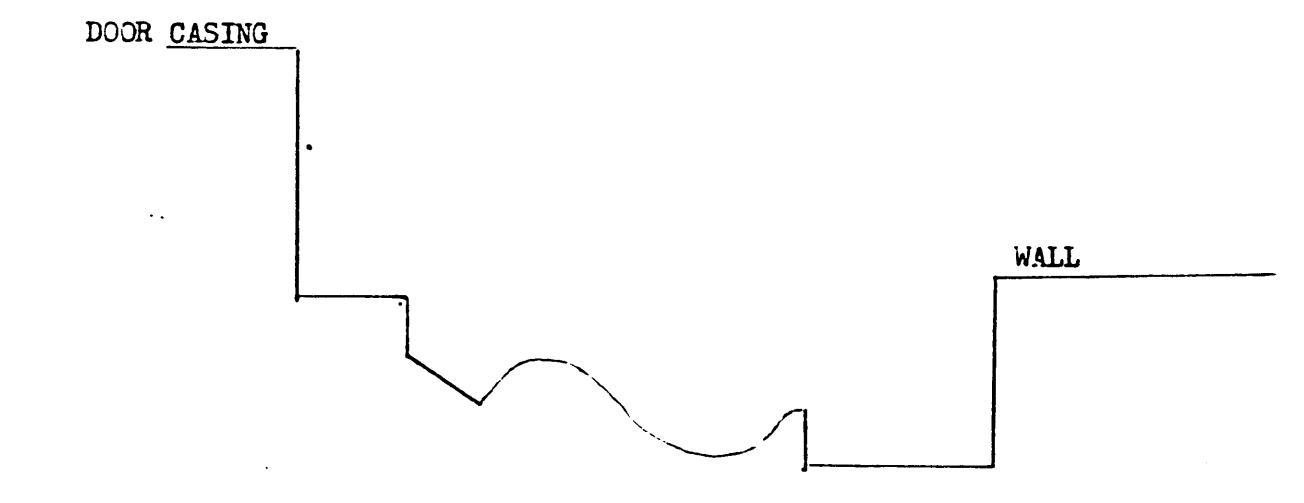
CROSS SECTION OF DOOR AND WINDOW MOLDINGS

The main entrance hall which is on the north elevation has a 39" wide paneled door. Original hardware has been kept on all doors throughout the house. Original oak flooring has been refinished. Plaster ceiling moldings in the entrance hall, living room, and family room have been saved and repaired. There are three plaster ceiling medallions in these rooms as well. The fireplace mantelpiece in the family room is composed of stark planes of painted wood. The wood mantelpiece in the current dining room is slightly more decorative having a nine inch mantelshelf supported by curved brackets. The face of the mantelpiece is decorated with grouted lines. The door and window moldings throughout the house remain unaltered.

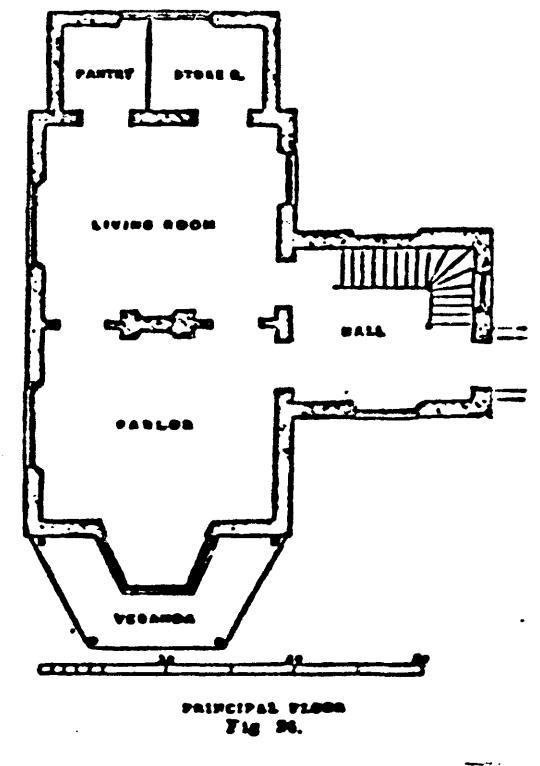
DOWNING PLANS FROM PAGE 101 OF THE ARCHITECTURE OF COUNTRY HOUSES. WATKINS GLEN, N.Y., 1968.

Bare Hills utilizes several features which are characteristic of frame Gothic Revival houses: board-and-batten siding, complex roof forms, extensive porches, bracketed eaves, and a cupola. The house shows a striking resemblence in style and plan to "A Gate Lodge in the English Style" illustrated in A.J. Downing's 1850 The Architecture of Country Houses. Though smaller in size and proposed in masonry, the floor plan, positioning of doors, windows, and stairs, and the exterior design of the Downing house is similar to that of Bare Hills and may have been the inspiration for its design.
