# National Register of Historic Places Registration Form

1. Name of Property				
historic name St. Thomas	Hospital			
other names/site number	Thomas County Hospital / KHR	I # 193-1060-00822		
2. Location				
street & number 210 South	Range Avenue			not for publication
city or town Colby				vicinity
state Kansas	code KS county Thor	mas code	193	zip code <u>67701</u>

#### St. Thomas Hospital

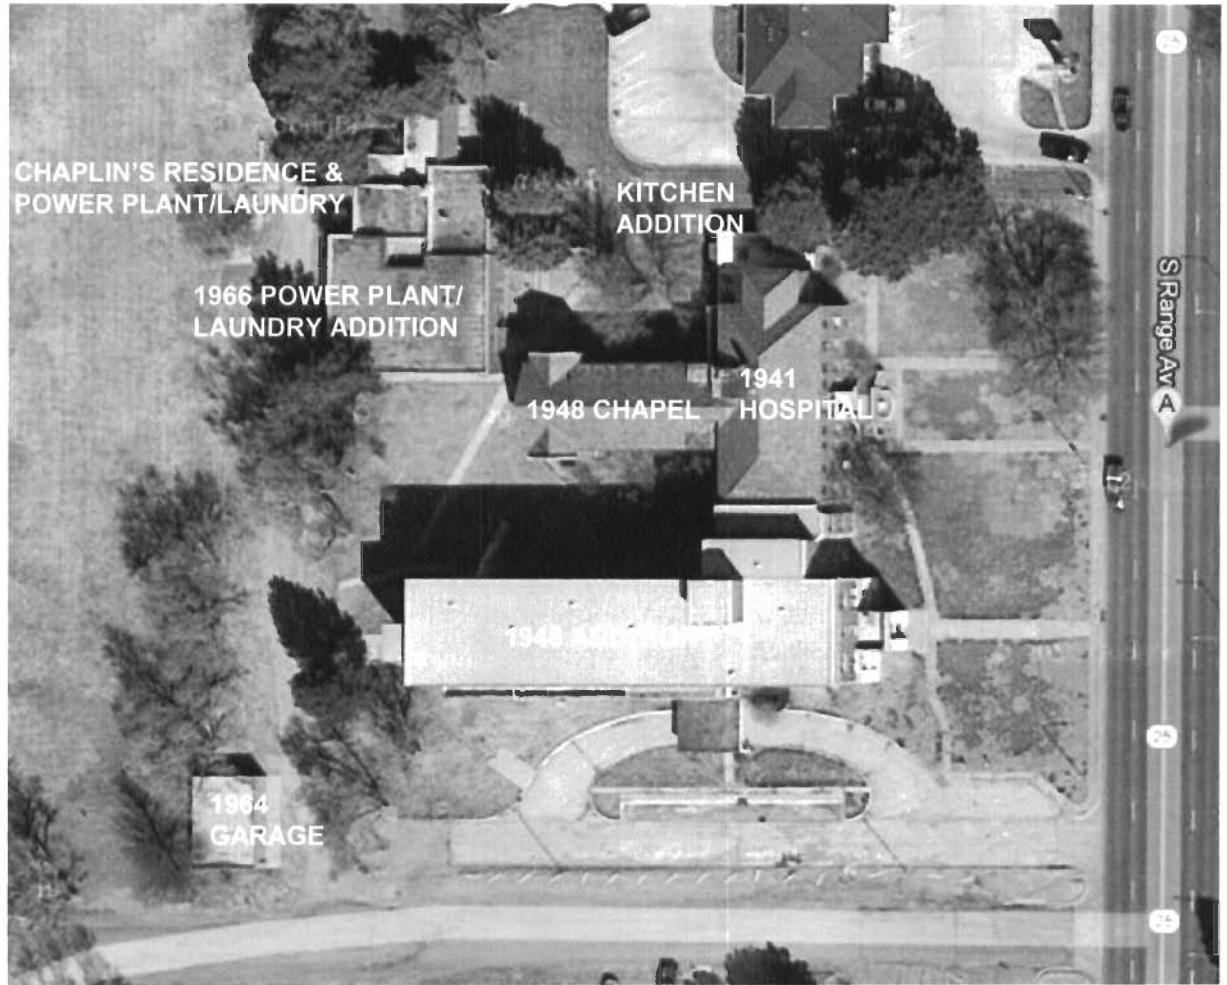
Figure 1 - Aerial image was downloaded 7/5/2012 from Google Maps

St. Thomas Hospital is located on South Range Avenue between I-70 and downtown Colby. The main hospital complex is comprised of three primary sections. The original building is a rectangular form oriented N/S with the front entrance in the center of the east facade, facing Range Avenue. A chapel was added at the rear of the original building in 1948 and is accessed from the interior of the hospital. A south wing was constructed at the same time as the chapel. The new wing is rectangular in form, oriented E/W with primary entrances on the east and south facades. The south wing and chapel additions frame a courtyard at the rear of the building. An enclosed stair tower was added at the west end of the south wing at an unknown date. A small one-story kitchen addition was built at an unknown date off the NW corner of the original hospital. The kitchen addition has exterior access on the west.

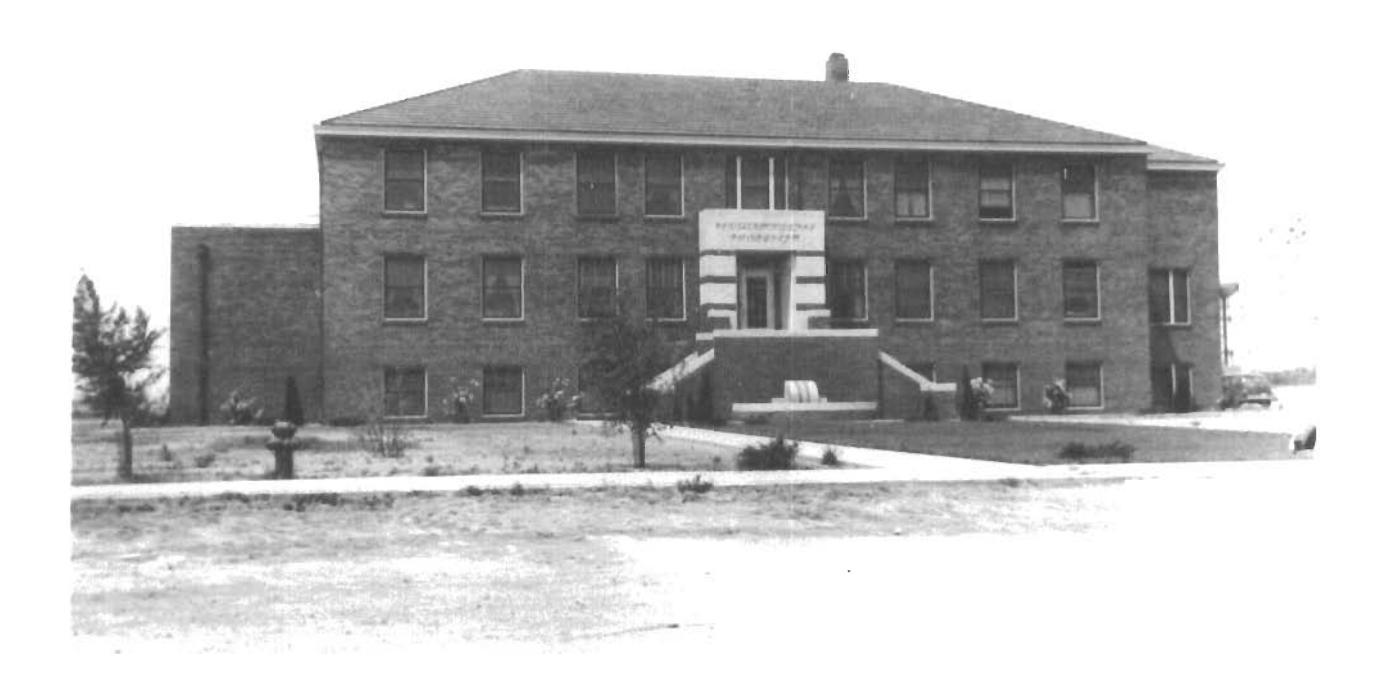
Figure 2 – Original hospital building completed in 1941 (photo c.1941 – 1948)

The east/front facade of the original building is nine bays in width and is symmetrical with the exception of the end bays. The center bay is distinguished by the above grade entrance at the 1<sup>st</sup> floor and a tripartite window on the 2<sup>nd</sup> floor. The entry bay is accessed by a split stairway on the north and south sides of the entry bay. The entrance retains its original configuration with a paneled wood door with glass lights, a three-light transom, and glass block sidelights. The stair provides access to a storage area on the lower level; the only public entrance was at the 1<sup>st</sup> floor, above grade. A fountain was incorporated into the base on the entry bay, in the center of the east side of the bay. The facade of the main building, north and south of the center bay, is comprised of four bays distinguished by a window on each floor. End bays are inset on the north and south. The north end bay is the same height as the main building, with an intersecting hip roof that is slightly shorter than the roof on the main building. However, the south end bay was only two stories in height and had a flat roof. The end bays featured a three-part window, like on the center bay over the entrance.

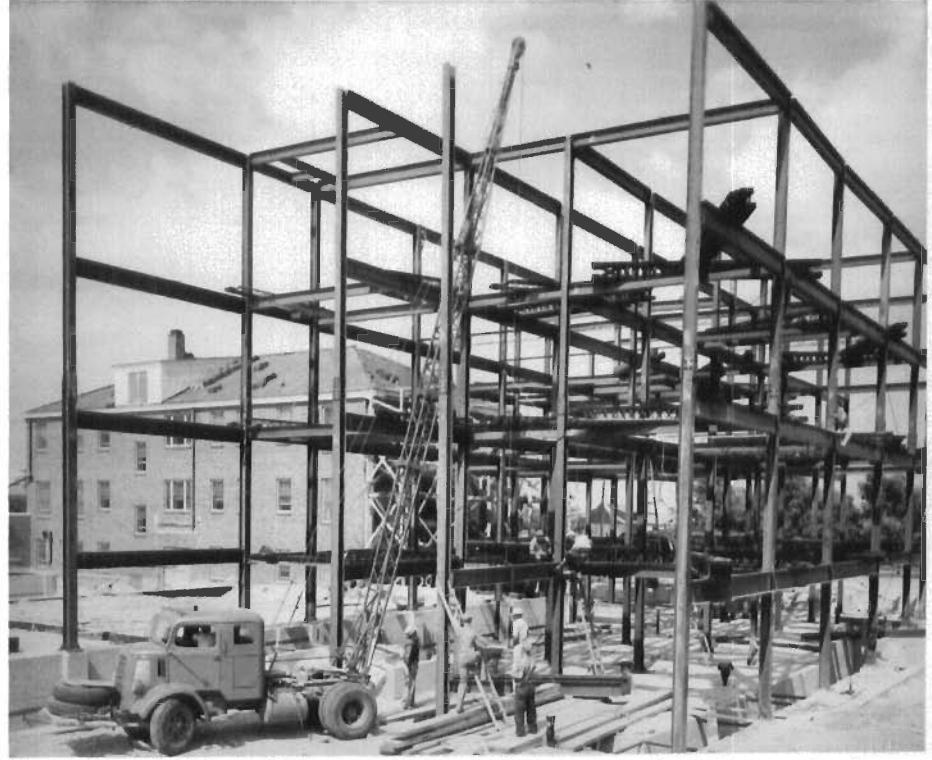
Figure 3 – Polio Ward addition on south end of original hospital under construction c.1947

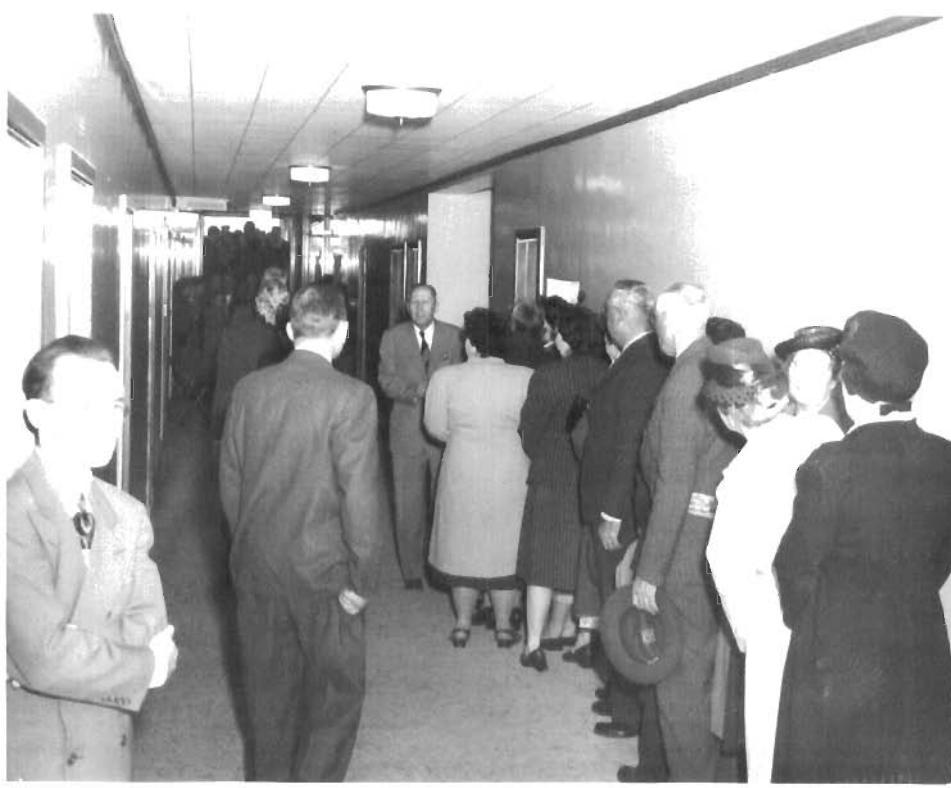
Figure 4 - Interior view of corridor in addition, thought to be building dedication c.1948

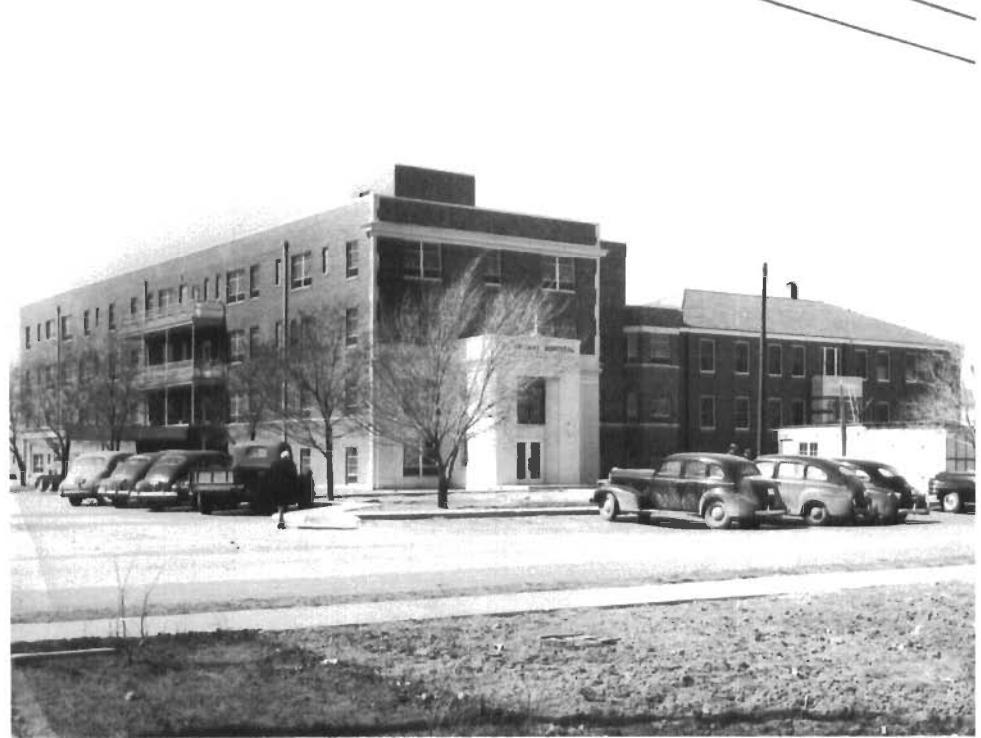
Figure 5 – Polio Ward built as south wing of original hospital c.1950

The south wing was constructed in 1948 to function as a polio ward and expanded emergency and operating facilities. This is the area of the hospital that was occupied by the school district in the 1980s and 1990s and further demolition work occurred when a medical clinic was planned in the 2000s. The south wing retains the lowest level of historic integrity with even the corridor walls removed in some locations. The demolition of interior partition walls has left voids in plaster perimeter walls and ceilings and in the terrazzo flooring in some locations. The shell of the wing retains historic plaster walls and the original steel windows. Terrazzo floors are in place throughout the south wing.

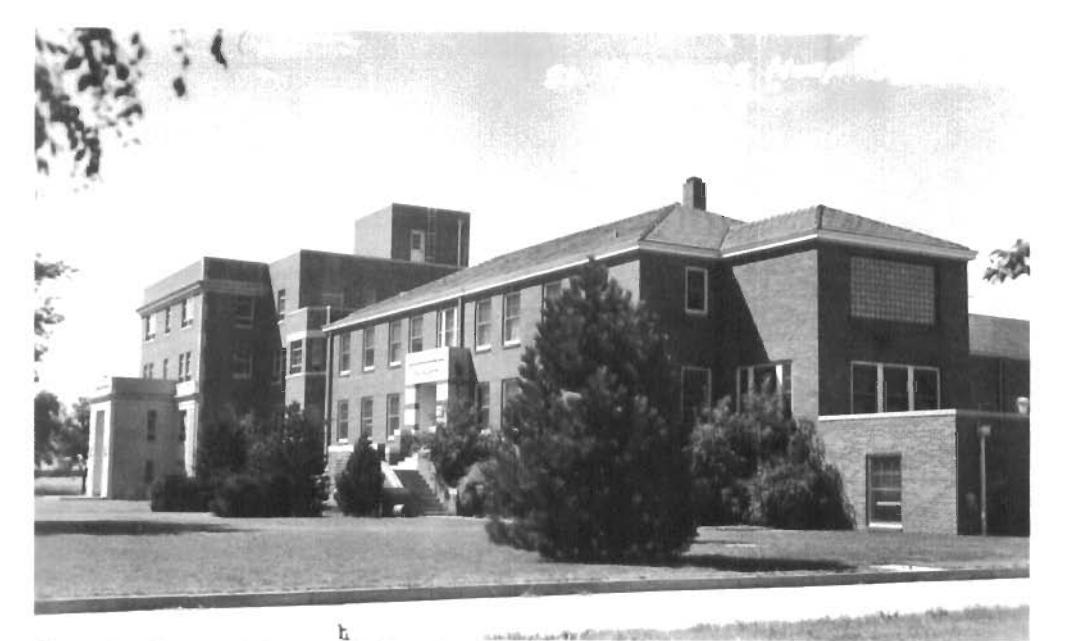
Figure 6 – Postcard of expanded hospital c.1950s

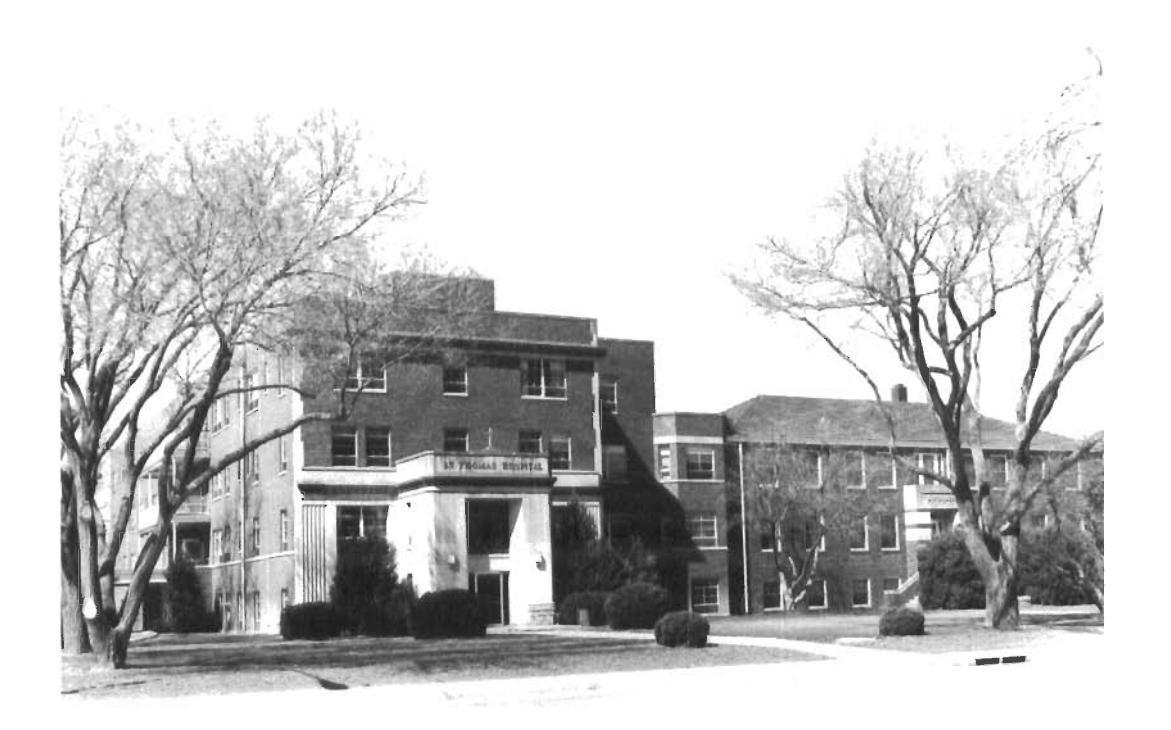
Figure 7 - Front/East facade of expanded hospital

The south wing is oriented to the south and east, the east facade being the front. The east facade is characterized by a projecting two-story entry bay with ashlar stone panels. The entrance is three bays in width with the center bay projecting almost like an entablature. The end bays feature paired windows on each floor with fluted vertical stone panels at the end of the bay. The center entry bay has a two-story recessed surround with a simple aluminum-framed door with sidelights and a stained glass window on the 2<sup>nd</sup> floor over the door. The entry bay has a stone cornice that defines a simple parapet. The upper floors of the east facade, above the entry bay, are red brick with stone quoining at the corners and a stone cornice approximately two feet below the parapet cap. A metal roof was formerly installed on the south wing, extending the roofline slightly and covering the parapet cap. The east facade of the south addition extends two bays north of the entry. The north end bay is a projecting 3-sided bay that extends over the south bay of the original hospital to connect the south wing.

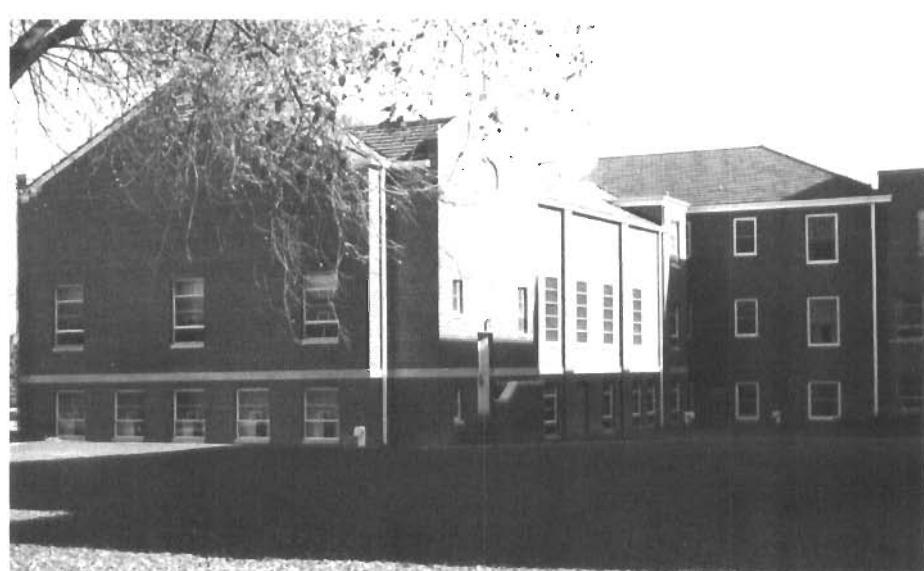
Figure 8 - Chapel built on rear of original hospital as part of 1948 addition

The chapel addition on the rear of the original hospital building was constructed as part of the 1948 hospital expansion. The chapel design effectively blends the Georgian Revival styling of the original hospital with the modern addition, primarily by incorporating a clay tile hipped roof. The chapel is red brick, with stone detailing, and features steel windows with horizontal lights, like the south wing.

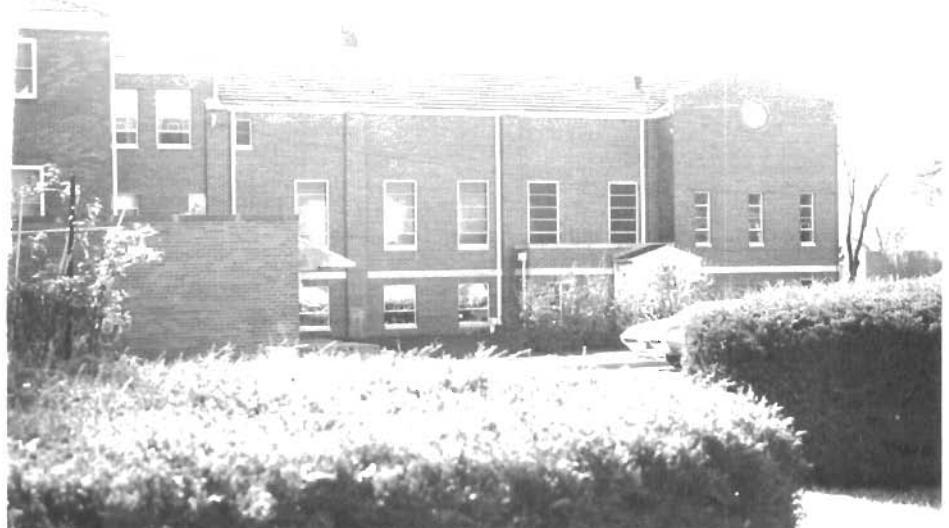
Figure 9 - North facade of South Wing, built in 1948 as Polio Ward

The body of the south wing is similar in style to the chapel addition with the exception of the tile roof. The south wing is four stories in height, the first floor projecting on the western portion of the south facade. A one-story port cochere is located approximately one-third of the width of the facade, from the southeast corner. The port cochere is a simple flat metal canopy with steel posts. A balcony with simple metal railings extends over the port cochere on the upper floors. The window openings are asymmetrical with single and paired steel windows in three primary sizes. The windows are steel with four horizontal lights, the center two of which are an operable awning panel. The primary exception to this window configuration is three openings on the west end of the north facade, on the 4<sup>th</sup> floor. These openings are three-part units with steel windows flanking a wide glass block panel; these openings correspond to the location of operating rooms in the original design of the south wing.

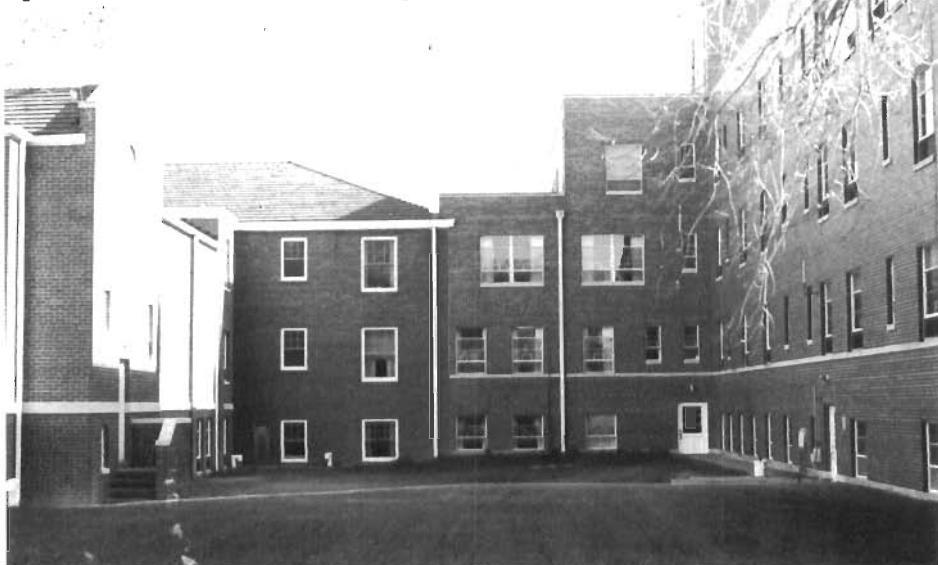
Figure 10 – Rear courtyard between South Wing on R and Chapel on L, both completed in 1948

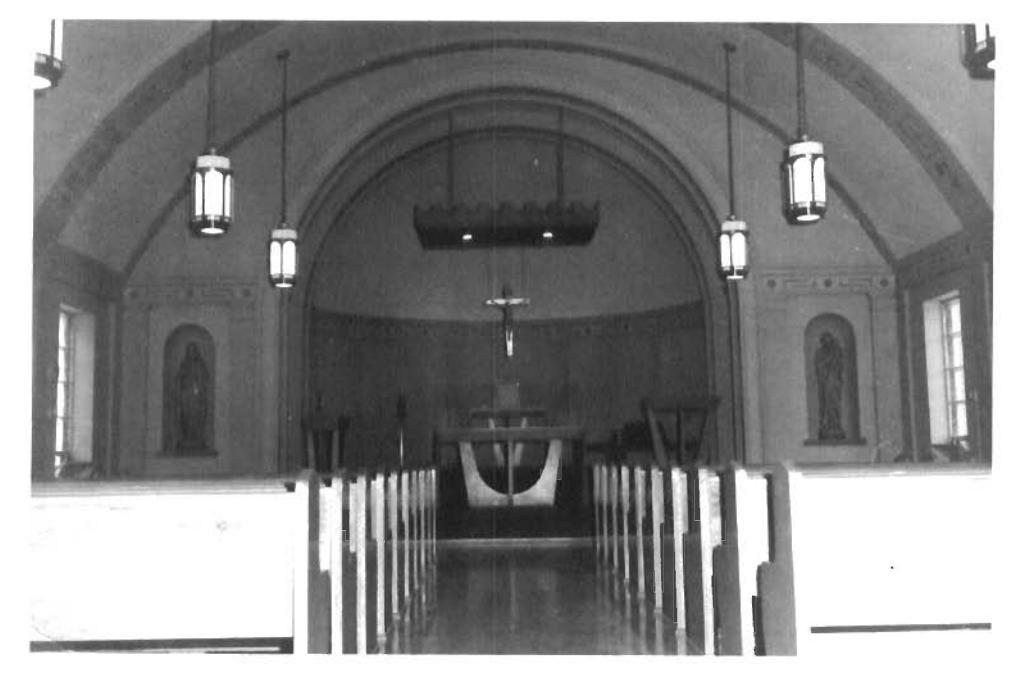
Figure 11 - Interior view of chapel, date unknown.

The chapel, constructed in 1948 as an addition to the original hospital, retains a high degree of architectural and historic integrity. With the exception of removal of religious artifacts, pews, and light fixtures, there have been no major modifications to the chapel space. The 2-story space has an arched Roman ceiling with rounded nave on the west and small projecting balcony on the east. The walls and ceiling are plaster with regularly-spaced steel windows with granite sills. Paired square pilasters frame each window opening and extend around the curved nave. A small balcony over the main entrance on the east provides a small platform for standing/viewing. The primary entrance to the chapel was through the 1<sup>st</sup> floor of the original hospital and secondary entrances were located on the north and south sides of the nave. A narrow terrazzo stairway remains in place on each side of the chapel. Functional spaces including a kitchenette, restroom, etc. were located on each side of the nave. These spaces also retain original finishes including plaster walls and ceilings, and pointed "schoolhouse" light fixtures.

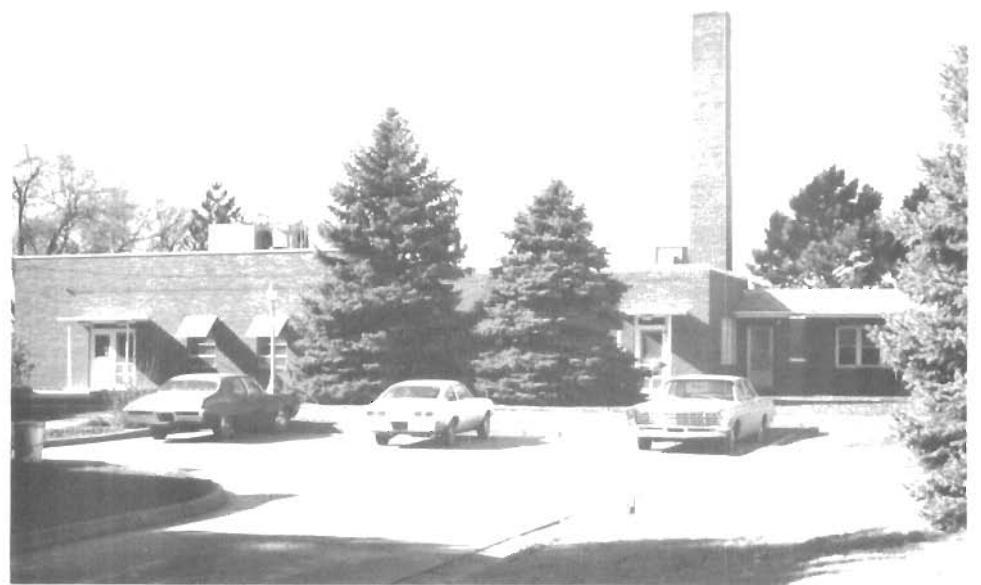
Figure 12 - c.1970 view of Chaplin's residence, power plant, and laundry. South bay (on L) added in 1966

A Chaplin's residence with connected power plant and laundry was constructed at an unknown date immediately northwest of the chapel. The Chaplin's residence and power plant appears to date to the original construction or shortly thereafter. A brick utility tunnel is extant on the west side of the original hospital suggesting a connection to an exterior power plant (combined with the fact that the original drawings do not include a boiler room in the hospital building itself). Although the available drawings for the original hospital and 1948 addition do not include the Chaplin's residence and power plant, the extant utility tunnels at the south wing and chapel suggest that the existing power plant was in place or constructed as a part of the 1948 hospital expansion/additions. The power plant was expanded in 1966 with a laundry addition on the south. Another secondary free-standing structure on the hospital site is a 3-bay, one-story brick garage, built southwest of the south wing of the hospital in 1964. The garage is a simple utilitarian structure that is in poor condition and will likely require demolition due to structural failure.

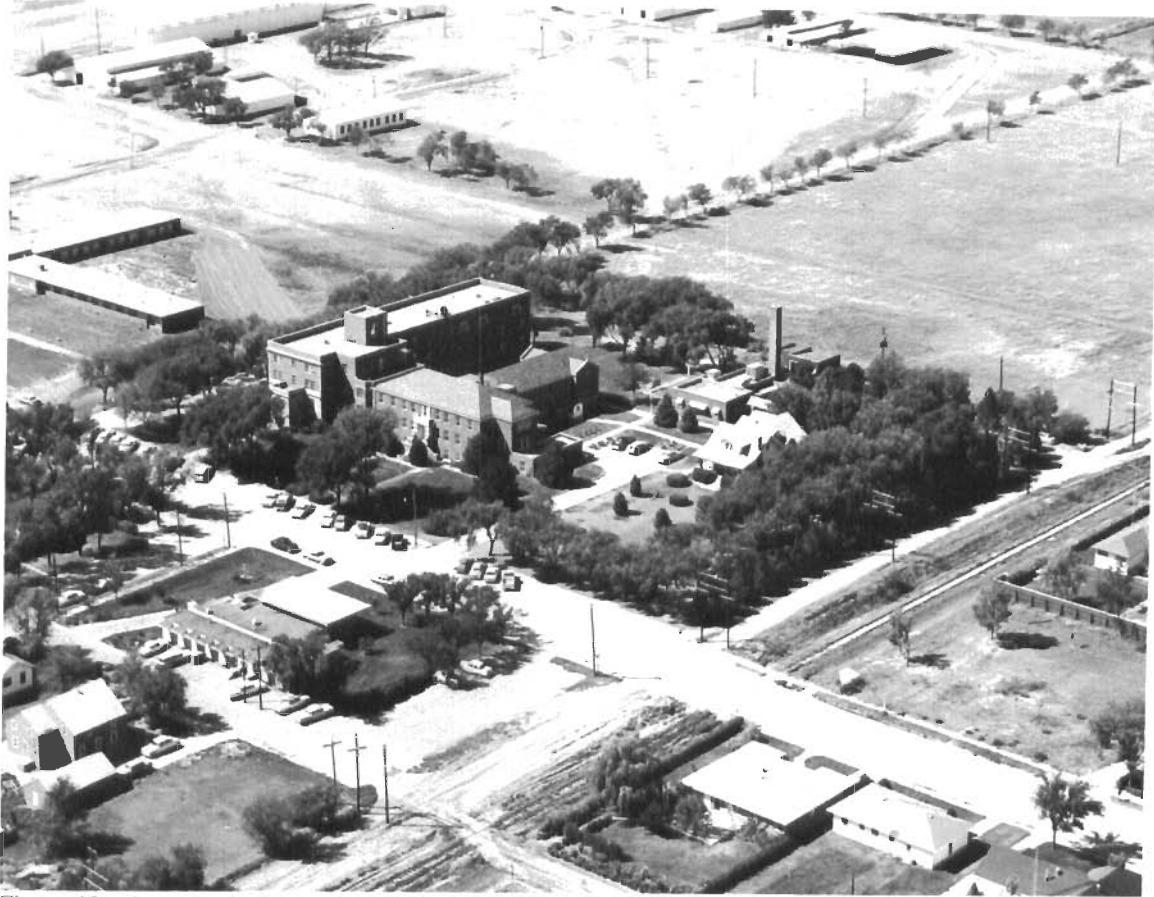
Figure 13 - Aerial view of hospital site, date unknown
