KENTUCKY	HISTORIC	RESOURCES
Individ	ual Invento	ry Form

Resource # 165 Shelby County Shelby

1. Name of Resource:	16. Date:
Logan House	Original Building
2. Original Owner:	Addition 1970
James Knox Logan (?)	17. Style:
3. Other Names:	Vernacular
Oxford

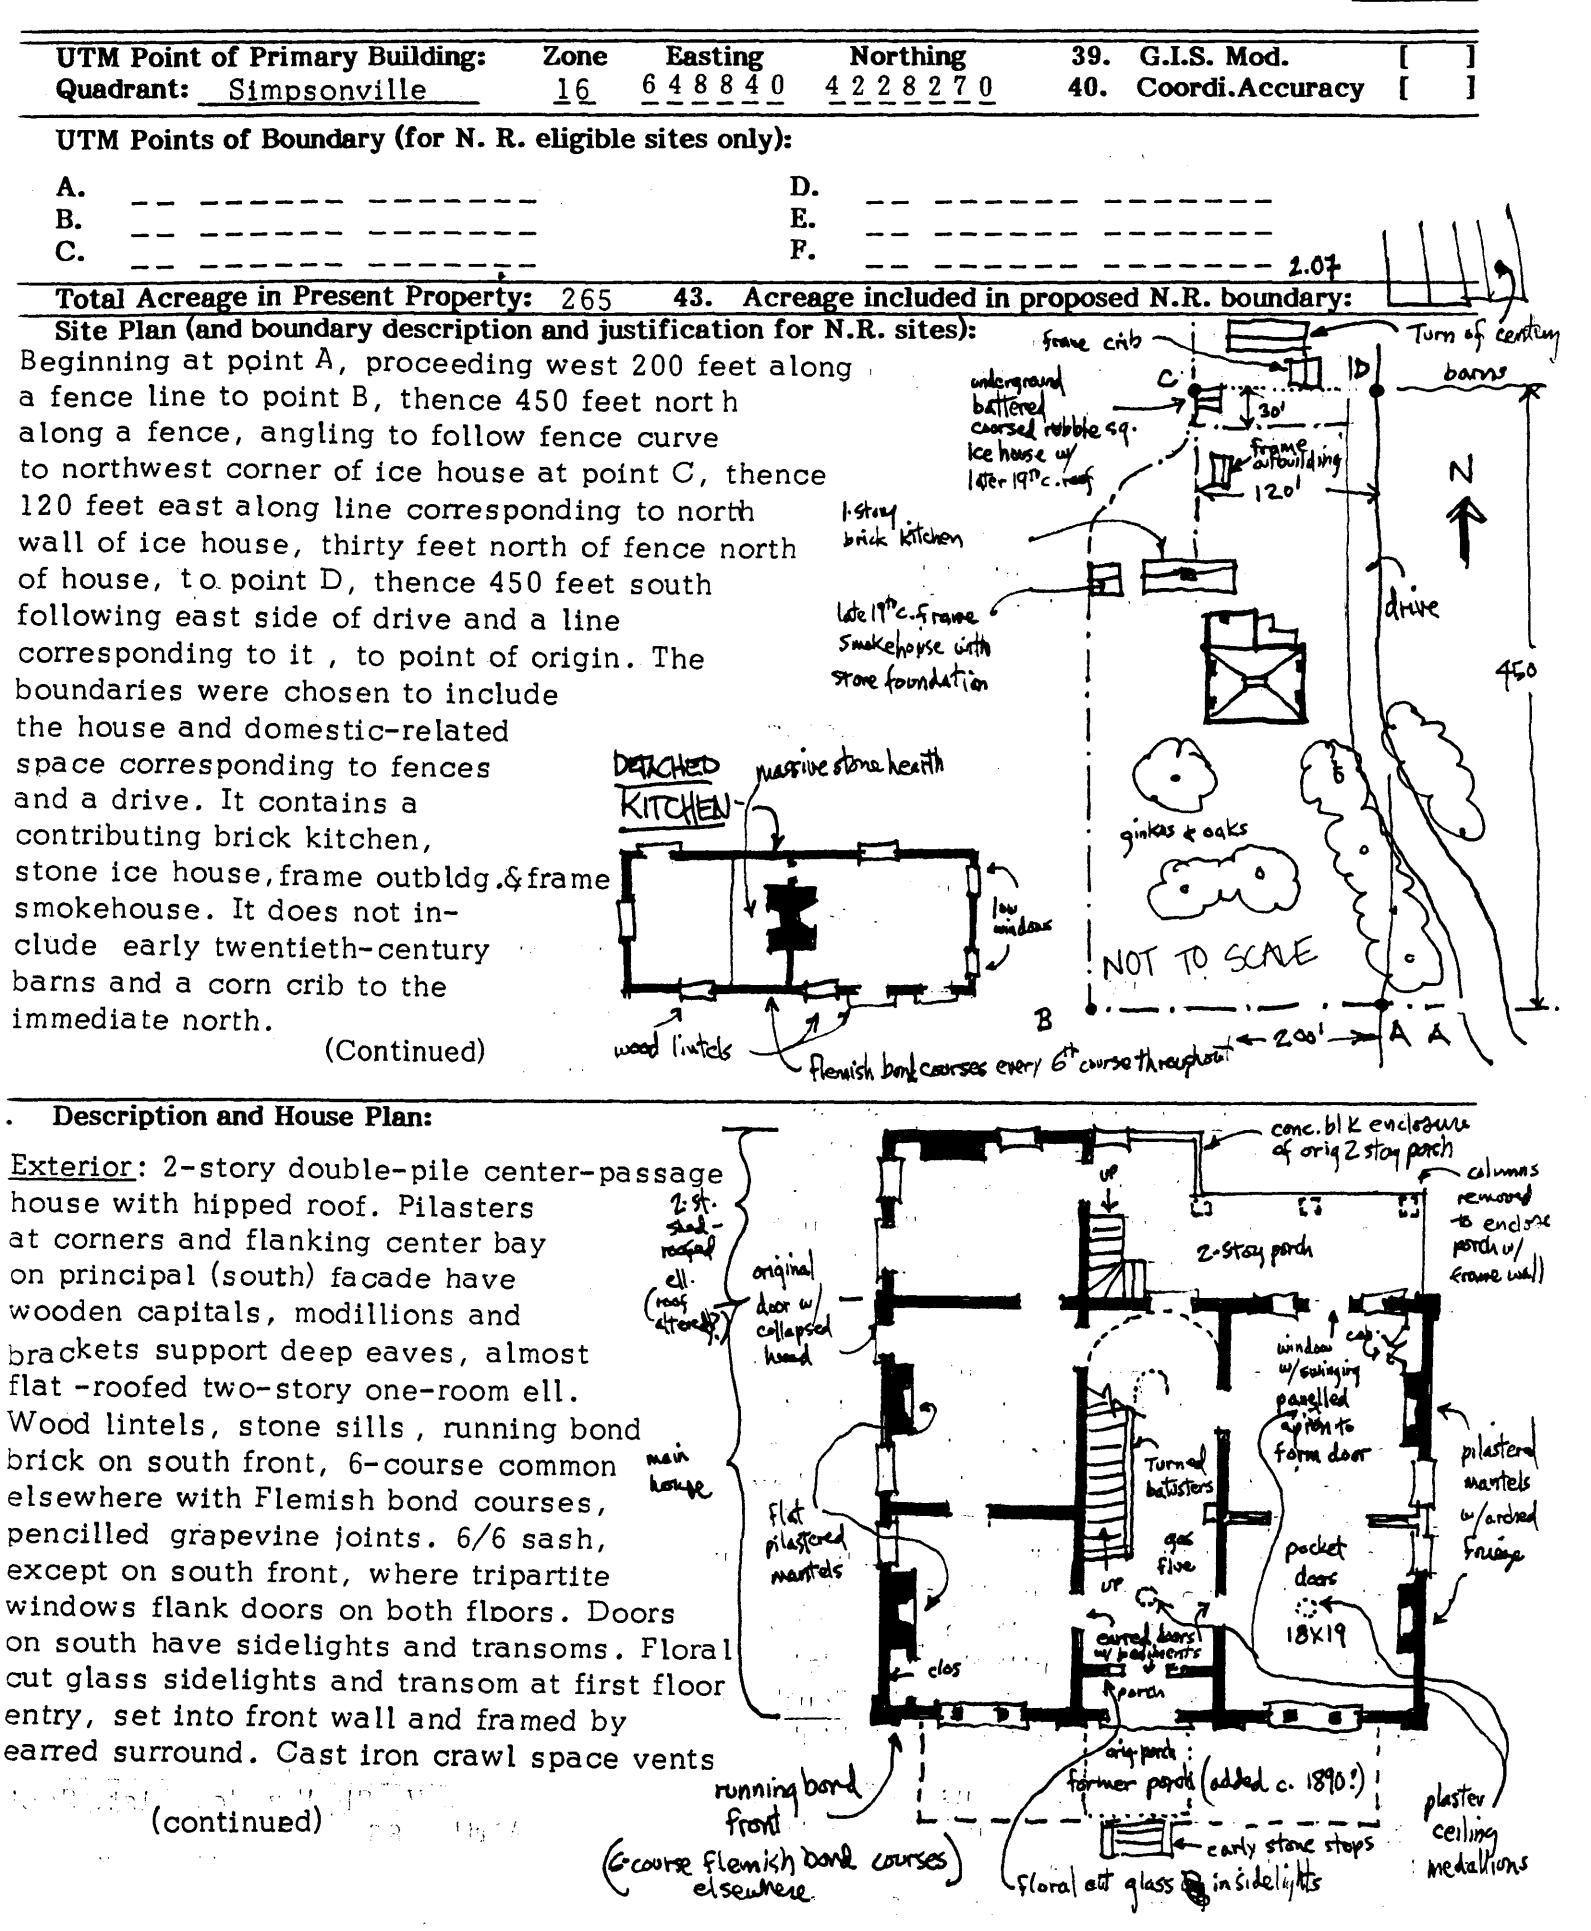
#### 44. Site Plan (and Boundary Description & Justification for N.R. Sites):

Point A is located on the front (southern) yard fence at its intersection with a line extended southward from the eastern edge of the drive at that point where the drive turns eastward. Point A is 200 feet south/southeast of the southeastern corner of the dwelling.
