United States Department of the Interior National Park Service
NATIONAL REGISTER OF HISTORIC PLACES REGISTRATION FORM
======================================
historic name <u>William Andrew House</u>
other names/site number <u>Richard Bryan House</u>

Section 7 Page 1_Description William Andrew House, Orange, New Haven County, CT

WILLIAM ANDREW HOUSE 131 OLD TAVERN ROAD ORANGE, CT DRAFT SECOND FLOOR PLAN

WILLIAM ANDREW HOUSE 131 OLD TAVERN ROAD ORANGE, CT DRAFT FIRST FLOOR PLAN

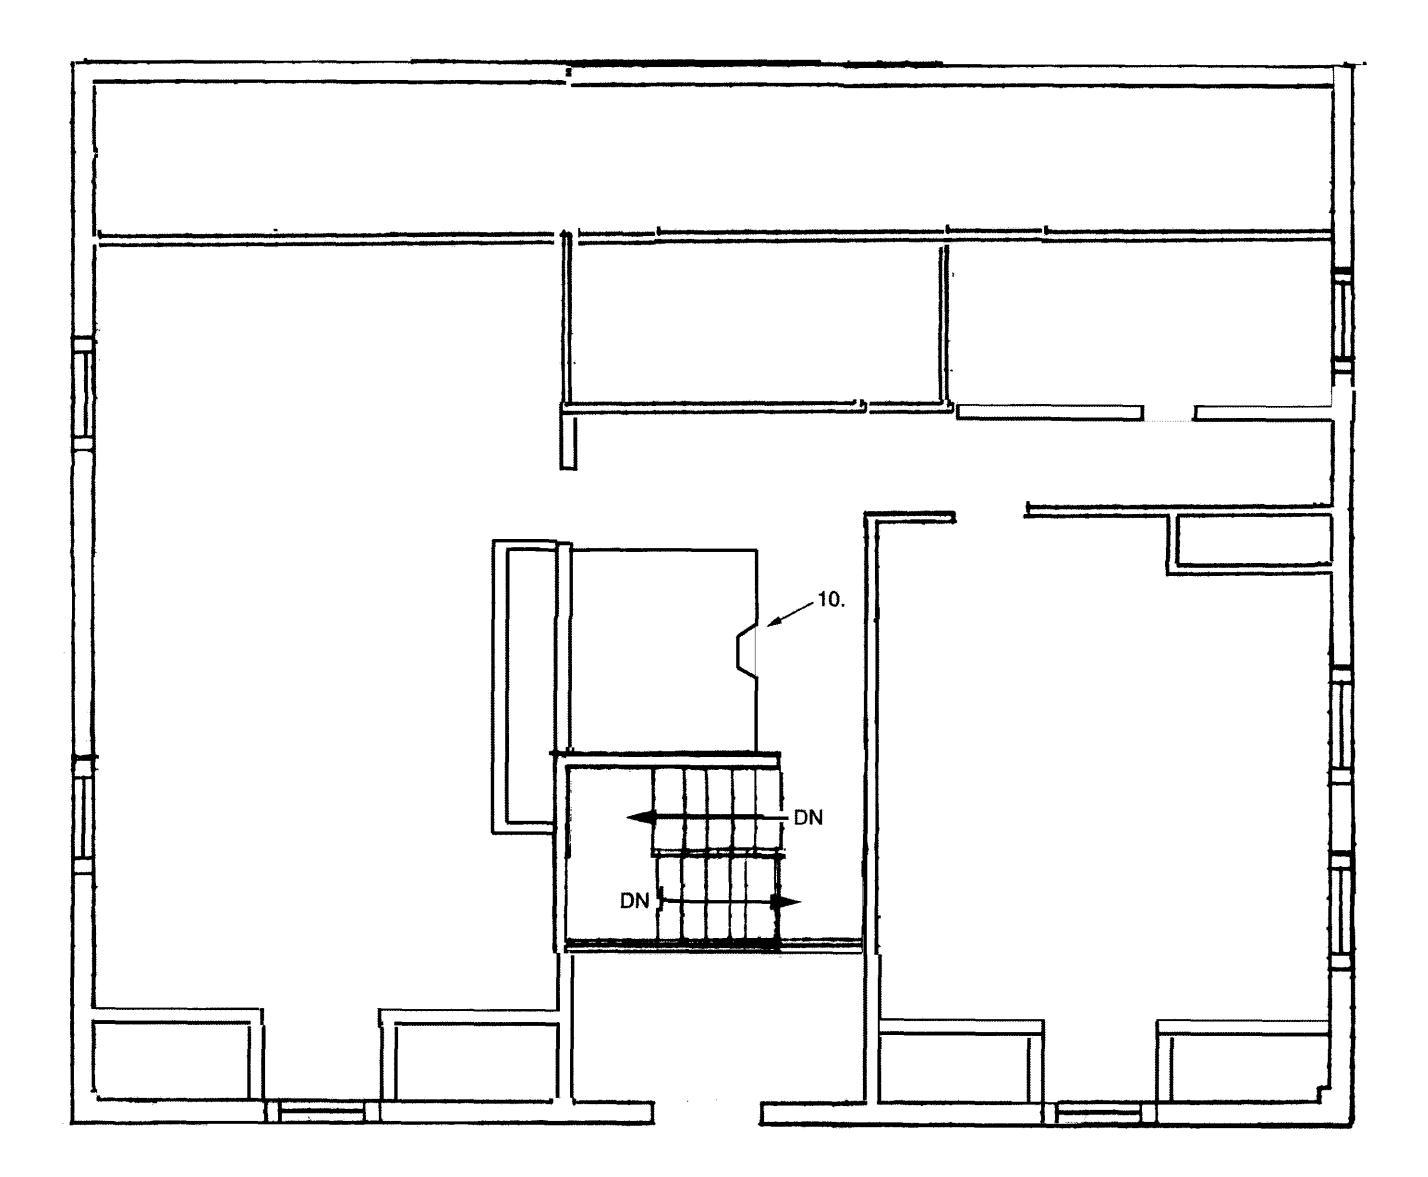
Arrows with numbers are photograph views

The second floor has been modernized, possibly in the 1950's, with some earlier 20th century work. There are two bedrooms, one bathroom and several closets. There is one wall with featheredged sheathing, although this is not in its original location. A small firebox has been uncovered in what is now the hallway on the east side of the chimney (photograph 10.) It is similar to one found at the Fowler/Miles house.

The attic is reached through a modern pull-down stairway. There is no indication of the original attic access. The attic floor is covered with plywood, although the original floorboards remain under most of this. The roofing boards are old, water-powered sawn boards, except for replacements around the chimney. The roofing system uses common rafters that are pegged at the top. The rafters are hewn. There are sawn studs of irregular size in the gable end.

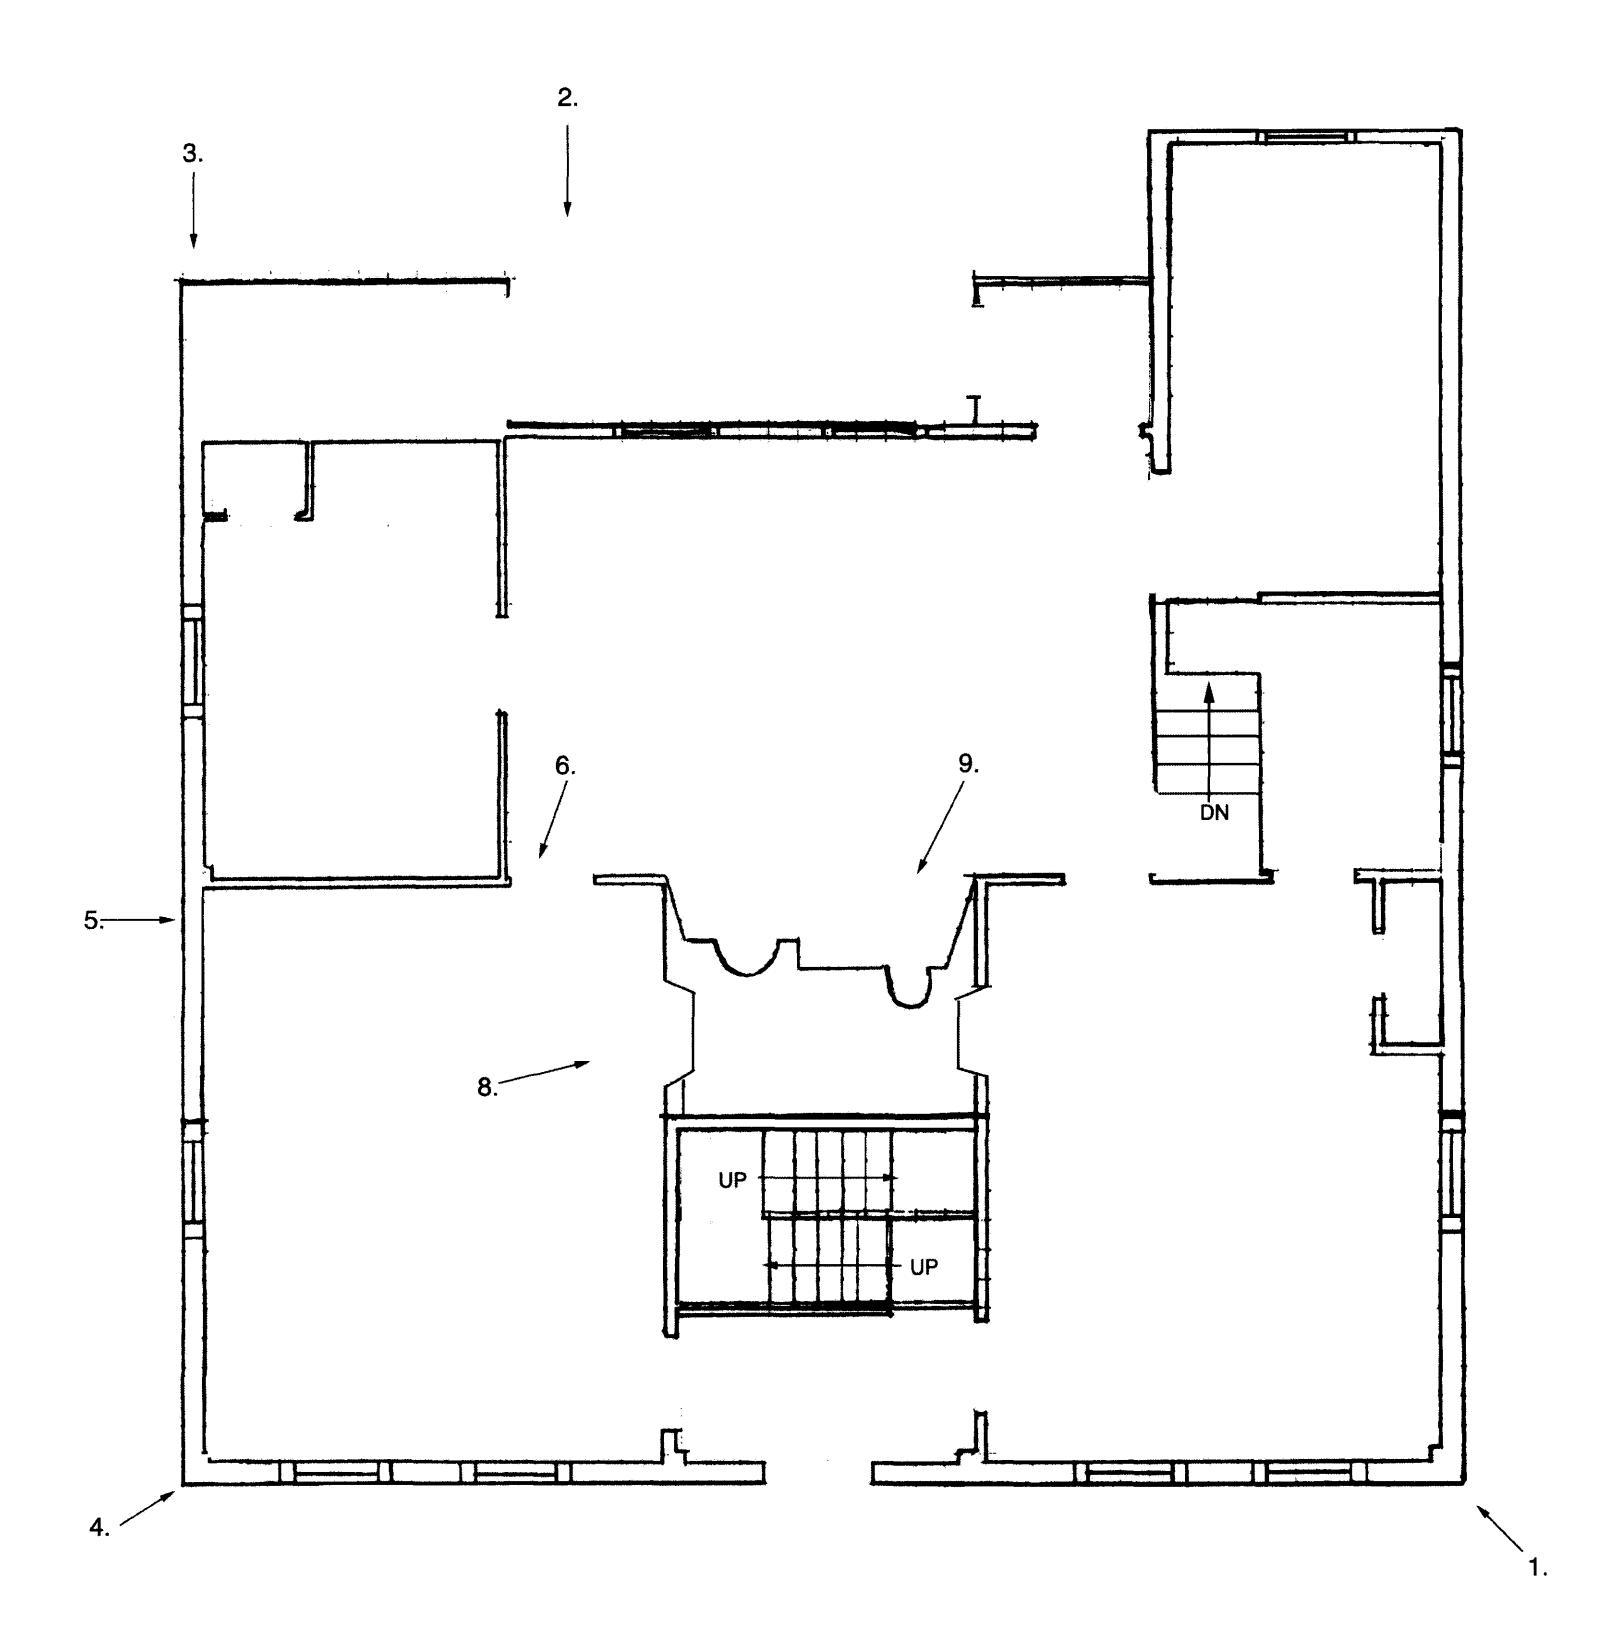
Arrows with numbers are photograph views.

The west front room measures approximately 13'4" by 16'8", and 7'8" high. It has two windows in the south wall and one in the west wall. There is a door to the front hall and a door to the old kitchen. Both of the doors are eighteenth-century four-panel doors (photograph 7), with newer hinges. They match the ones in the east room, and are also similar to the doors in the Fowler/Miles house on Orange Center Road, built c.1801. The floor is made up of wide tulip poplar boards – if not the original floor, certainly a very old one. The fairly large cracks between the boards and the old subfloor are indicative of considerable age. The horizontal wainscoting beneath the chair rail is probably original to the house. The chair rail molding is modern. The featheredged sheathing on the fireplace wall, while old, was not in this location. Removal of this sheathing has shown that the original treatment of the wall was plaster. The fireplace surround, with its bolection moulding, was made for John Kirk in 1965. An older fireplace surround which fits this opening was found in the barn (photograph 8). The southwest corner post projects into the room about five inches. The top portion was covered with joint tape and is now bare. It is extraordinarily smooth, as if it had been prepared for wallpaper. It is cased in the wainscoting section. There is no summer beam visible. The original plaster walls in this room were replaced with celotex, although the plaster ceiling remains. Removal of the celotex has revealed that the partition between the front west room and the rear west room is constructed of widely spaced planks morticed into the girt.

The east room measures about 13'2" by 16'8", and 7'8" high. It is finished like the west room with these exceptions: the sheathing on the fireplace wall dates to the early nineteenth century and was brought from an old house in Milford by the Hoyts about 1940.³ It does not match any of the other sheathing in the house. A firebox was revealed when the sheathing was removed. The firebox has brick sides with a stone back. The bricks on the south edge of the firebox also make up the edge of the chimney base —there was not enough space to continue the stone edge and have the sides faced with brick. Both plaster walls and plaster ceiling remain in this room.

The old kitchen measures about 19' by 12'6", and is dominated by the large cooking fireplace (photograph 9,) which measures 8' across the front opening. It has an unusual oven arrangement, having one in the back and one on the side, but only about halfway forward in the opening. This half-forward style of oven is also seen in the Fowler/Miles house on Orange Center Road. This firebox has a stone rear and brick sides. As in the east room, the brick sides of the firebox make up the outside of the stack as well. The lintel is appropriate to the style of the fireplace, but may be a replacement, as it looks very new on the back – no charring. There are indications that there was a surround for this firebox. The stone hearth has been rebuilt.

The old kitchen has two windows in the north wall, and a modern door to the outside. Interestingly, there are no posts for the chimney bay in the rear wall. There is horizontal wainscot on the north wall. When this was temporarily removed for maintenance it was determined that there are studs 5 1/2"wide by 3" deep at irregular intervals along the back wall. There is a 3" by 3" stud under the center of each window. The west wall of the kitchen consists of featheredge sheathing. There is a batten door opening into the west rear room. There is also a feather edged door closer to the rear wall that once opened into the rear west room. Both doors have modern hinges.

The west rear room measures 8'6" by 12'6". It also has the horizontal wainscoting around the room at the level of the bottom of the window. There is also a small integral lean-to on the northwest corner, which is currently used as a shed. It is probable that the northwest room and the shed functioned as a dairy. The wall between the shed and the northwest room is constructed as an interior partition, having once had planks mortised into the rear plate.
