1. Name of Property	
historic name Fort McHenry	
other names/site number Fort McHenry National Monument and His	storic Shrine
2. Location	
street & number Locust Point, at east end of Fort Aver	pue
city or town Baltimore	🔀 vicinity
state <u>Maryland</u> code <u>MD</u> county <u>Baltimore (City)</u>	code <u>510</u> zip code <u>21230</u>

# National Register of Historic Places Continuation Sheet

### Narrative Description

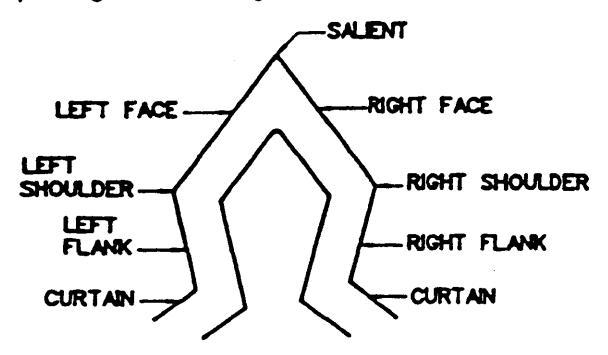
### BASTION COMPONENTS

**Bastion** A work consisting of two *faces* and two *flanks*, all the angles being salient. Fort McHenry has five, one at each quadrant of a pentagon. See diagram.

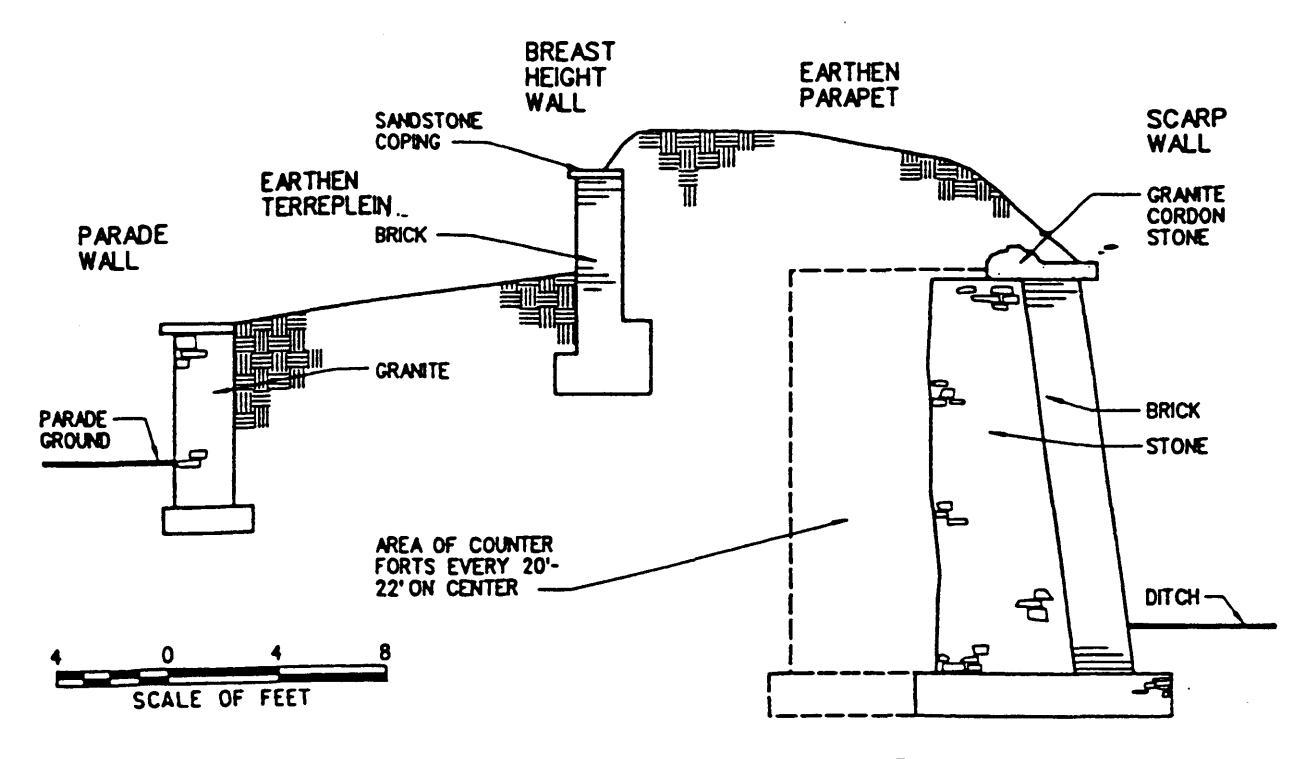
Illustration 1.1. Diagramatic section through the Star Fort showing the relationship between the scarp wall, breast height wall and the parade wall.

1A. Scarp Wall (FOMC 12; LCS no. 00352) - The scarp walls are the exterior walls of the star fort comprising the outer part of the bastions and the curtain walls separating adjacent bastions. These walls are battered (sloping inward from the ground up) and vary in height between 9 ft. 8 in. and 13 ft. 6 in. They are constructed of English bond brick facing, several courses thick, over an inner wall of mortared stone. Sandstone quoins are present at each external angle of the scarp. The foundation consists of roughly dressed and irregularly laid granite. Stone counterforts buttress the inner wall of the scarp. The scarp walls were originally capped with coping stones that soon deteriorated and were completely replaced with new granite coping in the 1830s. While the overall configuration of the scarp walls has not been altered, regular repair and replacement of the brick facing because of deterioration have resulted in little remaining original brick fabric.

and to retain the earth of the sodded interior parapet. Other than subsequent repairs necessitated by water damage, the breast-height wall has remained relatively unaltered.

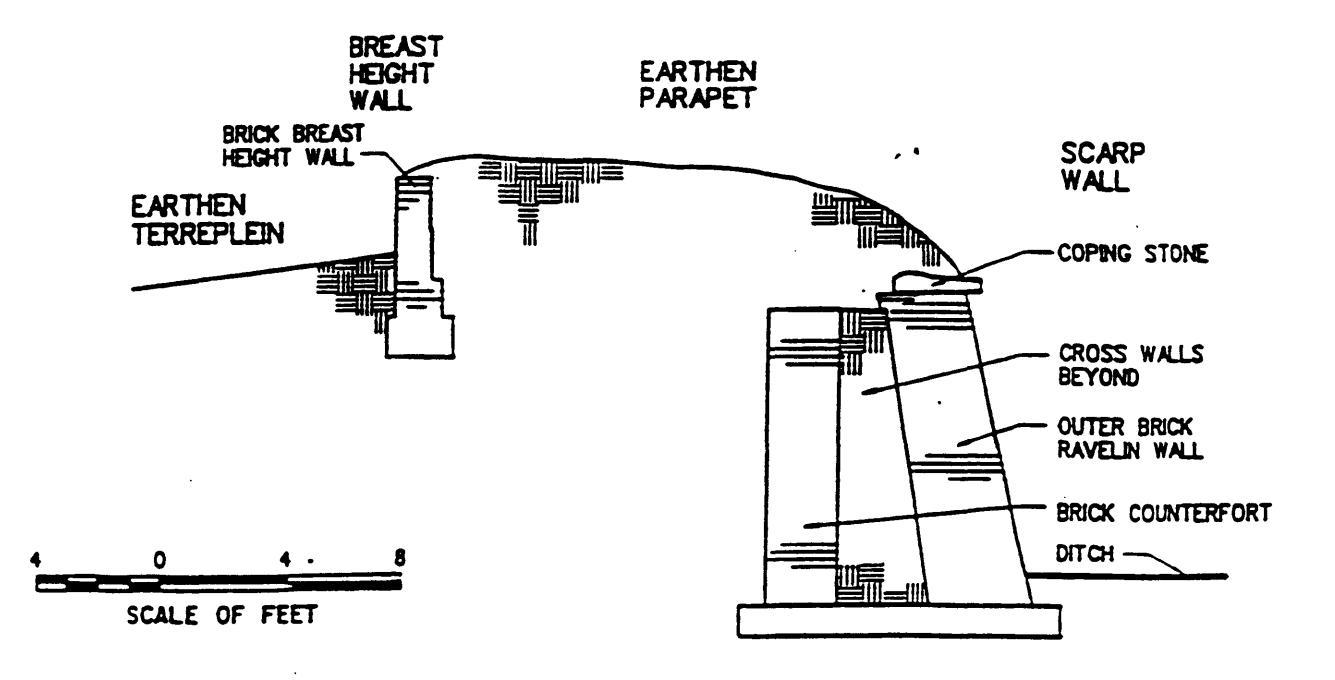
Illustration 2.01. Diagramatic section through the Ravelin showing the relationship between the scarp wall and breast height wall.

**4A. Ravelin Scarp Wall** (FOMC 13; LCS no. 07750) - The ravelin's battered brick scarp walls are similar in appearance to those of the star fort, varying in height between approximately 8 and 10 ft. However, the ravelin scarp walls were constructed on a brick foundation instead of stone and were buttressed with brick counterforts. Sandstone quoins are present at the exterior angles of the scarp, with granite coping at the top of the walls.
