### NAT. REGISTER OF HISTORIC PLACES United States Denarth And PARK Striferior National Park Service NATIONAL REGISTER OF HISTORIC PLACES REGISTRATION FORM

Historic Name: Other Name/Site Nur	mber:	Lang-Hess House		·
			-	
2. Location			· ·	
مد دو دو به این می می او می موجد مع			و الله جرية على إيلا حوال كال من الله على الله الله الله الله الله	بر هم کم کم میں کر
Street & Number:	1625 Wood S	Street	Not f	or Publication: N/A
City/Town: Whee	ling	· · ·		ity: <u>NA</u>
Sate: West Virginia	Code: <u>WV</u>	County: <u>Ohio</u>	Code: <u>069</u>	Zip Code: <u>26003</u>

Lang-Hess House Name of Property Ohio County, West Virginia County and State

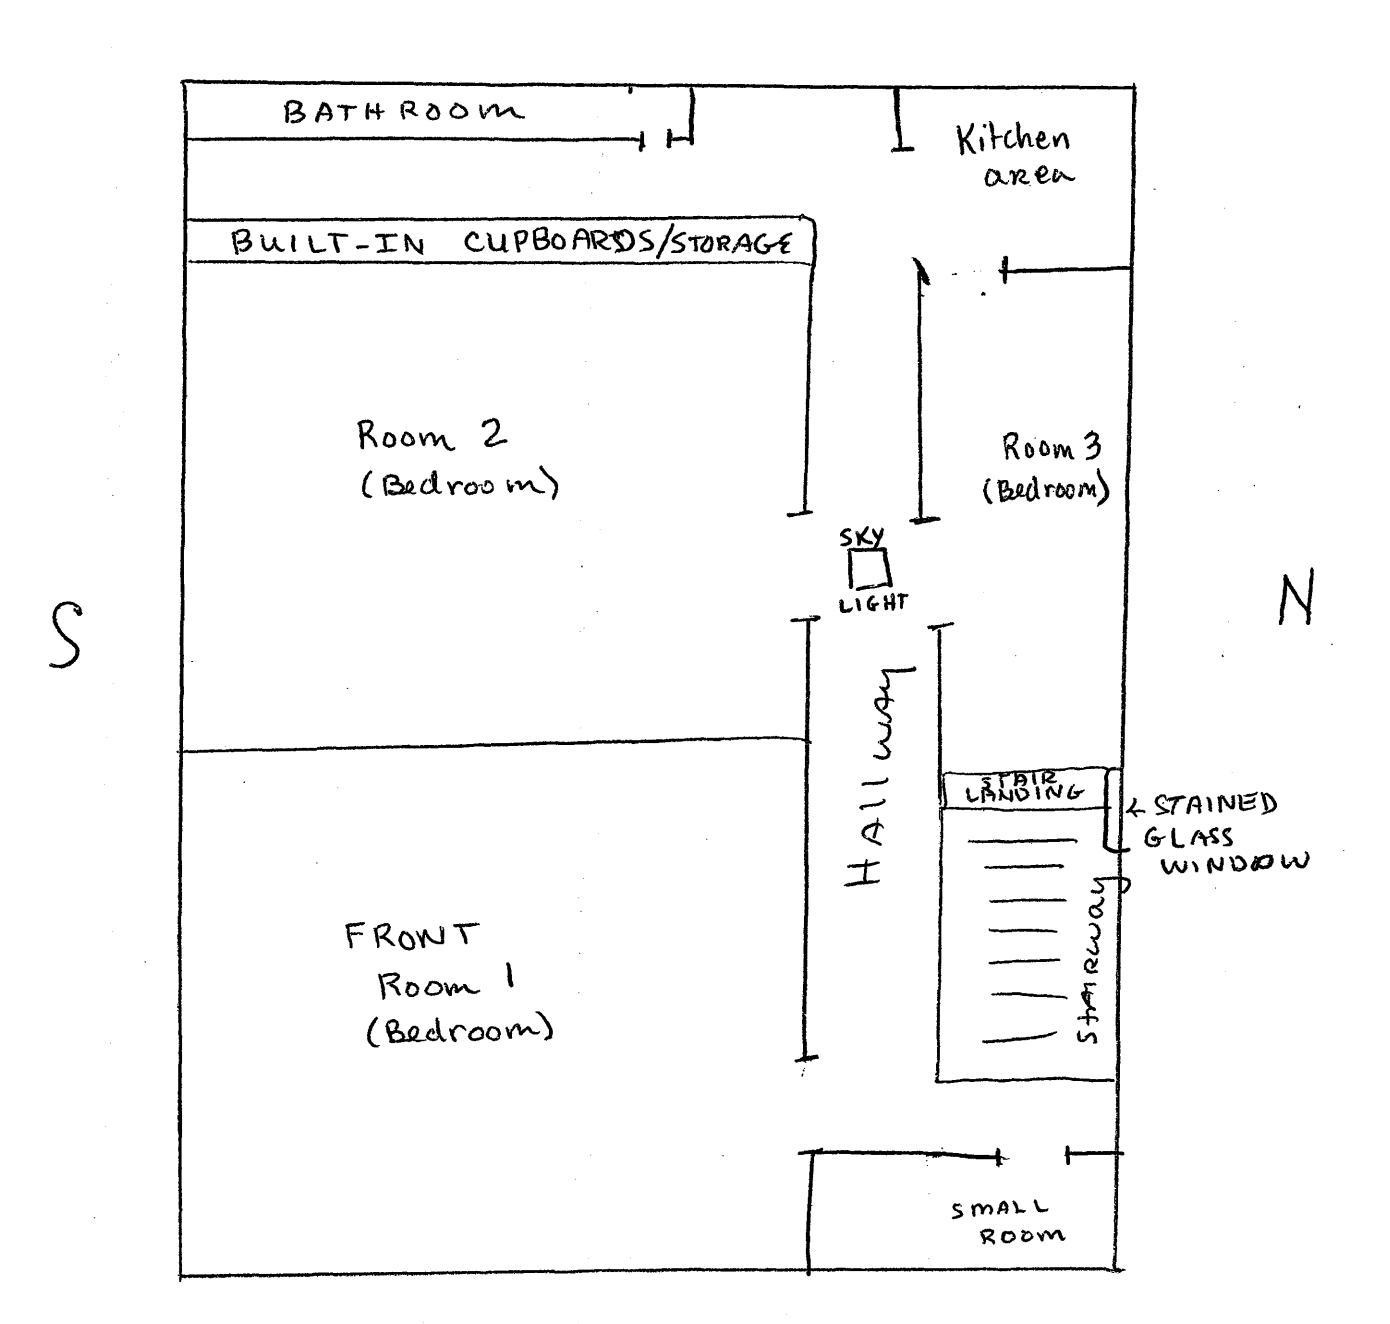
2 nd Floor Floorplan LANG/Hess House onio County, WV

The second story is composed of a long hallway with an east-west axis. Midway along the hallway ceiling, there is a glass skylight of later, yet still historic, provenance. The stairs rise from the landing, meeting the second story at the east end of the hall. Immediately to the east of the stairs is a small room. A bedroom is present to the south of the small room, accessed through the hallway. To the west of the first bedroom, and accessed through the hallway, is a second bedroom. The second bedroom features a large built in cupboard along the west wall. To the north of the second bedroom, and across the hallway, is a smaller third bedroom. A kitchen, relict from the use of the second story as an apartment, is present in the northwest corner of the house. A long, narrow bathroom completes the room divisions of the second story, present along the southwest corner of the house. Trim and general finish is less decorative when compared with the high level of finish visible on the first story.
