National Register of Historic Places Registration Form

1. Name of Property			
historic name Schuyler Ma	ansion National Historic	Landmark	
	Pastures (not used in th		!)
2. Location			
street & number 32 Catharin	ne Street (corner of Schu	yler Street)	not for publication
city, town Albany			vicinity
state New York co	de 36 county Alba	any code ()(1 zip code 12202
····		-

Continuation sheet Schuyler Mansion

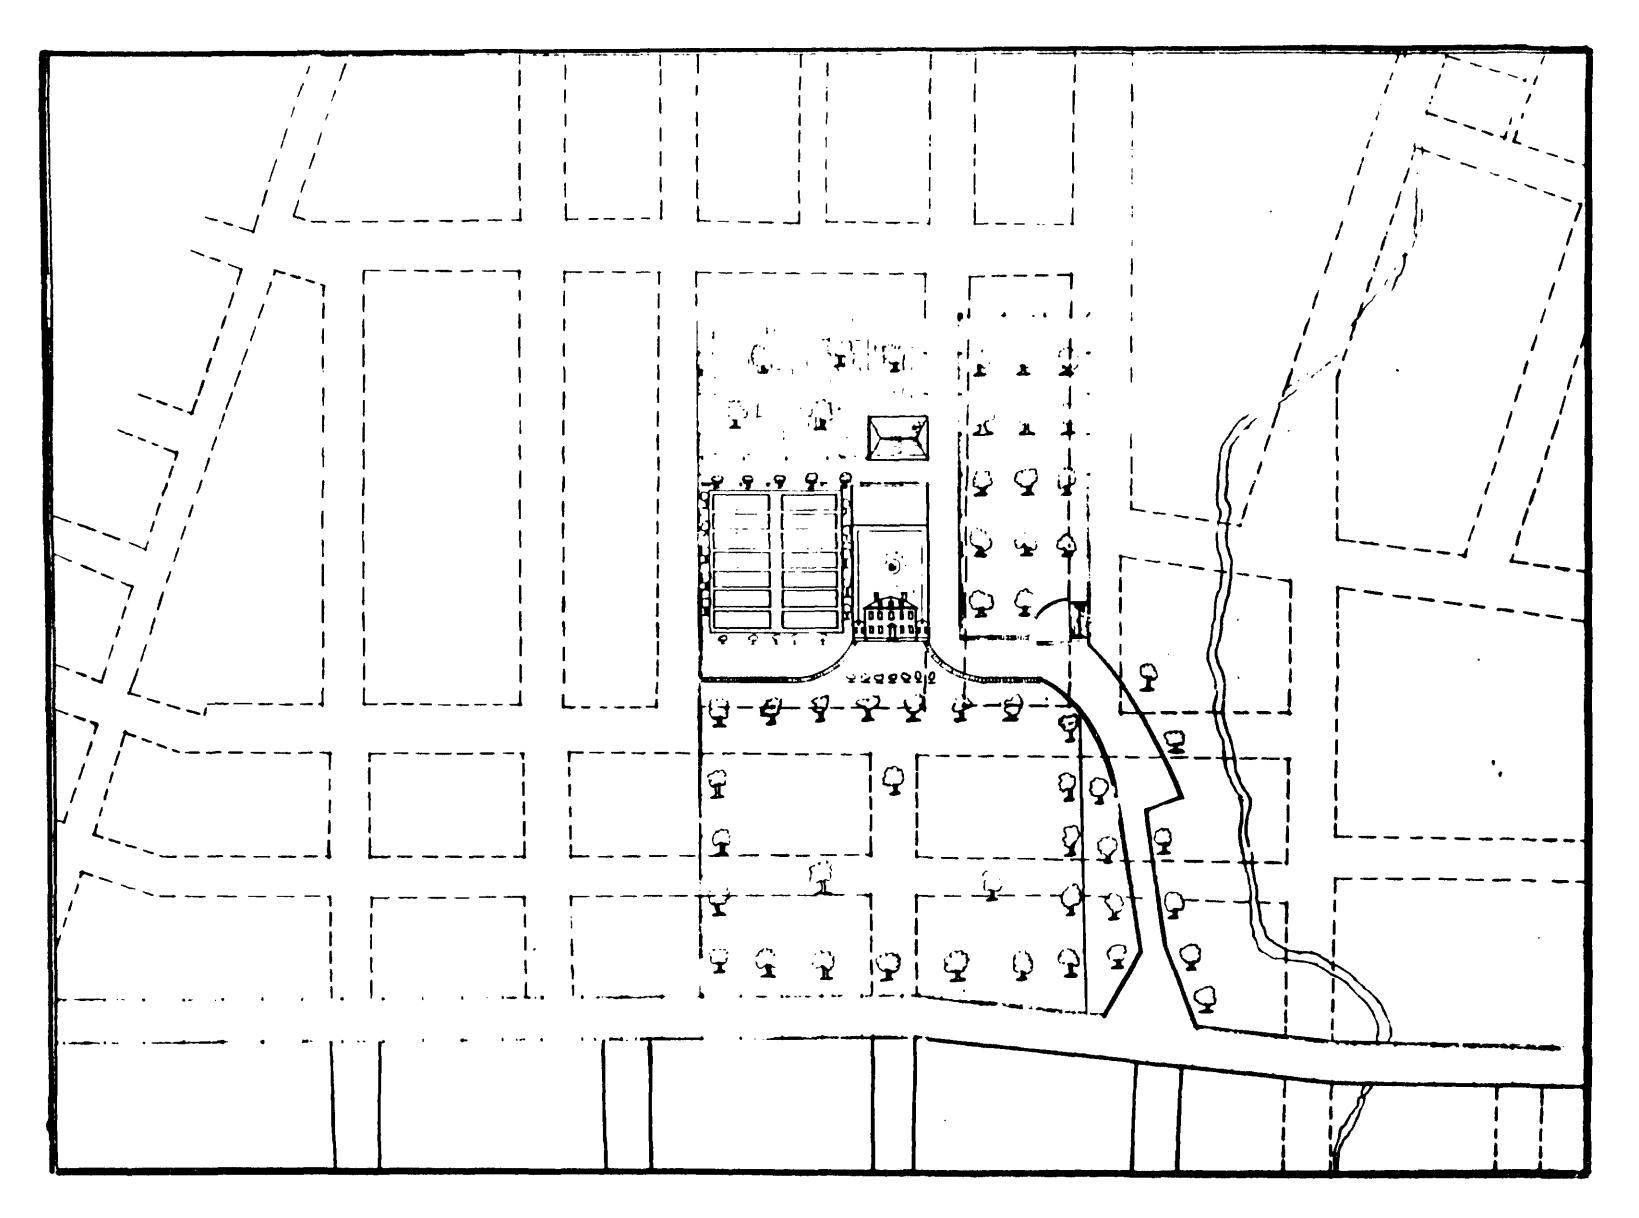
SCHUYLER MANSION NATIONAL HISTORIC LANDMARK Albany, New York. DeWitt Map, 1794 superimposed on modern street grid. (Source: Bullock, 1969.)

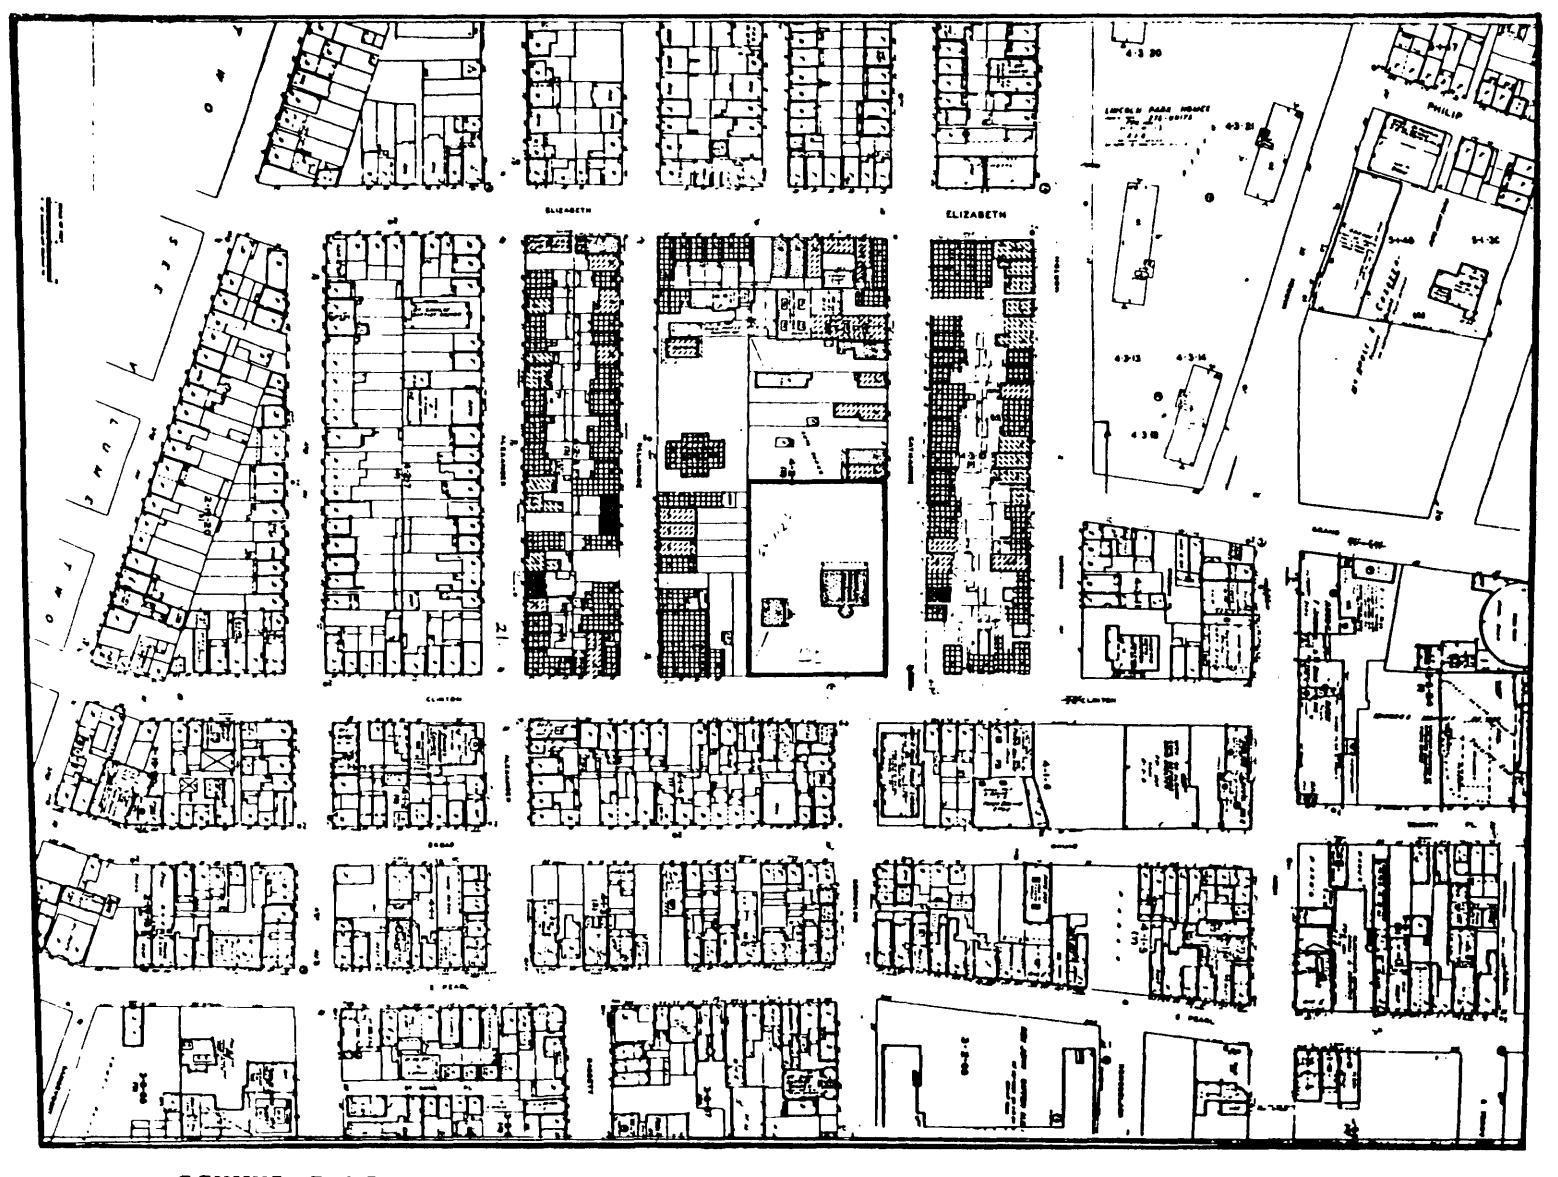
SCHUYLER MANSION NATIONAL HISTORIC LANDMARK Albany, New York Map showing extent of New York State's property, 1969. (Source: Bullock, 1969

- It includes land owned by the State of New York since 1912 and about half the parcel of land added to the state's holdings in 1974. When a previous National Historic Landmark Study was prepared for this site (1976), it did not include the additional land recently purchased by the State of New York. Since that time the State has developed the eastern portion of its additional holdings as an intrinsic part of the Schuyler Mansion site. In addition, preliminary archaeological testing has identified 18th-century sites, including the location of Schuyler's barn, on the eastern portion of the recently acquired land under the present parking lot. Despite development in this area, other 18th-century features may remain undisturbed. Archaeological potential may also exist on the western portion of the lot, but testing has identified only sites related to the lot's 19th-century usage. Because these sites, although part of the property's subsequent history, do not pertain to the period determined to be of national significance for this property, the western part of the state's more recently acquired property (approximately 120 feet west of the boundary line) has not been included within the National Historic Landmark boundary. The excluded part of the property is partially vacant and partially still occupied by 19th-century row houses.

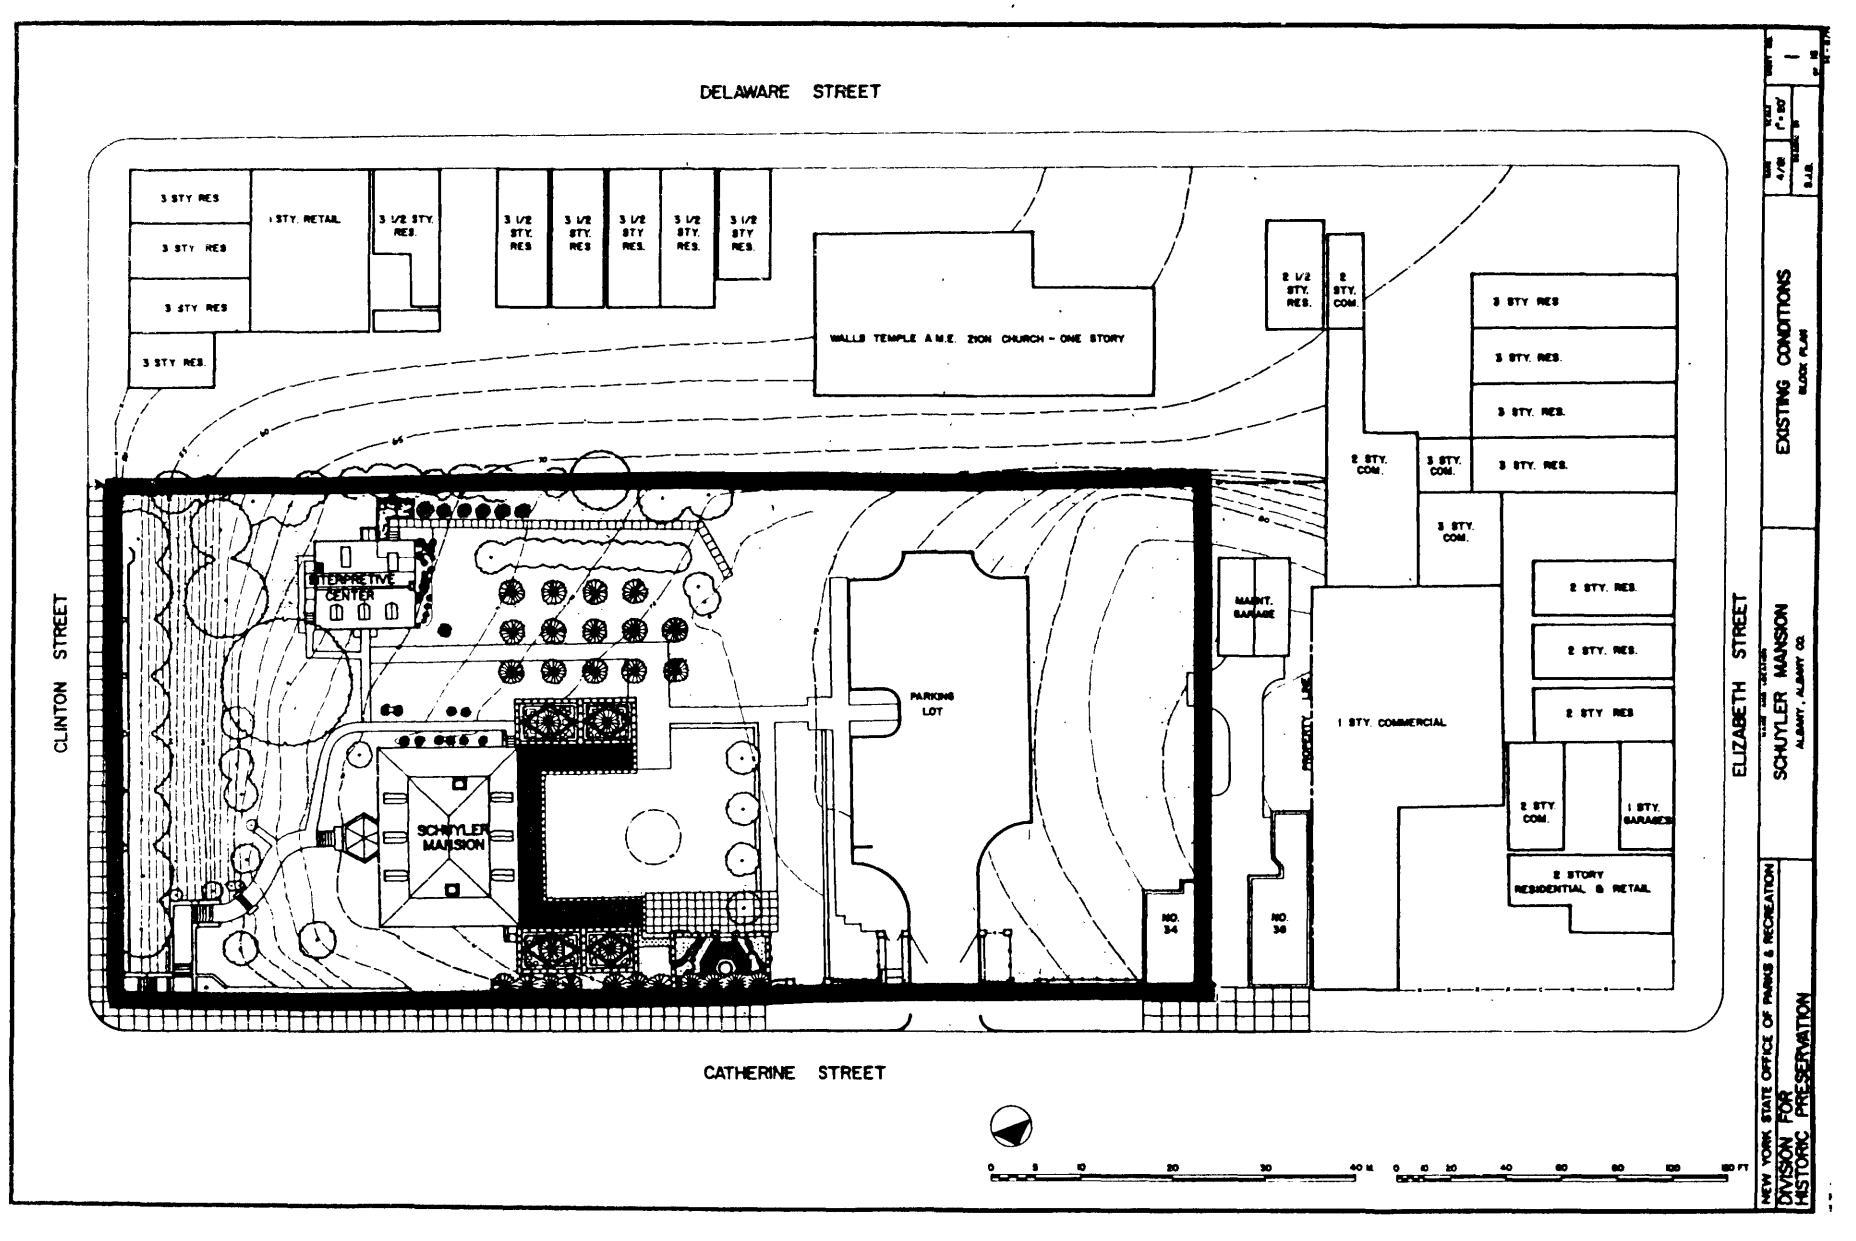
SCHUYLER MANSION NATIONAL HISTORIC LANDMARK Landmark boundary shown as heavy solid line.

Beginning at the northeast corner of the stone boundary wall, which lies just southwest of the intersection of Catherine and Clinton Streets. and proceeding west along the wall parallel to Catherine Street approximately 396 feet, thence south along a line perpendicular to Catherine Street 172 feet to the southern line of the state's property, then east along that line to the stone wall paralleling Clinton Street, then north along the wall to the place of beginning.

- The boundary coincides with historic boundaries as they existed following the division ordered by Schuyler's will, and incorporates land closely associated with Schuyler's domestic use of the property. It includes the mansion lot of 112 feet by 396 feet and the adjoining 60 foot by 396 foot southern lot on which the garden was located. This represents the property as it existed following John Bryan's purchases of 1815, and as it is shown in the earliest known historic view, the Hooker watercolor of 1818.

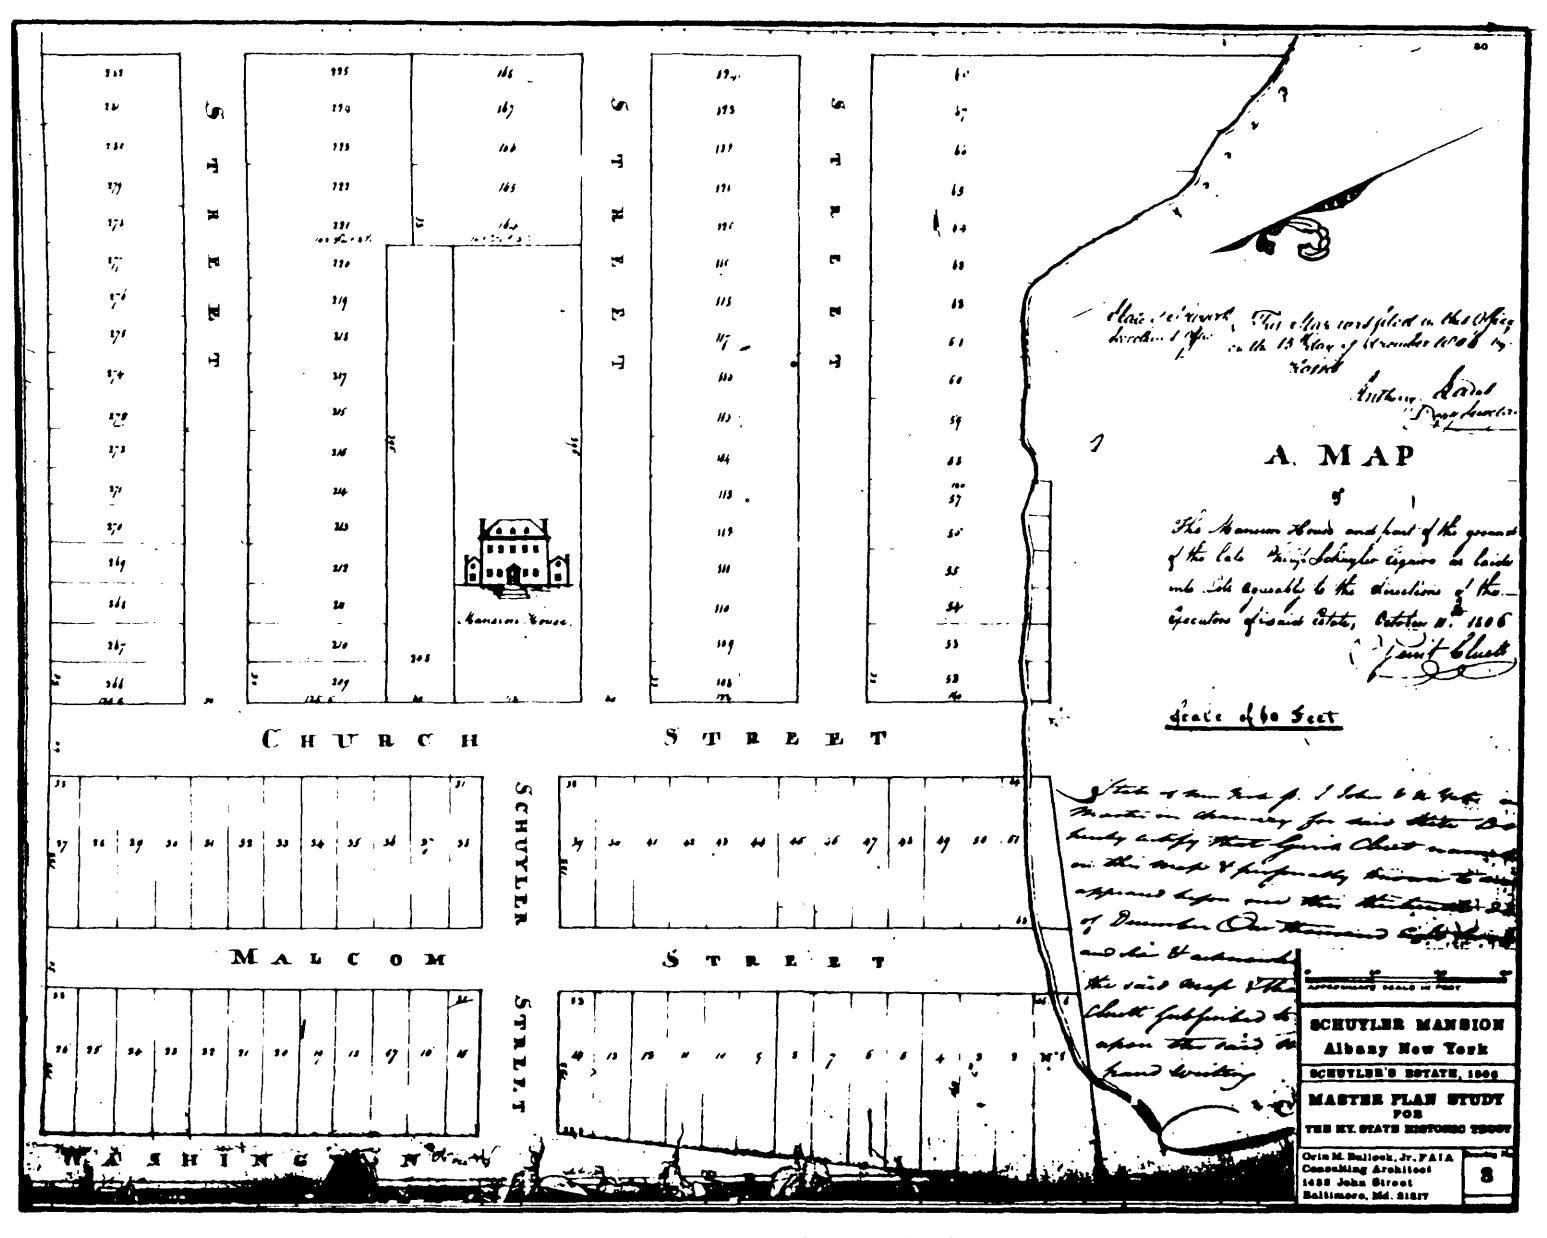
SCHUYLER MANSION NATIONAL HISTORIC LANDMARK Albany, New York Property division made for Philip Schuyler's estate, 1806. (Source: Bullock, 1969.)

After Schuyler's death in 1804 the property was subdivided as he had directed. Following this subdivision, the house stood on a lot measuring 112 feet on Clinton [then Church] Street and 396 feet on the new Catherine Street. It was acquired in 1815 by John Bryan, who Continuation sheet
