National Register of Historic Places Inventory---Nomination Form

historic	Kissock Block	k Building		
and/or common	Kissock Block	k Building		
2. Loca	ation			
street & number	115–117–119– 2	121 East Mountain Av	venue	n/a not for publication
city, town	Fort Collins	n/a vicinity of		
state Co1	orado co	de 08 county	Larimer	code 069

The Kissock Block Building, originally constructed in 1889, currently stands as the only remaining Colorado Commercial Victorian structure on East Mountain Avenue outside of the Old Town Historic District. The recently renovated two story sixty-one foot wide facade consists of red brick highlighted with native sandstone lintels, formed metal cornices with applied ornament, and typical period grade level storefronts. This facade also serves as the streetscape focal point of the south side of the 100 Block of East Mountain Avenue since it is flanked by an alley to the east and open nondescript parking lots on both sides.

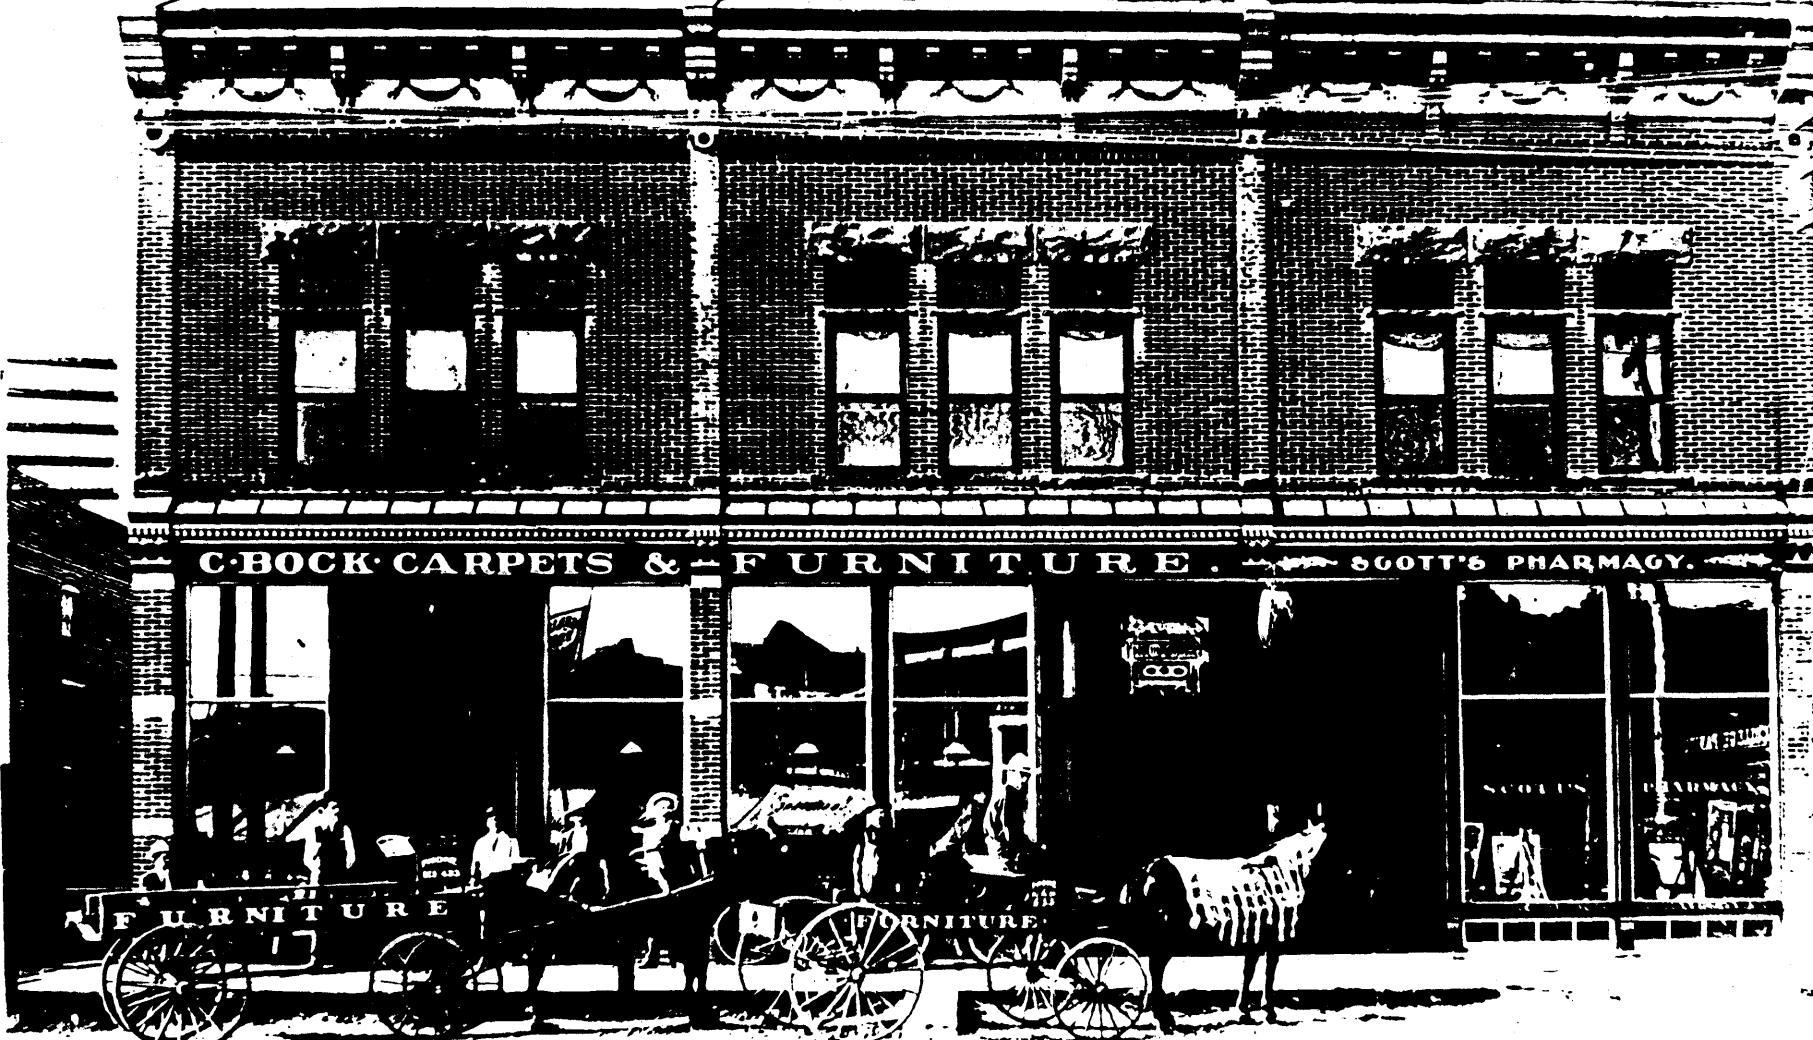
Kissock Block Building Larimer County, Colorado Photo: Photographer & date unknown. Shows building as it appeared in 1895. Photo courtesy of Fort Collins Library.
