Louisiana State Capitol, 1849-1932, Baton Rouge, Louisiana

NATIONAL REGISTER OF HISTORIC PLACES  
PROPERTY PHOTOGRAPH FORM

1. NAME COMMON		AND/OR HISTORIC	NUMERIC CODE (Assigned by NPS)
Old Louisiana State Capitol		State House	JAN 12 1973
2. LOCATION			
STATE		COUNTY	TOWNSHIP
Louisiana		East Baton Rouge	Baton Rouge
STREET AND NUMBER			
North Boulevard and St. Philip Street			
3. PHOTO REFERENCE			
PHOTO CREDIT		DATE	NEGATIVE FILED AT
Grady Smart		Unknown	La. Historical Preservation and Cultural Commission, Baton Rouge
4. IDENTIFICATION			
DESCRIBE VIEW, DIRECTION, ETC.

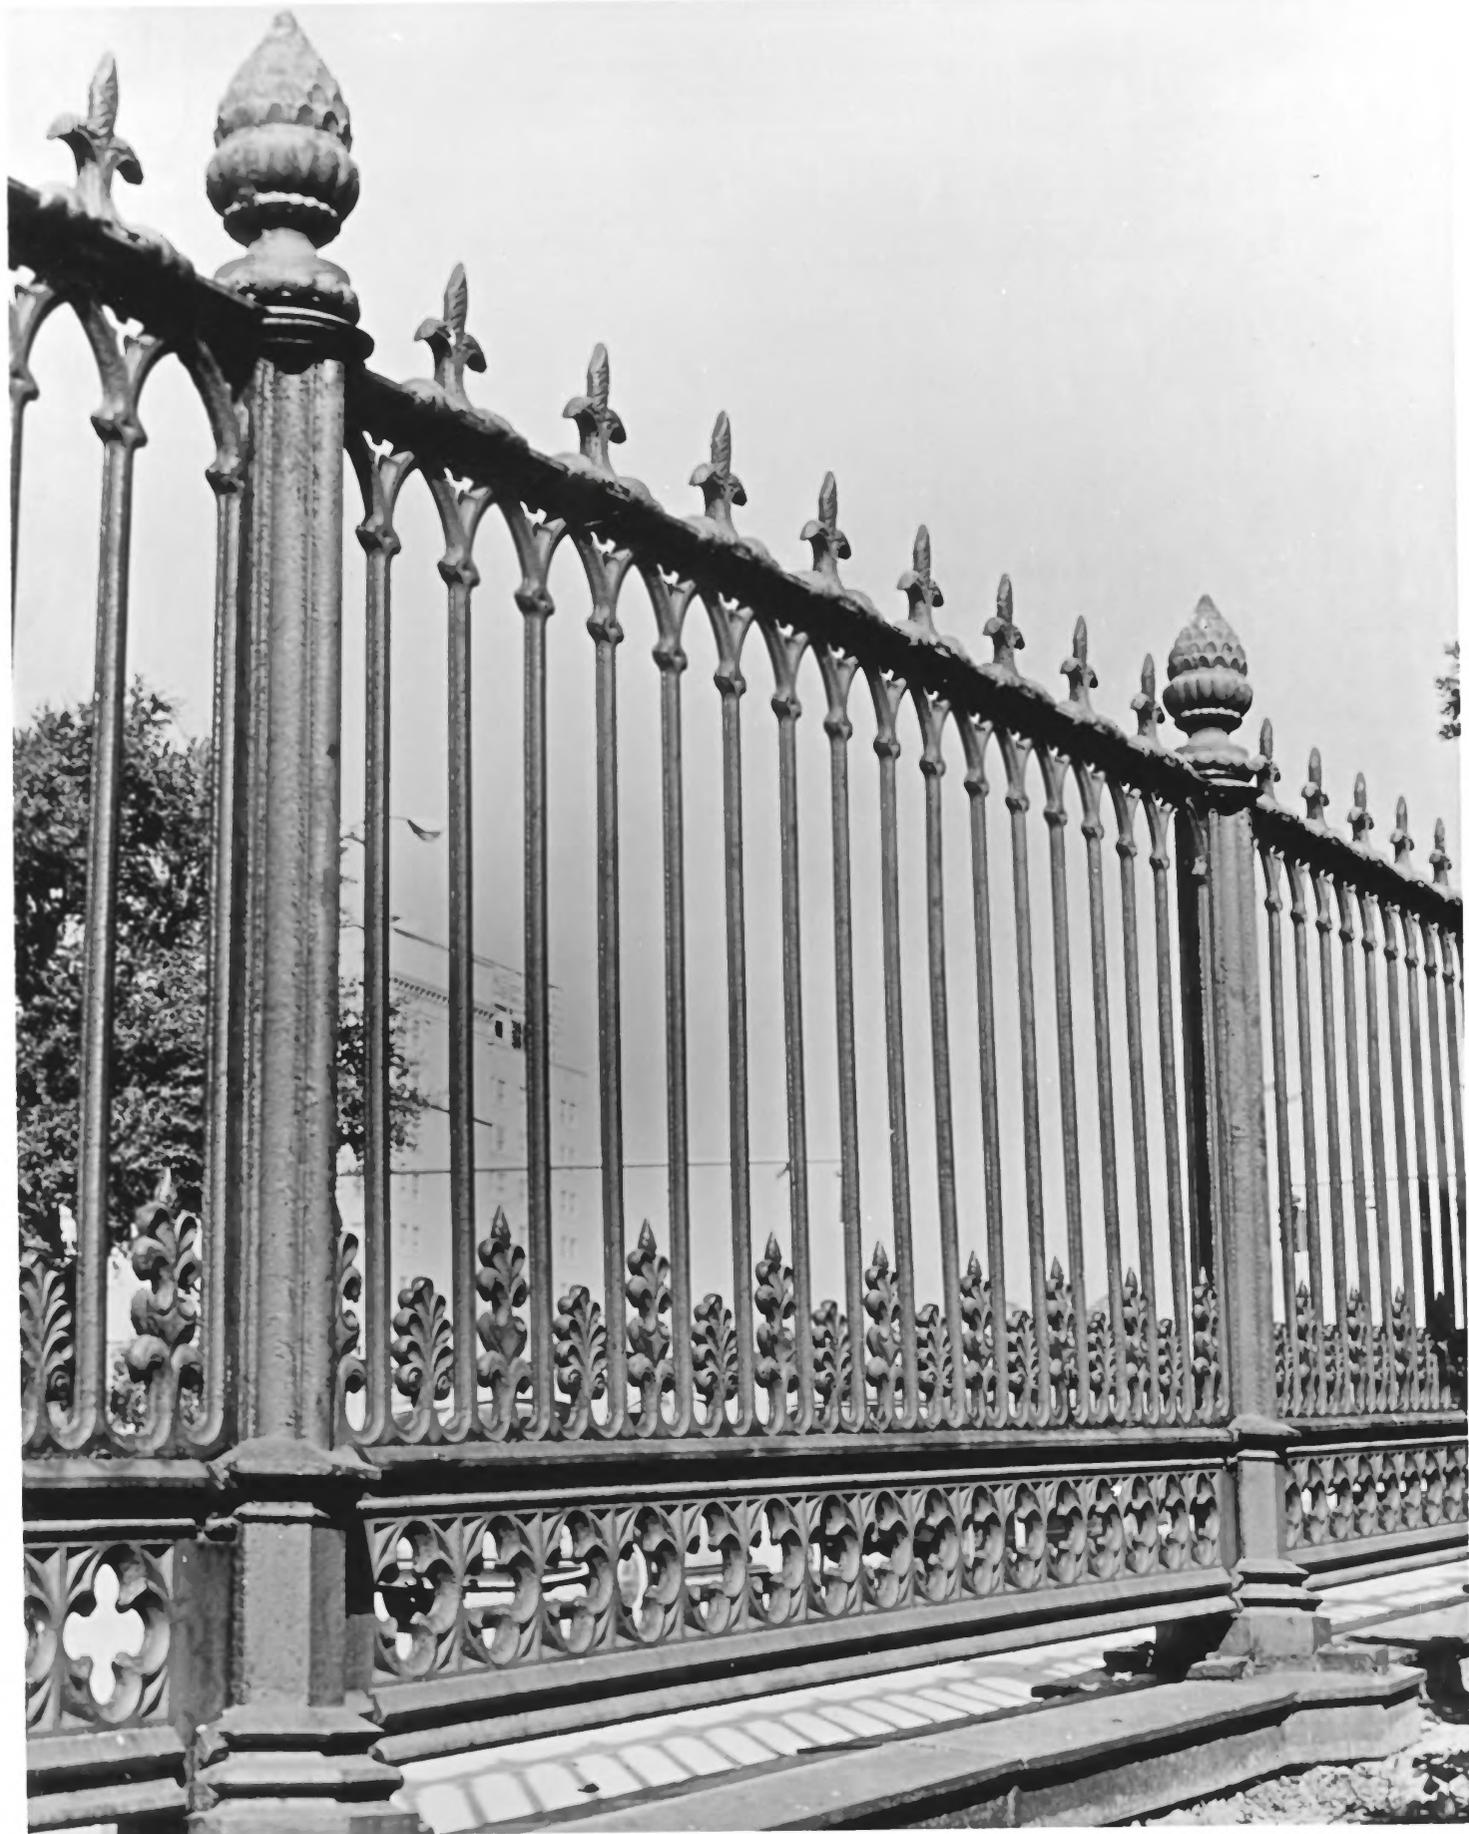
View of the 1849 cast iron fence taken from inside the fence facing northeast. The fence is so constructed that the only bolts in the fence are those holding the fence to its concrete base--it "jigsaws" together.

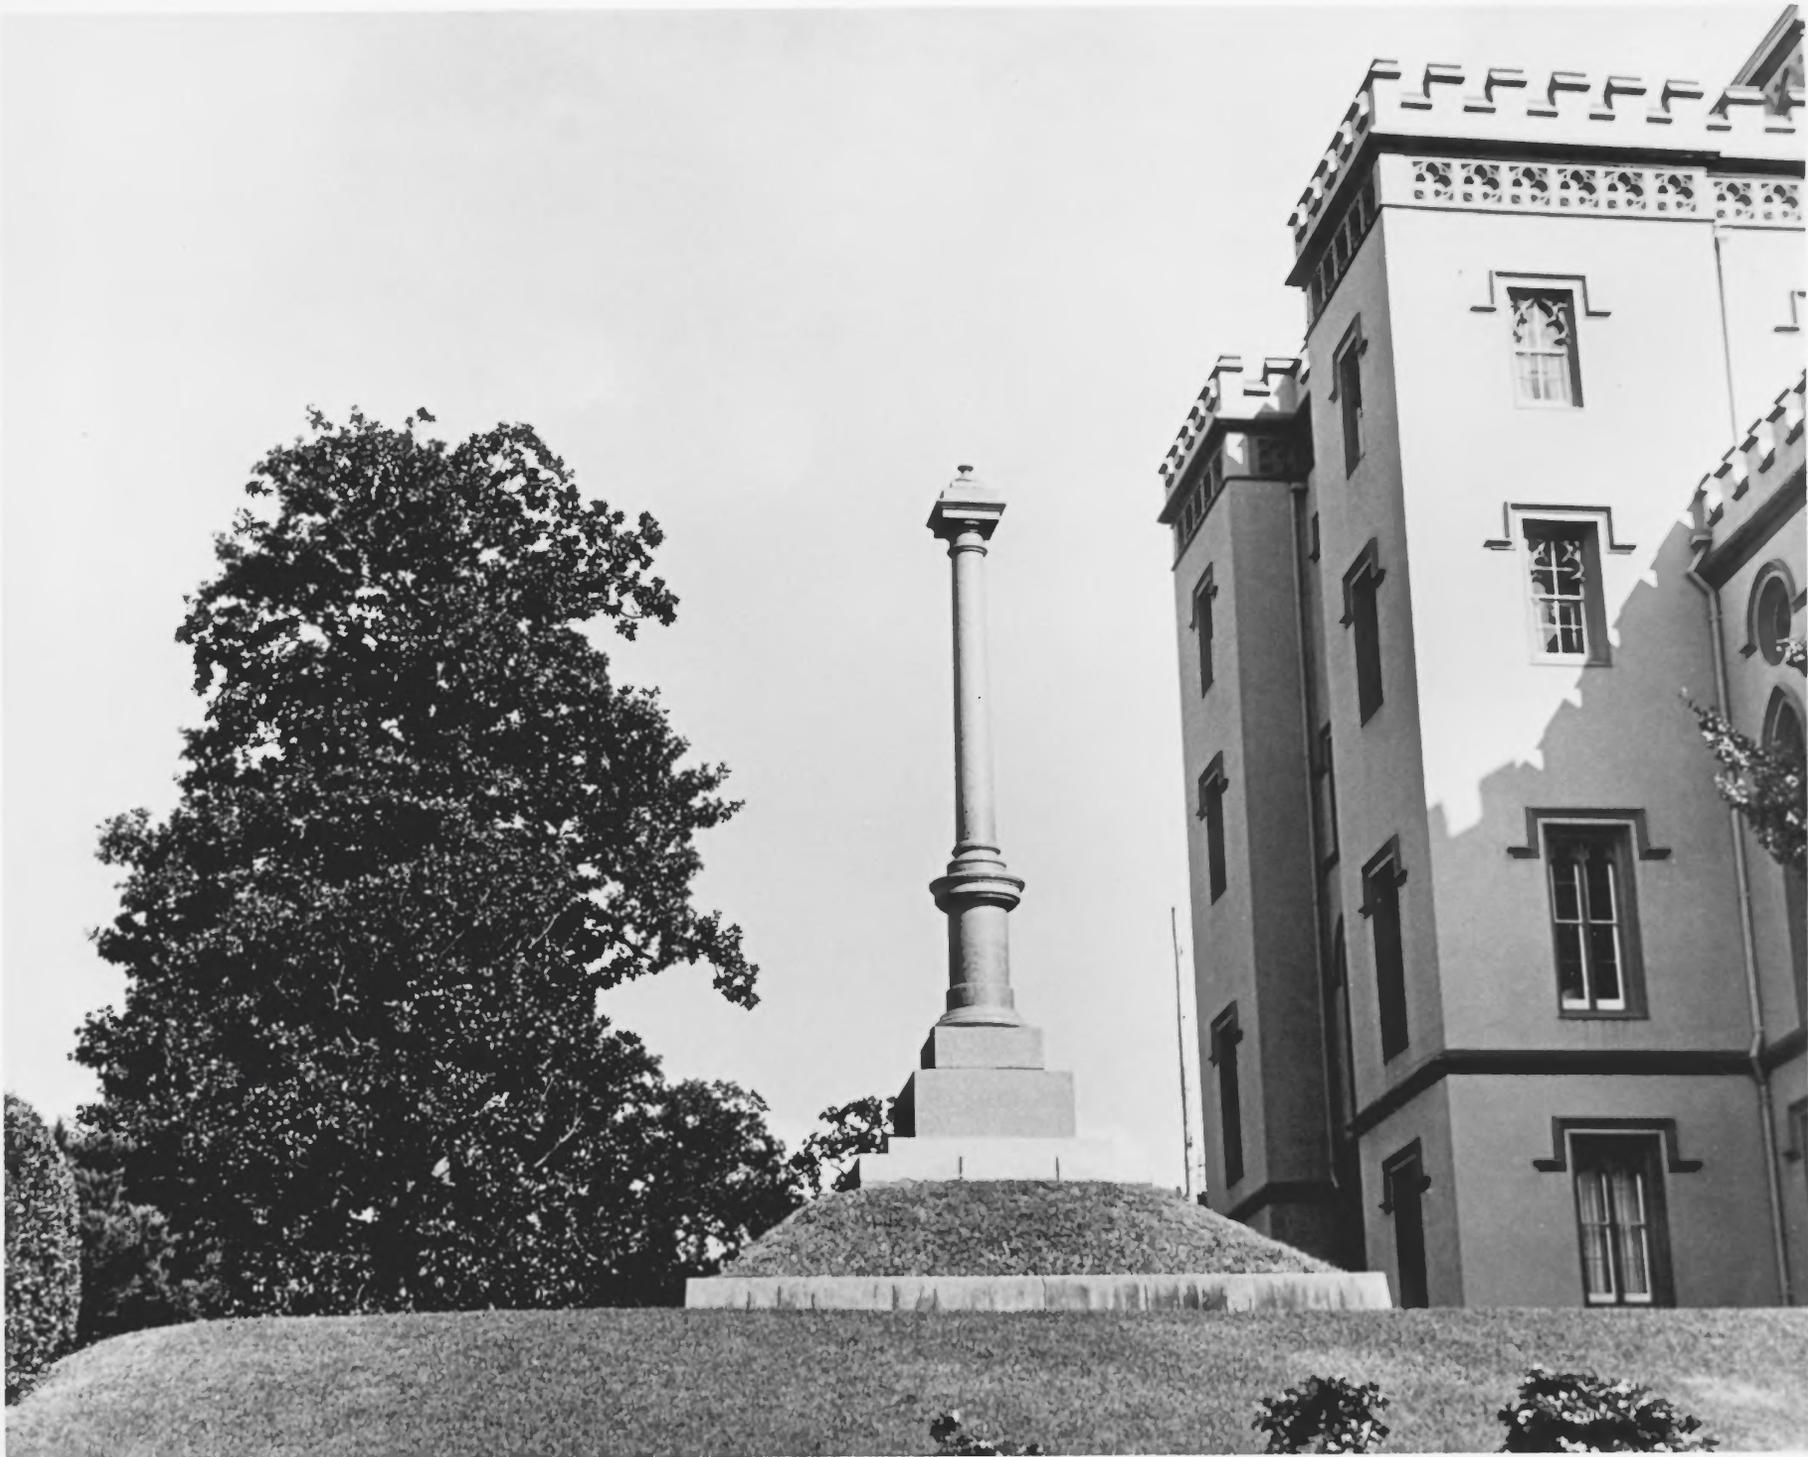
View taken from the west of the Gov. Henry Watkins Allen Monument and grave. The Monument is made of pink Vermont marble. There is carving on the base of the Monument giving facts and quotes about Allen. The northern facade of the Old State Capitol is on the right.

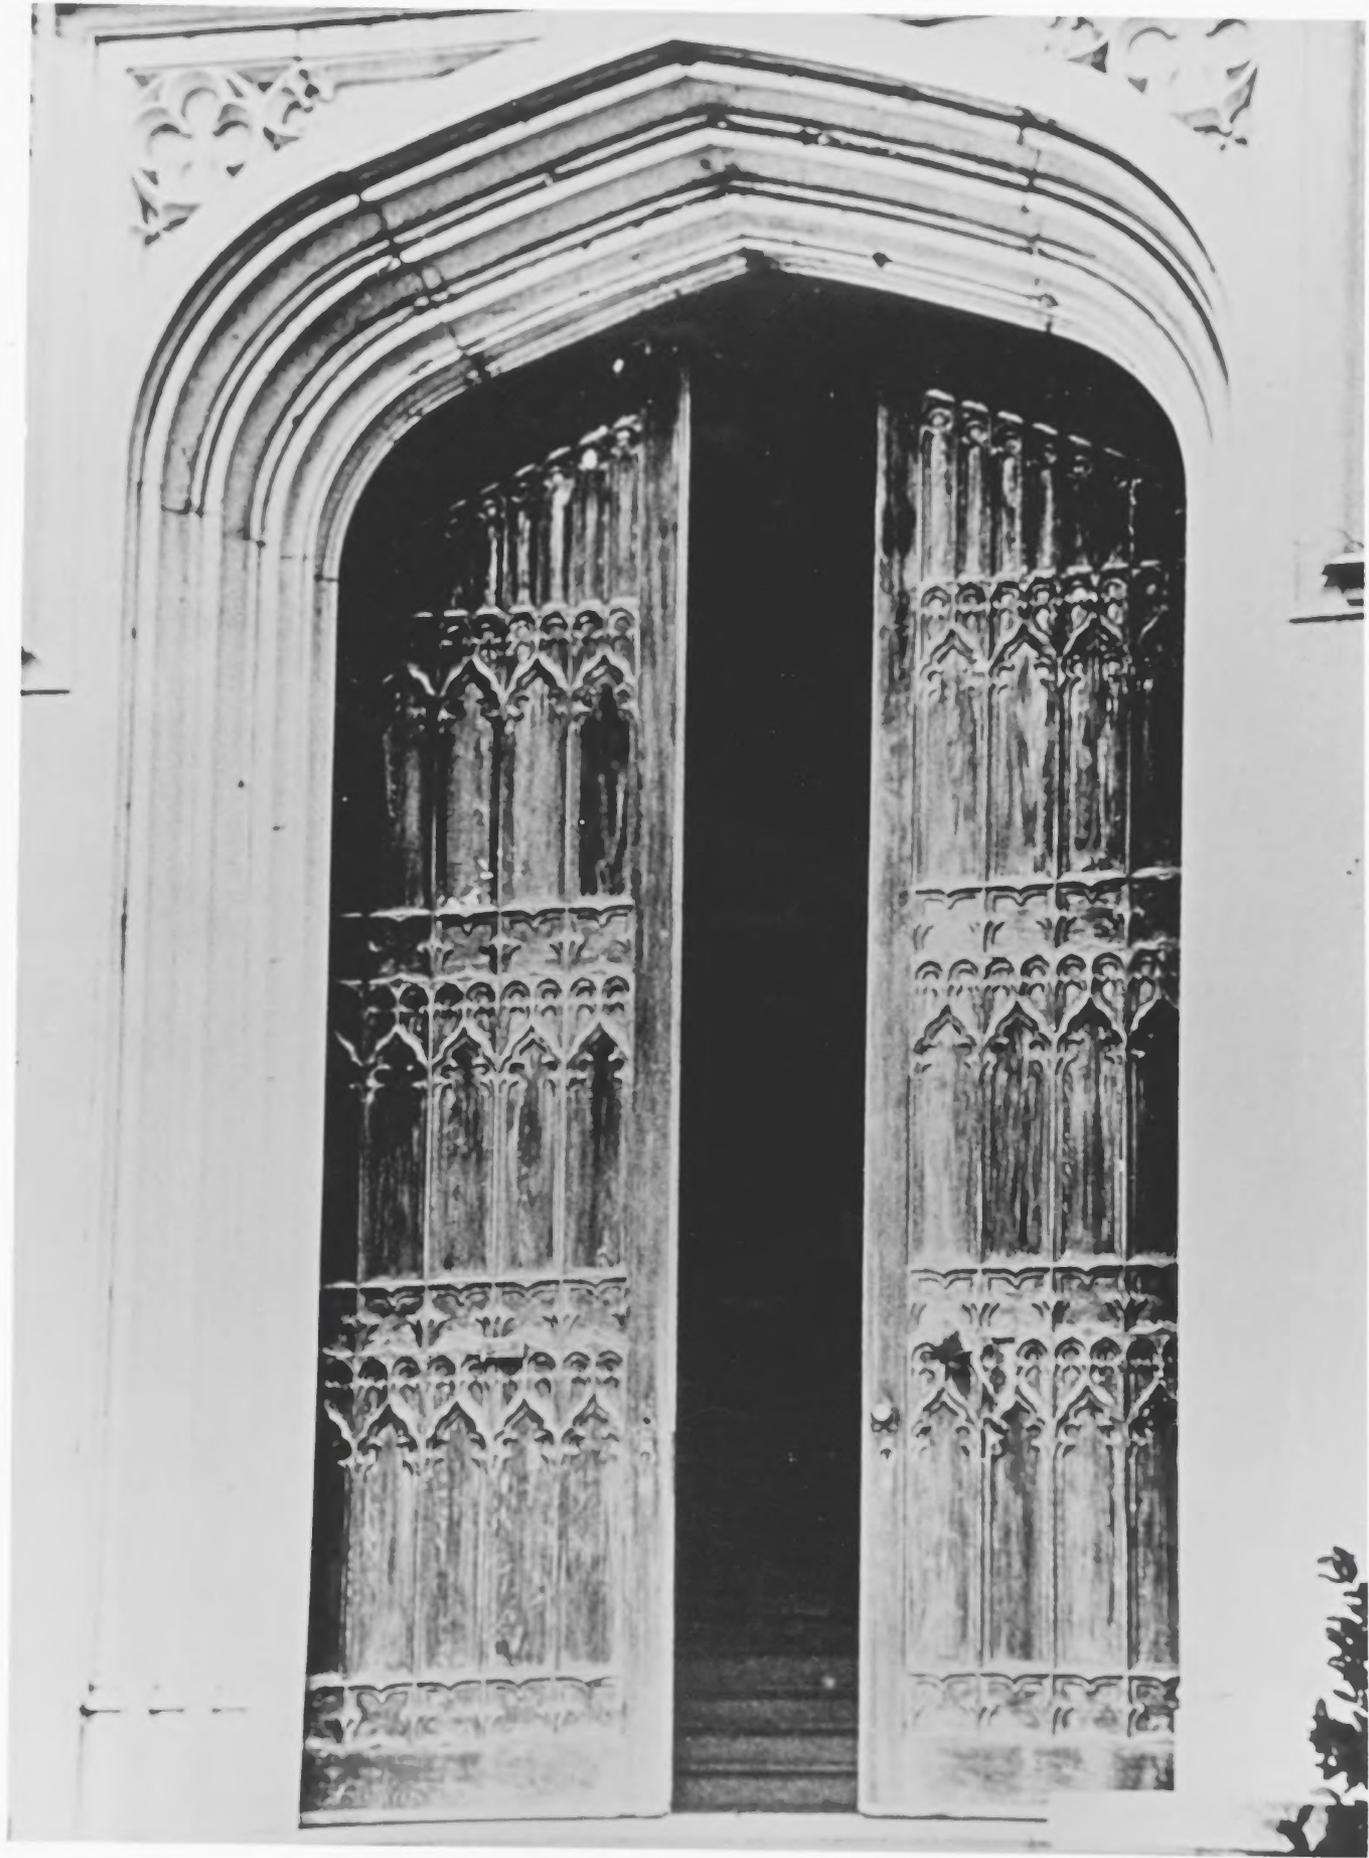
View of the wooden double doors on the western side of the building. Note the carving on the doors and the fact that they slide into the wall to open. This picture was taken prior to sandblasting and painting of the doors.

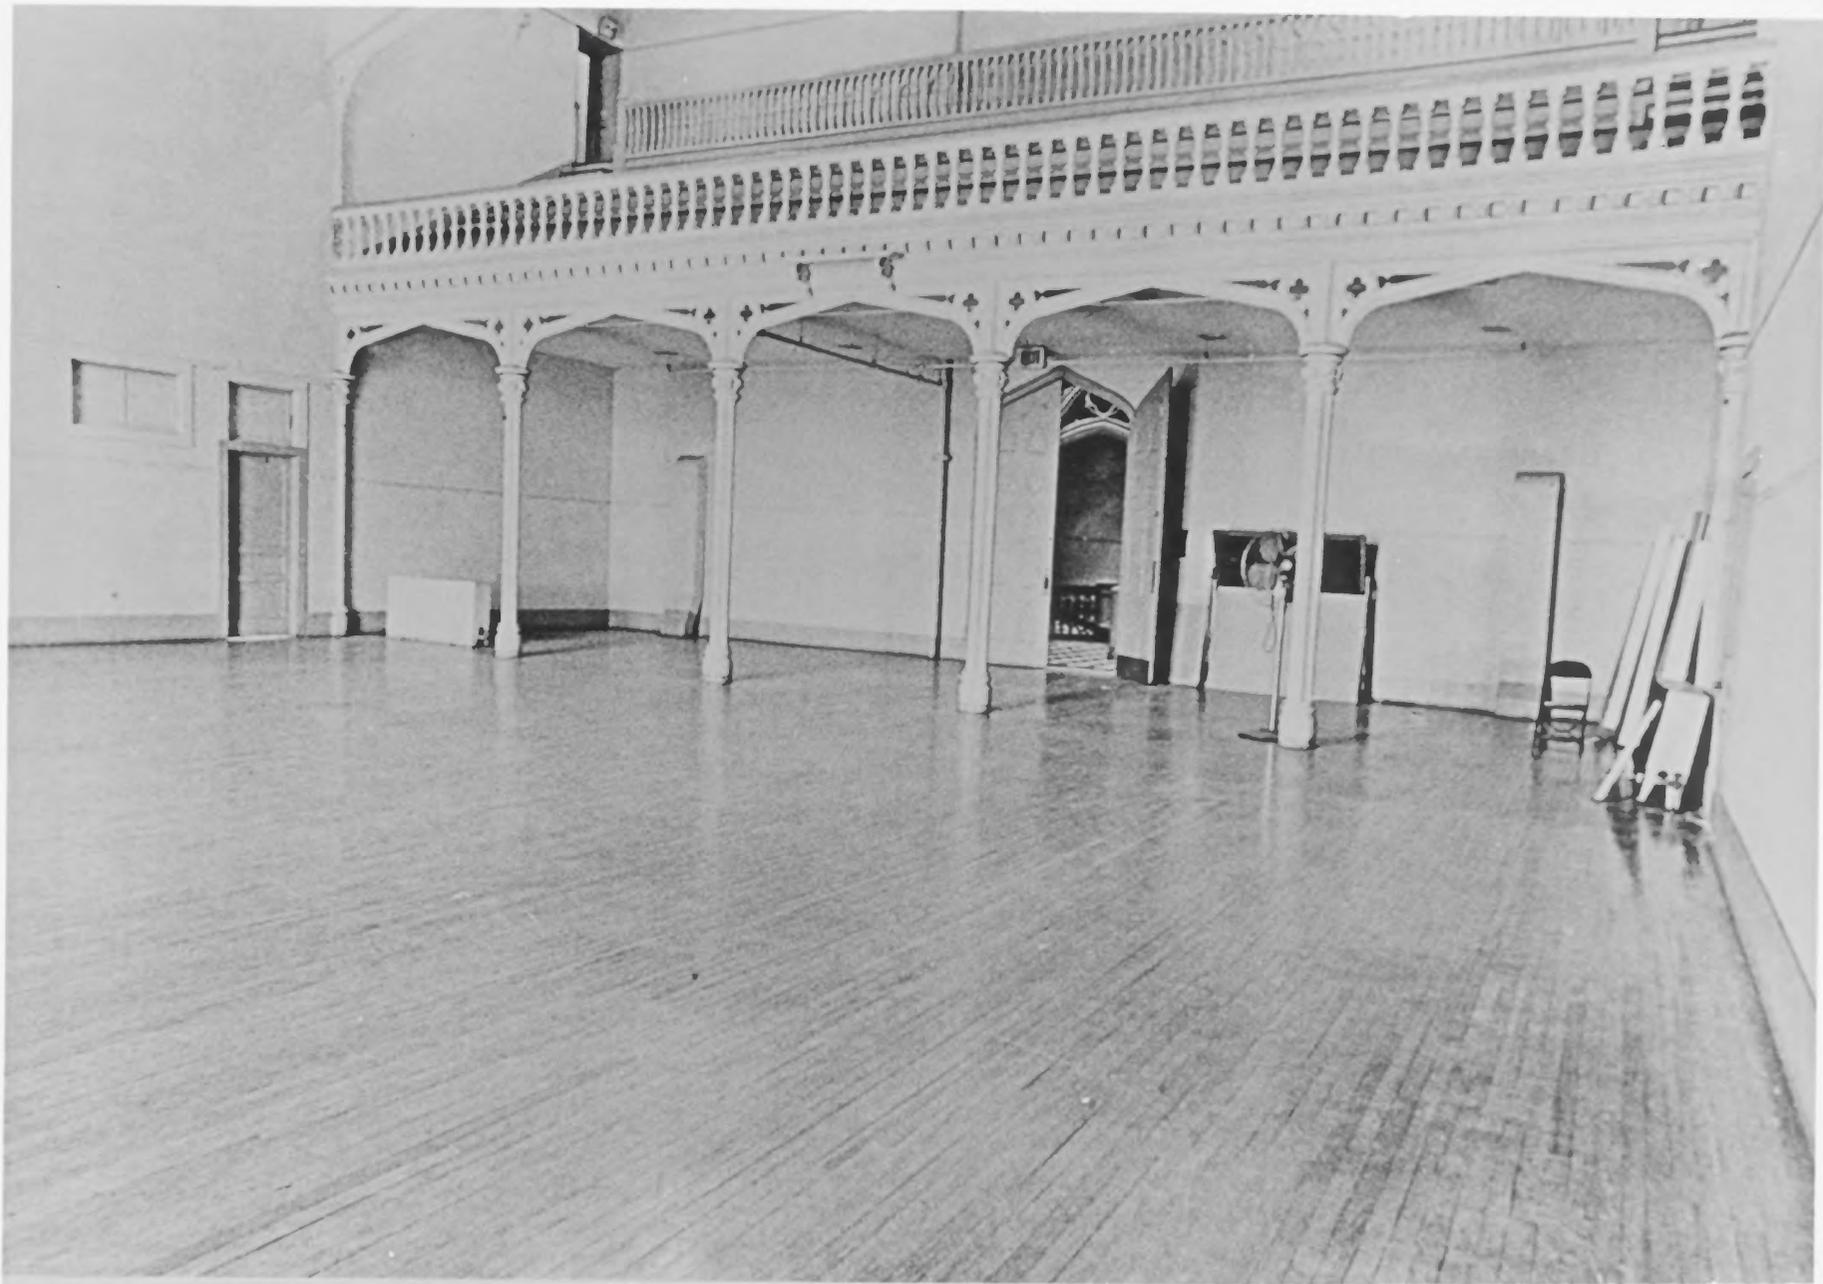
View of the gallery in the House of Representatives Chamber taken facing east. The walls on the extreme right and left of the picture were removed in the 1968 restoration. The doorway leads to the rotunda area.

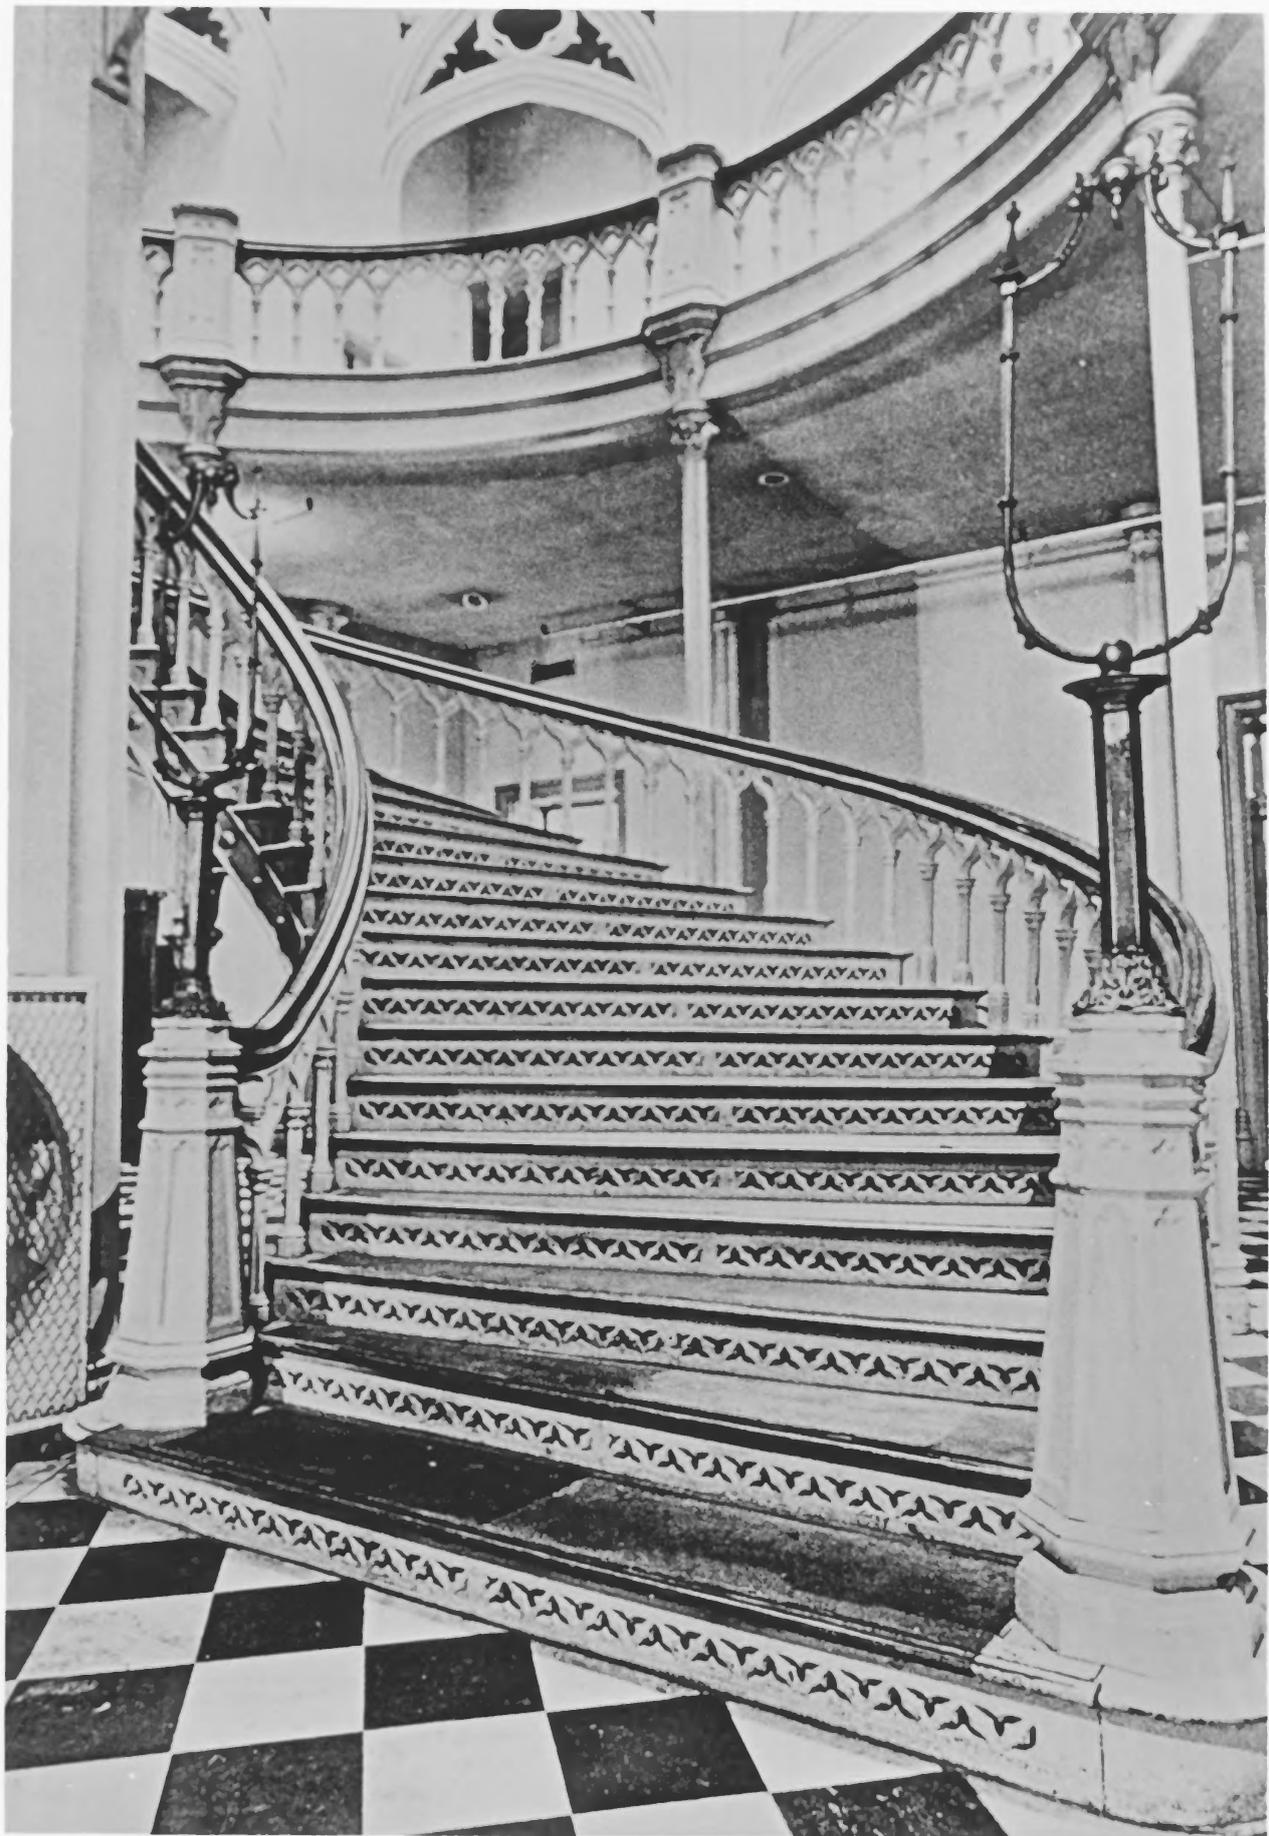
DESCRIBE VIEW, DIRECTION, ETC.  
View of the cast iron stairs taken from the first floor. The brackets on the newels posts held elaborate gas lamps.

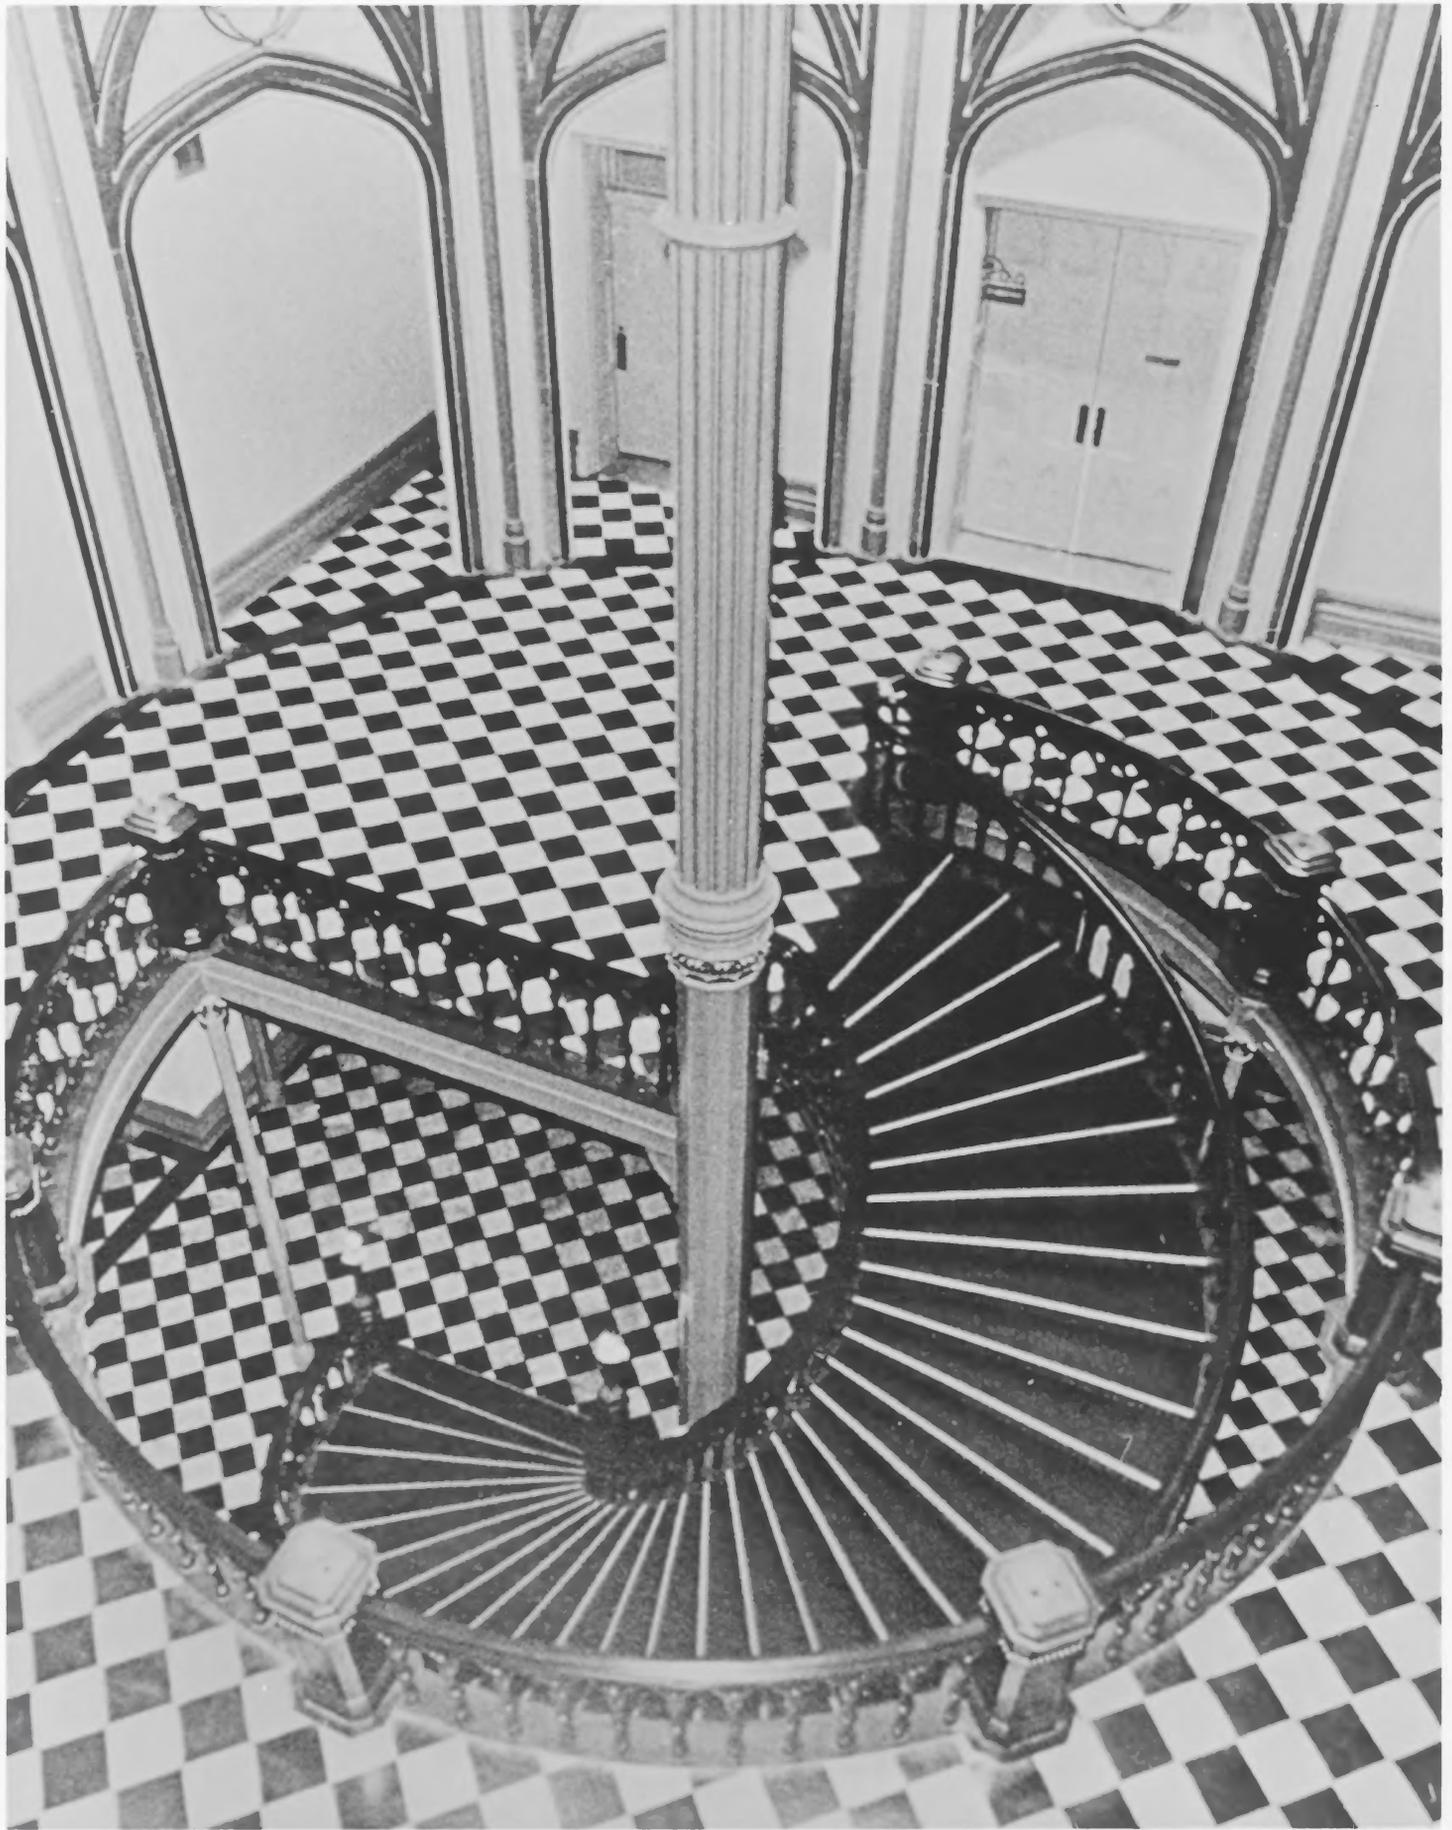
View of the spiral cast iron staircase taken from the fourth floor gallery by the elevator door (facing northwest). Note the poyntell floor and massive cast iron column that rises from the basement to support the stained glass rotunda.

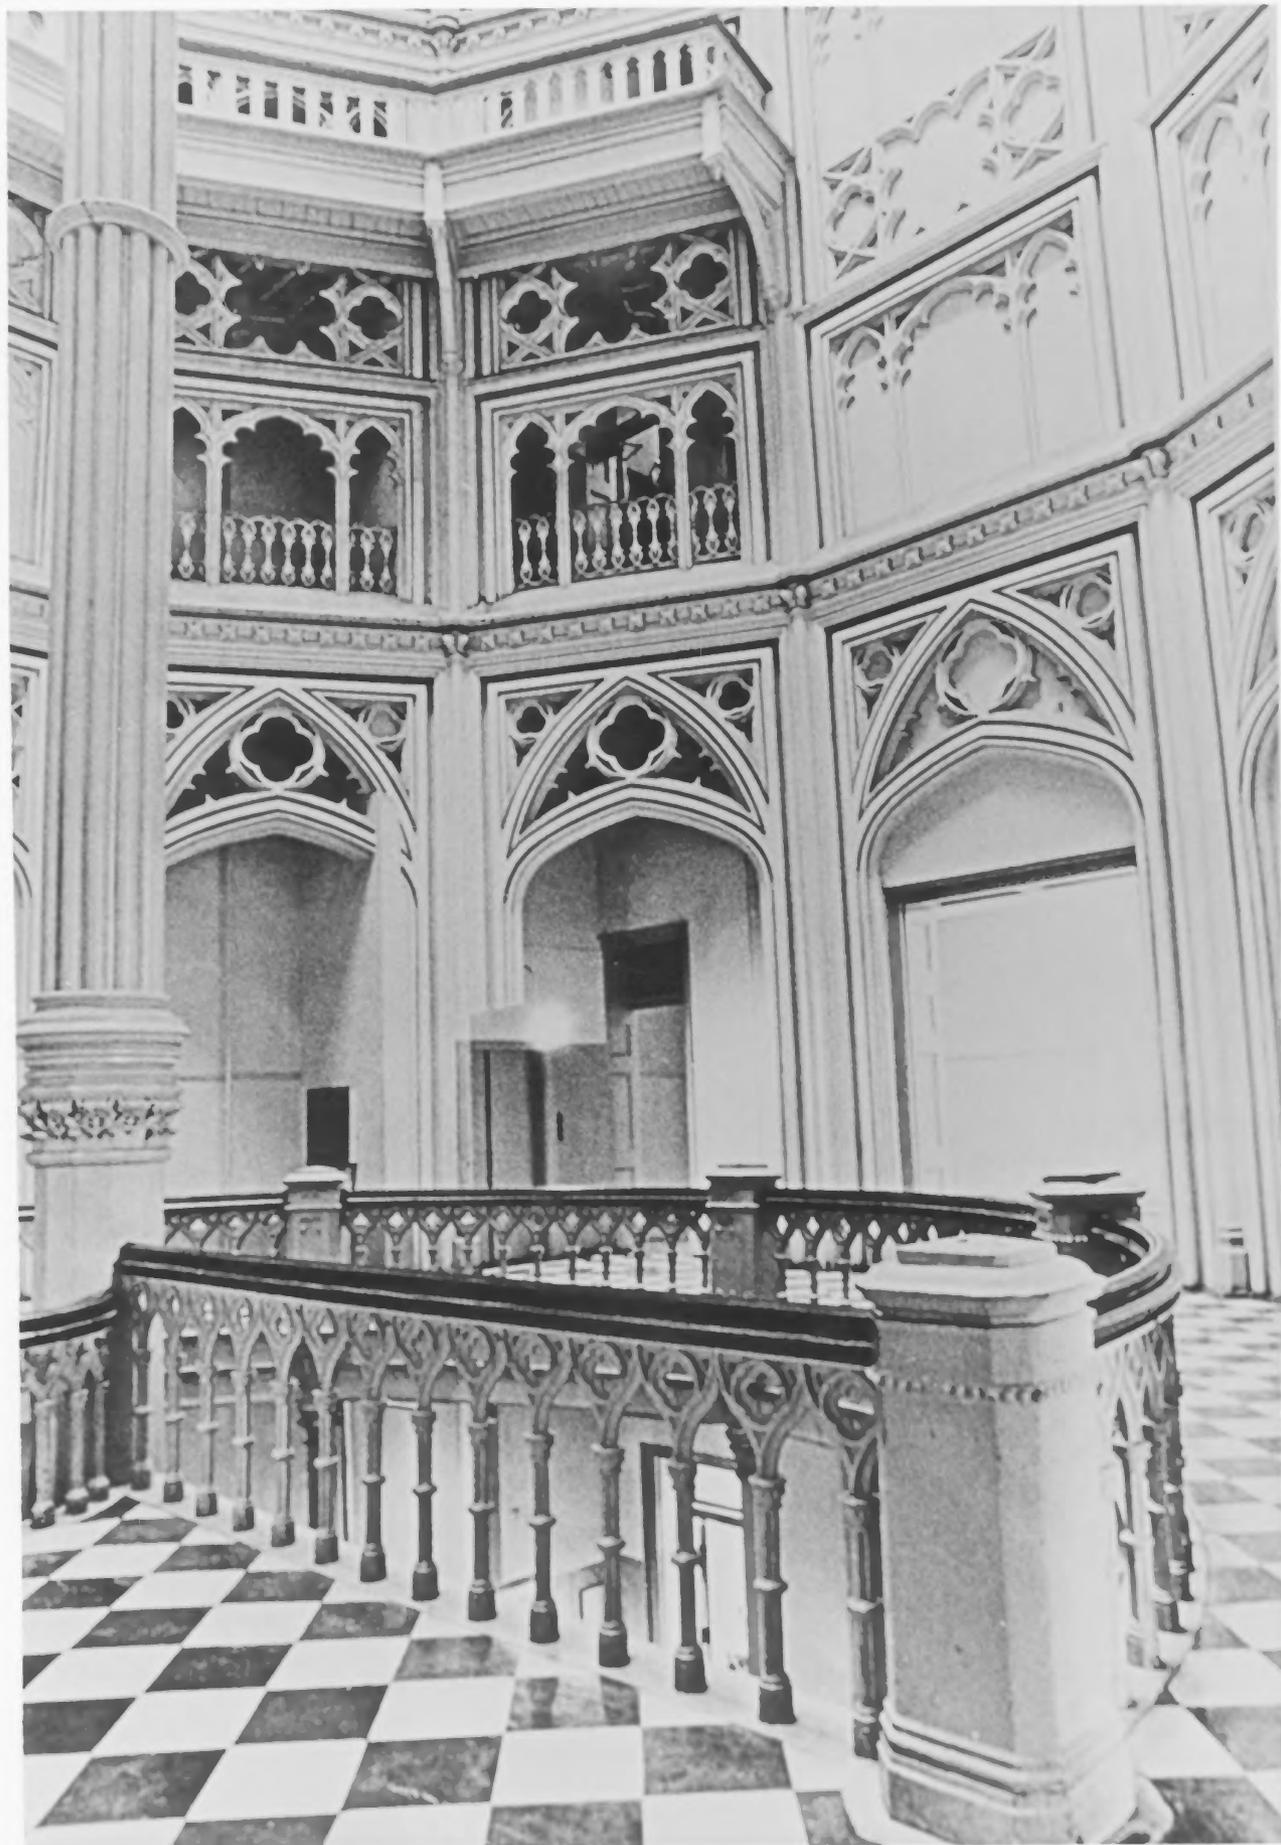
View of the rotunda area taken from the second floor facing southeast. The second floor elevator door is in the center of the picture. The fourth floor gallery can be seen at the top.

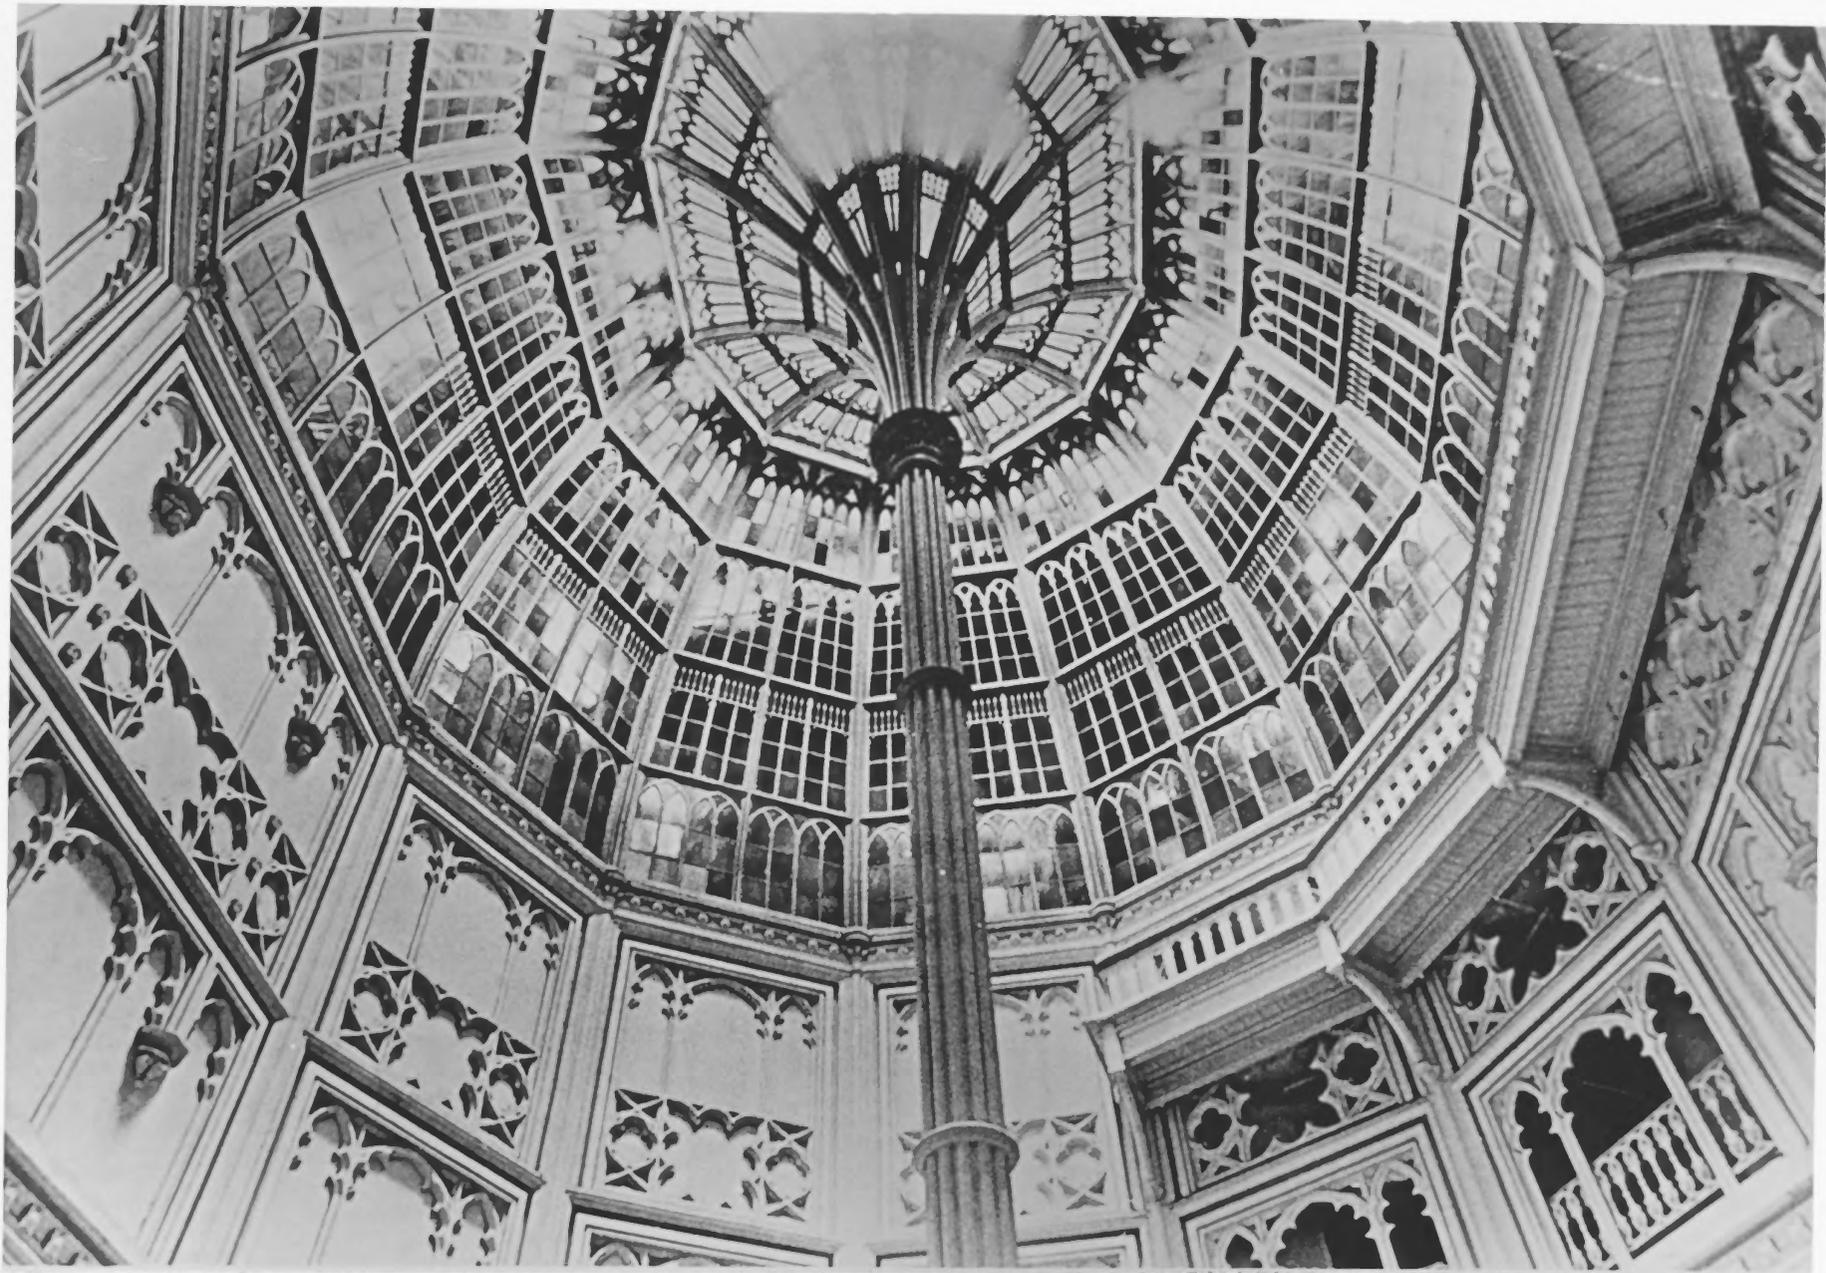
View of the stained glass rotunda taken facing north. Note the fourth floor gallery in the right side of the picture. The cast iron column supporting the rotunda rises from the basement floor.
