**United States Department of the Interior**  
**Heritage Conservation and Recreation Service**  
**National Register of Historic Places**  
**Inventory—Nomination Form**

historic Trumpington

Trumpington  
Kent County  
Maryland

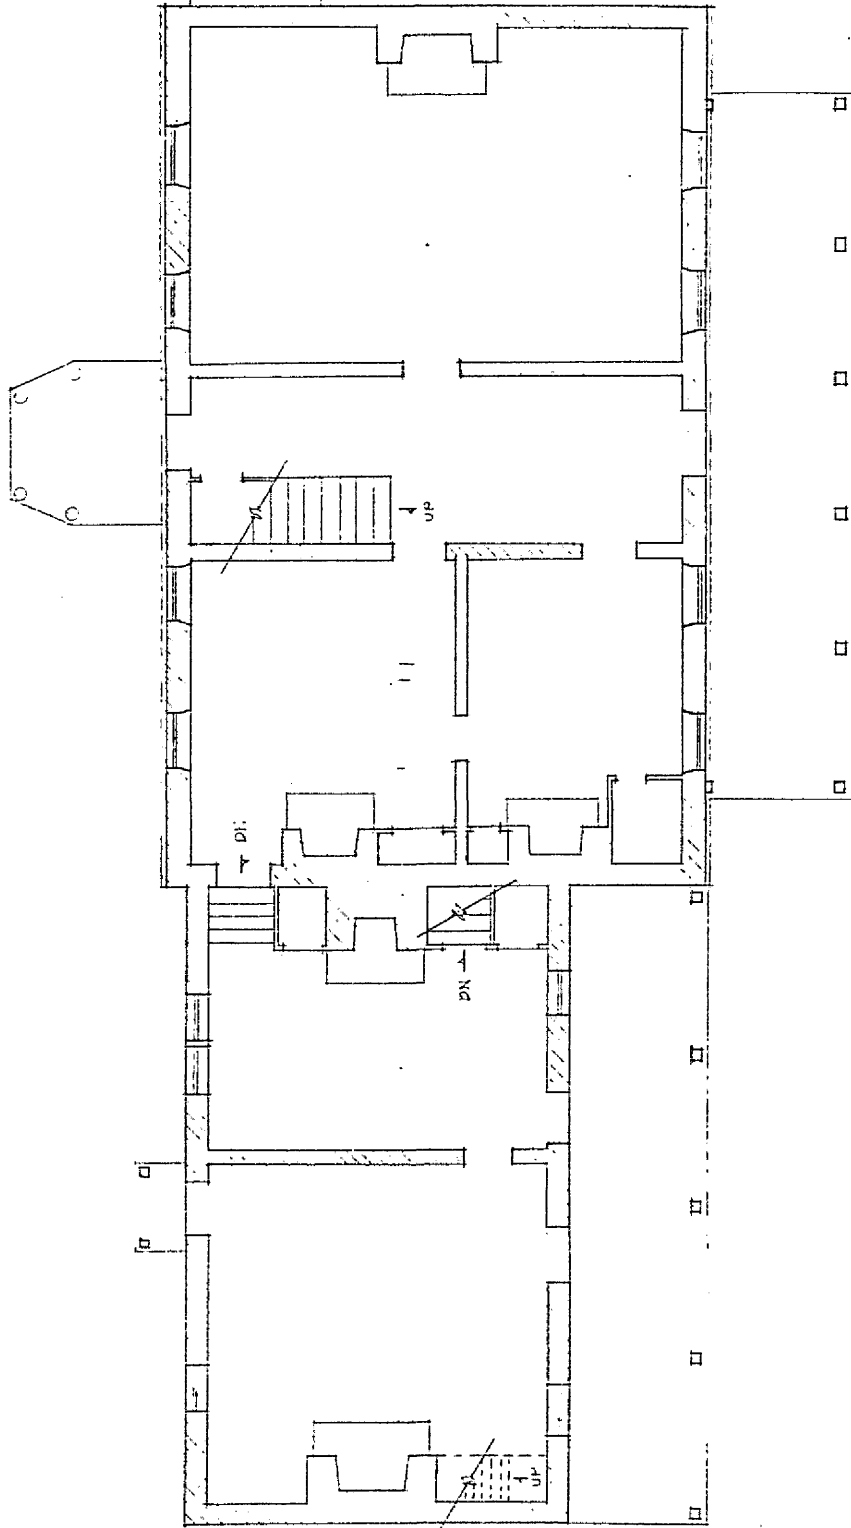
K-271

SCALE: 3/32" = 1'-0"

TRUMPINGTON  
 ROCK HALL, MARYLAND  
 KENT COUNTY

The interior of the main house is laid out in a variation of the full Georgian plan, with a wide central stair hall flanked by two rooms on the northwest and a single room on the southeast that runs the full depth of the house. The two northwest rooms are not equal in size: the east room was presumably intended as a parlor and/or dining room, while the west room is smaller and probably served as a library or small sitting room.

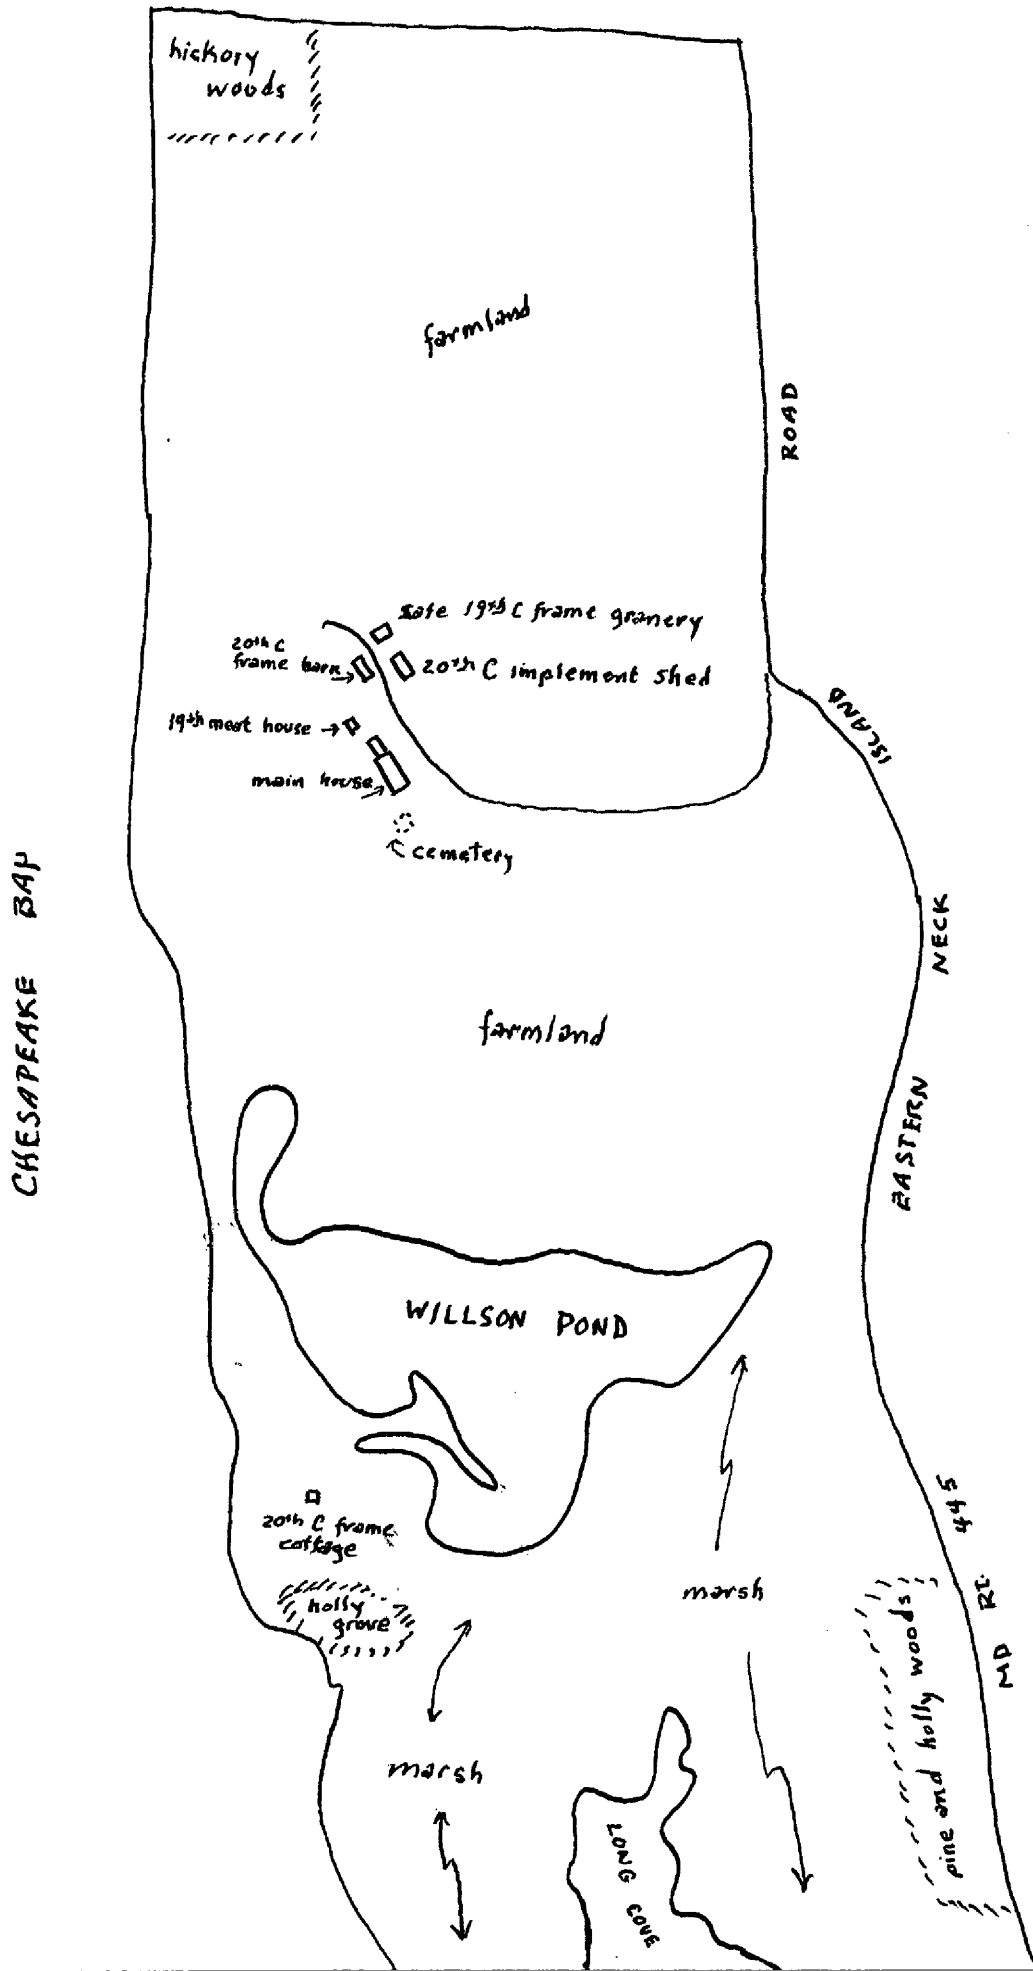
Trumpington  
Kent Co, Maryland

sketch map, 1980  
scale 1" = 600'

The nominated property is bounded on the west by Maryland Route 445, Eastern Neck Island Road, on the south and west by the Chesapeake Bay, and on the north by the present property line as designated in Kent County Deeds EHP 72/318 and EHP 78/832 and Kent County Will ERB 8/93.
