National Register of Historic Places
Registration Form

historic name Social Security Administration Building
other names / site number Wilbur J. Cohen Building

Social Security Administration Building

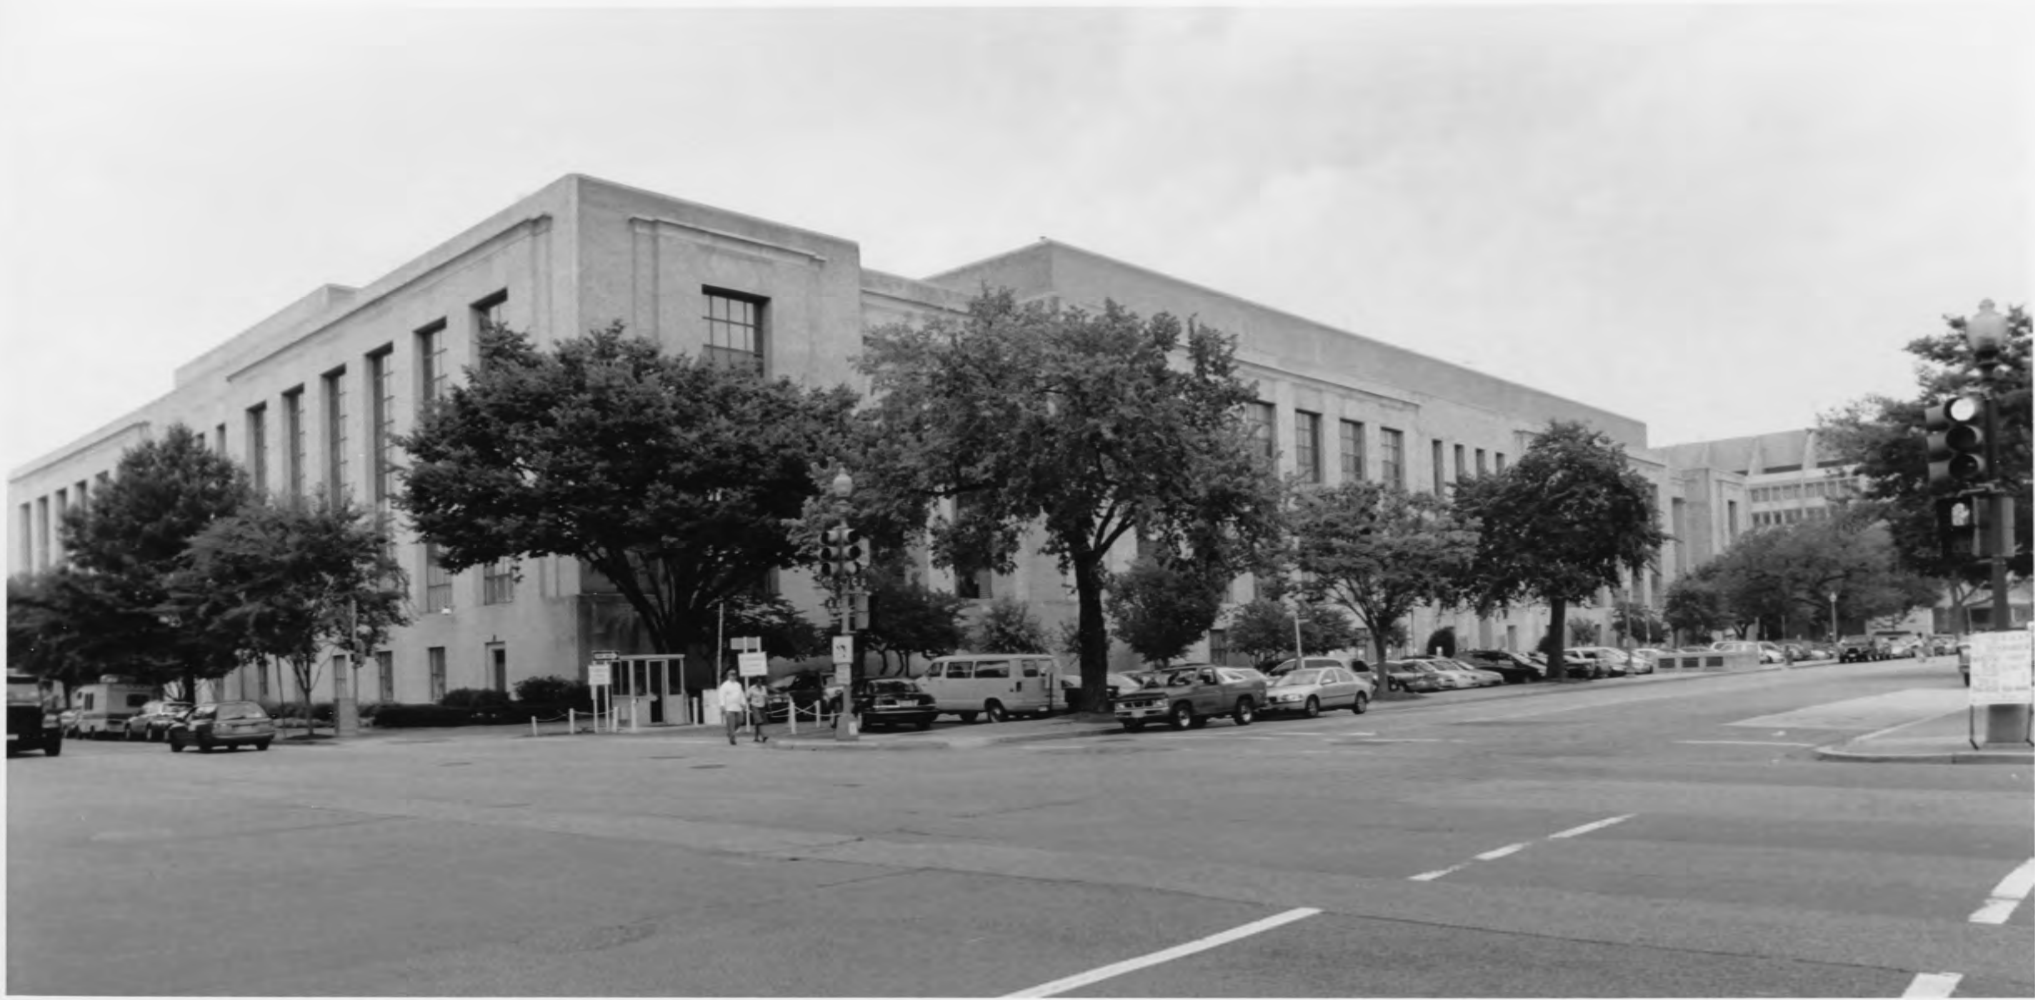
DC003422-1

View looking northeast

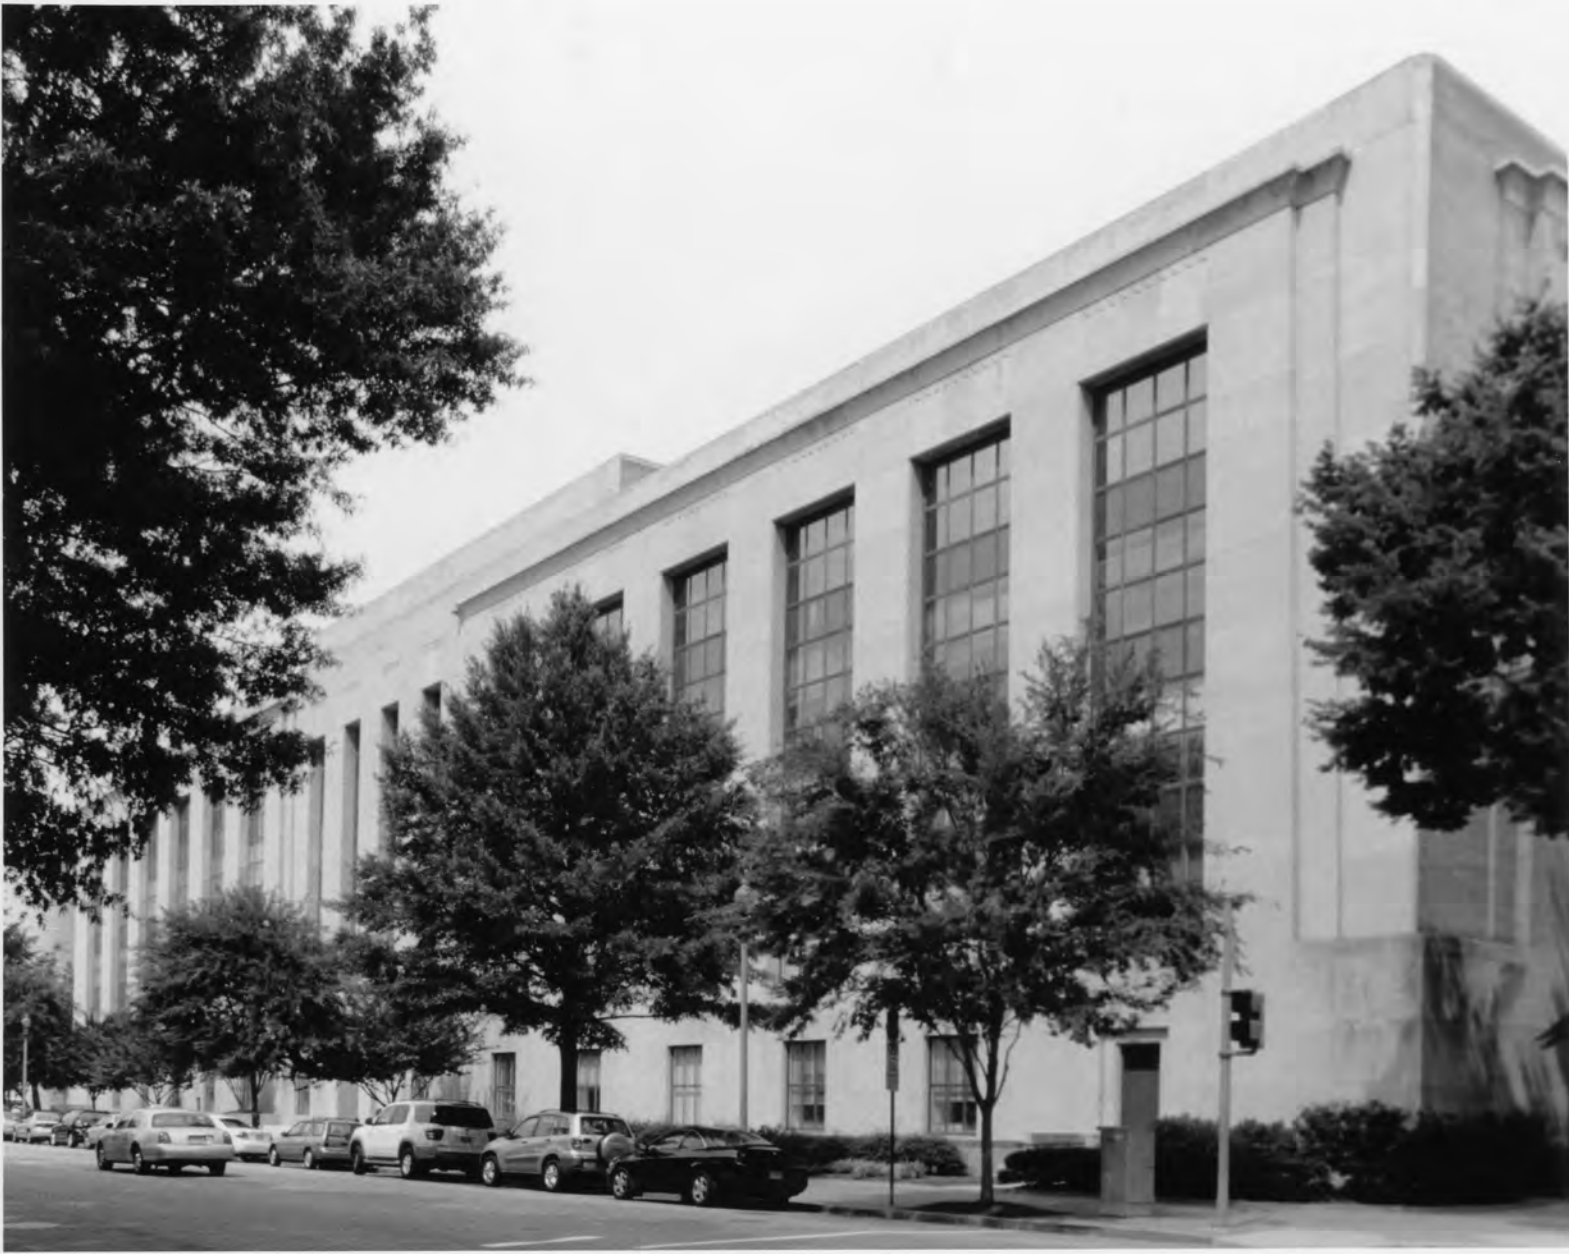
DC003422-2

View looking northeast

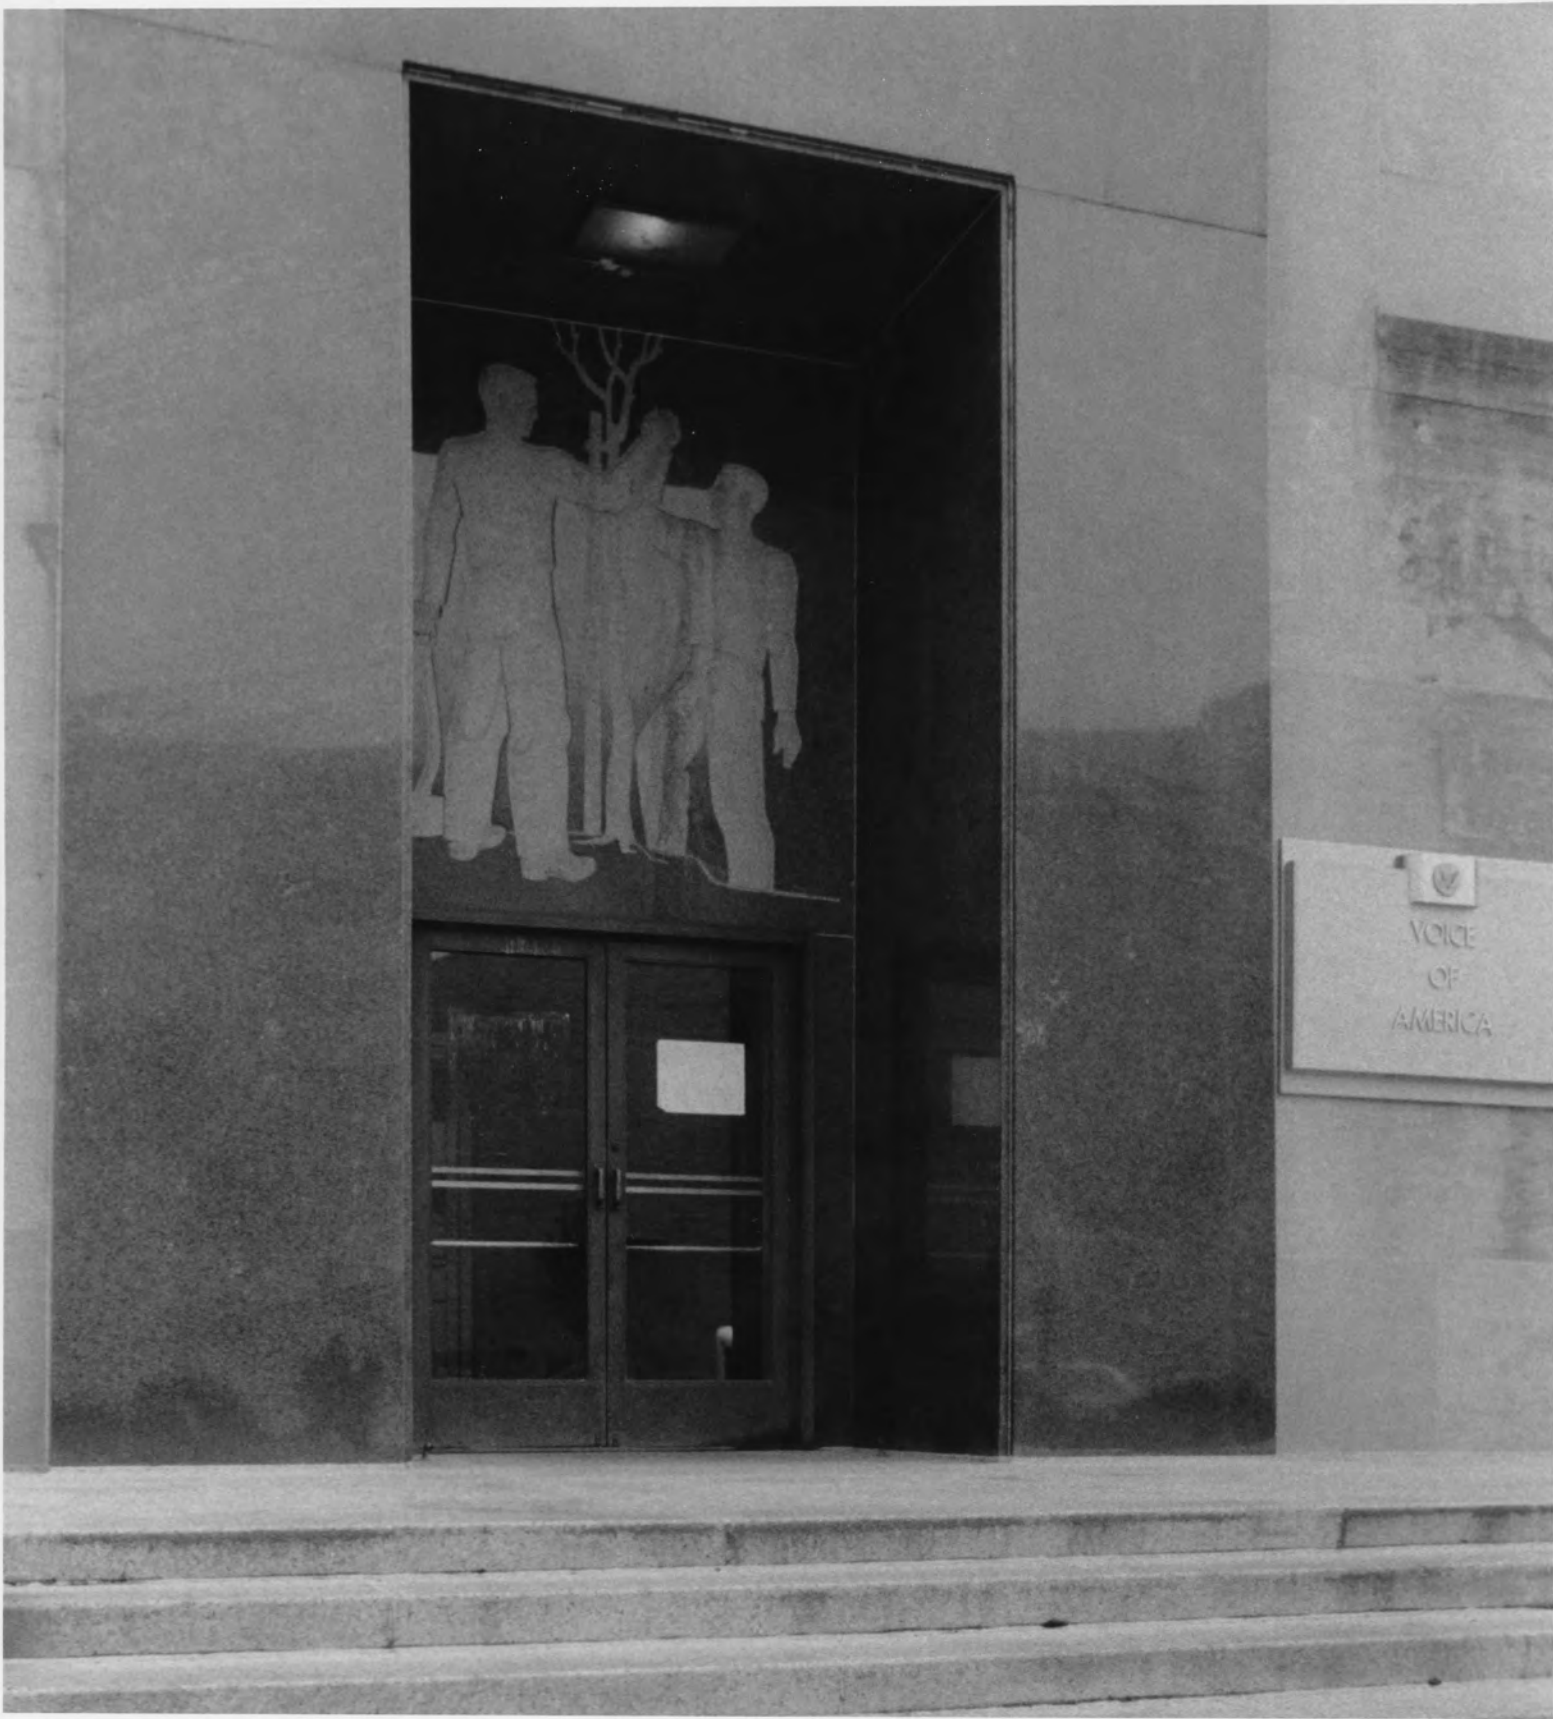
DC003422-3

View looking south
