KENTUCKY HISTORIC RESOURCES Individual

Individual Inve		Shelby County
Name of Resource: Redmon House	16. Date: Original Building	c. 1850 [6]
Original Owner:	Addition C. 1	980 [1]
Unknown	17. Style:	
Other Names: None	Antebellum Vern	acular [3V]
Prehistoric Site X Building Object Historic Site Structure Other	18. Architect/Builder: Unknown	
Location:	19. No. of Stories:	2 [2.0]
East side KY 395, 2 mi. N of Bagdad	20. Original Floor Plan:	
Owner's Name:	Dogtrot	[DT]
Owner's Name:	21. Single Pile X Do	uble Pile N.A.
T-1 - 0 - 1	The state of the s	<u> </u>
John Cook P P P P P P P P P P P P P P P P P P	Gable, standing seam 23. Structural Material:	metanot Original
Owner's Audress:		r - 1
Route 1, Box 318 Bagdad, KY 40083	Log(hewn) 24. Exterior Material:	<u> </u>

KENTUCKY HISTORIC RESOURCES Individual Inventory Form

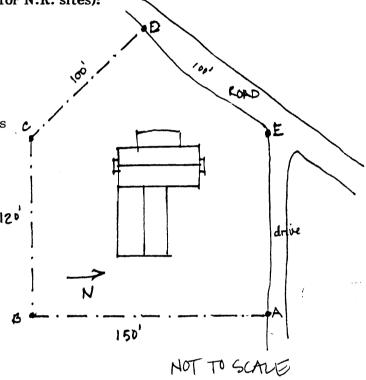
42. Total Acreage in Present Property: 137 43. Acreage included in proposed N.R. boundary: 0.42 44. Site Plan (and boundary description and justification for N.R. sites):

Beginning at A, in a corner of the drive, S 150' along the drive to B, W 120' along a fence to C, NW 100'with a fence to D, at KY 395, NE 100'along the east side of KY 395 to E, E 120' along the drive to the point of origin. Boundaries drawn to encompass the house and domestic space as defined by fences and drive as separate from fields. No contributing outbuildings.

Point A is at the intersection of a fence with the southern edge of the drive and is 83 feet north northeast of the northeastern corner of the ell.

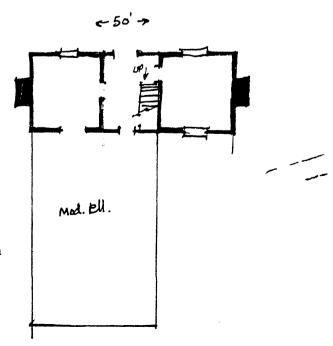
45. Description and House Plan:

2-story, 3-bay log dogtrot with exterior stone end chimneys, rubble stone foundation, weatherbord, frame one-story replaced c. 1980 with brick veneer ell of same shape and proportions, hipped roof porch on brick piers 20th century, original 6/6 sash

Logs exposed in rear of house inside connection to ell, ell designed as self-contained unit for modern living so that log portion may be left intact, Greek Revival mantel in south log pen, mantel removed and closet added in north pen, high baseboard in north pen, low baseboard with no bead in south room, baseboard profiles similar in both pens and dogtrot, square open wall stair in dogtrot, earred on surrounds in dogtrot.
