National Register of Historic Places Registration Form

Fourth Church of Christ, Scientist

FOURTH CHURCH OF CHRIST, SCIENTIST KING COUNTY, WASHINGTON

National Register Nomination Fourth Church of Christ, Scientist 1119 8th Avenue, Seattle King County, Washington State

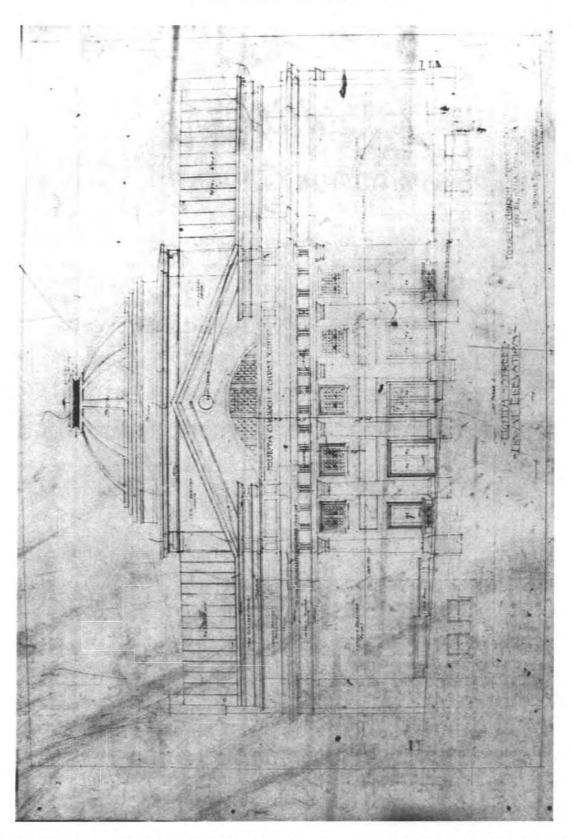
East Facade, Front Elevation, 1916-1922, by George Foote Dunham. Source: Seattle Department of Planning and Development, Microfilm Library.

Serving as the main, front facade of the building the composition of the east entrance off 8th Avenue dominates. A row of six, non-structural, Roman Doric columns support a projecting portico. A pediment rises above and behind this portico from the building's main rectangular mass. A prominent cornice wraps along this facade around the portico, continuing around the north facade and the outer corners of the west and south facades. Flat terra cotta units with thin joints comprise the majority of the cladding and serve as a base to contrast with ornamental details. At the basement level and at the outer bays, larger terra cotta units with pronounced joints imitate quoins and rustication. Raised terra cotta panels with rounds at the outer corners decorate the first floor's outer bays. Similar rounds are also used in the cornice. Molded terra cotta units comprise projecting elements such as dentils and pilasters. A narrow band of stained glass windows above each panel provides second floor day lighting. Within the pediment a large, arched stained glass window streams day lighting to the inner auditorium while a round vent above lets air circulate through the attic. At the entry, a series of concrete steps lead up to a concrete landing. Three double-leaf doorways flanked by single leaf doors open to the first floor vestibule. Each double-leaf doorway features a narrow, single lite transom above. Low terra cotta clad railings frame the landing's ends and outer front bays. Painted iron light standards supporting round white glass globes illuminate the entrance approach. Above the doorways, stained glass casement windows yield day lighting to the third floor auditorium.

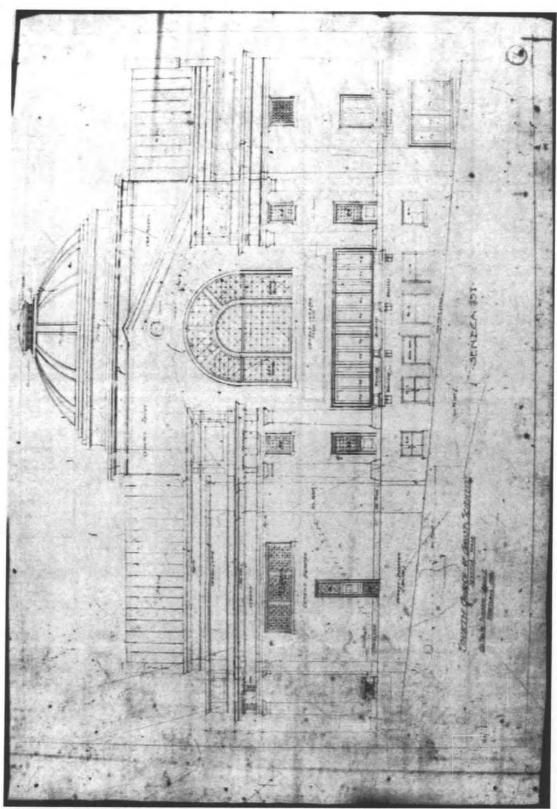
North Facade Elevation, 1916-1922, by George Foote Dunham. Source: Seattle Department of Planning and Development, Microfilm Library.

Striking in composition, this facade features two sets of engaged columns supporting a prominent cornice with the pediment carried upon a series of short pilasters. Recessed within this composition resides a massive round arched assembly of fixed sash stained glass windows illuminating the auditorium. Directly below, four double-leaf French doors open from the first floor onto a balcony. A round vent above the stained glass windows allows ventilation to the attic. Single leaf doors set between engaged columns at the first floor continue the doorway symmetry from the front east facade, but are non-functional. The French doors all feature a single fixed lite. The narrow balcony is an extension of the first floor's structural concrete floor slab, with decorative terra cotta brackets along the exterior. A series of windows directly below the first floor doorways provide day lighting to the first floor. Stained glass windows above the single leaf inoperable doors bring day lighting to the third floor's inner auditorium. The terra cotta cladding on the north facade echoes the patterns from the east facade. Raised panels decorate the first story's end bays, each capped by a narrow band of stained glass windows illuminating the second floor.

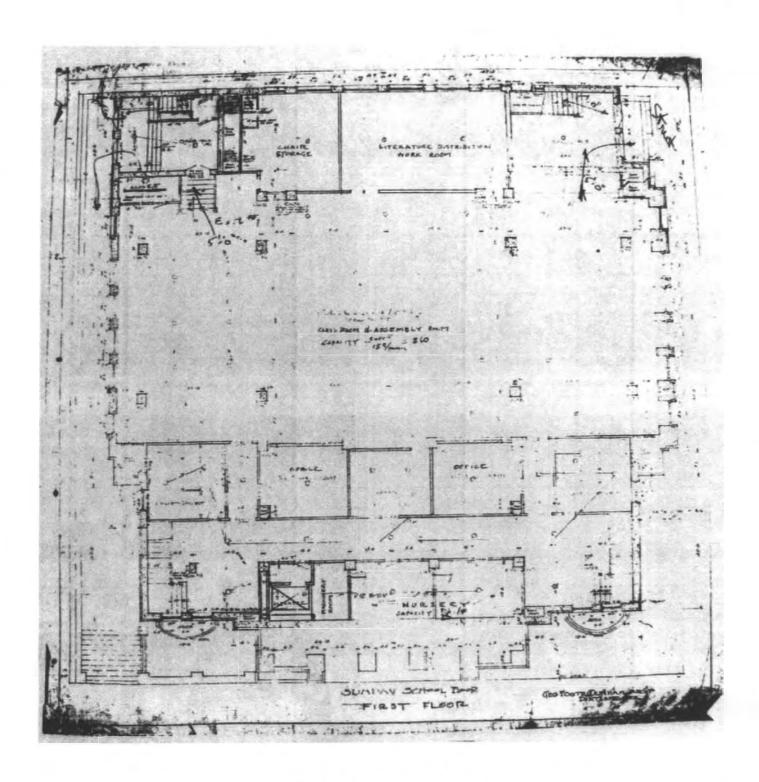
Basement (First Floor), Sunday School Room Floor Plan, 1916-1922, by George Foote Dunham. Source: Seattle Department of Planning and Development, Microfilm Library.

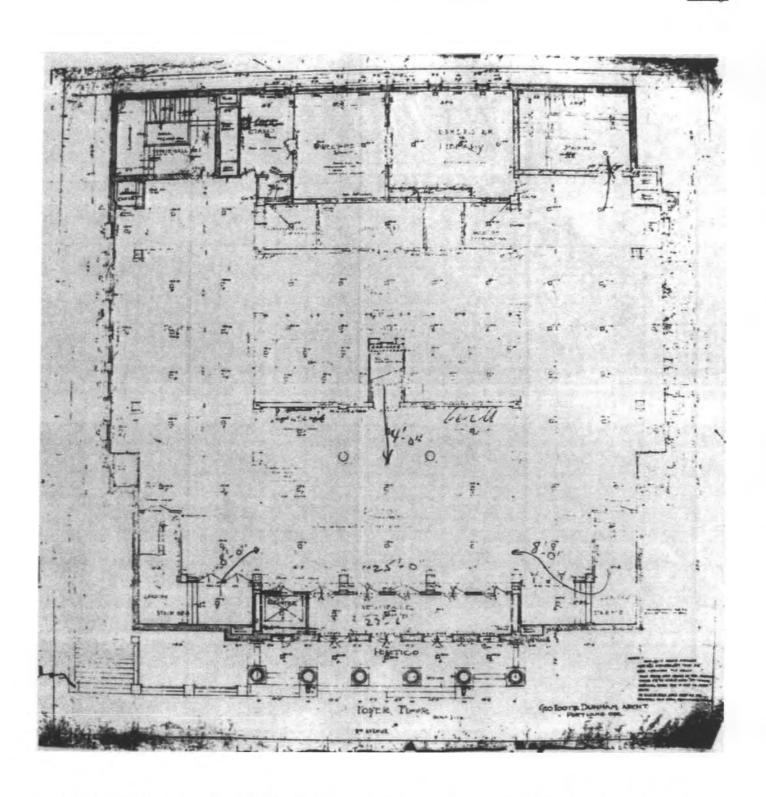
First Floor (Foyer Floor) Floor Plan, 1916-1922, by George Foote Dunham. Source: Seattle Department of Planning and Development, Microfilm Library.

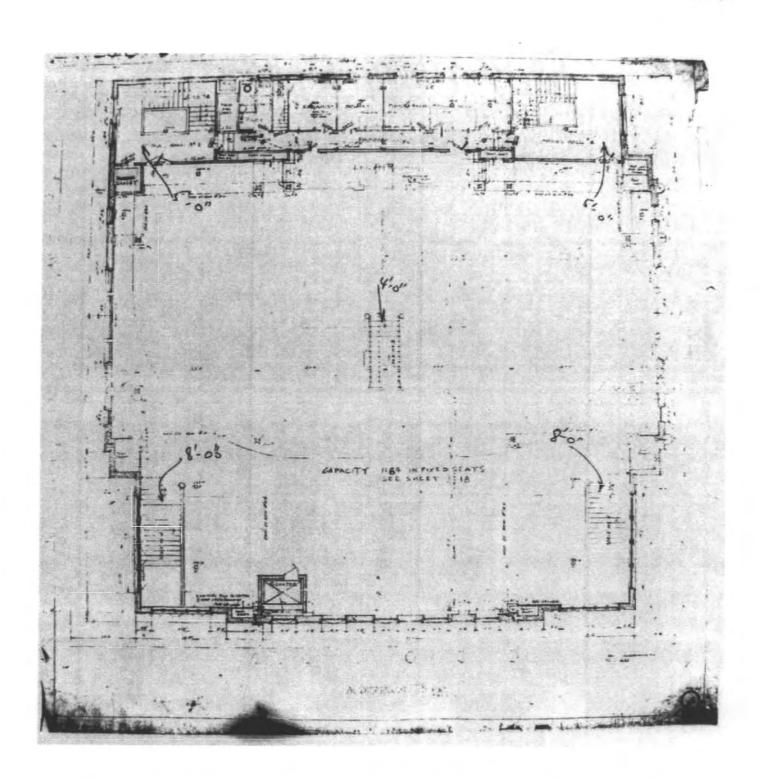
Auditorium (Second Floor) Floor Plan, 1916-1922, by George Foote Dunham. Source: Seattle Department of Planning and Development, Microfilm Library.

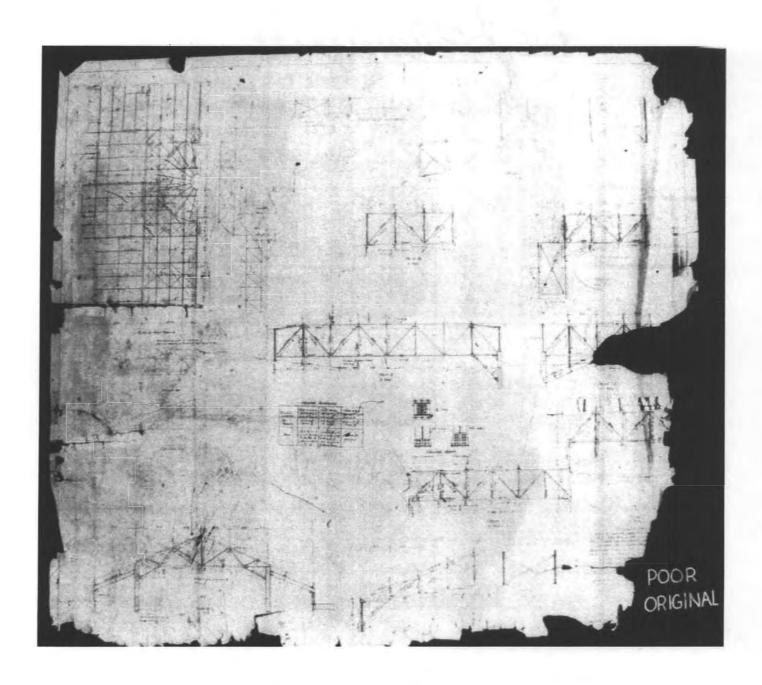
Roof Steel Detail, 1916-1922, by George Foote Dunham. Source: Seattle Department of Planning and Development, Microfilm Library.

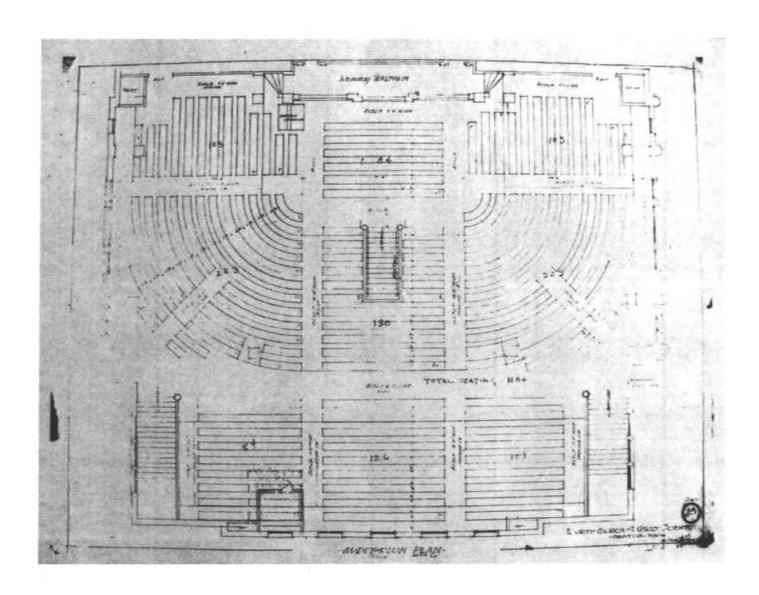
Auditorium Plan, 1916-1922, by George Foote Dunham. Note elevator location sketched in over original drawing. Source: Seattle Department of Planning and Development, Microfilm Library.

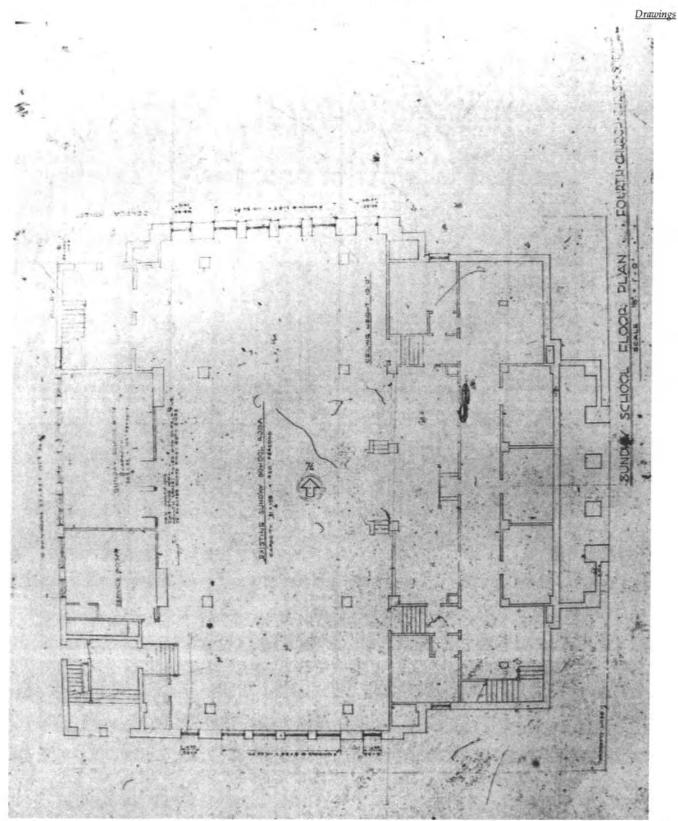
Sunday School (Basement) Floor Plan, Stairway Detail, 1940s, by G.C. Fields. Source: Seattle Department of Planning and Development, Microfilm Library.

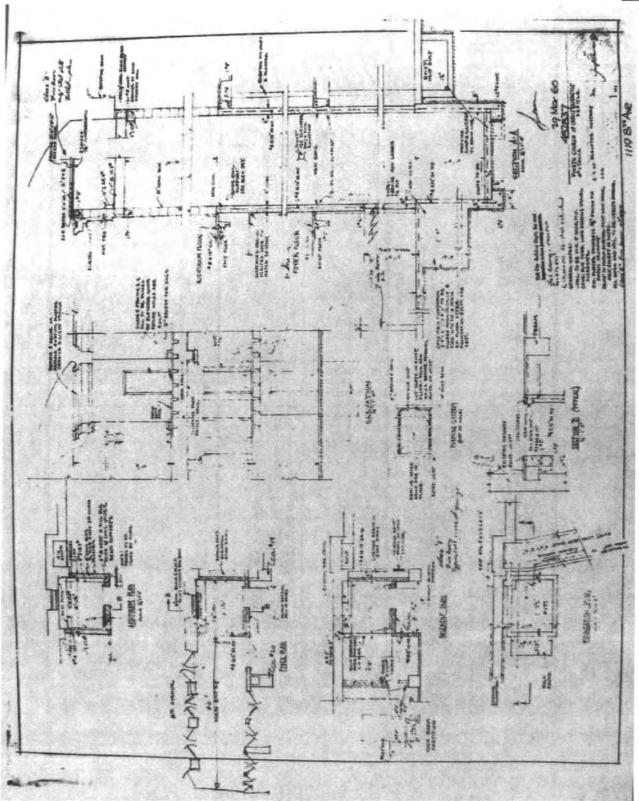
Elevator Hoistway Plan, 1960, by Jay Robinson. Source: Seattle Department of Planning and Development, Microfilm Library.

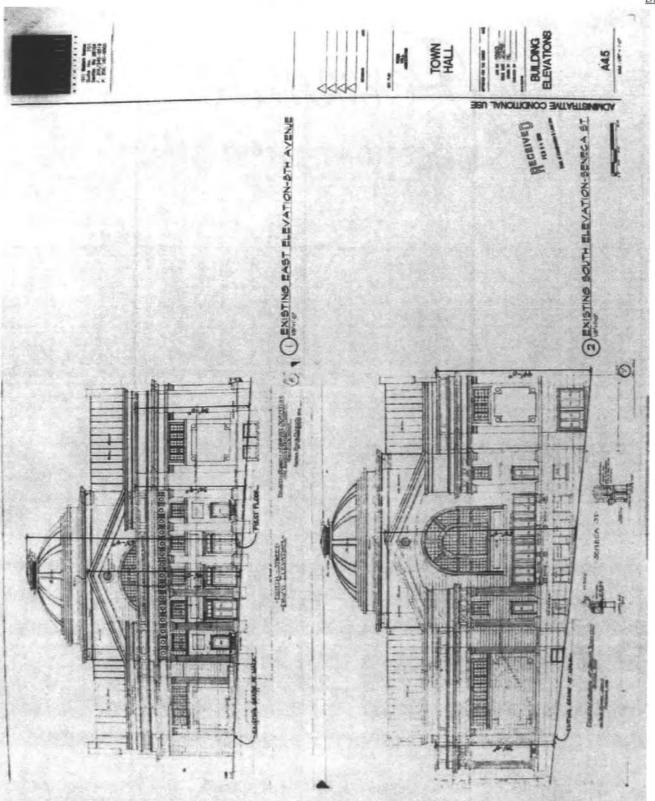
East and South Elevations, 1998 existing elevation notes by Bassetti Architects over 1916-1922 drawings by George Foote Dunham. Source: Seattle Department of Planning and Development, Microfilm Library.

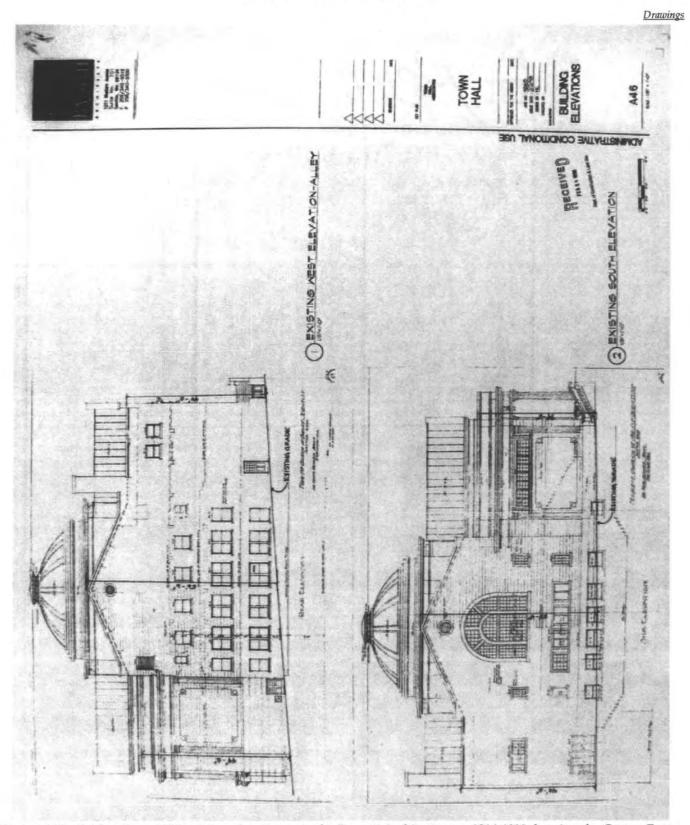
West and North Elevations, 1998 existing elevation notes by Bassetti Architects over 1916-1922 drawings by George Foote Dunham. Source: Seattle Department of Planning and Development, Microfilm Library.

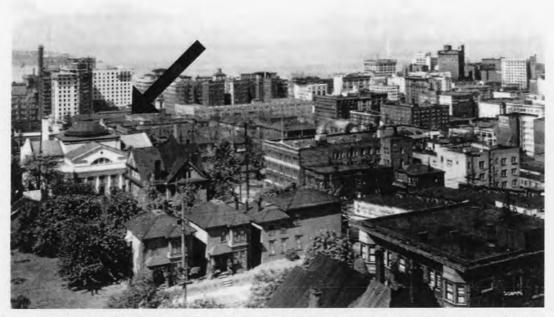
Historic photograph of the Fourth Church of Christ, Scientist. View looking northwest. Source: Town Hall Seattle.

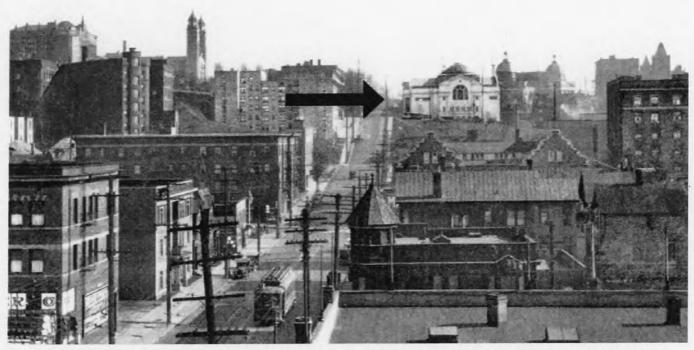
Circa 1923 photograph of the Fourth Church of Christ, Scientist. View looking northeast up 8th Avenue. Source: Town Hall Seattle.

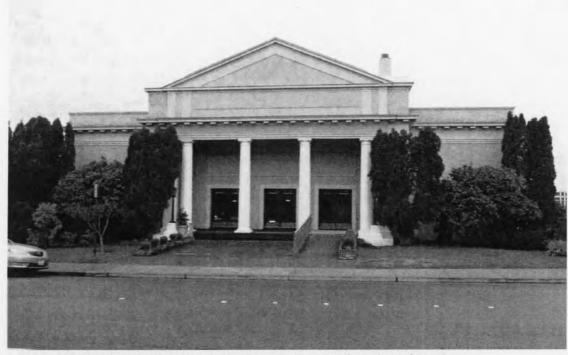
2012 image of First Church of Christ, Scientist, Bellingham. Source: Artifacts Consulting, Inc.

Dunham designed a Christian Science church in Bellingham, Washington, as well, the First Church of Christ, Scientist (1027 N Forest Street, built 1910). Bellingham's First Church and Seattle's Fourth Church have similar footprints and massing and both employ Neoclassical elements. The main entrances on both buildings feature pedimented porticos supported by Doric columns. The Bellingham Christian Science church lacks the terra cotta cladding, prominent copper capped dome, and stained glass which highlight the facades of the Fourth Church.
