National Register of Historic Places Registration Form

historic name Old Headquarters Area Historic District
other names/site number 48CK1499

Old Headquarters Area HD
Crook County, WY
Devils Tower National Monument MPS

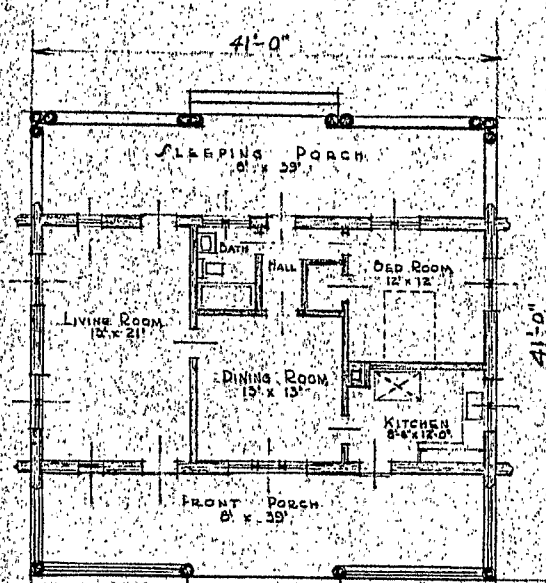
- PLAN -

1621 Sq. Ft.

The interior plan includes a kitchen, living room, bathroom, two bedrooms, garage on the main floor, and a half-basement. All rooms retain the original fiberboard walls and ceilings (with 2 1/2" fiberboard battens), wood doors, and hardwood floors except for the bath and kitchen, which have modern vinyl flooring. Original light fixtures are located in the living room, bath ceiling and hall; all others are modern. The living room has, in addition to original floors, walls, ceilings, and wrought iron light fixtures, an original stone fireplace against a wall of random-

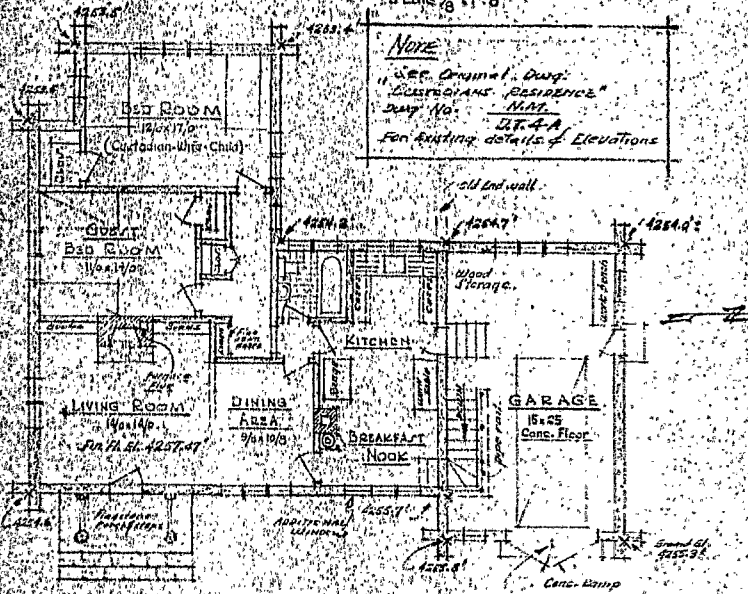
REVISED FLOOR PLAN SHOWING ADDITION
 Scale 1/8" = 1'-0" Approval by Cust.

Notes:
 Details of addition to conform with those on orig. bldg. see dwg No. 444-
 Provide adequate basement area to provide for laundry,
 storage room - coal of wood storage and storage space.
 Kitchen floor & wall foundations surrounding basement
 area to be carried down when basement is excavated.
 Area under existing steps is already partially excavated.
 (See letter from Custodian)

The 1931 custodian's residence was much smaller than it is today. The floor plan included a living room, dining room, bedroom, kitchen, and bath. A back porch was located at the northwest corner. Remodeling in 1937 included the addition of a large bedroom, a stone fireplace in the living room, the expansion of the living room, a one-car garage addition, and the excavation of a half-basement. The old entry was eliminated and replaced by a new one with a small masonry porch and projecting roof. The building was reroofed with wood shingles (red cedar) in 1980.

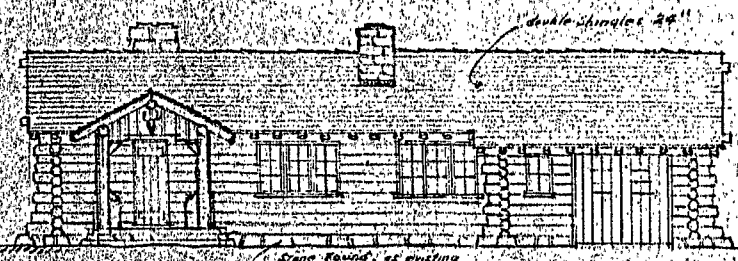
(Approx) REVISED FRONT ELEVATION
 Scale 1/8" = 1'-0"

ECW PROJ. 47 - CLASS # 110 - CAMP NM - L. CL
 PRELIMINARY SKETCH FOR
 ADDITION TO CUSTODIAN'S RESIDENCE
 DEVILS TOWER NATIONAL MONUMENT

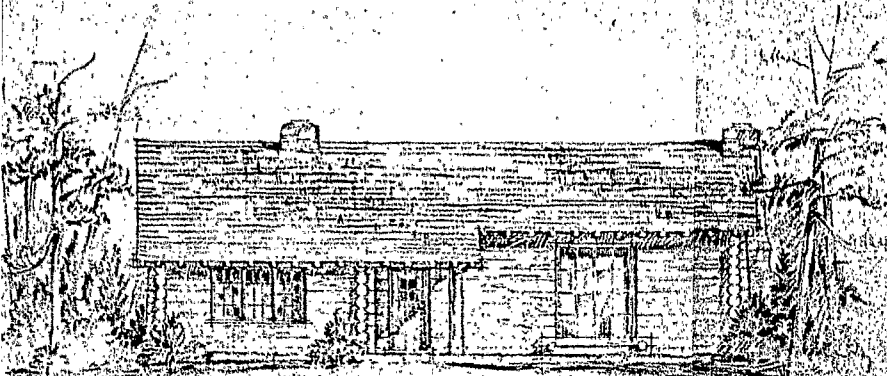
EAST ELEVATION
Scale 1/8" = 1'-0"

FOUNDATION WALLS - CONCRETE WITH STONE VENEER.
 EXTERIOR WALLS - 12" LOGS - BOARD & BATTEN GABLES.
 ROOF RAFTERS - 6" LOGS - 24" O.C. SHAKE ROOF.
 INTERIOR WALLS - OFFICES 2x4" STUDS - PLASTER WALLS & CEILING.
 BED ROOM - 2x4" STUDS - PLASTER WALLS & CEILING.
 MUSEUM - EXPOSED LOG WALLS - WOOD CEILING.
 FLOORS - BASEMENT - CEMENT. ALL OTHER FLOORS PIR.
 WINDOWS - WOOD CASSEMENT.
 TERRACE - FLAGSTONE.

The old administration building is a rectangular plan, two-story building constructed on a concrete foundation with sandstone veneer. Log walls are reverse saddle-notched with evenly sawn ends, chinked with cement, and painted brown. The north-south oriented gable roof has wide overhanging eaves with exposed purlins; it is covered with cedar shingles, painted green. Gable ends are covered with board and batten. The building has one angled stone chimney on the north elevation and another stone chimney toward the south end. There is a shed-roofed porch on the east elevation that covers a flagstone terrace. Modern concrete stairways with metal handrails are located on each end of the building (north and south elevations). These provide access to public restrooms and to the rear entry of the basement.

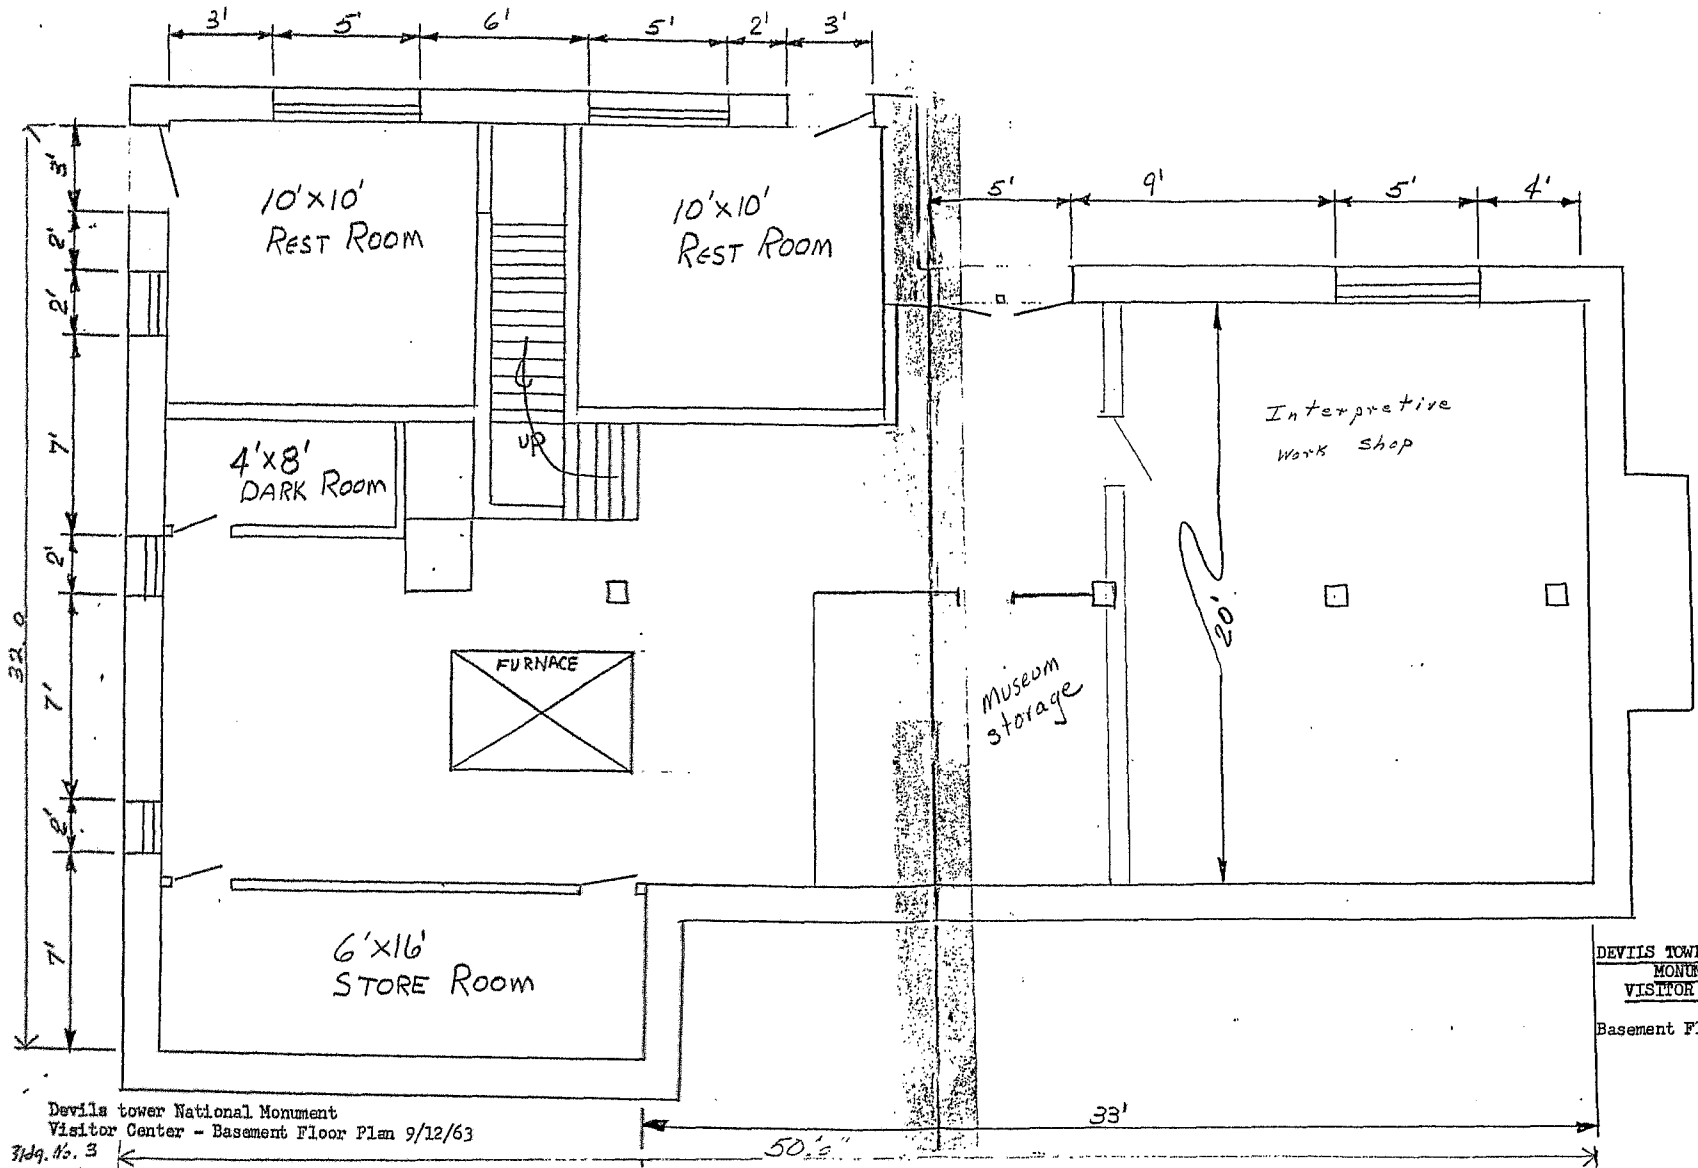
DEVILS TOWER NATIONAL
MONUMENT
VISITOR CENTER

Basement Floor Plan
9/12/63

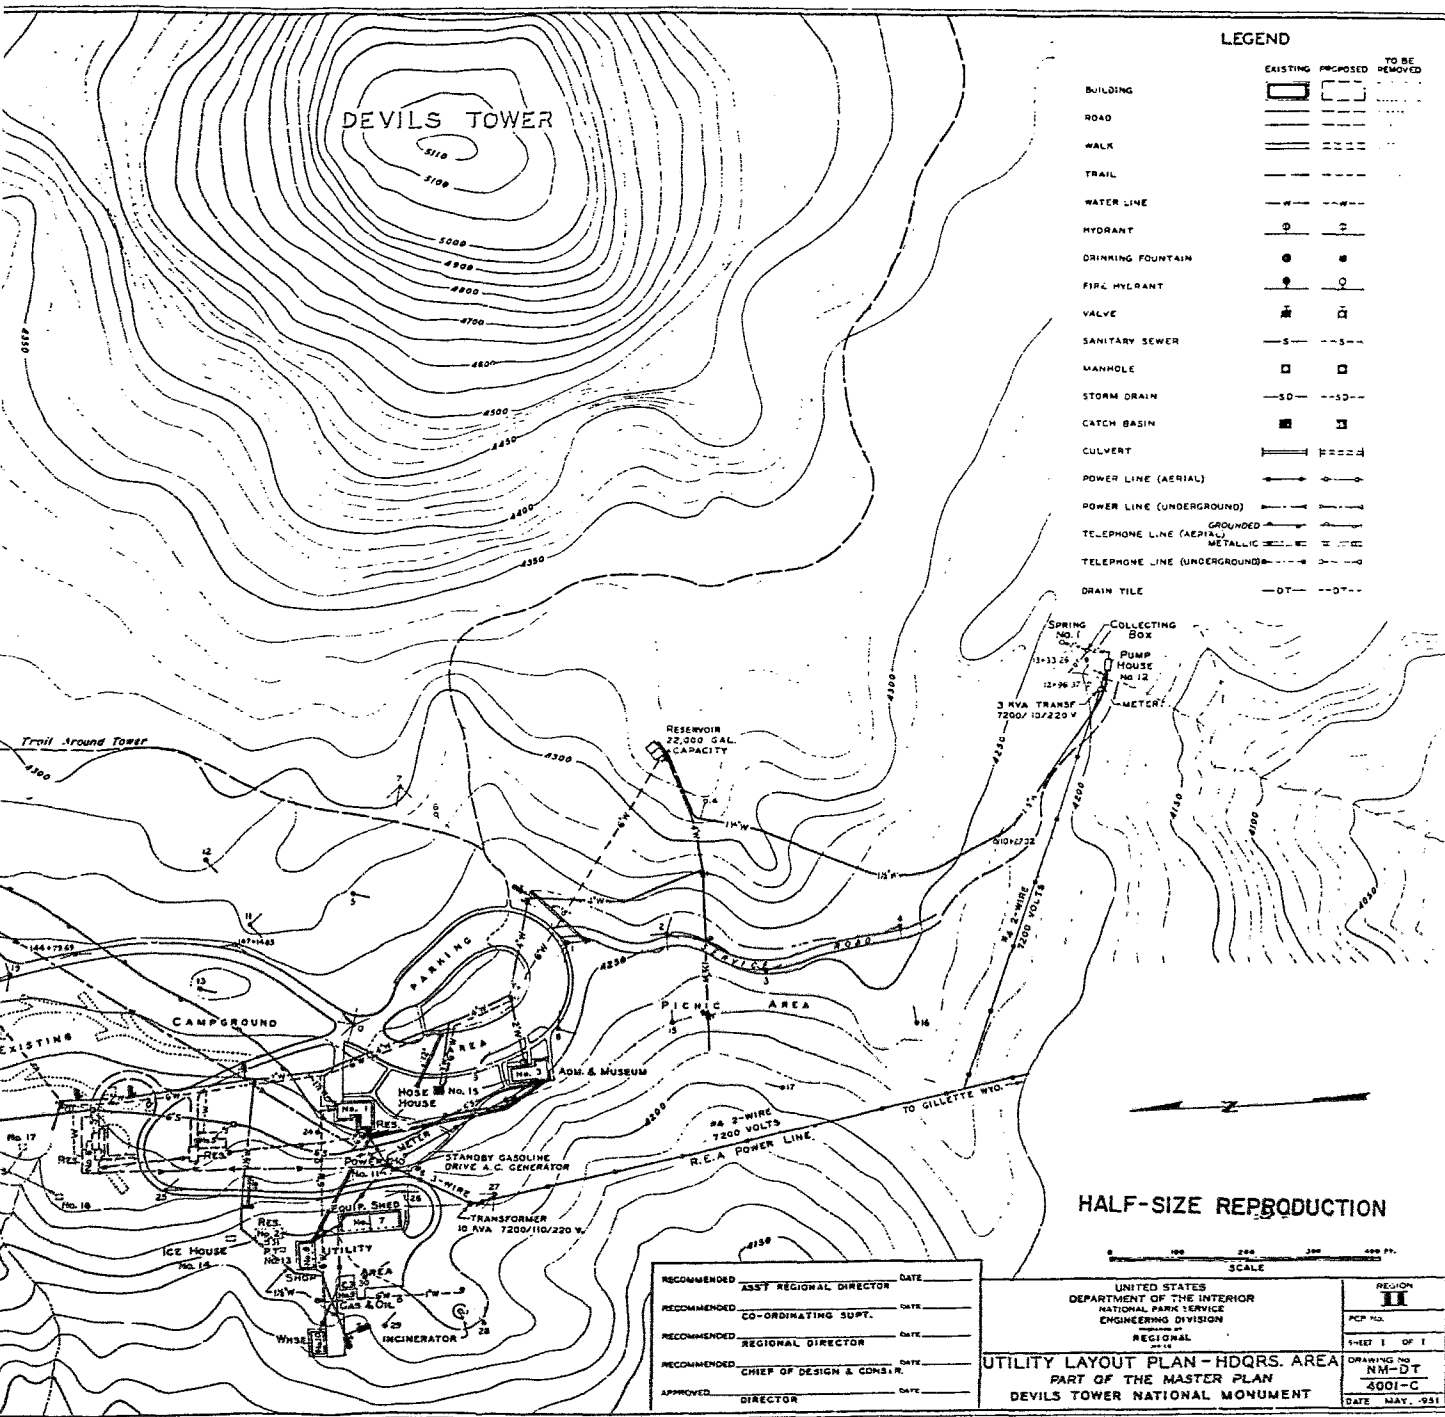
UTILITY LAYOUT PLAN - HDQRS. AREA
 PART OF THE MASTER PLAN
 DEVILS TOWER NATIONAL MONUMENT
