NATIONAL REGISTER OF HISTORIC PLACES
REGISTRATION FORM

historic name TREASURE HAMMOCK RANCH FARMSTEAD

other names/site number Sexton Ranch; FMSF# IR01040

TREASURE HAMMOCK RANCH FARMSTEAD
VERO BEACH, INDIAN RIVER COUNTY, FLORIDA
DESCRIPTION

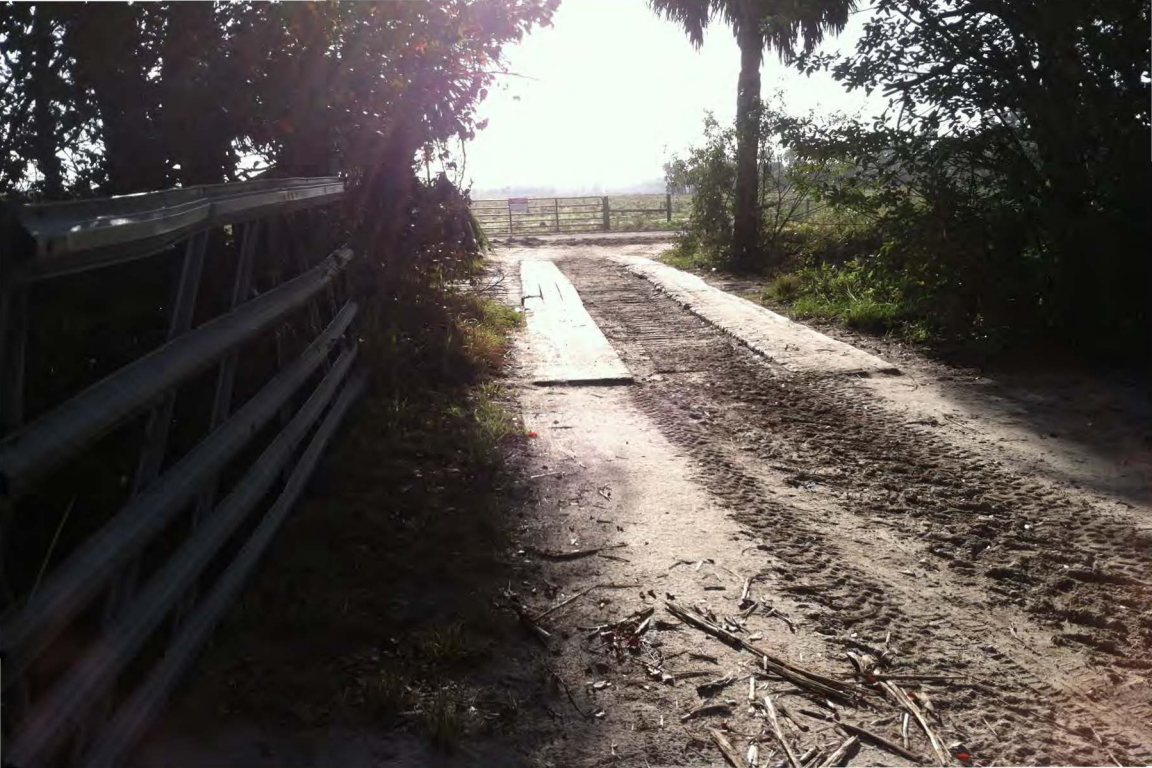
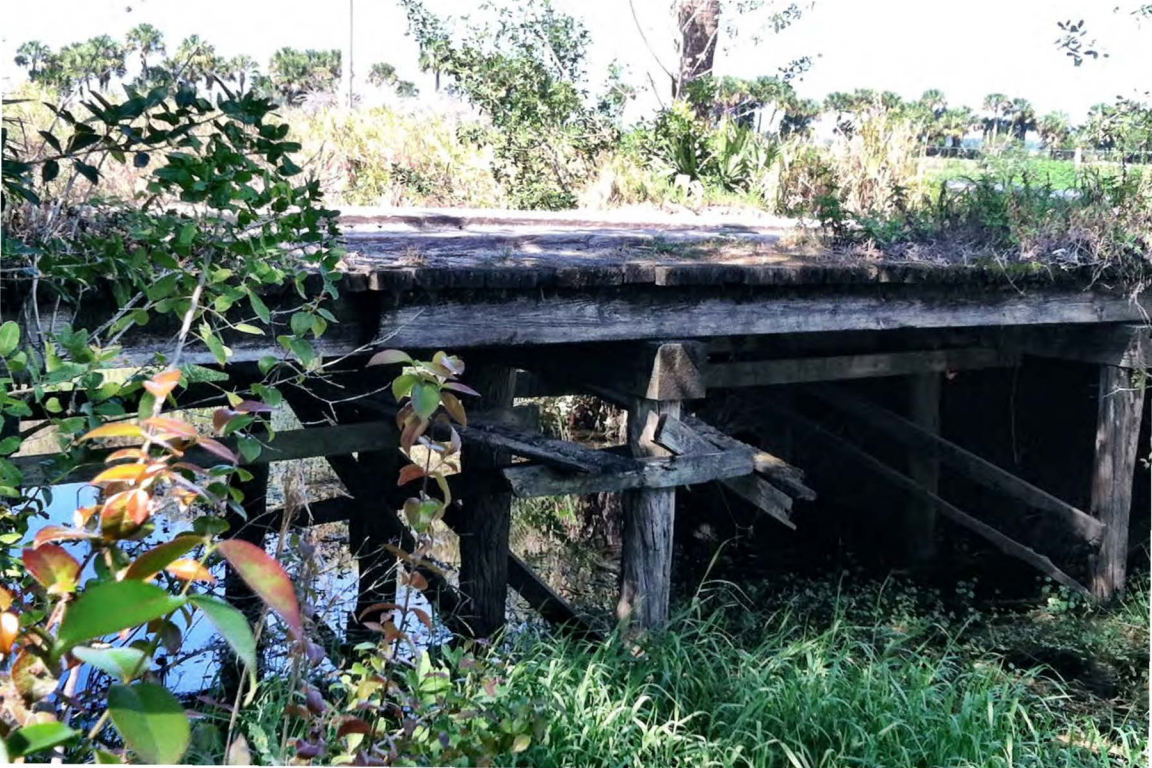
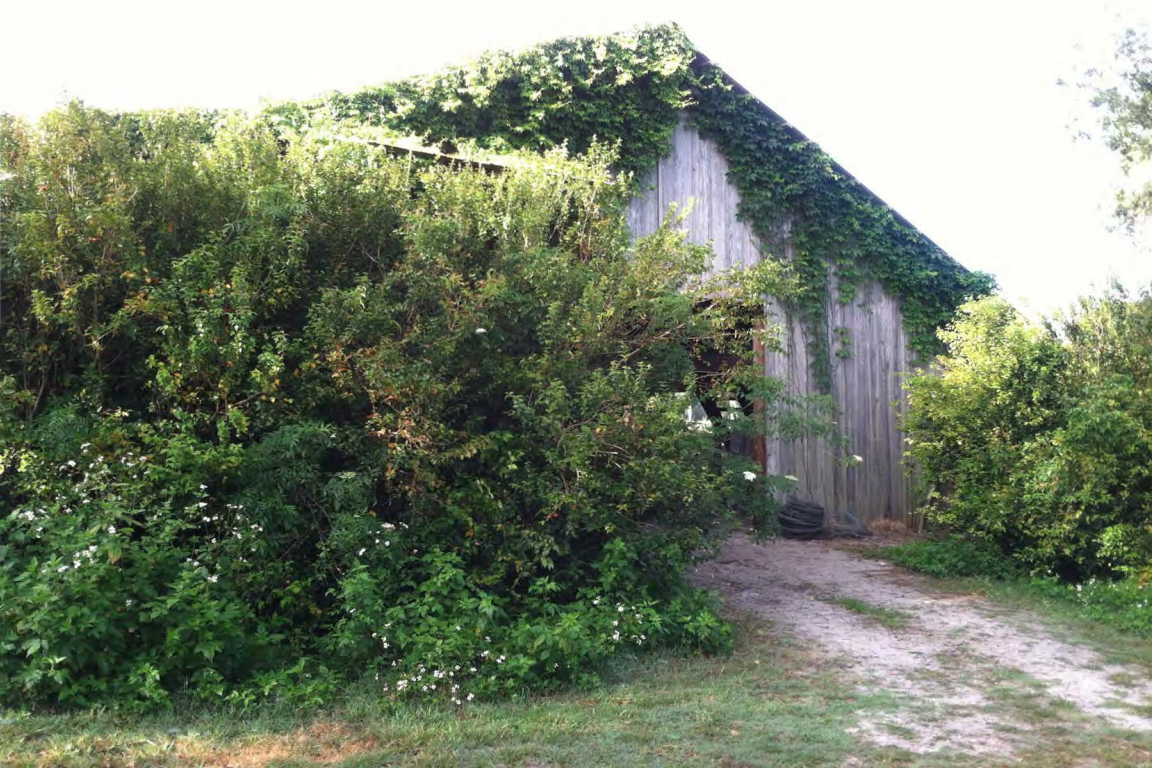
A bridge over the Lateral C Canal (Photos 1-3) built of lightered posts, creosote pine stringers, beams, deck and runners was installed upon purchase of the west side of the Ranch c. 1943.³ The original pilings are still in place but the deck, runners, and a few structural members have been replaced over the ensuing 70 years. The bridge provides access between western and eastern halves of the ranch which facilitates separating calves and cows during heifer weaning and development. The entrance to the east pasture is found directly across 82nd Avenue (Ranch Road) from the bridge. Heifers are parted from the cows, held in the pens of the farmstead for five days, taught to eat feed and establish a herd instinct, then driven across the bridge to the pasture where they

Ranch Road and the canal are the primary dividers between the east and west sides of the ranch for as many as four herds of cattle. This has been the case since the inception of the ranch. The road provides access for herds on the other side of the canal to enable a balance of the supplies of grass between the different sectors of the ranch. Heifers are kept in the east side pastures where their nutrition requirements associated with their stage of development can be addressed separately from the main mature herds. During the herding of cattle on Ranch Road, from one side of the ranch to the other, riders on horses are posted along the still unpaved road to control the cattle and stop automobile traffic, as has been done for 70 years.

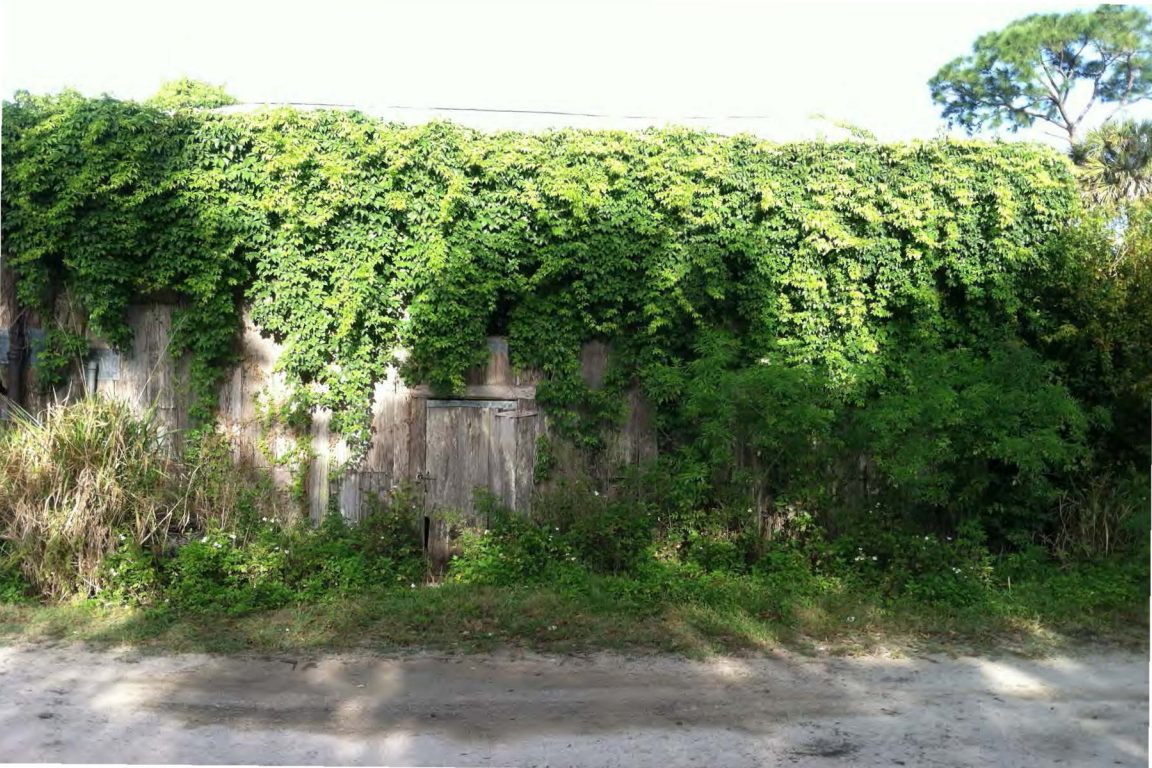
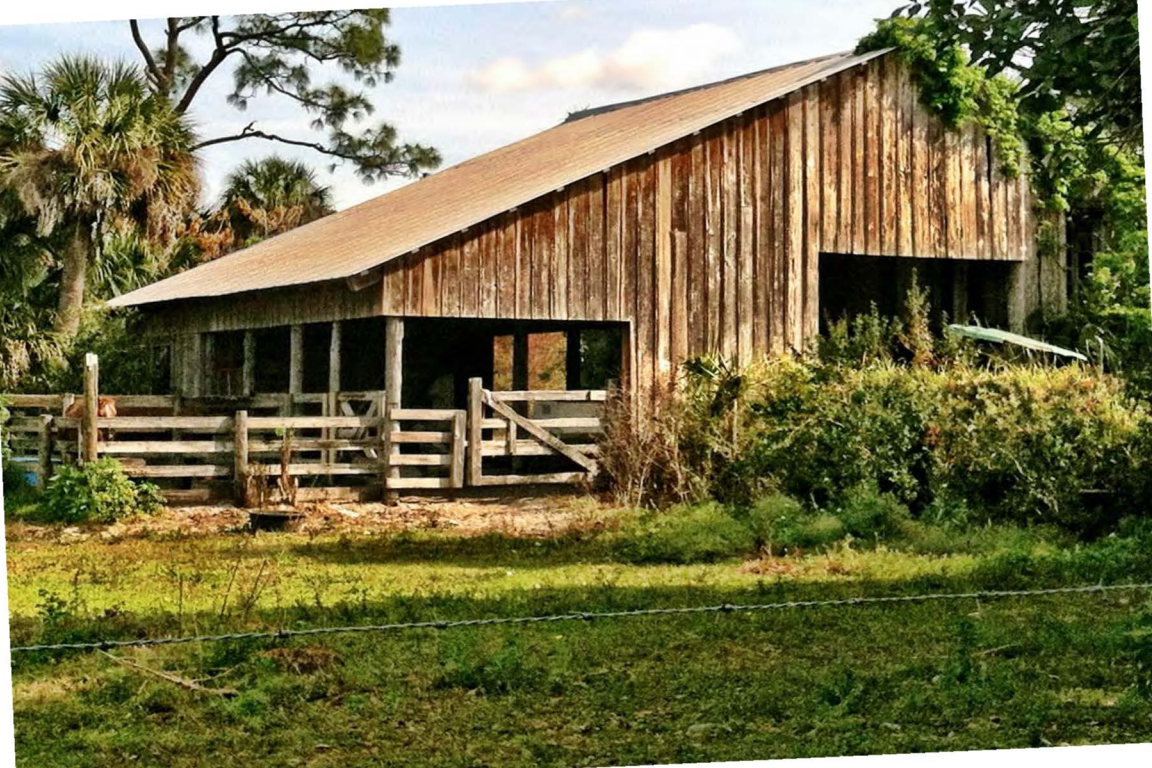
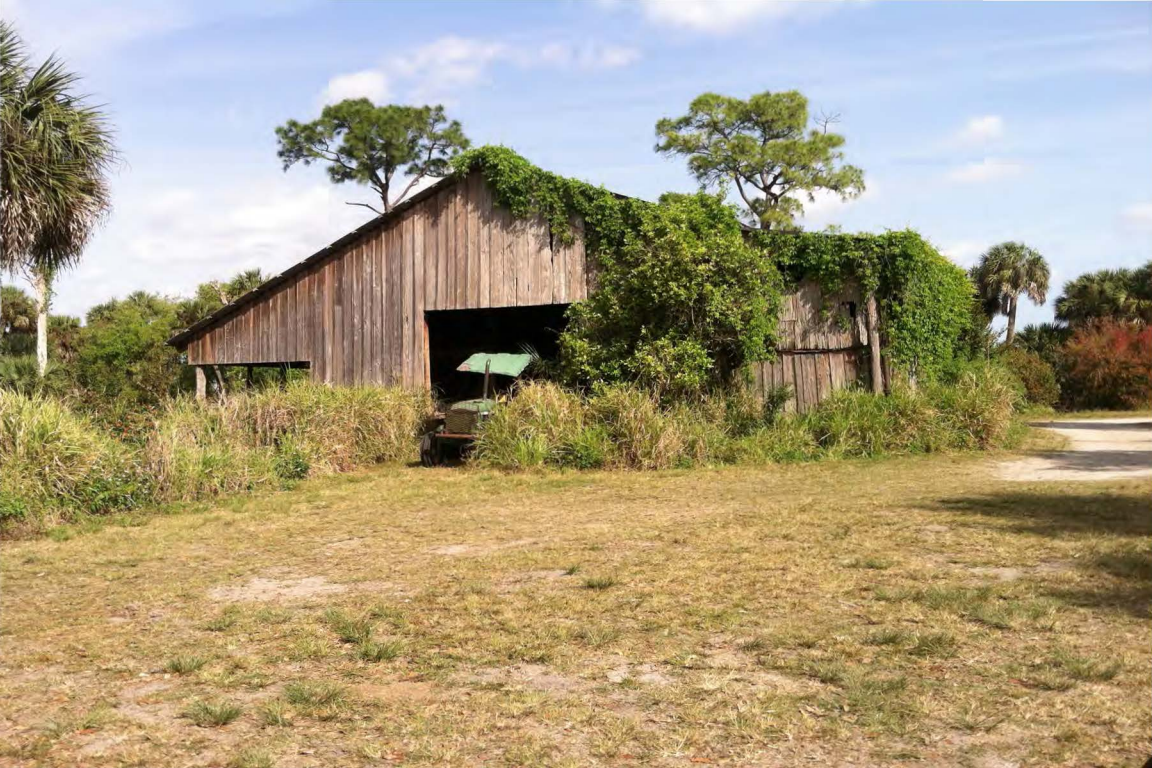
A two-story pecky cypress, metal-roofed barn (Photos 3-6), constructed 1942-1943, originally contained a residence on the second floor for ranch overseers and their families. The second floor was also used for the storage of feed, tools, riding tack (saddles and reins) and supplies. No longer extant are the exterior stairs on the north elevation and the cantilevered balconies on the east and south elevations that rotted away over the years. The ground level is used for the storage of farm equipment and stalls for horses. The barn is pole framed with a conventionally framed roof. Half the barn was restored in 2007-2008, re-paneled in cypress, and re-roofed in 2007-2008. Plans are underway to restore the eastern half of the barn, comprising a feed room, living quarters, and tool room.

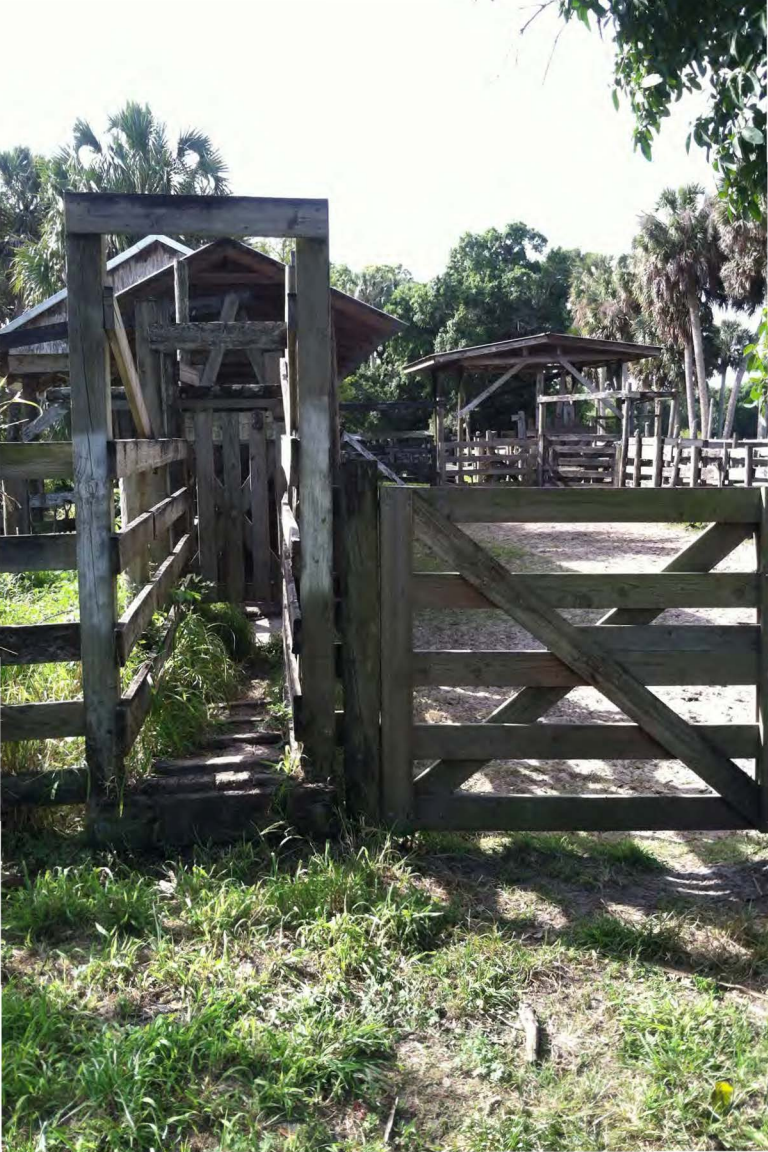
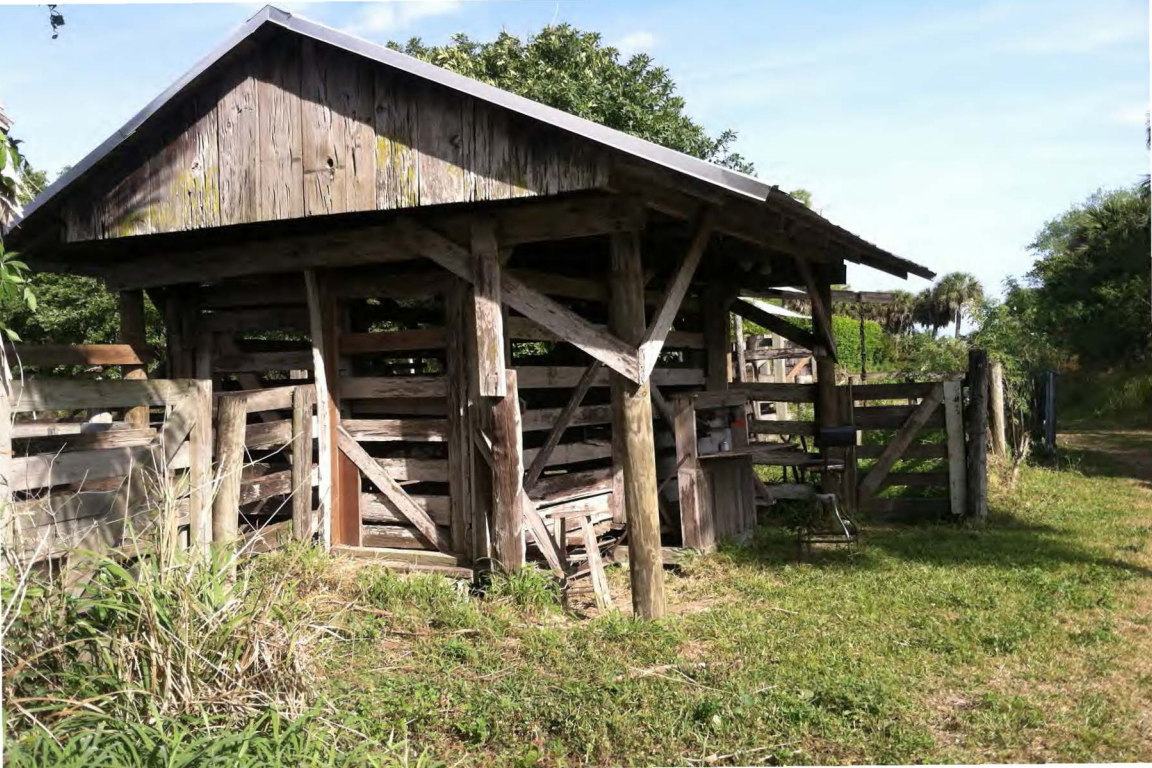
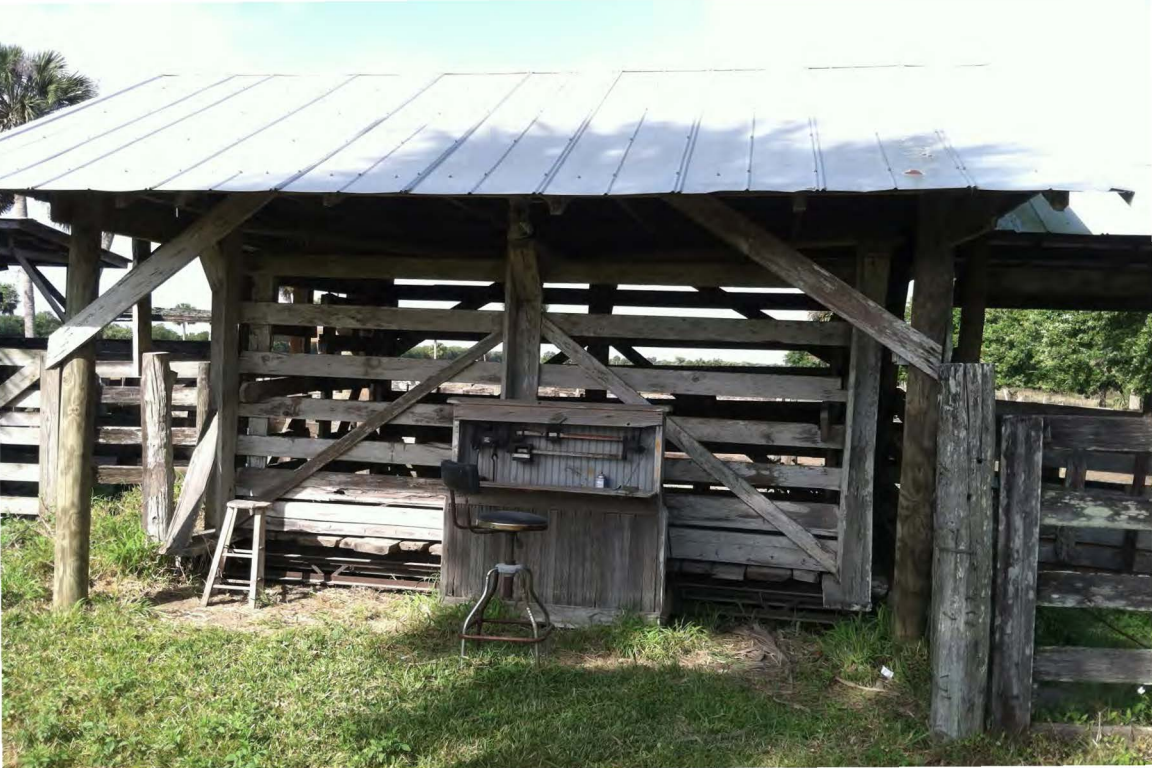
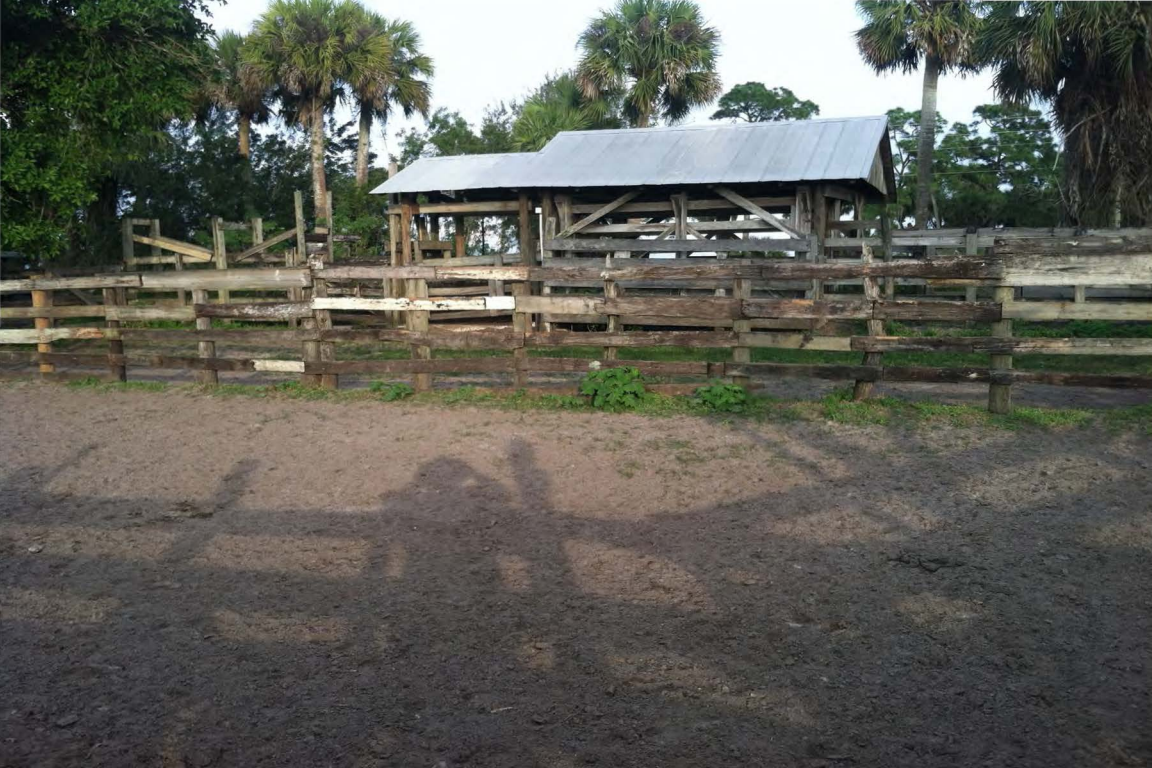
The Fairbanks Company Cattle Scale (Photos 7-10) was installed in its shed which was constructed in 1943 and improved in the early 1950s.⁴ The scale was originally set on crossties, installed beneath a roofed cover constructed of lightered posts and cypress framing and a roof sheathed in pecky cypress boards and covered with a corrugated metal roof. A new foundation was poured and set in 1951, and the scale box was further improved in the mid-1960s by replacing the swinging gates with sliding gates to better confine the cattle. A short chute and head catch was added, connecting to the loading ramp for the loading and unloading of livestock onto and off of trucks. The post-2004 hurricane restoration of the scale shed included new corner posts and a new roof framed and extended over the chute and head catch area to protect cattle and people from the rain. A new V-crimp metal roof replaced the old corrugated metal roof which had been blown off by the storm. The scale has been in use almost since the founding of the ranch to determine the value of the livestock, which is bought and sold by the pound. The scale is also used to judge the quality of every calf produced on the

ranch each year. The scale has been a community resource in the county, serving the Youth Livestock Association for the annual Indian River County Fair weigh-in of both cattle and hogs for many years.

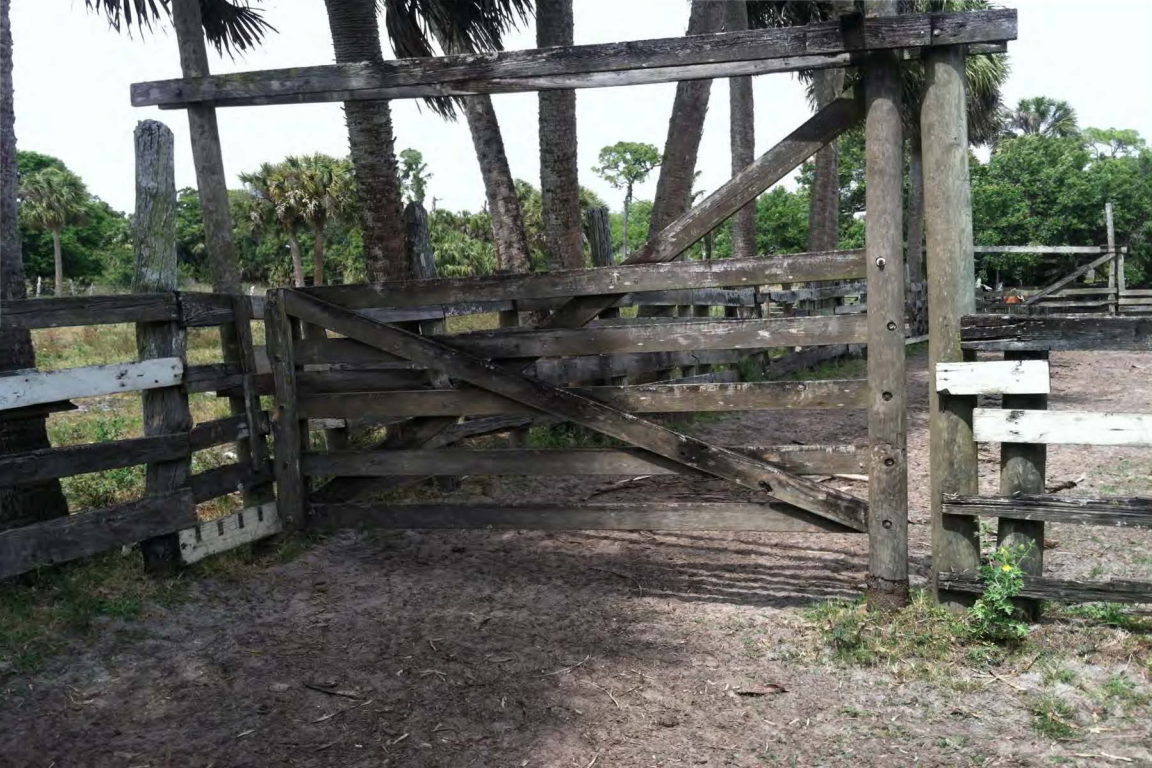
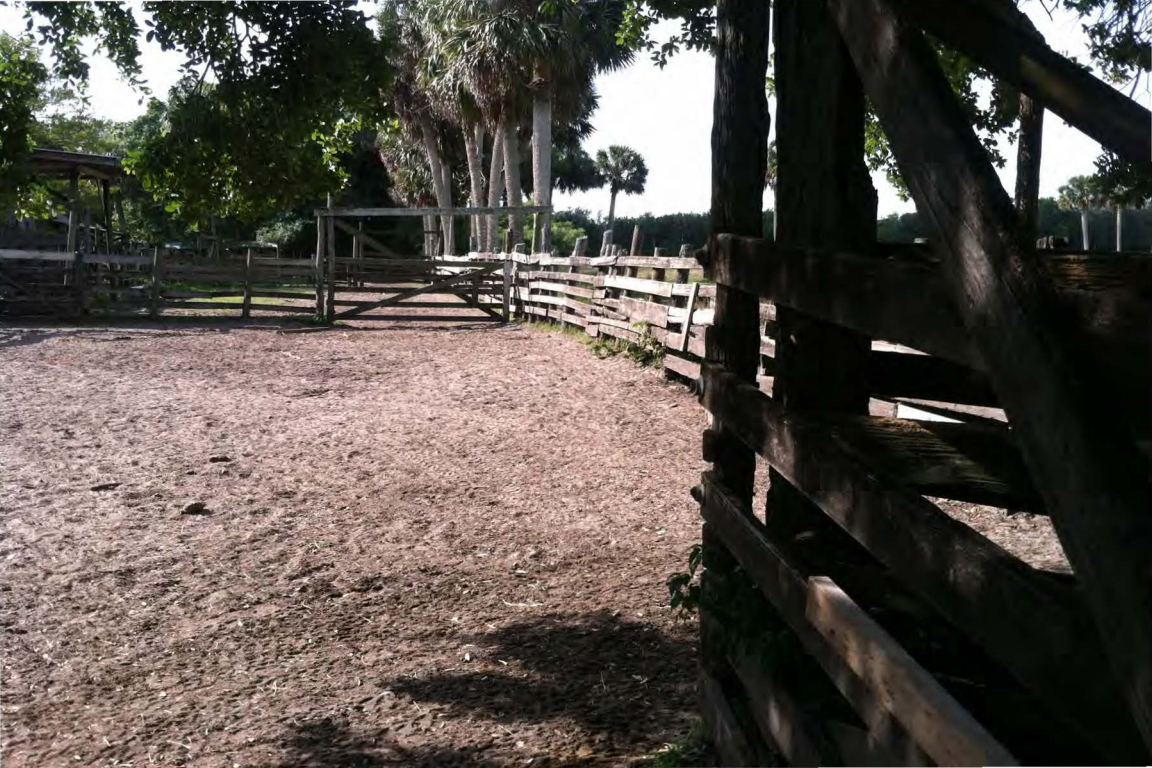
The original cow pens were built in 1943 by Waldo Sexton. The front gate of the main pen (Photos 11-12) was located upon a hewn "lightered" post, upon which the gate swings to this day.⁵ The individual pens are bounded and divided with post and board fences made of cypress, "lightered" and heart yellow pine harvested on the ranch. Each pen is accessed through swinging post gates based on the design of those Waldo Sexton had seen when he was growing up on farms in Indiana.⁶ They are hung between two posts and suspended from above. The gate posts were originally grounded upon lightered stumps, but were later set on buried foundation piers, and more recently set in poured concrete pillars and the gates attached to the main pivot post by metal pins. The cow pens were enlarged and further divided around 1952.⁷ The improvements to the pens came in an effort to create more capacity and sorting capability for the ranch herds and to further hold and direct calves into the scale for the weighing and grading programs for recordkeeping functions.

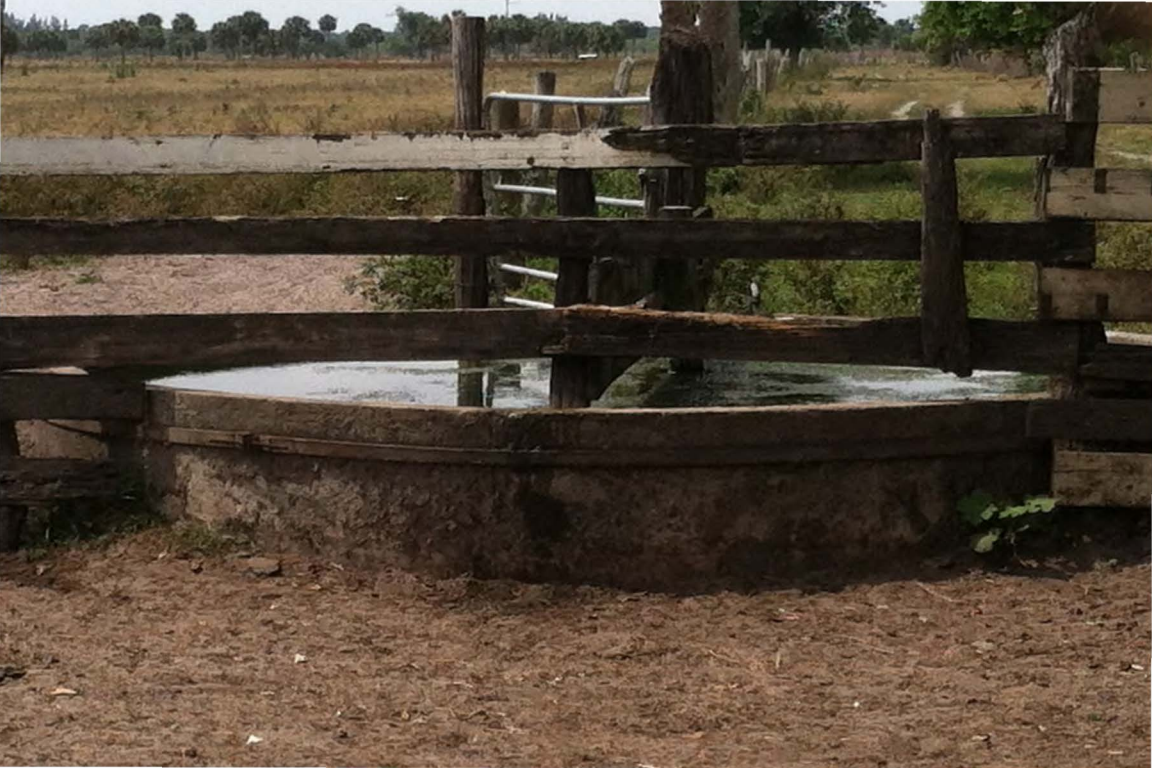
Round watering troughs (Photo 13) were constructed of poured concrete in all three sectors of the ranch from slip forms used at the original Vero Beach Dairy founded by Waldo Sexton and established in the early 1920s to construct grain and haylage⁸ silos for the dairy. The troughs made, c. 1941, are approximately 14 feet in diameter, 42 feet in circumference, 24 inches deep and are located next to artesian wells found throughout the ranch to provide water for the cattle. They were constructed without internal steel due to its scarcity during World War II and required metal bands mounted to keep the walls intact. There are eight of these troughs located throughout the ranch.

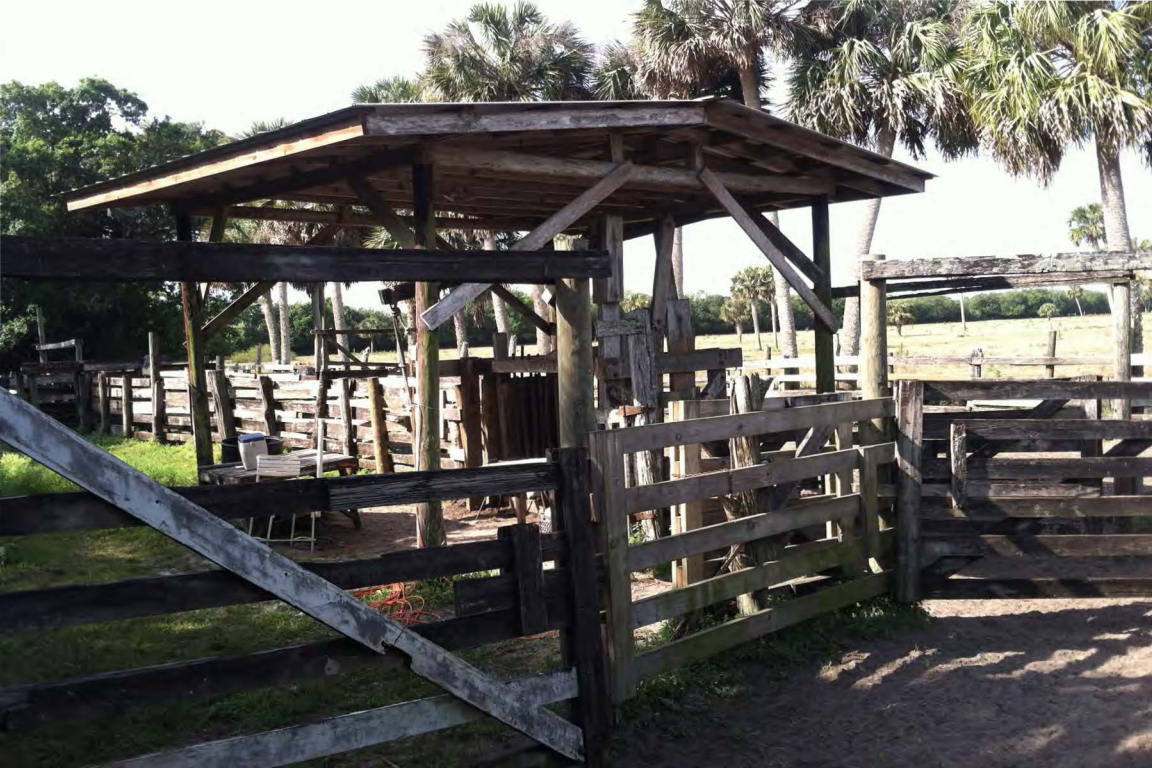
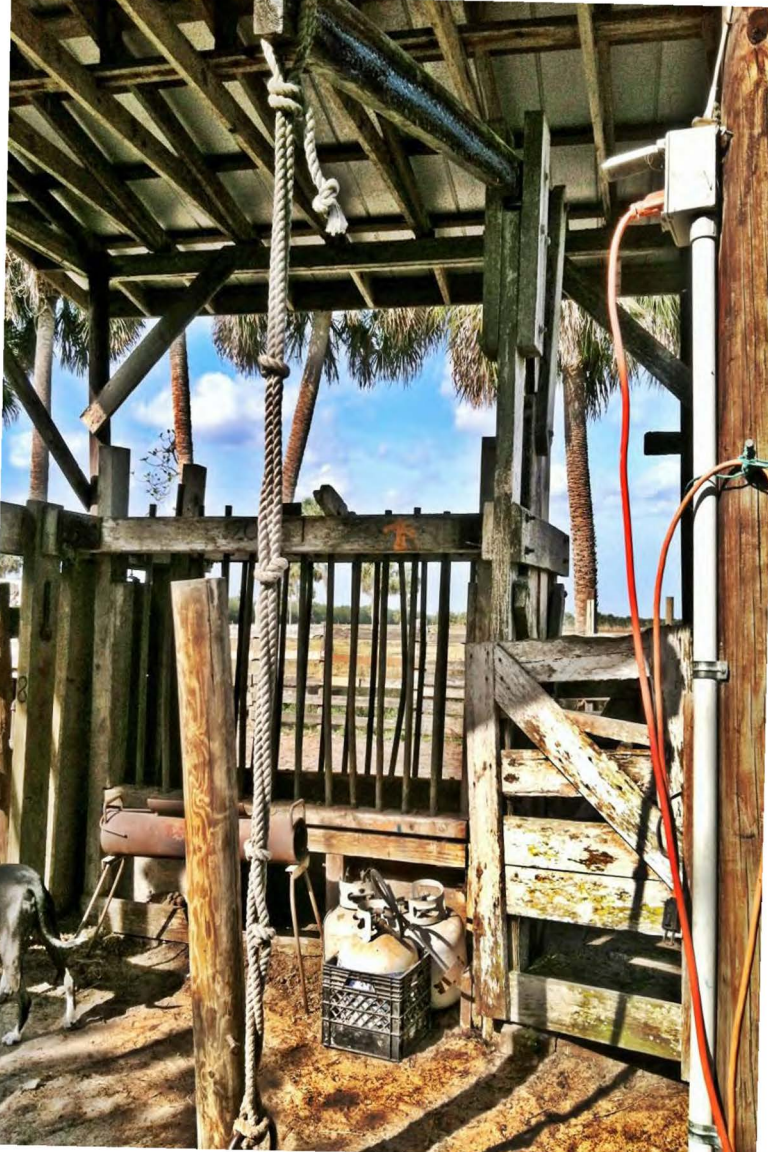
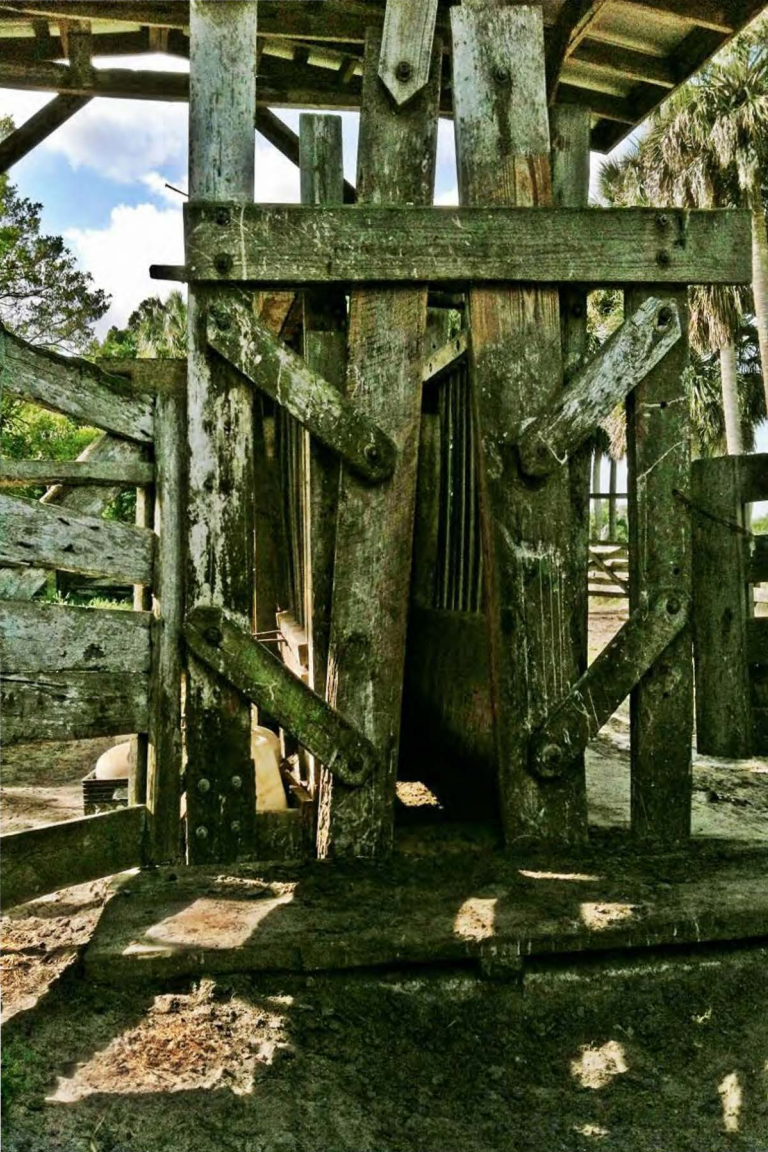
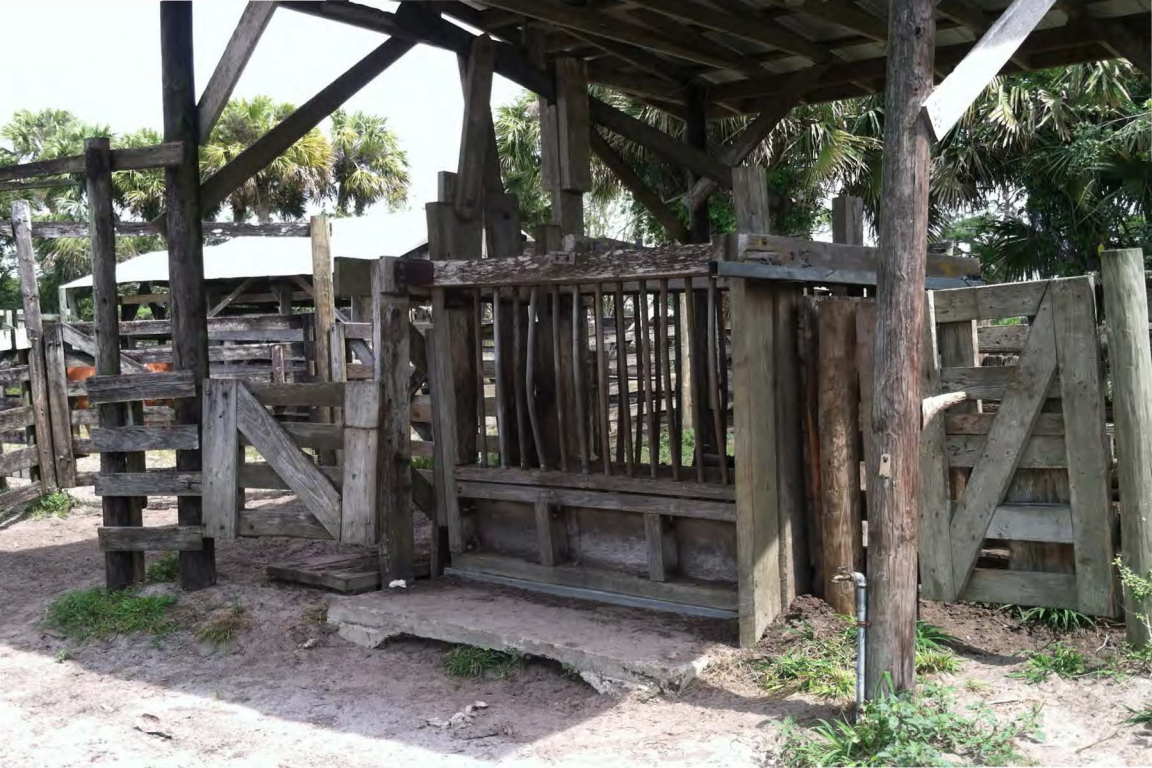
Near the center of the pens is a work shed (Photo 14) which is connected to the wooden squeeze chute (Photos 15-17). Originally introduced by Waldo Sexton, the construction was improved upon⁹ by Ralph Sexton, who constructed the pit and cover arrangement whereby the boards of the head gate are free to fall and rise in the opening and closing of the chute. This enabled the cow to step out across a covered platform when it is released. The east chute wall pivots inward to enclose a narrower space for smaller animals and to apply

pressure to larger animals. The arrangement provides greater access to the captured livestock for inoculations, treatments and surgery with removal of the metal pipes from the side panels of the chute. The head gate comprises two boards worked by a lever that operates the chute both in catching and releasing each animal. A wooden runway that holds approximately 12 to 15 mature cattle or 18 to 24 calves connects the crowding pen to the head catch through two sliding wooden gates hung on rolling metal tracks. The wooden squeeze chute has largely maintained its original 1943 construction, with improvements made in the early 1950s and requiring occasional routine replacement of broken or worn components. In the mid 1960s, a cover was built over the runway and chute to provide shade and shelter for both men and livestock. Overhead lights were installed 25 years later.

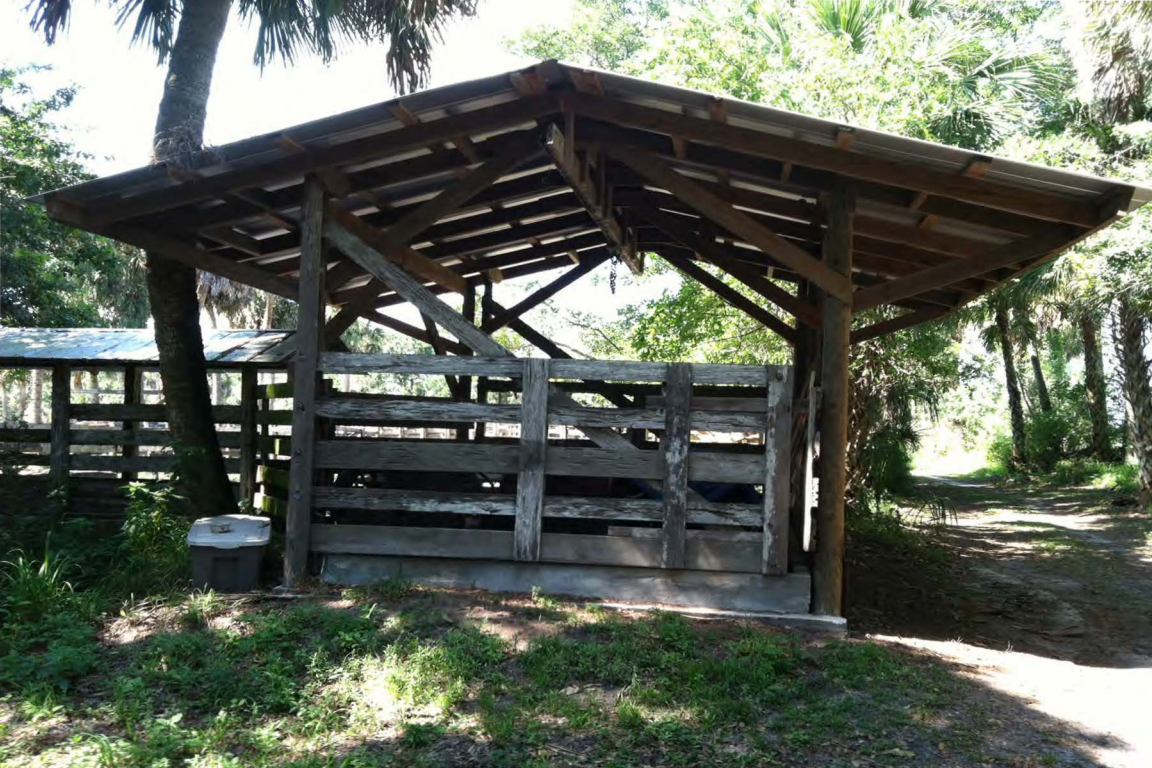
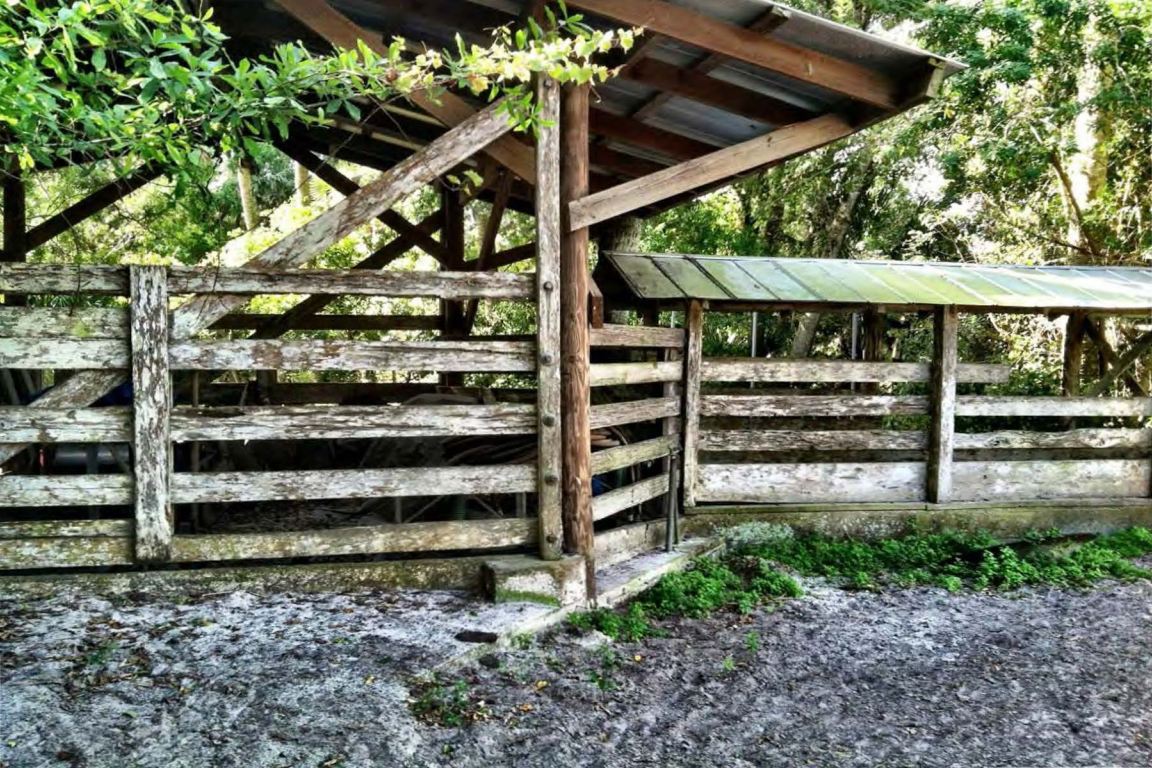
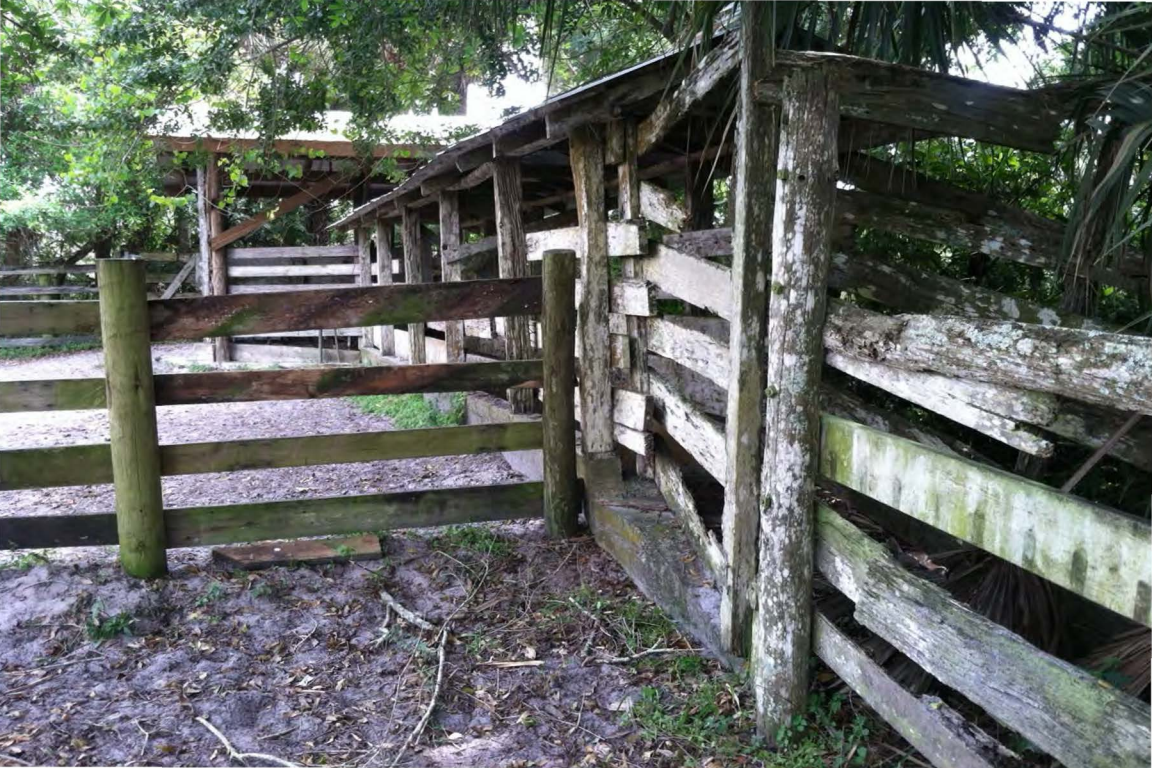
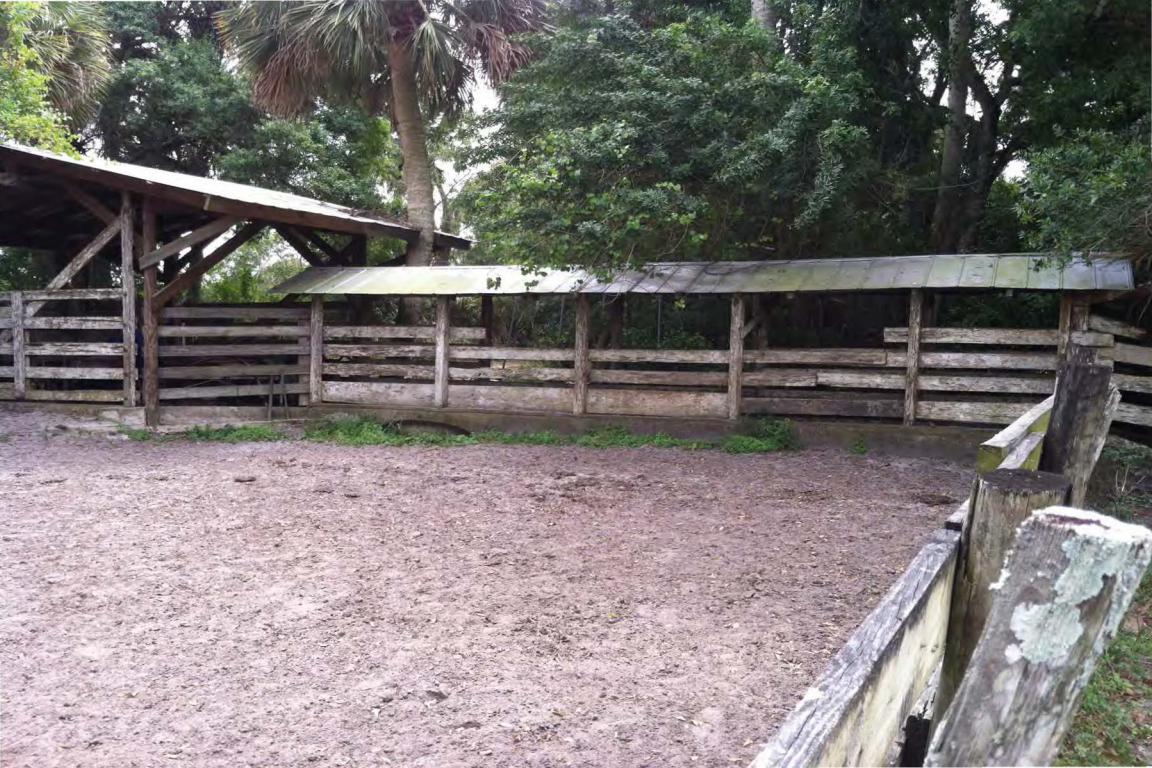
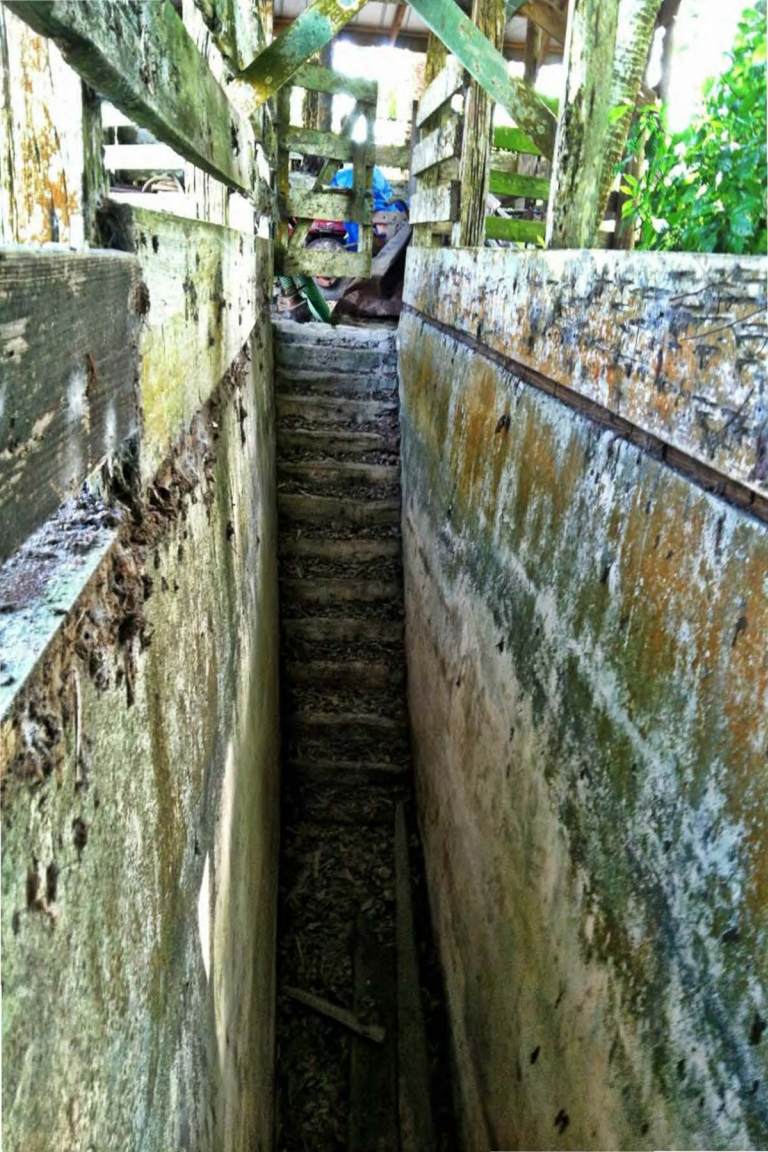
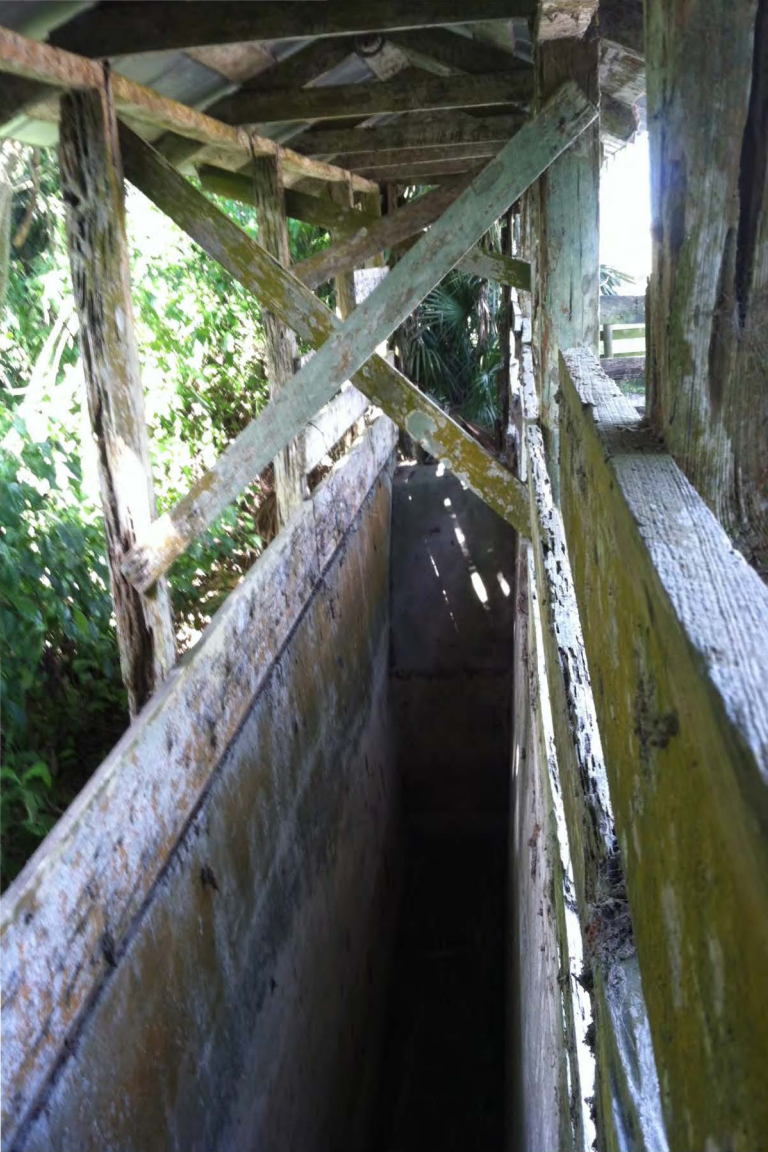
At the south end of the complex is the butchering pen and the dipping vat which were constructed at the same time (Photos 18-23). They are connected by a set of stairs at the east end of the vat which is used by the cattle to climb out of the vat through a small gate into the butchering pen, where they could stand before being turned out into the cow pens. The cattle were allowed to stand to dry off and allow the dip liquid to flow back into the vat. The floor of the butchering pen was pitched toward the mouth of the vat to help drain the liquid. The vat was created from forms using pecky cypress boards into which the concrete was poured. The boards were then mounted on the sides of the vat, above the concrete sill to keep cattle contained upon entering and exiting the vat. The imprints of the boards can be seen in the concrete walls. The roof is framed and stripped in cypress and was originally covered with corrugated metal instead of the newer V-crimp metal.

In the early 1900s, Texas fever tick entered Florida with cattle from other states. By the 1920s, the Florida State Livestock Board made it mandatory for ranchers to construct vats and dip cattle in an arsenic solution every two weeks. The fever resurfaced in 1935 and 1960, resulting in intense eradication programs implemented by Florida's Department of Agriculture.¹⁰ According to Ralph Sexton, "Waldo Sexton built the dipping vat and the butchering pen in 1943 at the same time he was constructing the cattle pens. "The dipping vat was used only about a year after it was built. Back then, DDT came in powder form and Waldo figured out you could put it in a grove sprayer and spray the cows, a method that he used from then on."¹¹

The butchering pen features gates on the north and south ends. The animal to be slaughtered was driven into the pen through the north gate, and the hoisted carcass was loaded on a vehicle backed through the open south gate to the edge of the pen. A sliding track runs the length of the underside of the roof ridge for this purpose. The floor of the butchering pen is incised with grooves to allow the blood and offal to flow into the dipping vat

and as a conduit for washing the pen after butchering had taken place. The roof and supports rest upon a pole framed foundation with open board walls on the east and west elevations and, together with the dipping vat, comprise the south end wall boundary of the cow pens. These structures, like the rest of the complex, were constructed of hand-hewn timbers. The other two notable features of the penned area are the fenced alleyway to the squeeze shoot (Photo 24) and the crowding pen near the dipping vat (Photo 25).
