NATIONAL REGISTER OF HISTORIC PLACES
REGISTRATION FORM

historic name TREASURE HAMMOCK RANCH FARMSTEAD

other names/site number Sexton Ranch; FMSF# IR01040

TREASURE HAMMOCK RANCH FARMSTEAD
VERO BEACH, INDIAN RIVER COUNTY, FLORIDA
DESCRIPTION

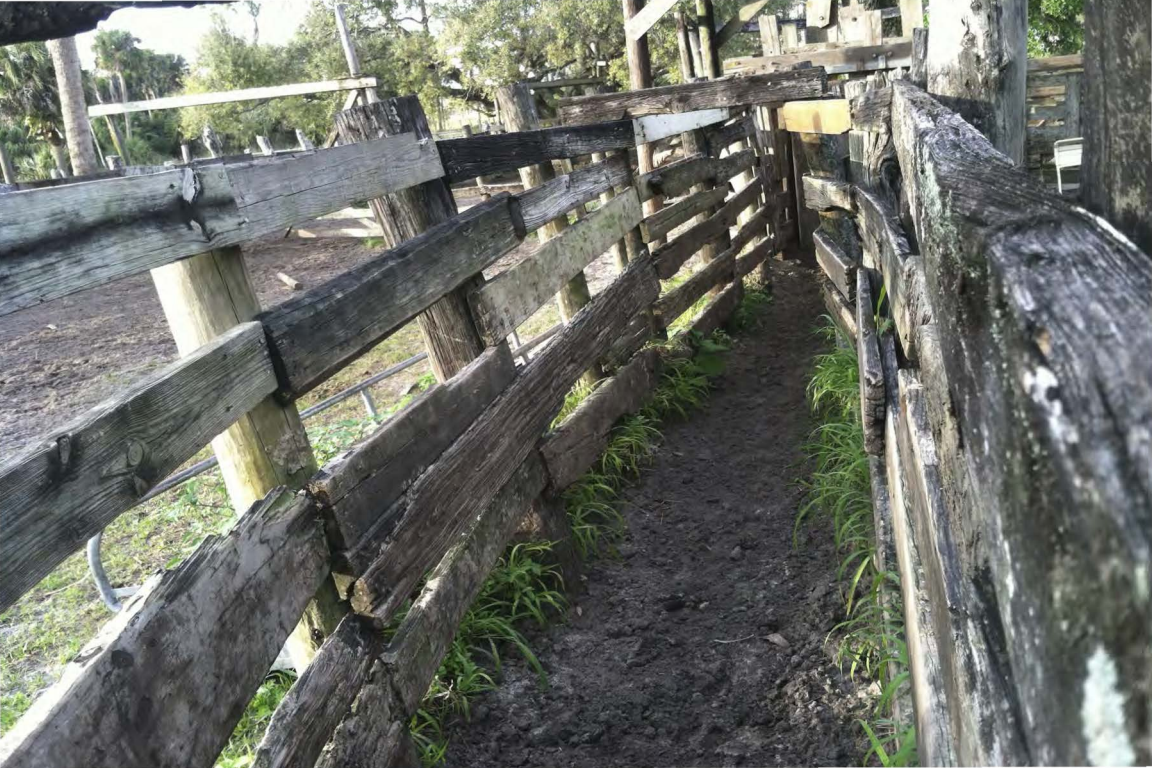
7. Photo 25 of 25

6. Crowding Pen, Looking Southeast

and as a conduit for washing the pen after butchering had taken place. The roof and supports rest upon a pole framed foundation with open board walls on the east and west elevations and, together with the dipping vat, comprise the south end wall boundary of the cow pens. These structures, like the rest of the complex, were constructed of hand-hewn timbers. The other two notable features of the penned area are the fenced alleyway to the squeeze shoot (Photo 24) and the crowding pen near the dipping vat (Photo 25).
