United States Department of the Interior  
National Park ServiceNational Register of Historic Places  
Inventory—Nomination Form

## INDIVIDUAL DATA SHEET

PROPERTY NAME Bank of Osceola

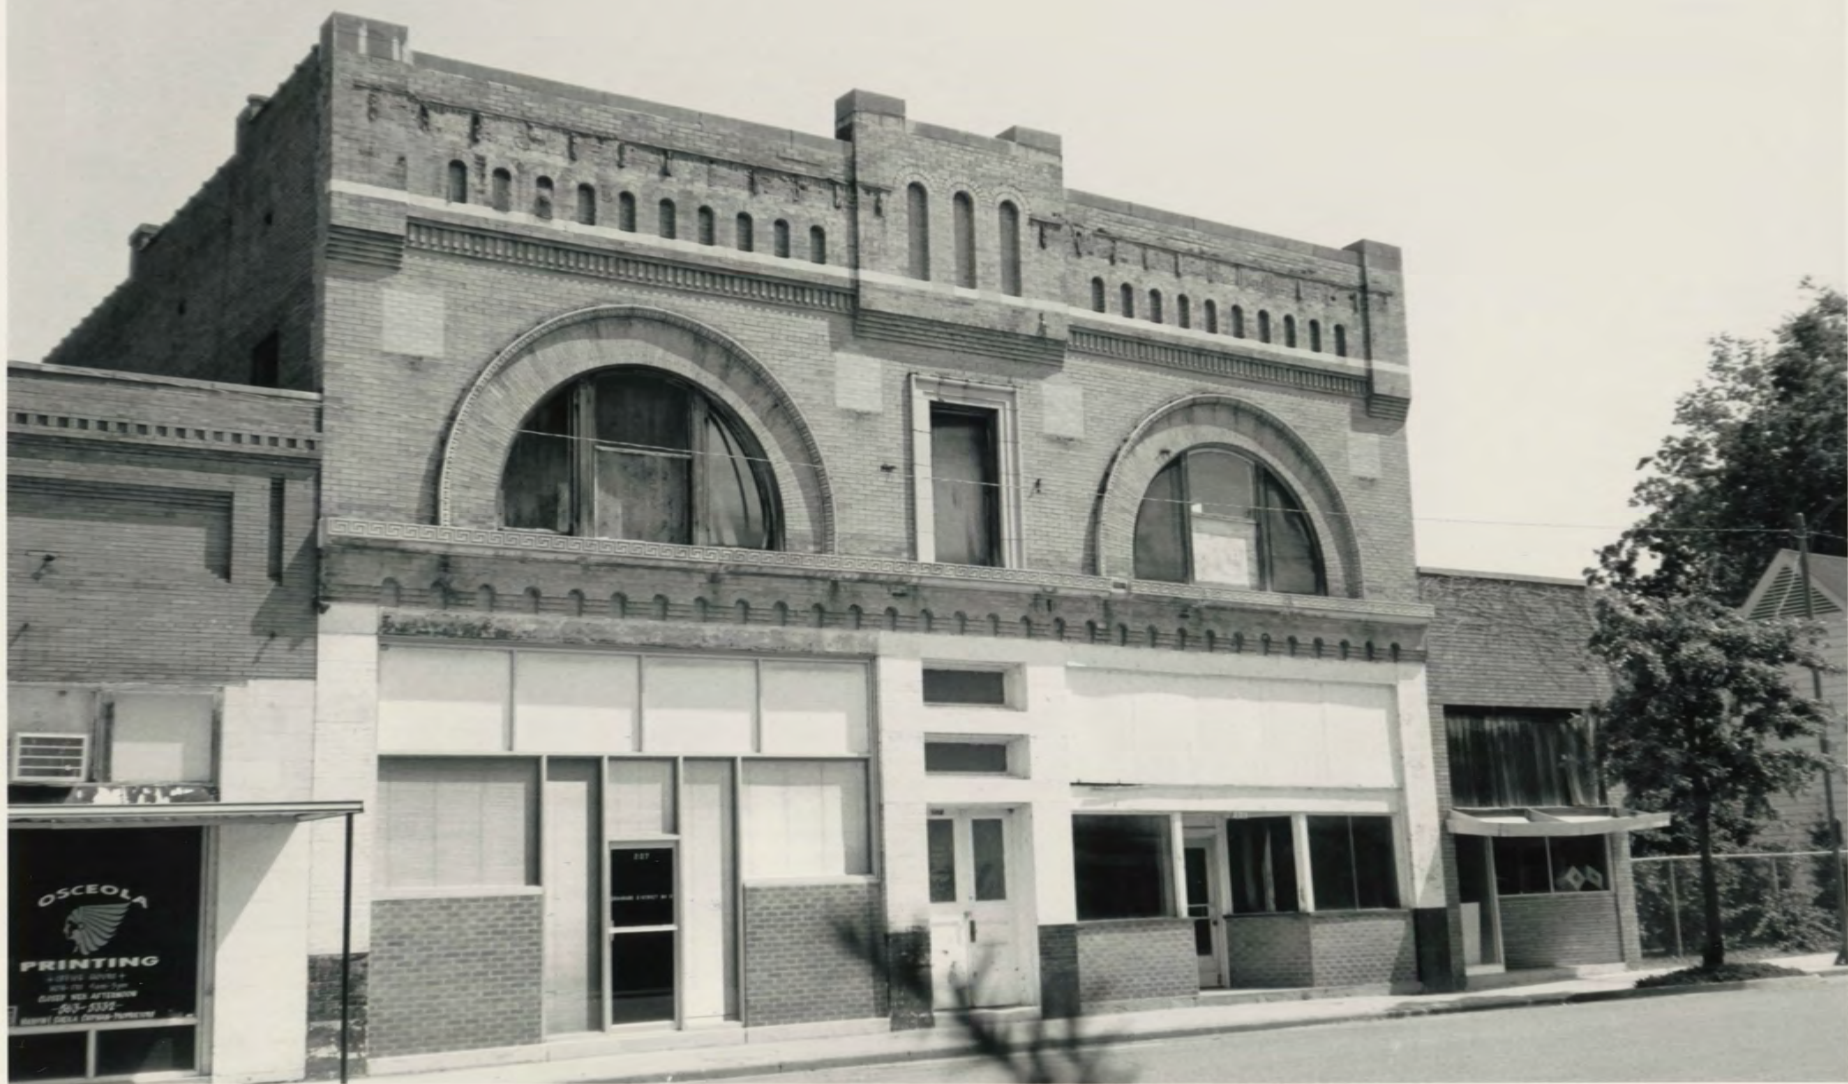
Bank of Osceola - 0022

BANK OF OSCEOLA  
207 E. HALE 1909  
OSCEOLA, AR

Built in 1909, the Bank of Osceola is a two-story brick building measuring 56' by 100'. The structure rests on a continuous brick foundation. The facade (south elevation) contains a centered entrance featuring double doors topped by double transoms, and flanked by altered store front openings. The second story of the facade is distinguished by two large semi-circular arched windows surrounded by vertically-laid brick and outlined by a narrow bank of dentiled stone. These arched openings contain a center plate glass sash window flanked by plate glass panels. A rectangular window with wide stone surrounds is centered above the entrance between the arched windows. Just below the second story windows a decorative narrow stone band extends across the width of the building, forming a cornice at the top of the first floor. The frieze under this cornice features scalloping across its width. Originally four square stone panels spaced evenly across the second story of the facade contained identical Indian heads. These were said to be the profile of Chief Osceola, a well known Indian Chief in the nineteenth century. These panels are now located on a building at Osceola High School. The original projecting wood cornice which extends across the top of the facade has been removed. A decorative parapet rises at the center of the roofline. This parapet contains three narrow arched recessed areas and features brick corbelling at its base. The original cornice was segmented; placed on either side of the center parapet, setting off its decorative effect. Small arched recessions along the frieze add to the detailing of the facade. A stone string course and a band of dentilling runs across the facade under the arched frieze. Although this building is currently in deteriorated condition, plans are underway to restore the facade to the original appearance. Two large atriums on the interior of the building still exist, the decorative Indian heads will be returned, and the cornice replaced.
