National Register of Historic Places Registration Form

sneets (NPS Form 10-900a). Use a typewriter, word processor, or complete	ater, to complete all items.
1. Name of Property	
historic name Methodist Episcopal Church of Montrose	
other names/site number United Methodist Church of Mo	introse, 5MN4493

Methodist Episcopal Church of Montrose

DESCRIPTION

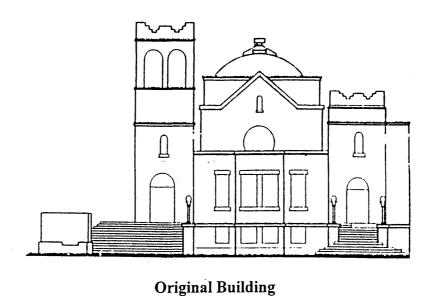
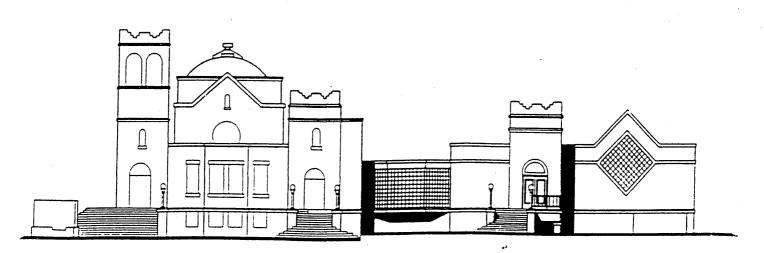
SOUTH ELEVATION

With 1991 Addition

Source: Brochure from 1991 Consecration Ceremony

On the south facade, below the gable there is a one story flat roofed bay which extends forward beyond the edge of the corner bell tower and the low secondary tower that is toward the east end. The bay opens into the nave to provide additional seating and has four 1/1 double hung secular stained glass windows. The arched stained glass window in the gable end depicts "The Good Shepherd", by Bernhard Pluckhorst, Syracuse, New York, Museum of Fine Art and includes geometric and foliate patterns.

The Post Modern style, one story addition is clearly distinguishable from the original building. The yellow brick used in the construction of its walls varies slightly from the original, as the Montrose Brick Company has not been in business for some 60 years. On its street-side south facade, the forms, textures, colors, and detailing resulted in a compatible design that complements the original building. The addition has an irregular plan and a partial raised basement. It includes approximately 8,800 square feet of useable space. The main level houses restrooms, storage facilities, a large fellowship hall, and a kitchen. The basement houses classrooms, storage space, and a play area.

On the south facade, concrete steps, with a wrought iron railing, lead up to an entry patio that has a low wrought iron balustrade. Entry to the building is through double doors with transom set in a semicircular arch. The arched opening is located in a rose colored, stuccoed square tower that complements the towers of the original building. Below the gable peak, set within a diamond shape, there is a "rose" window filled with glass block. The building's belt course of red brick intersects two points of the diamond.
