**National Register of Historic Places  
Inventory—Nomination Form**

historic Church San Germán Auxerre of San Germán (*Historic Churches of*  
*Puerto Rico TR*)  
and/or common same

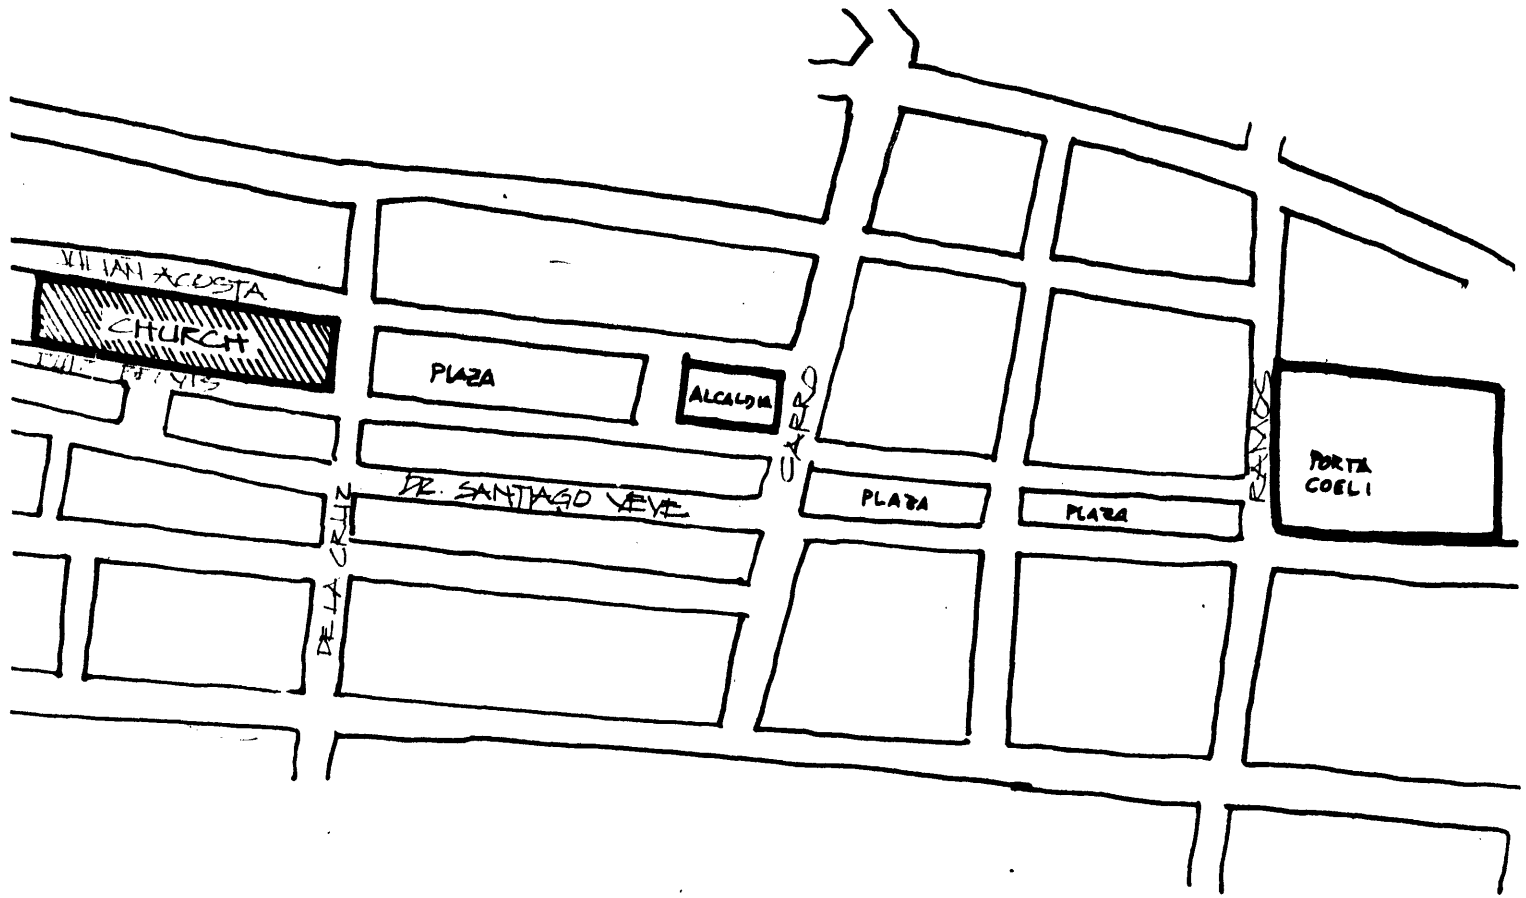
town: **SAN GERMAN**

scale: 1:2000

The church is bounded on the north by Juan Acosta Street, on the east by the town plaza and De la Cruz St., on the south by Ruiz Belvis St., and on the west by the parish house. (see enclosed location plan).
