National Register of Historic Places Registration Form

historic name YMCA Building - Walla Walla
other names/site number Odd Fellows Building

street & number 28 S. Spokane Street not for publication
city or town Walla Walla vicinity
state Washington code WA county Walla Walla code 071 zip code 99362

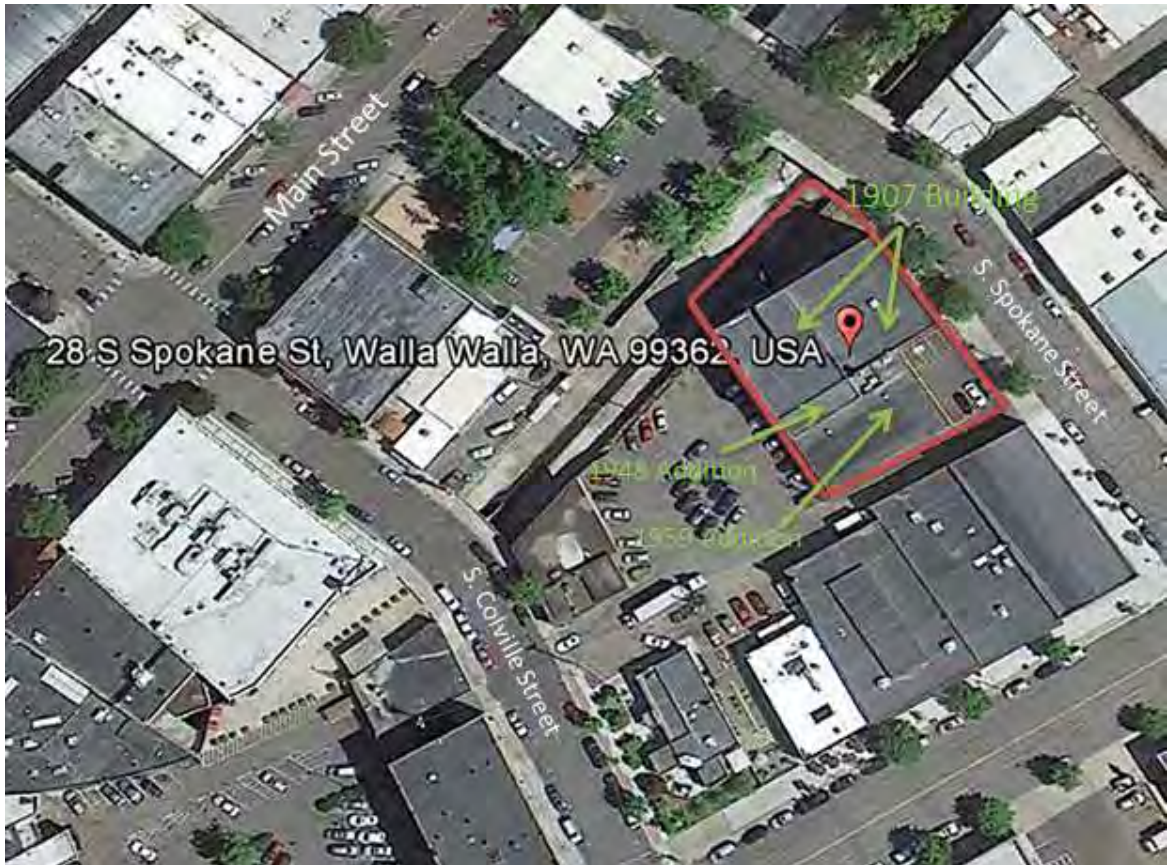
Fig. 1-A. Walla Walla, WA YMCA. Aerial photograph showing the property boundaries and 1907 building, with 1948 and 1959 noncontributing one-story additions. Source: Google Earth, Stephen Day Architecture.

The Walla Walla, Washington YMCA building was constructed in 1907 on a prominent site located one block south of Main Street, bordering Mill Creek (see aerial photograph at Fig. 1A, photo key plans at Figs. 1B, 1C, 1D and 1E, and parcel map at Fig. 1F). Designed by Henry Osterman, one of Walla Walla's most prominent architects, the YMCA building was constructed in a simplified Beaux Arts classical style (see 1907 photograph at Fig. 2). The dominant exterior material is Flemish bond brick with a sandstone rusticated base and segmental sandstone lintels (see exterior view from South Spokane Street and masonry detail photograph at Fig. 3B). The original 1907 contributing building is three stories above a daylight basement, with a concrete foundation and steel and timber structure. A small, noncompatible addition was added at the rear of the building in 1949 and a noncompatible one-story swimming pool structure was added to the south side of the building in 1959. There have been plan revisions over time, the front entry porch area was altered and the pressed metal cornice was removed in 1948. Nevertheless, the contributing 1907 building has retained a relatively high degree of historic integrity in its brick and stone masonry, its window openings, in its basic structural components and many of its plan elements.

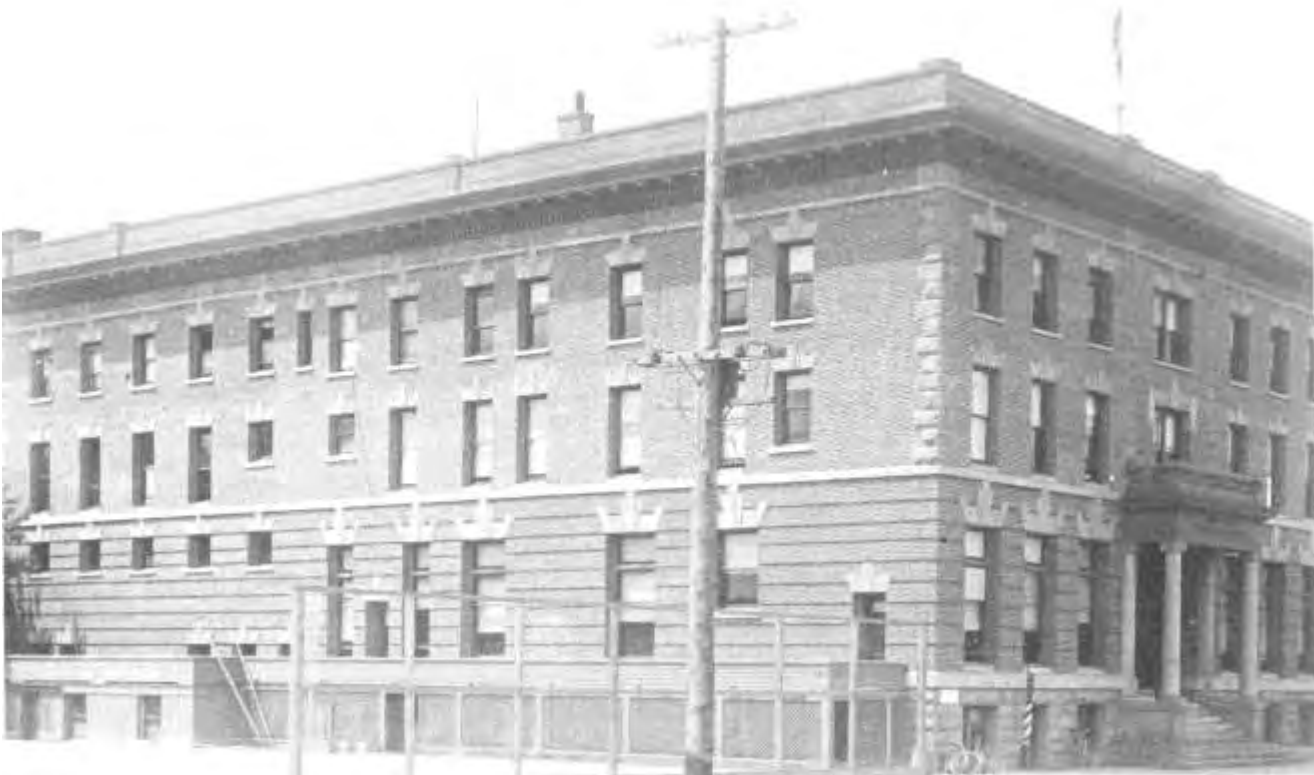
Fig. 7. Walla Walla, WA YMCA. View looking northwest towards south elevation and east (Spokane Street) elevation, 1908. Source: Penrose Memorial Library collections, Whitman College.

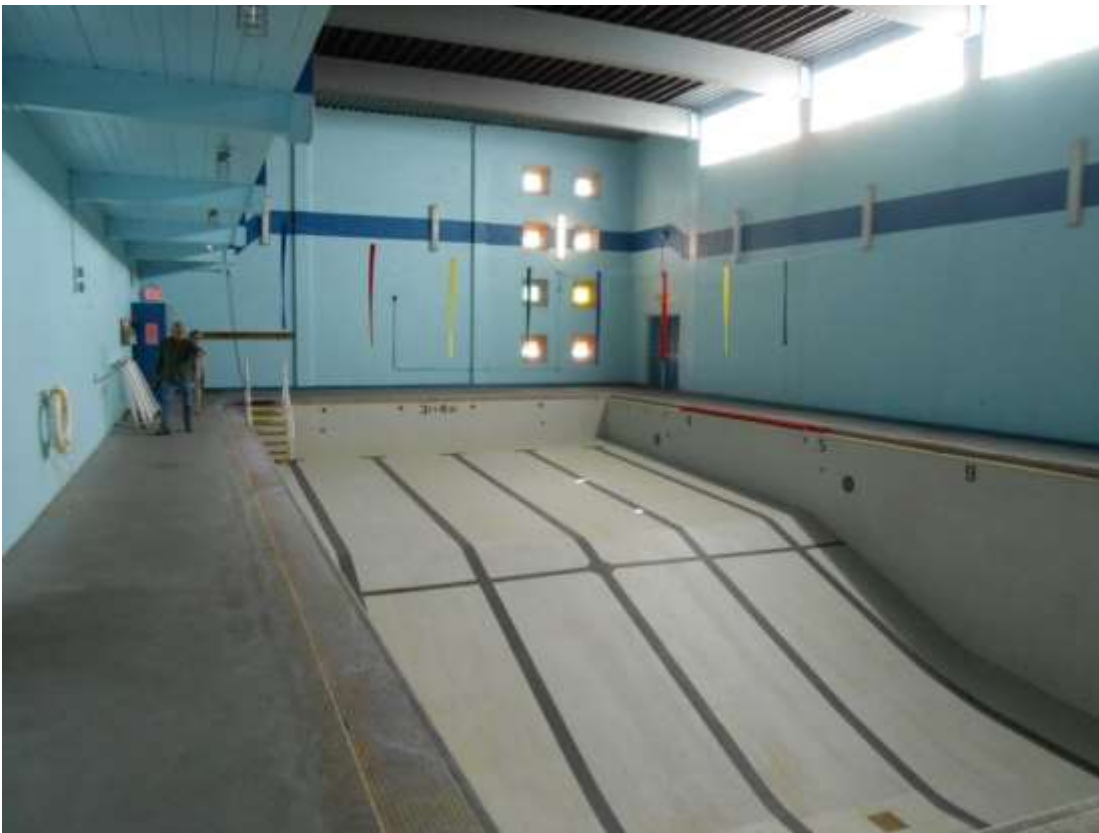
Fig. 14. Walla Walla, WA YMCA. Interior view, 1959 swimming pool addition, looking east, June 2014. Source: Stephen Day Architecture.

<p>Fig. 13 Walla Walla YMCA Walla Walla, Walla Walla County, WA Source: SDA Date: June, 2014 West elevation of 1907 building with additions, looking NW WA_Walla Walla County_Walla Walla YMCA_0013.tif</p>
<p>Fig. 14 Walla Walla YMCA Walla Walla, Walla Walla County, WA Source: SDA Date: June 2014 Interior view, noncompatible addition WA_Walla Walla County_Walla Walla YMCA_0014.tif</p>
<p>Fig. 15</p>

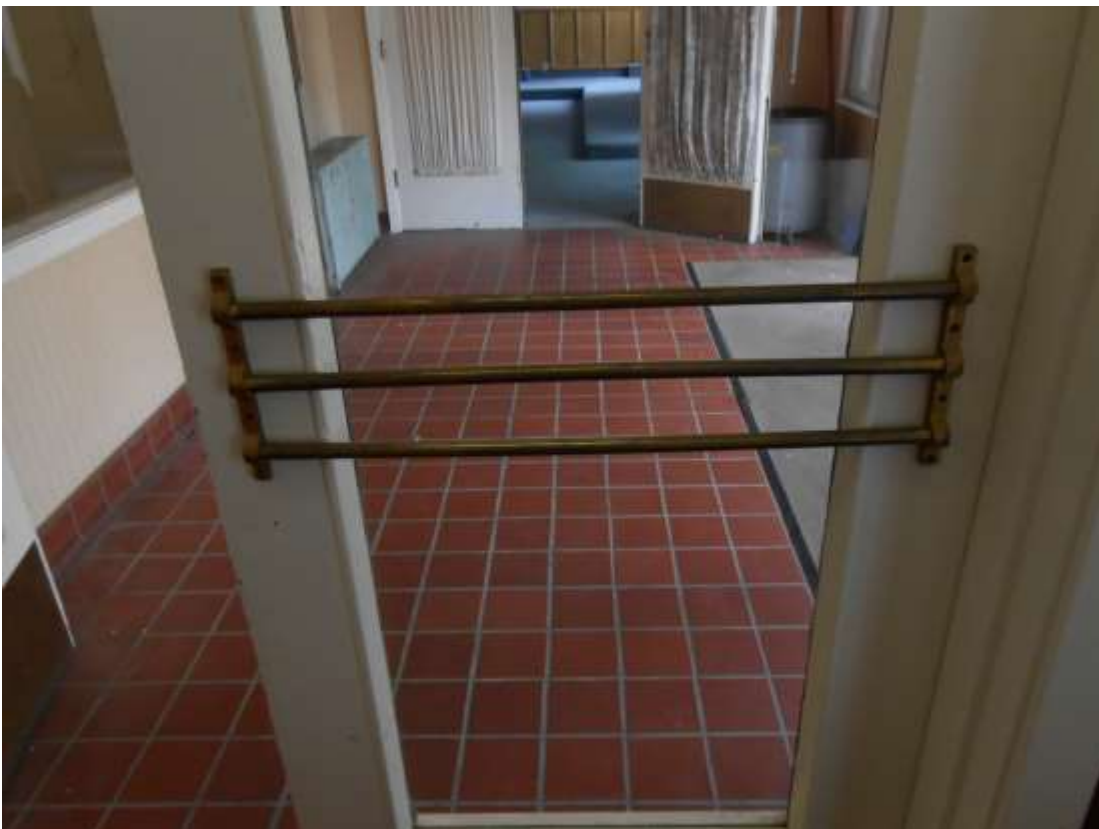
Fig. 15. Walla Walla, WA YMCA. Entry vestibule at South Spokane Street entry, looking north, June 2014. Source: Stephen Day Architecture.

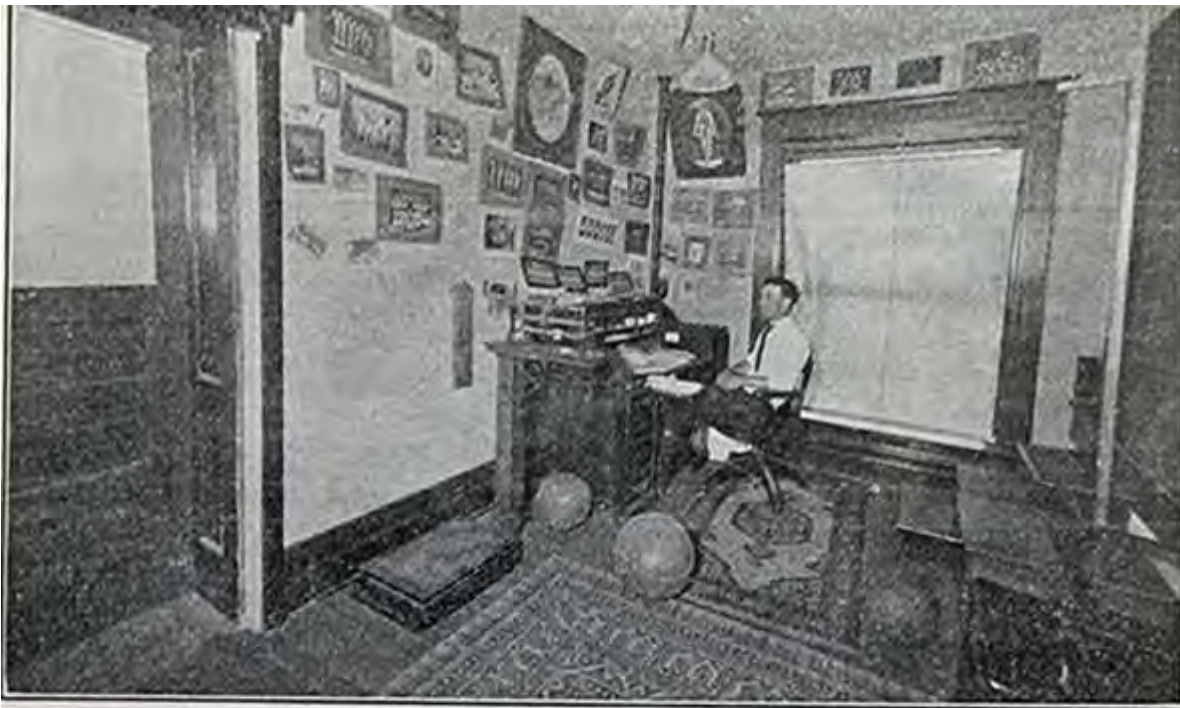
Fig. 16. Walla Walla, WA YMCA. First floor office of F.D. Applegate, showing dark-stained millwork and typical detailing, looking north, c. 1910. Source: Penrose Memorial Library collections, Whitman College.

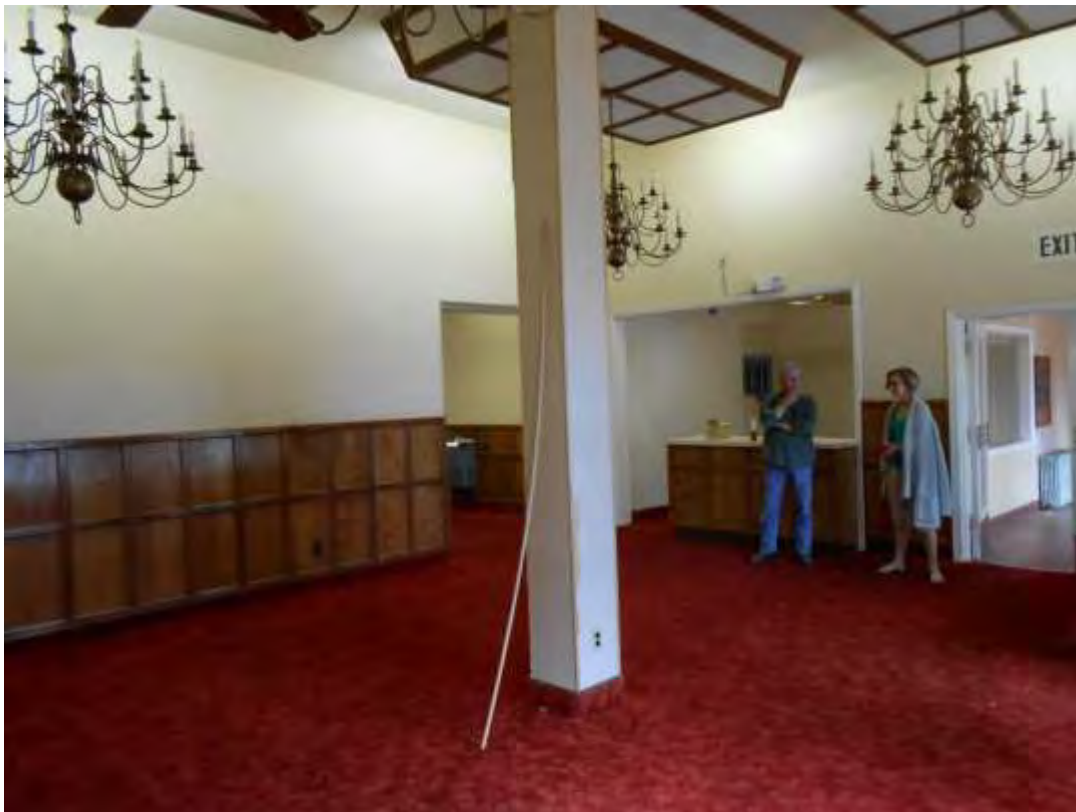
Fig. 17. Walla Walla, WA YMCA. First floor lobby area (originally Men's Lounge in 1907, altered) at SE corner of building, looking NW, June 2014. Source: Stephen Day Architecture.

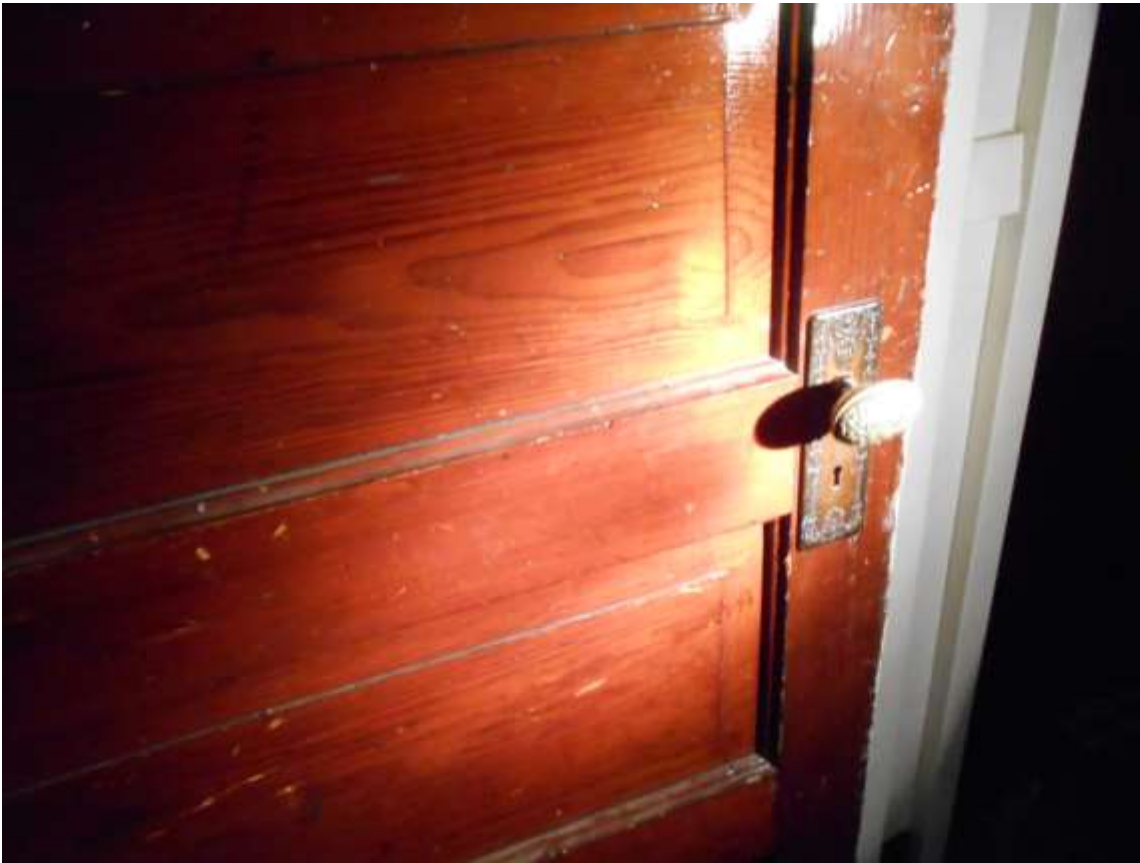
Fig.18. Walla Walla, WA YMCA. Detail of 1907 stained and varnished door, with original hardware, First Floor, June 2014. Source: Stephen Day Architecture.

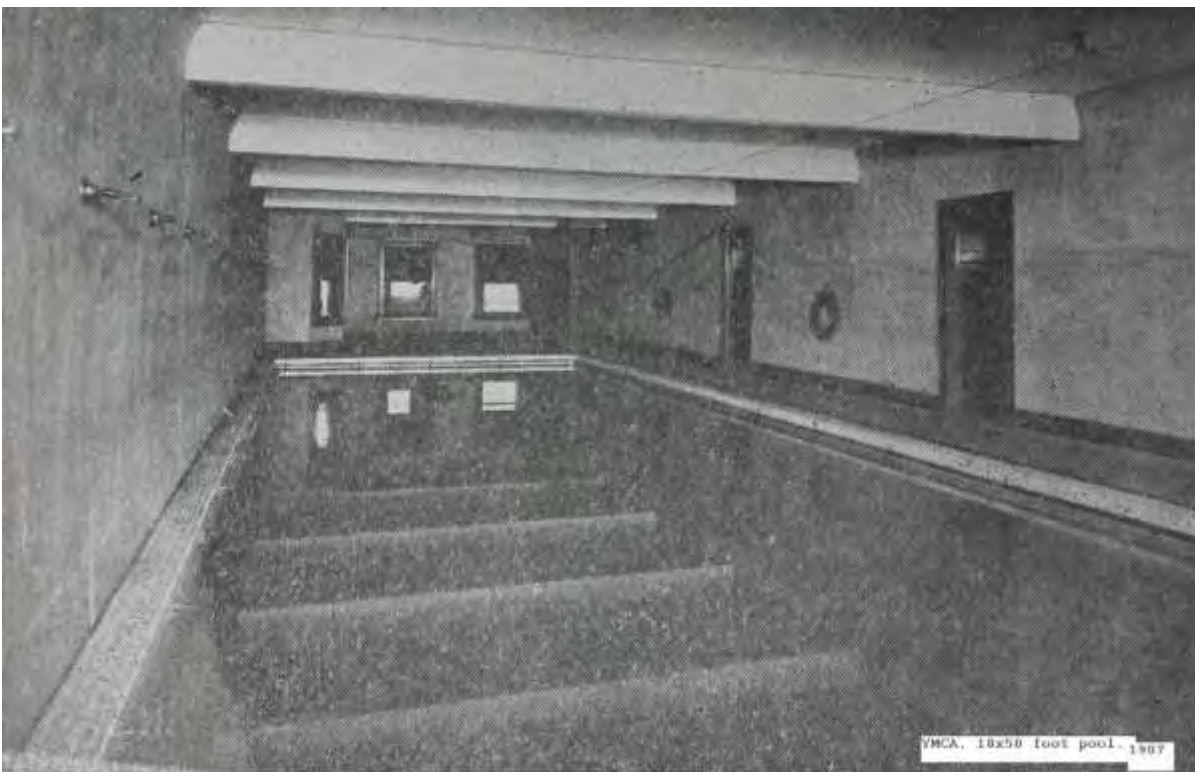
Fig. 21. Walla Walla, WA YMCA. Natatorium (indoor swimming pool), at daylight basement west, view looking north, 1907. Source: Penrose Memorial Library collections, Whitman College.

<p>Fig. 21 Walla Walla YMCA Walla Walla, Walla Walla County, WA Source: PML Date: 1907 View of natatorium, looking north WA_Walla Walla County_Walla Walla YMCA_0021.tif</p>
<p>Fig. 22 Walla Walla YMCA Walla Walla, Walla Walla County, WA Source: PML Date: 1906 Schematic plans of basement and first floor, prepared by</p>

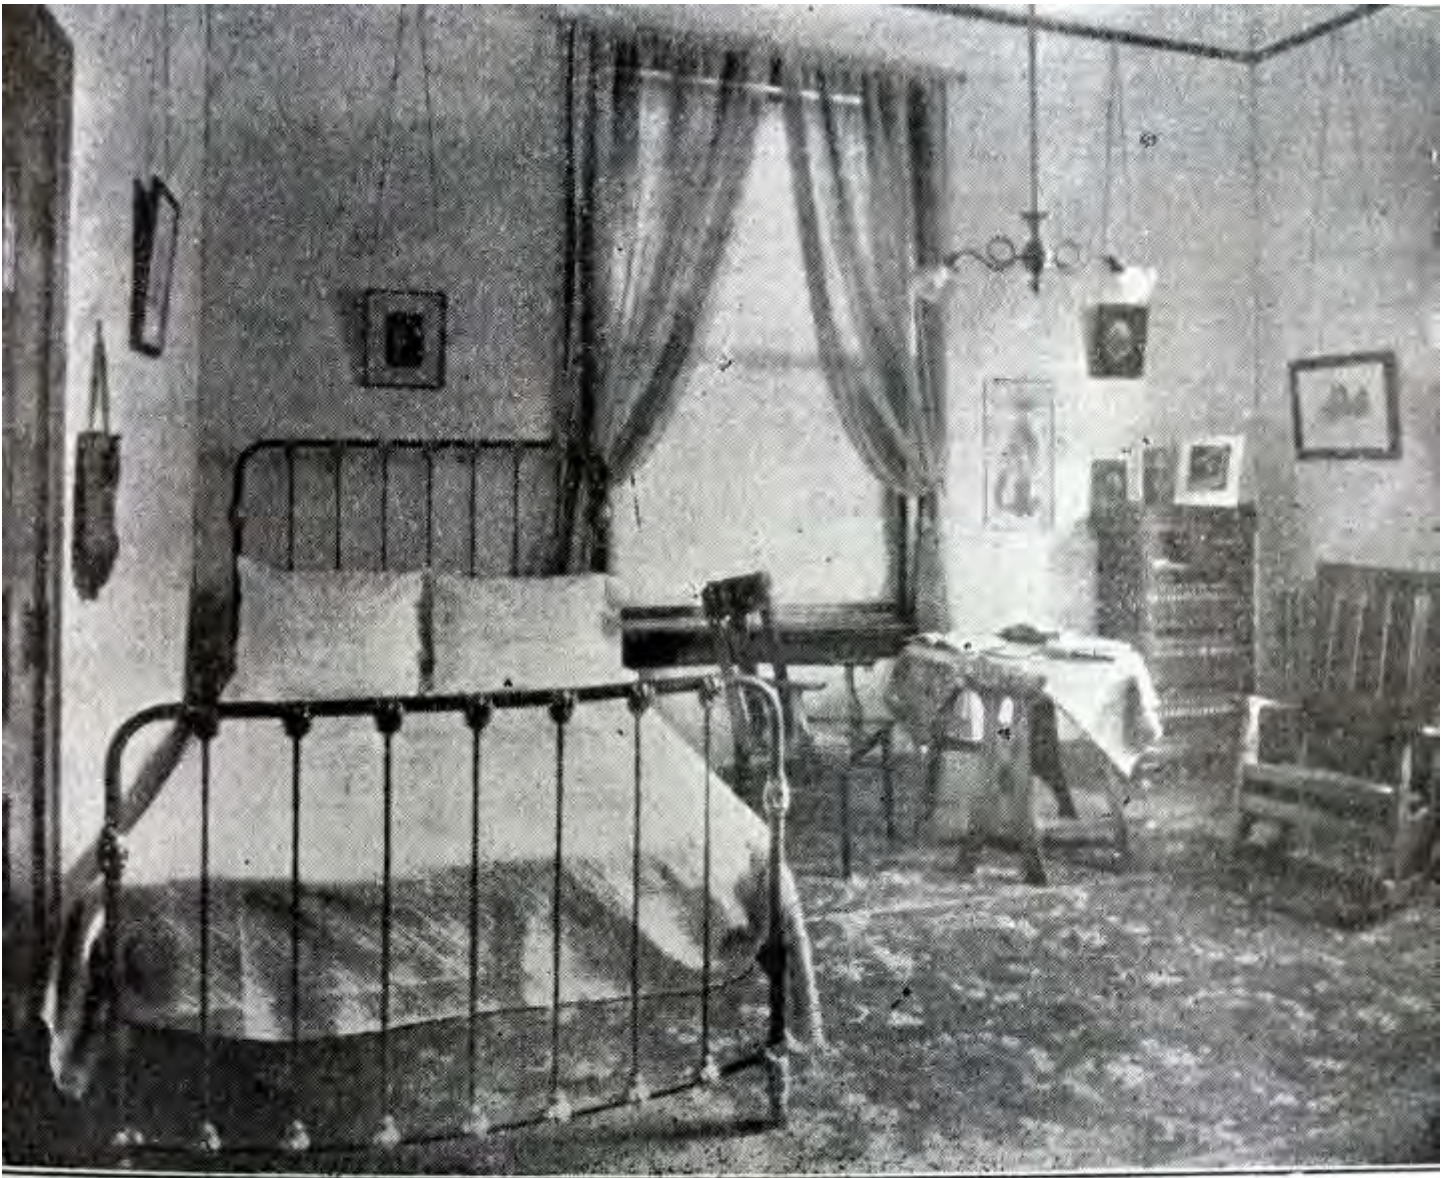
Fig. 24. Walla Walla, WA YMCA. Example of third floor "Bachelor's Quarters", exact location unknown, 1907. Source: Penrose Memorial Library Collections, Whitman College.

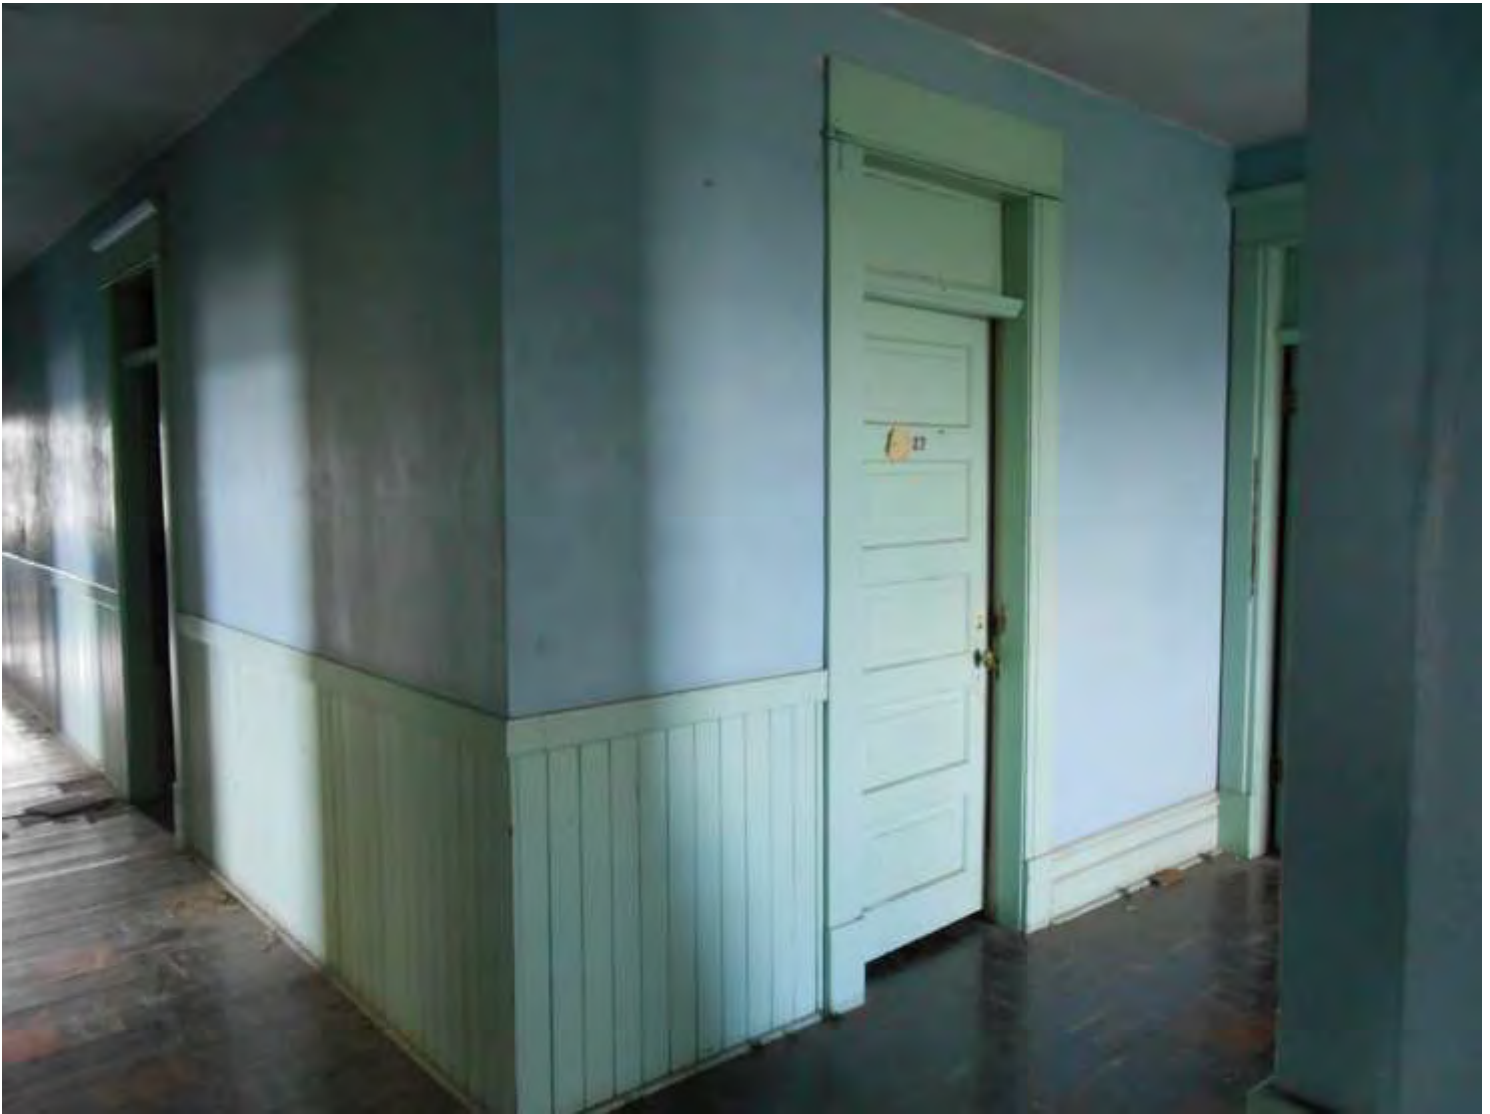
Fig. 25. Walla Walla, WA YMCA. Third floor lodging corridors and millwork details, view looking SW, June 2014.
Source: Stephen Day Architecture.

Twenty-seven “bachelor” apartments were available for rent from \$9 to \$12 per month, with roommate costs at \$2 per month, providing a safe, comfortable and socially stimulating residential environment. These rooms were furnished (see Fig. 25), heated with steam, with a large state of the art bathroom facility shared by the boarders. The Association and facility privileges were also available to these boarders and included in the rent.

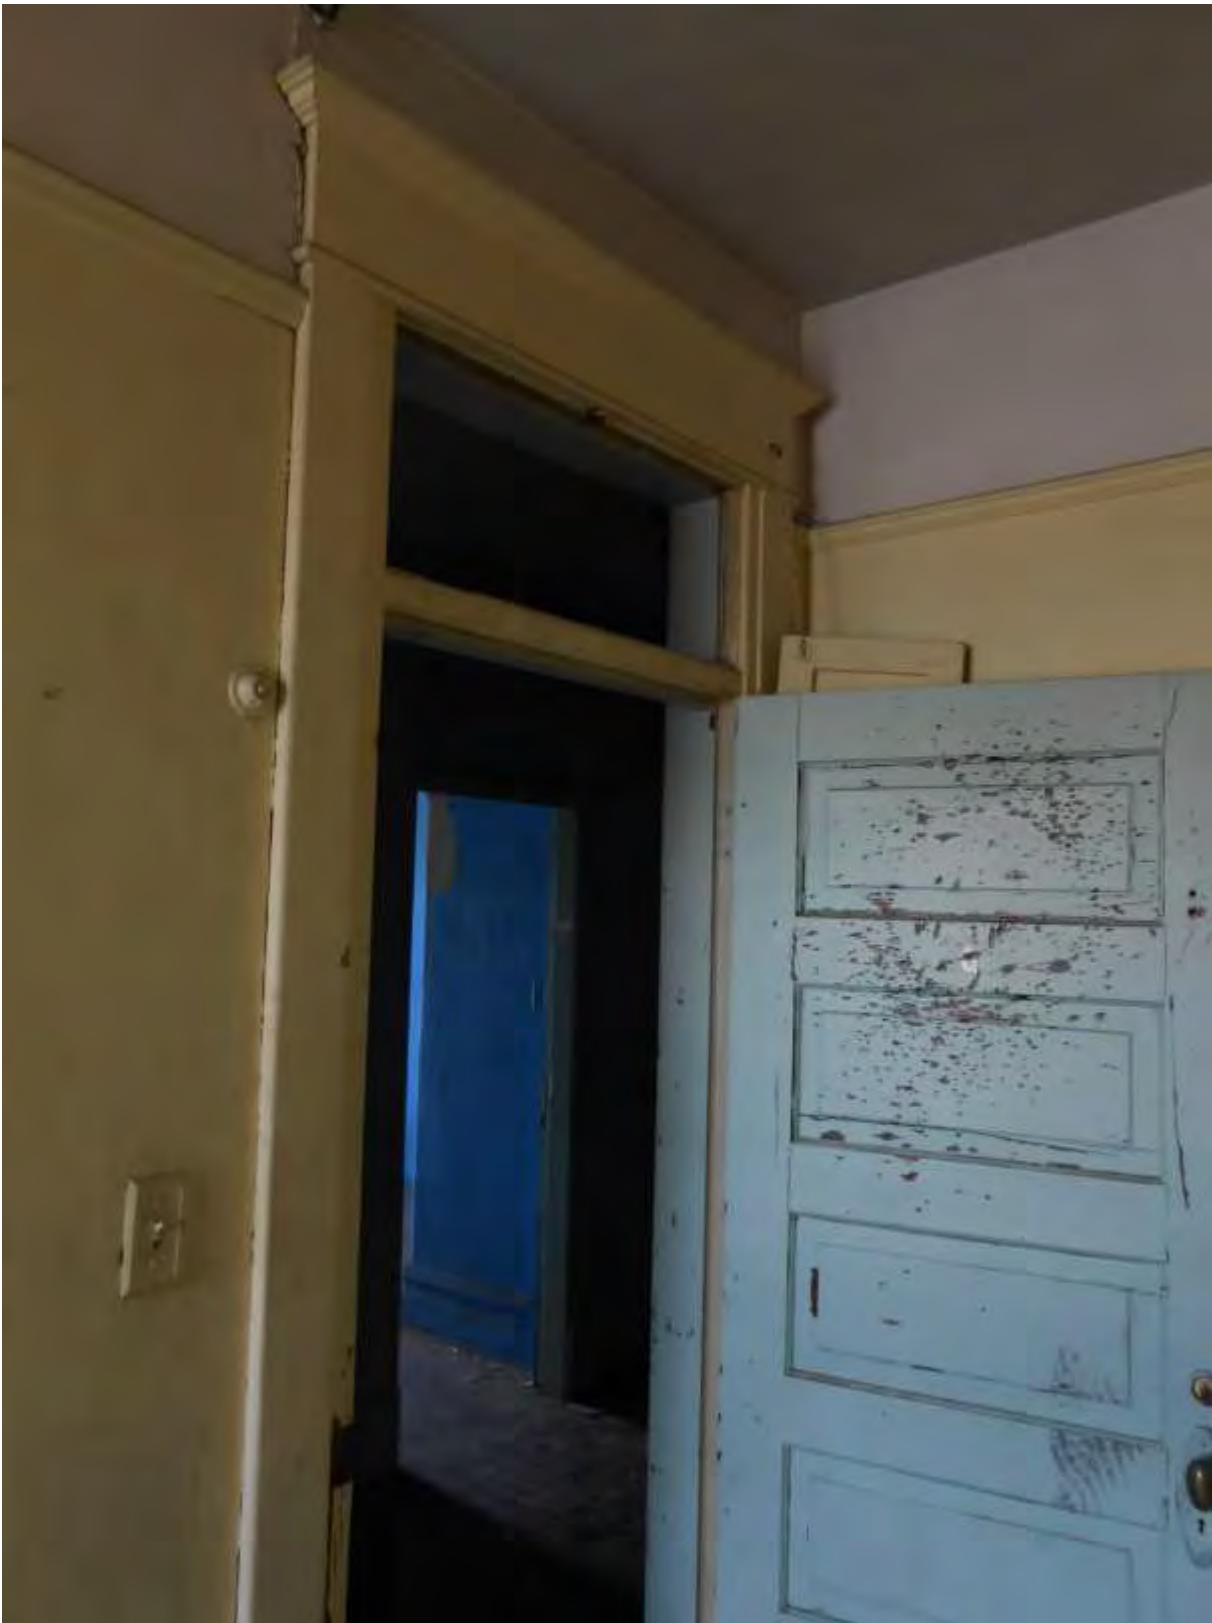
Fig. 26. Walla Walla, WA YMCA. Third floor lodging room door, casing, transoms, view looking east, June 2014.
Source: Stephen Day Architecture.
