Gulick House 1978
South Brunswick southwest
Middlesex County corner of
New Jersey 034 house

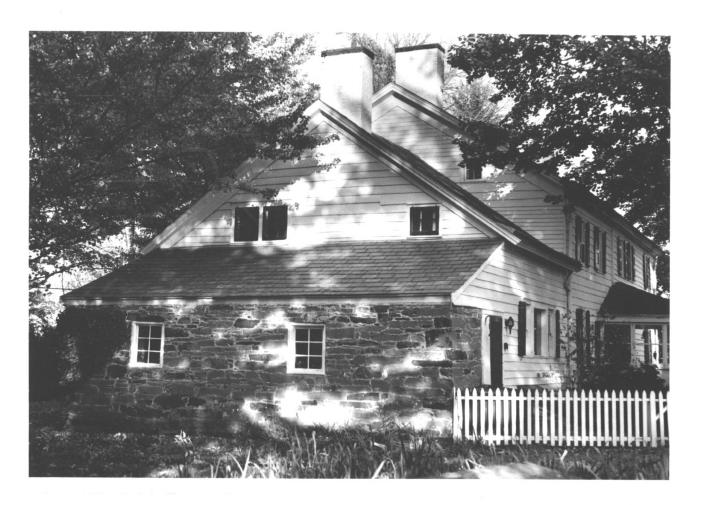
195

Southwest corner of Gulick House. Segments, beginning in foreground, are west segment masonry "Cold Room" added soon after first construction; west center segment (oldest part of house, ca. 1740-50); east center segment (a "bridge" built ca. 1800 to connect two parts of house); and east segment (built as free standing side-hall house, before ca. 1770).

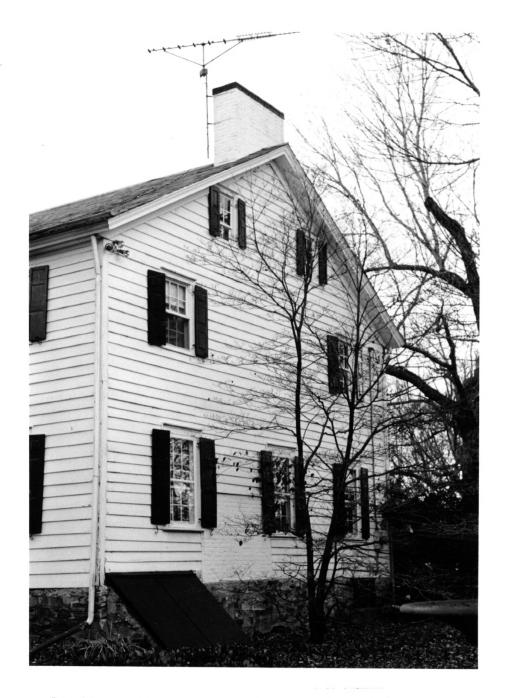
315

Southeast corner of Gulick House. This was built sometime after the first unit, but well before 1800, and probably before ca. 1770. This shows east end wall of this east segment, with brick chimney back behind the main fire place. Windows are 9/6 double hung on first floor, and 6/6 on second.

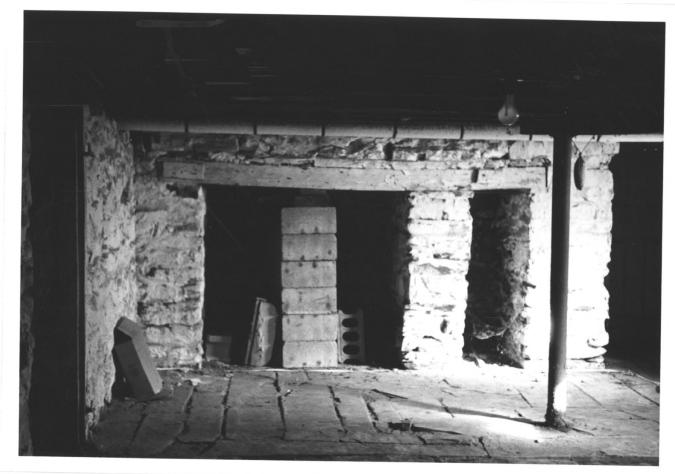
40/5

Working-kitchen fire place at east end of eastern segment of Gulick House, in stone-paved cellar room, looking east. There is a similar fire place at the other end of the cellar under the west end of the west-center segment.

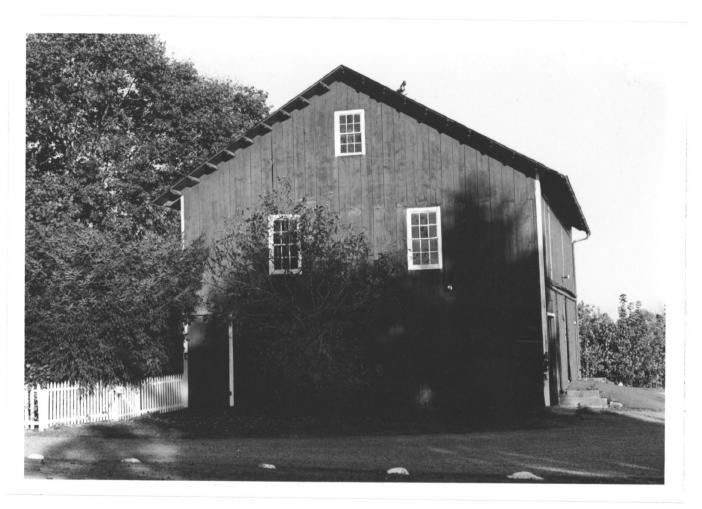
5075

West end of Gulick Barn, looking east. The main doors are on the barely visible south wall. This mortised and tenoned brace-framed structure dates from ca. 1850, but incorporates parts of an older barn with hewn beams. This barn, 30 ft. by 40 ft., is about 90 ft. south of the Gulick House.
