National Register of Historic Places Registration Form

Historic name Cynthia-Kinzer Historic District

City or town Poplar Bluff N/A vicinity

State Missouri Code MO County Butler Code 23 Zip code 63901

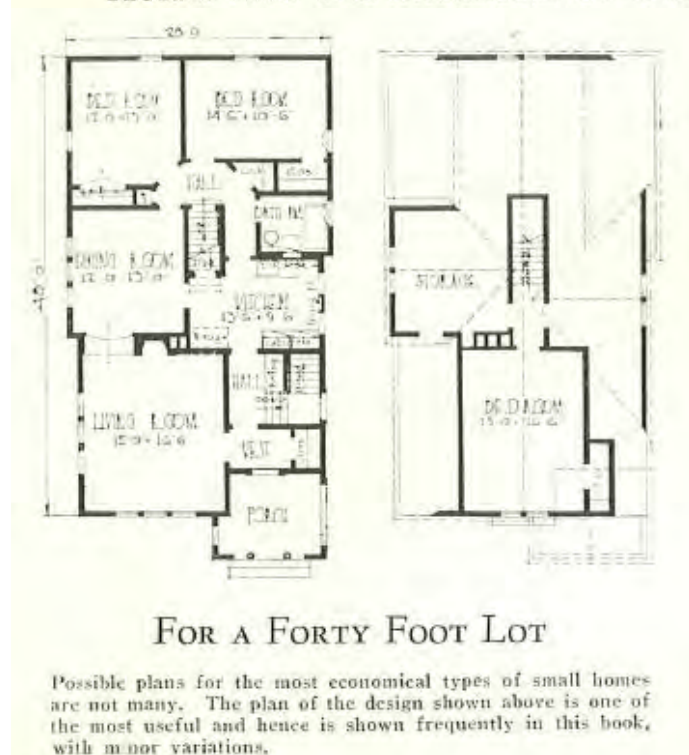
Figure 15: House plans from the Architects' Small House Bureau of the United States. Source: The Architects' Small House Bureau of the United States, *The Home Builder's Library: One Hundred Bungalows*, 1927, p. 18.
