NATIONAL REGISTER OF HISTORIC PLACES INVENTORY - NOMINATION FORM FOR FEDERAL PROPERTIES

AND/OR HISTORIC:
Whitcomb Cabin

**NATIONAL REGISTER OF HISTORIC PLACES
REGISTRATION FORM**

The Whitcomb-Cole Hewn Log House is a late-nineteenth century, 1-1/2 story side gable dwelling originally sited on the Glenwood-BZ Corners Road. The house was listed on the National Register in 1975, in 1986 the Nomination form was updated (Saul 1975; Staehli 1986). The log house was deteriorating and efforts to restore the building required relocating it to a secure setting. The house was documented to HABS standards prior to moving it in September 1987. This narrative provides documentation of the move, describes the new setting, and details the restoration work completed.

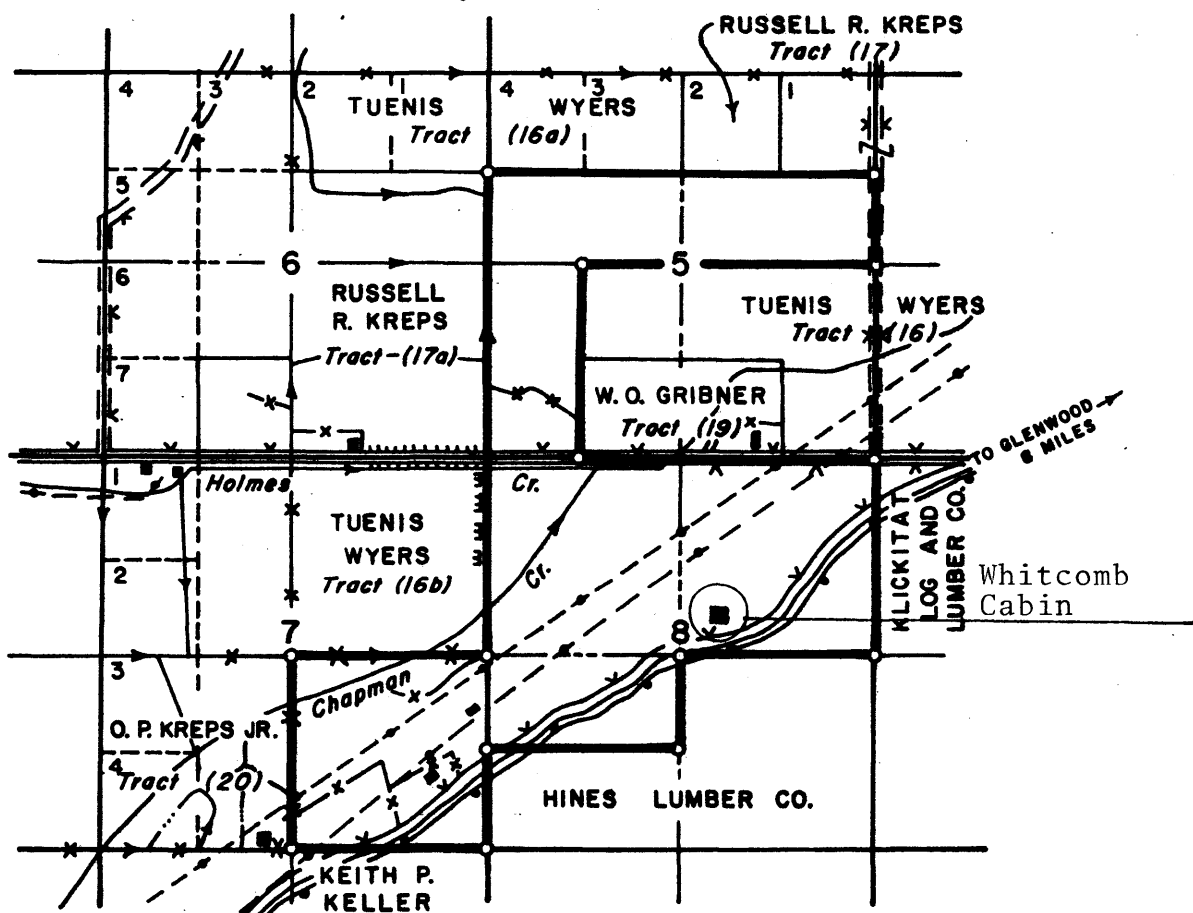
Property record site map: Cabin is
near center of Sect. 8, north of
county road, marked with circle.
Map No. 1
