KENTUCKY HISTORIC RESOURCES INVENTORY

Ht-19

1. Historic Name (s) Munford Inn Original Owner Thomas Munford			22. ADD/County □□□ Barren River/Hart																				
Present Name Old Munford Inn			23. Zoning Classification Magisterial District

Munfordville Multiple Resources

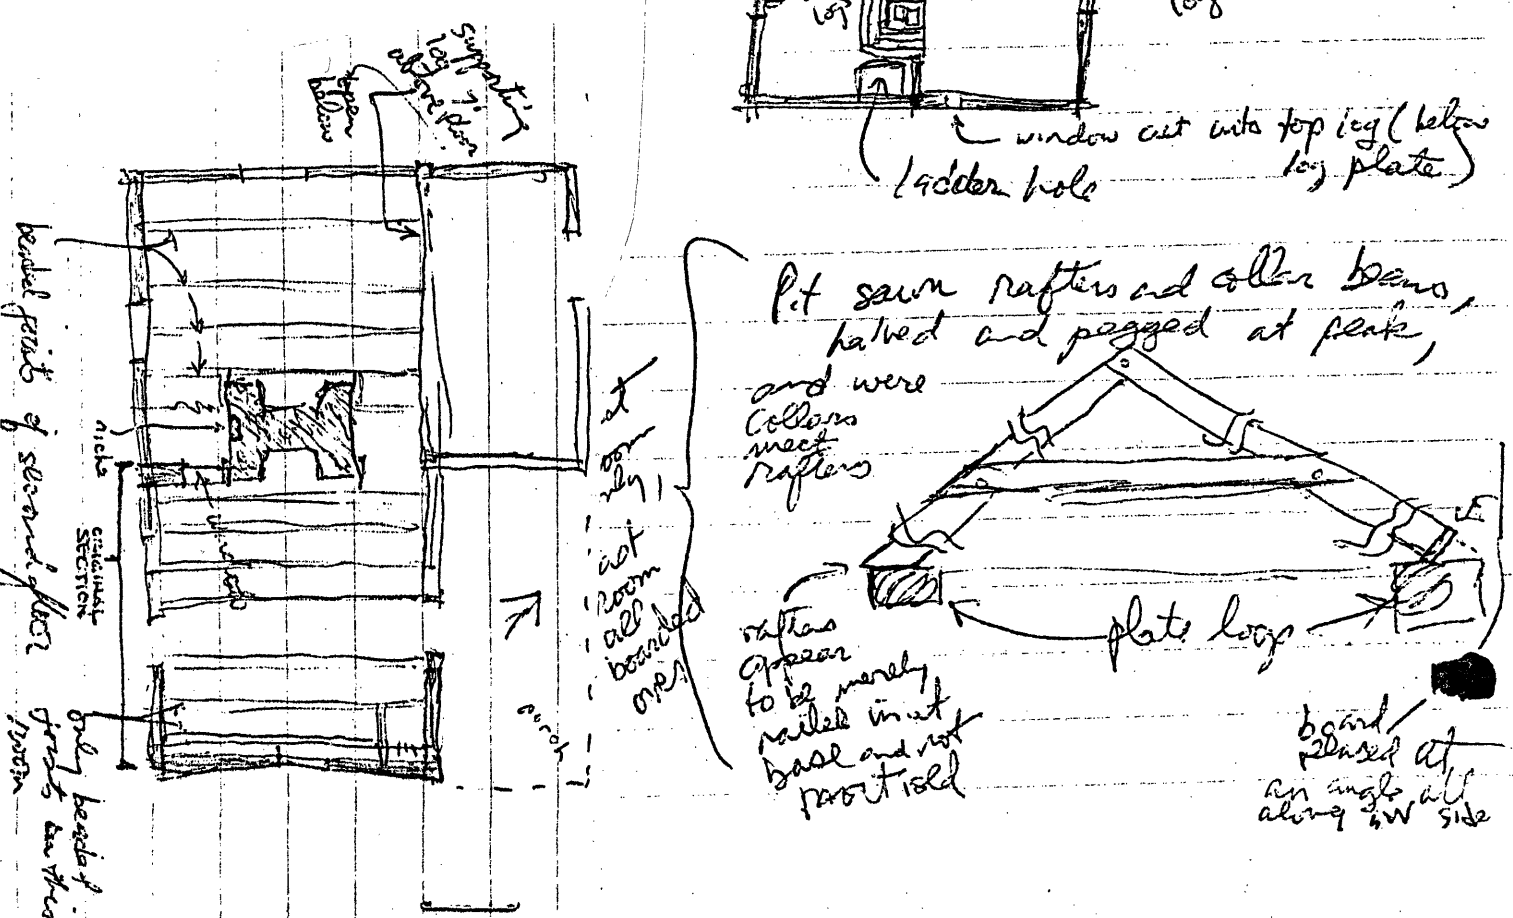
LEFT PART
RESTORED

was to restore the building to its original appearance. A shed porch (see photo) across the front was removed; logs were rechinked with cement; the building was reroofed with hand-split red oak shakes; the foundation was reinforced with cement blocks; interior wall covering installed by the previous occupants --said to be pasteboard and paper-- was removed; both fireplaces were cleaned and repaired with no alteration to their original composition or design; logs, which had been creosoted by the previous occupants, were given another coating of creosote; windows and doors were repaired without altering the size; the space to the rear in the west pen was enclosed for use as a bathroom and storage area.

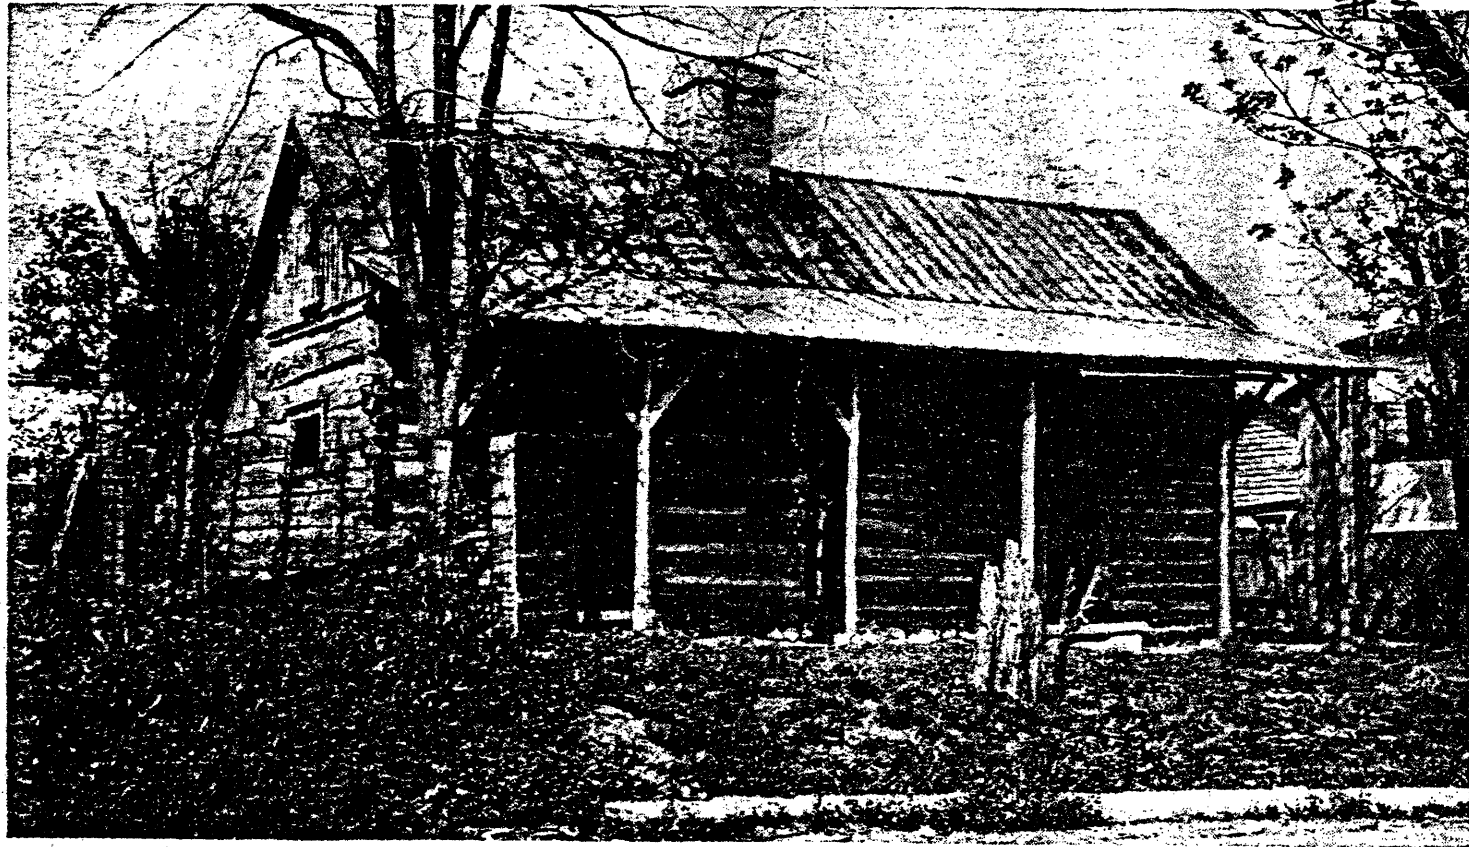
Munford Inn.

Old Inn, Munfordville, Ky. Here Andrew Jackson spent the night on his way to Washington to become President

Pre-1953 photo. Exact date
unknown.
