PU'U'ŌPAE BRIDGE, KAHALA COUNTY, HAWAII
BY PAUL GRIFFIN 8.13.04

NEGATIVES HELD BY PHOTOGRAPHER

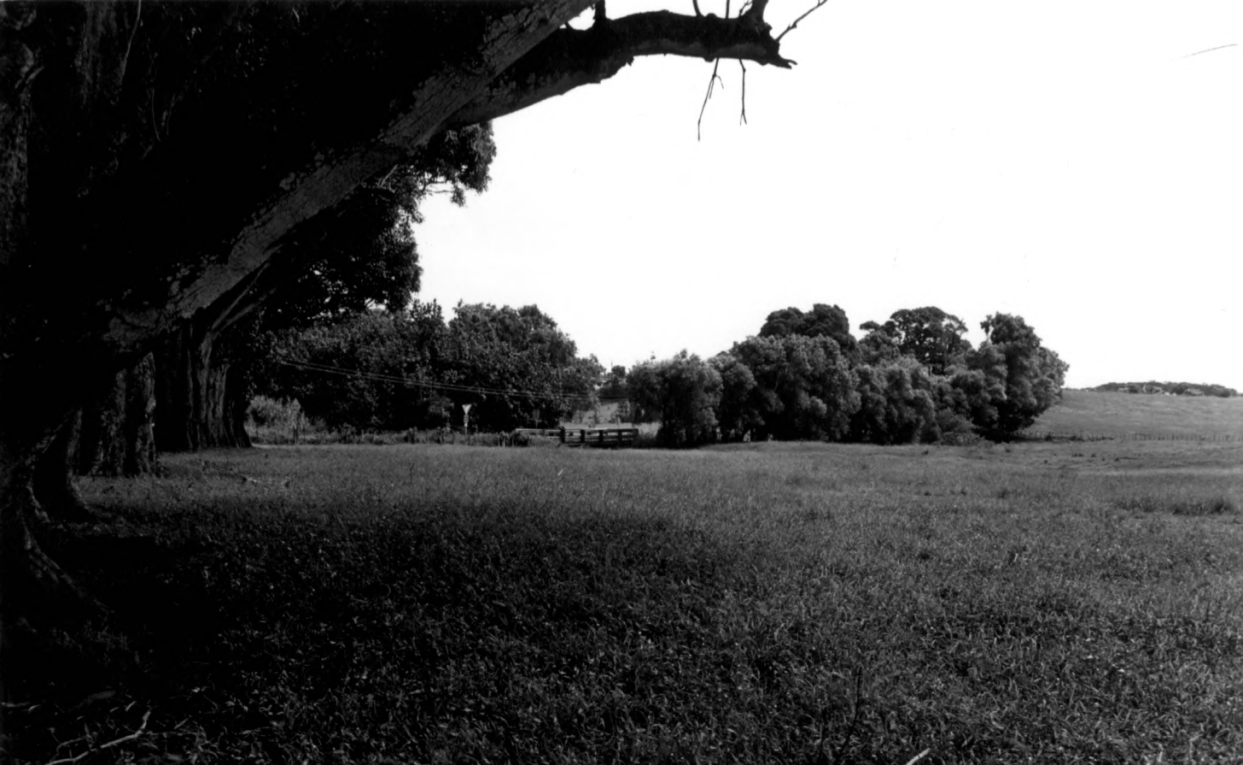
1.

VIEW OF BRIDGE FROM PASTURE, NEAR FENCE LINE, ALONG ROAD
TO SOUTHEAST OF BRIDGE

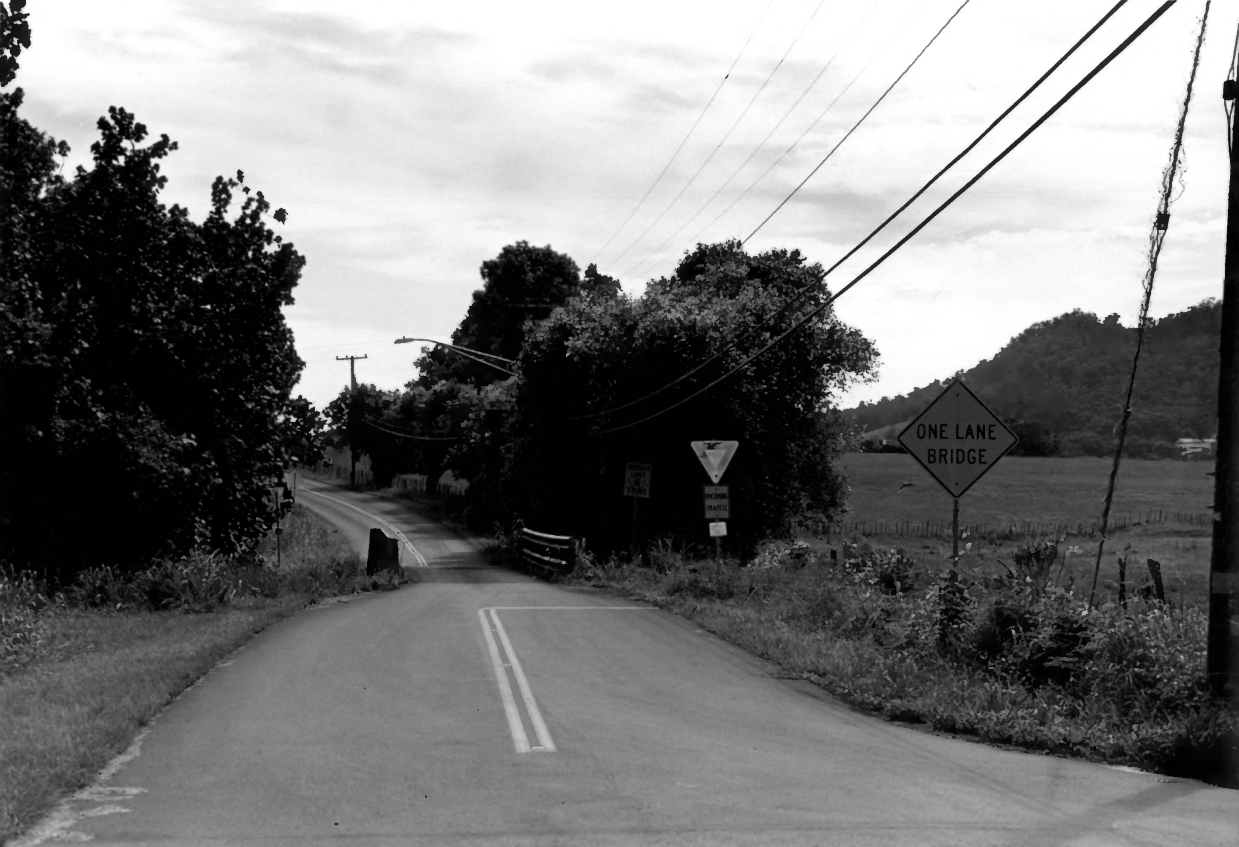
2.

PU'U'ŌPAE BRIDGE, KAUAI COUNTY, HAWAII
BY PAT L. GRIFFIN 8-13-04, NEGS HELD BY PHOTOGRAPHER
VIEW OF BRIDGE FROM INTERSECTION OF KALAMA AND
PU'U'ŌPAE ROADS

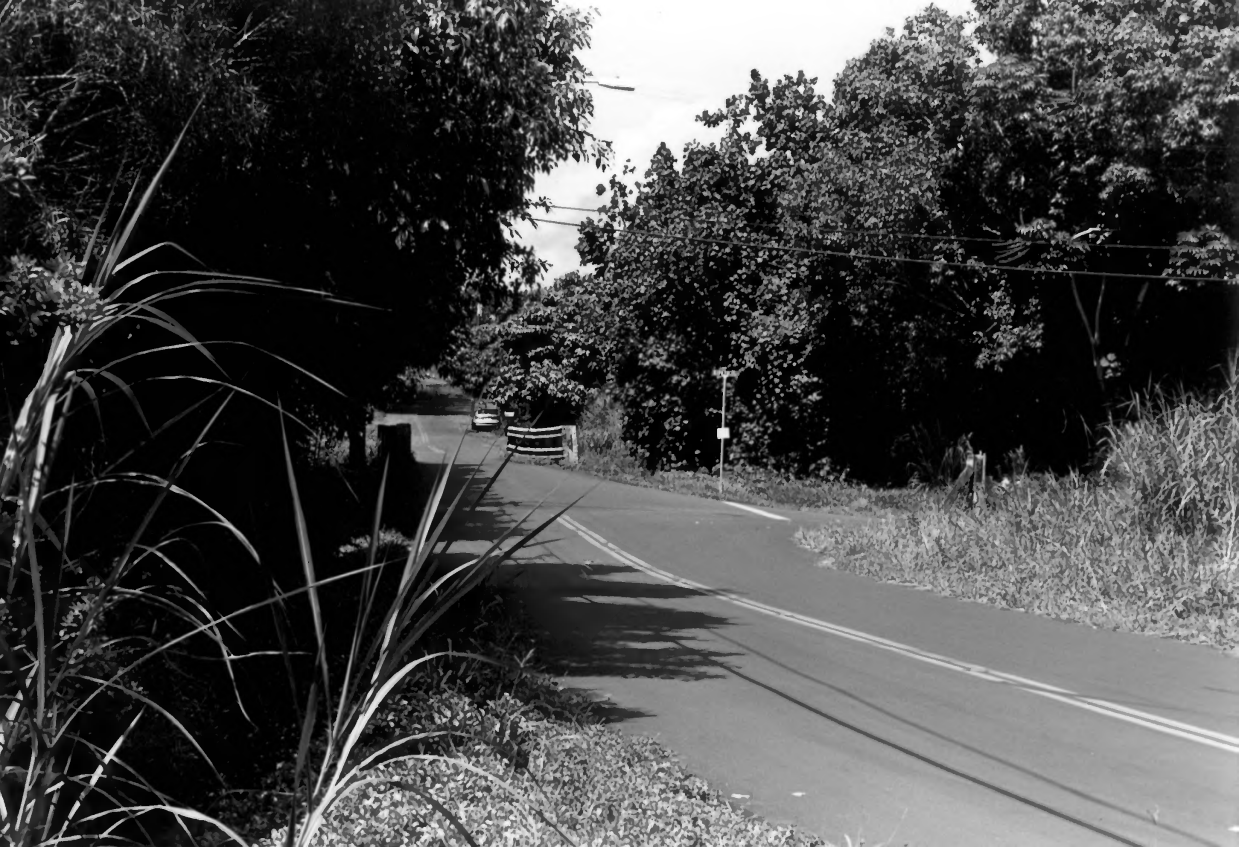
3.

HU'OPAE BRIDGE, KAUAI COUNTY, HAWAII
BY PAT GRIFFIN, B.13.04, NEGS HELD BY PHOTOGRAPHER
VIEW OF BRIDGE FROM NE, LOOKING TOWARD
KALAMA RD (KIPAPA RD AT RIGHT, BEFORE
BRIDGE)

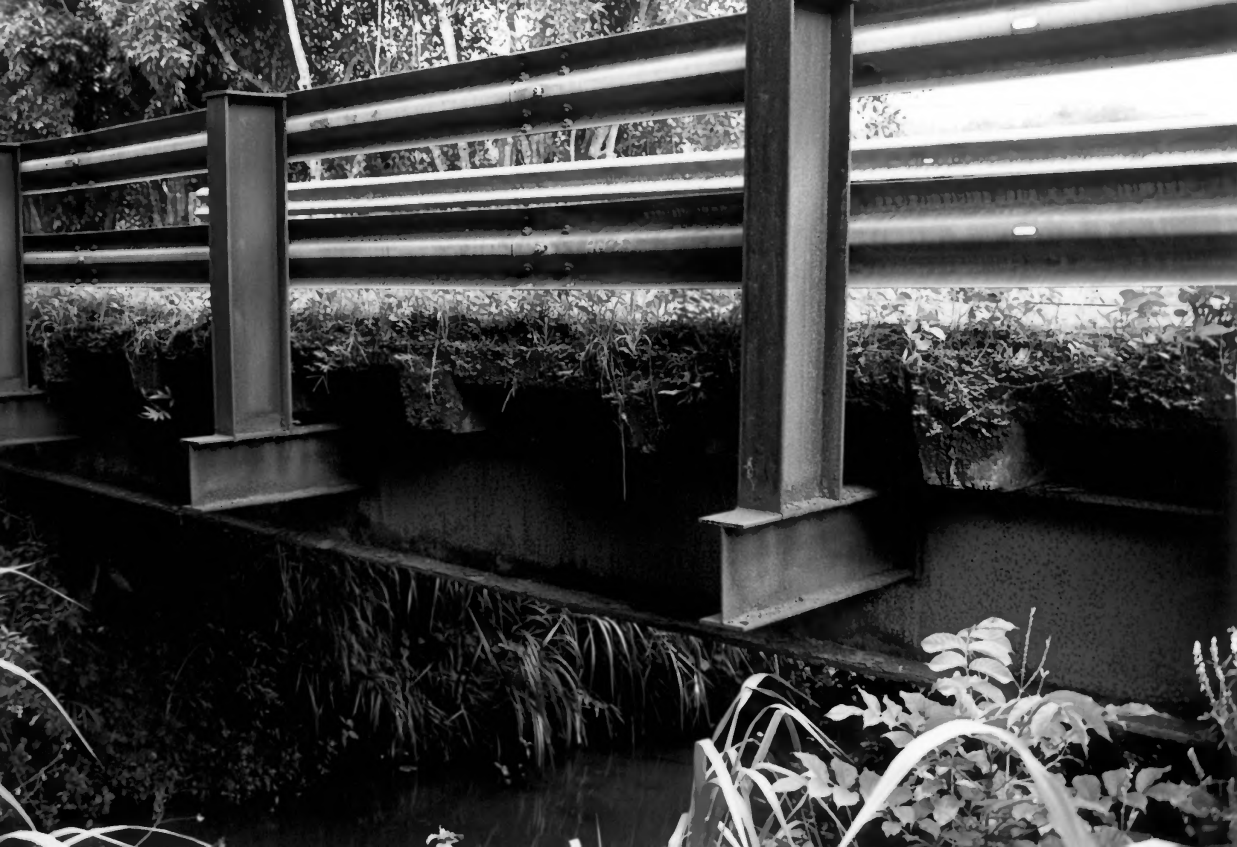
4.
PU'U'ŌPAE, KAUAI COUNTY, HAWAII
BY PAT GRIFFIN, 8.13.04, NEGS HELD BY PHOTOGRAPHER
WEST SIDE OF BRIDGE SHOWING NEW RAILINGS,
ORIGINAL CONCRETE-ENCASED STEEL GIRDER
FLOORING, AND SUPPORTING I-BEAMS INSTALLED
IN 1958

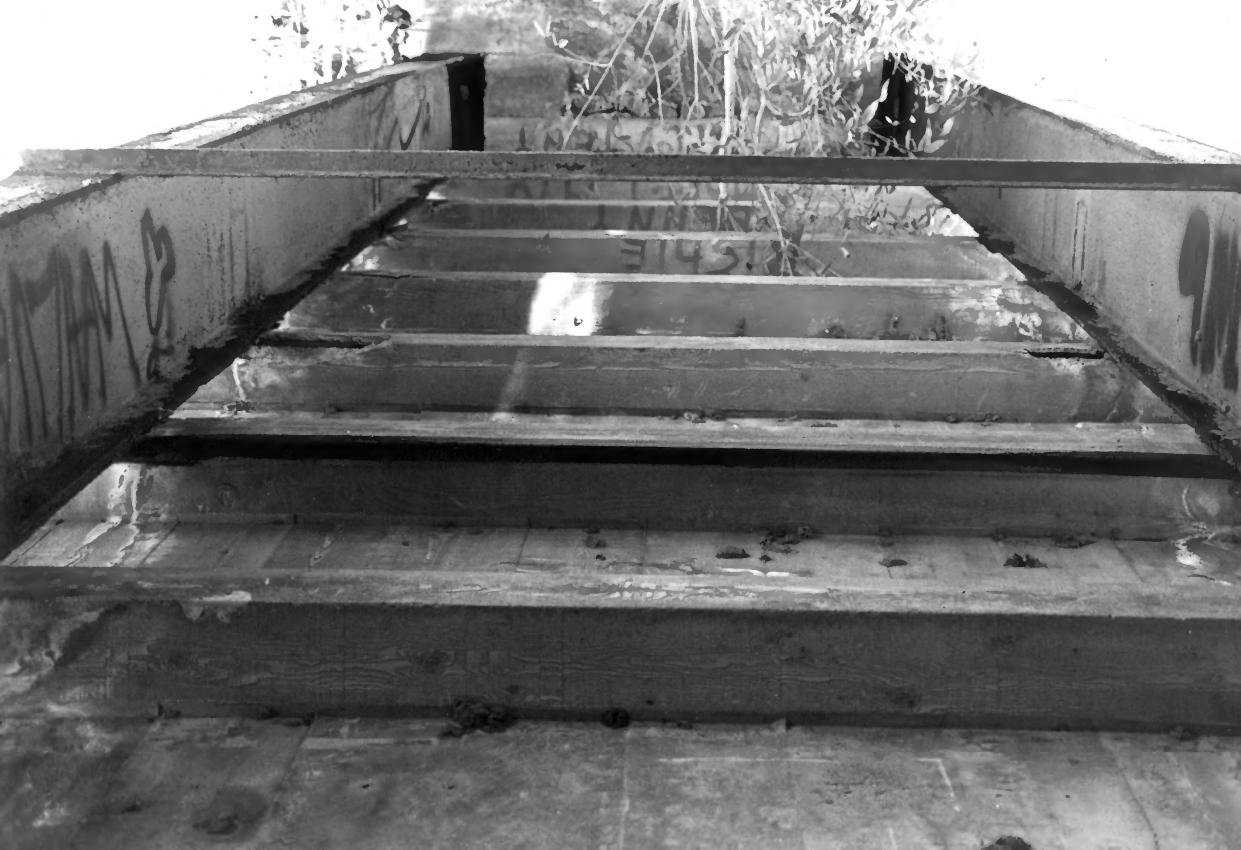
5.
PU'U'ŌPAE BRIDGE, KAHALA COUNTY, HAWAII
PAT GRIFFIN, 8-13-04, NEGS HELD BY PHOTOGRAPHER
FLOORING, I-BEAMS, AND PARTIAL VIEW
OF ORIGINAL ROCK ABUTMENT

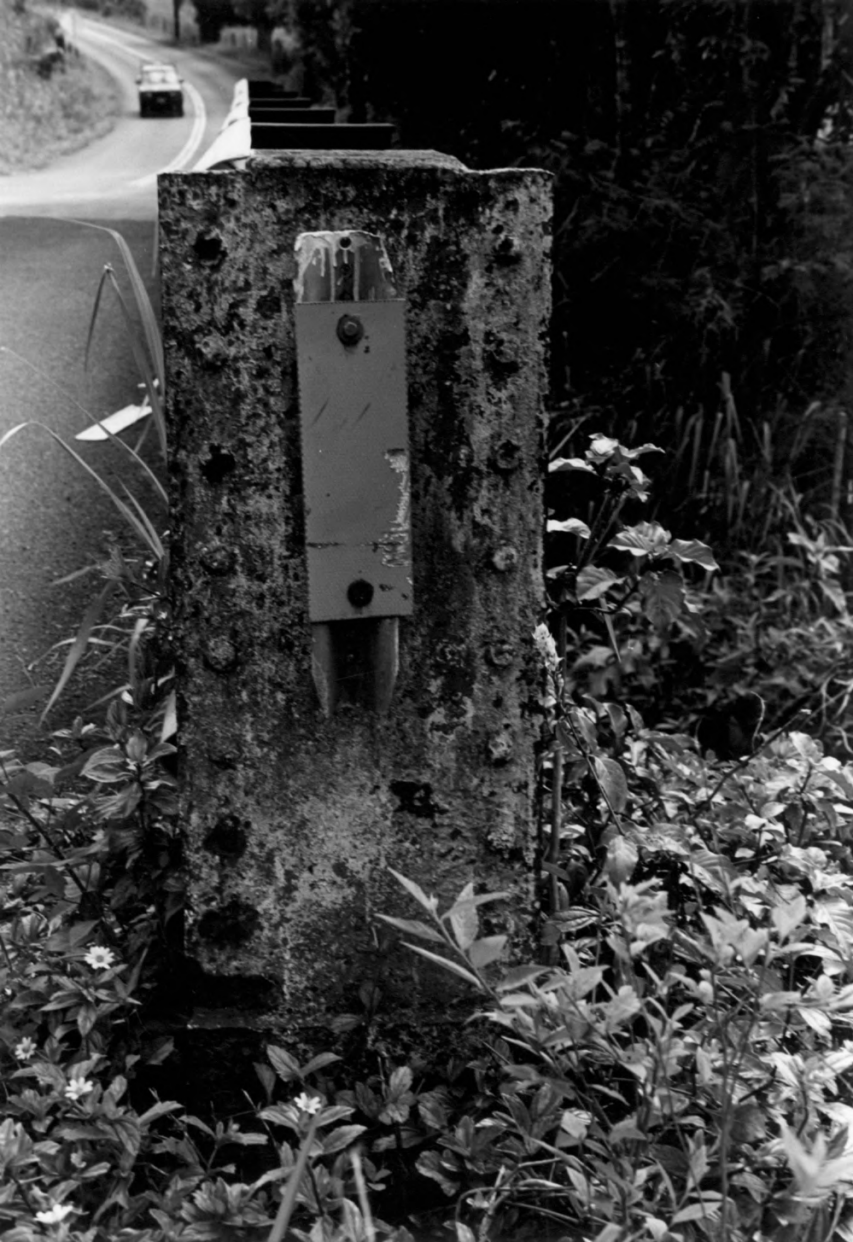
6.

PU'U'ŪPAE BRIDGE, KAUAI COUNTY, HAWAII
PAT GRIFFIN, B. 13. 04, NEGS HELD BY PHOTOGRAPHER
ENDPOSTS, PROBABLY FROM RECYCLED PARTS
OF DISMANTLED 19th CENTURY WAILUA
RIVER BRIDGE
