**NATIONAL REGISTER OF HISTORIC PLACES
REGISTRATION FORM**

historic name Hart, Moses and Mary, Stone House and Ranch Complex

Section number 7 **Page** 1 **Moses and Mary Hart Stone House and Ranch Complex
Westfall, Malheur County, Oregon**

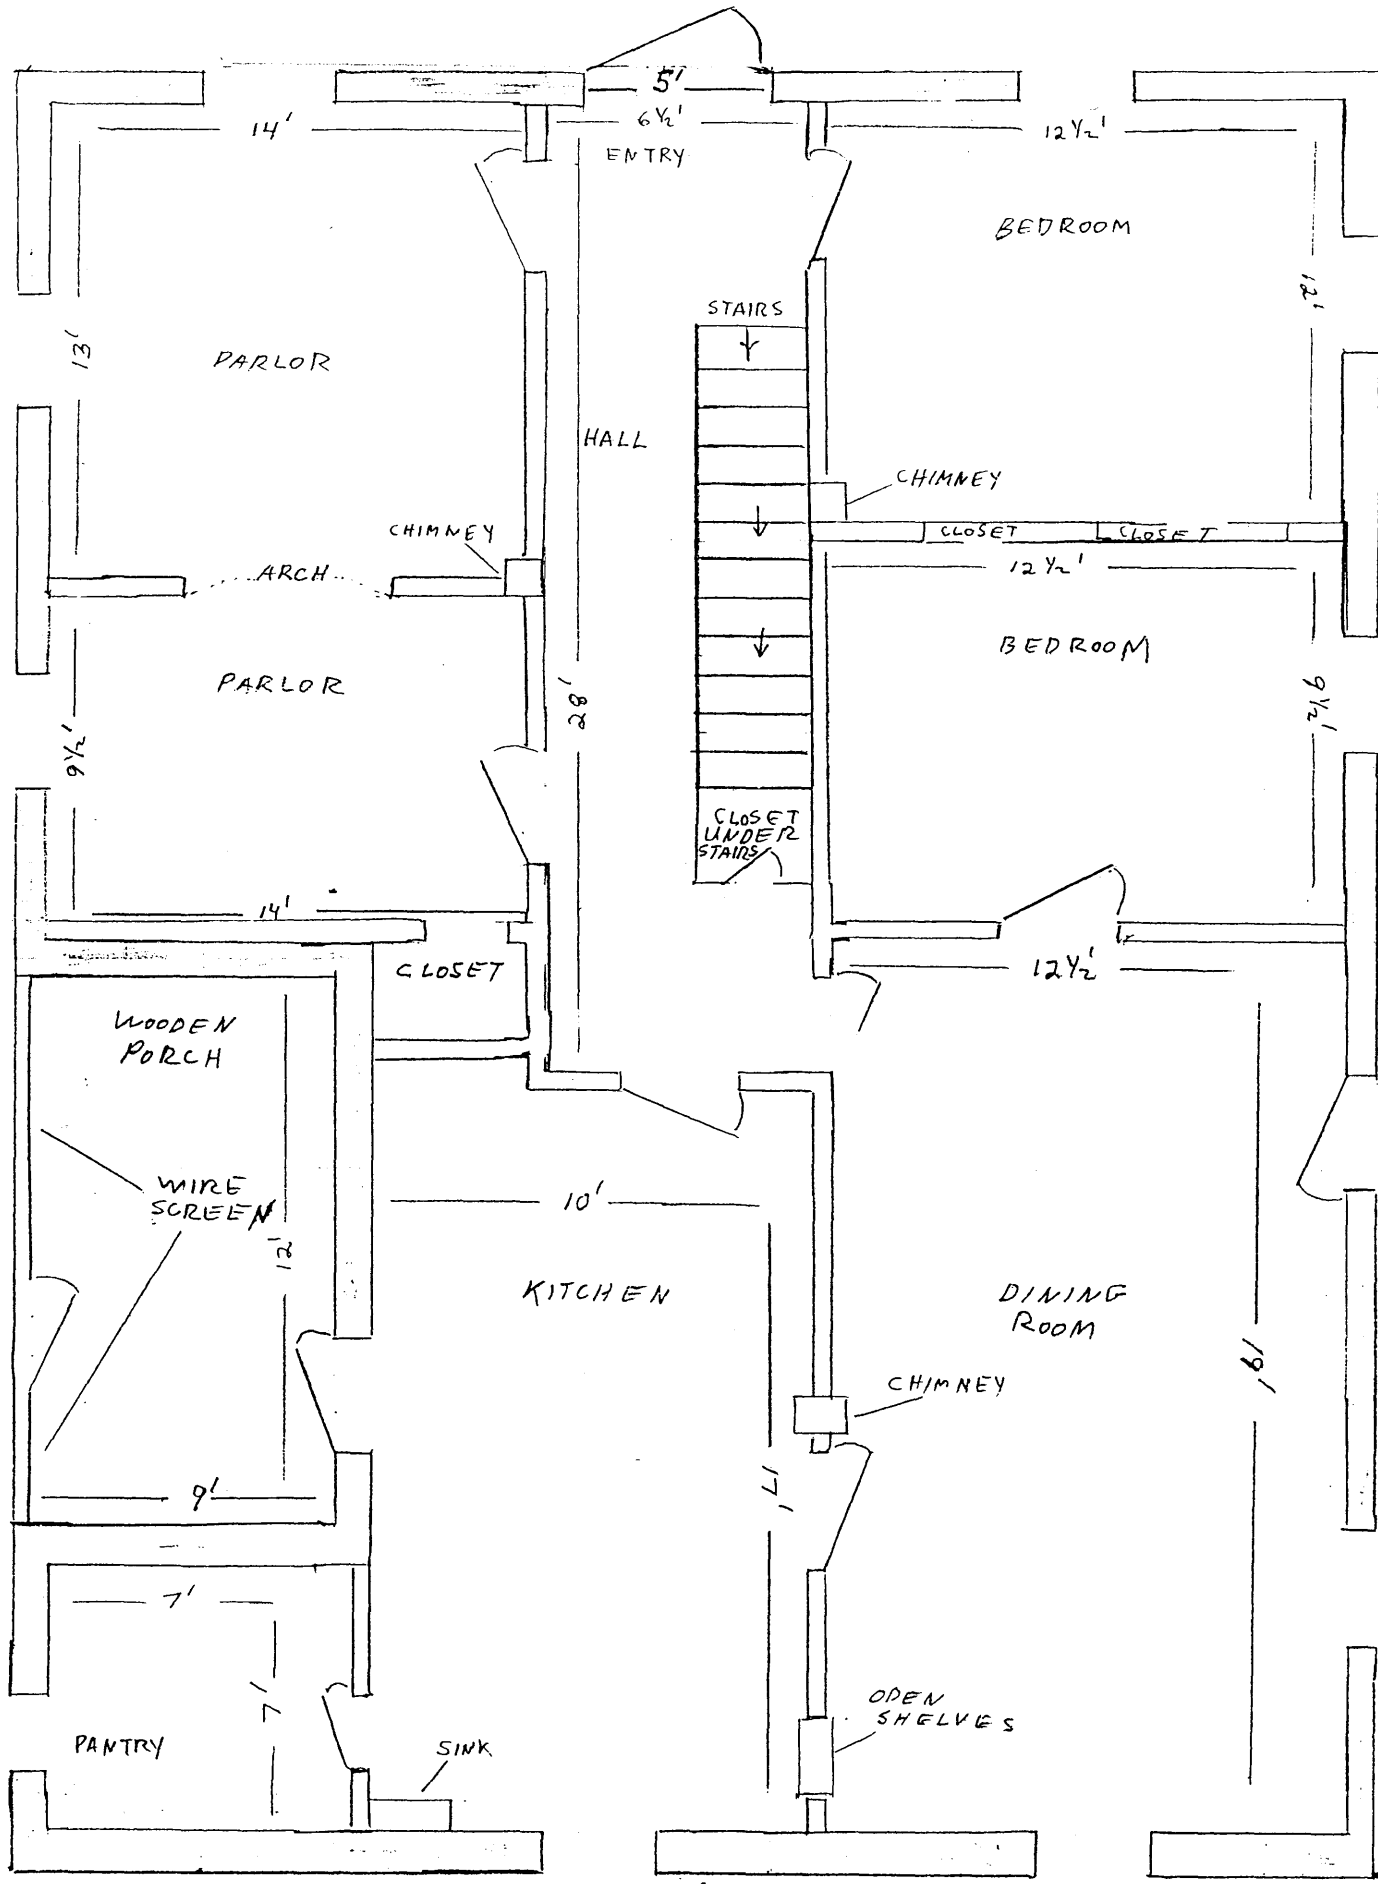
N
FIRST FLOOR

SCALE 1"=5 FEET

On the first floor, the bridging floor joists are supported by basalt masonry about one foot above grade. There is no basement. No sub-flooring is noted in areas permitting examination. Tongue and groove fir flooring is utilized throughout the first and second floors. The stairs are single return with an intermediate landing. The first floor interior includes two bedrooms, a parlor, hallway, dining room, kitchen, pantry, and wire screened wood porch. The interior walls are wood lathe/plaster. The dining room walls utilize wood wainscot facing. The kitchen has a sink with a drain. There is no indoor plumbing.

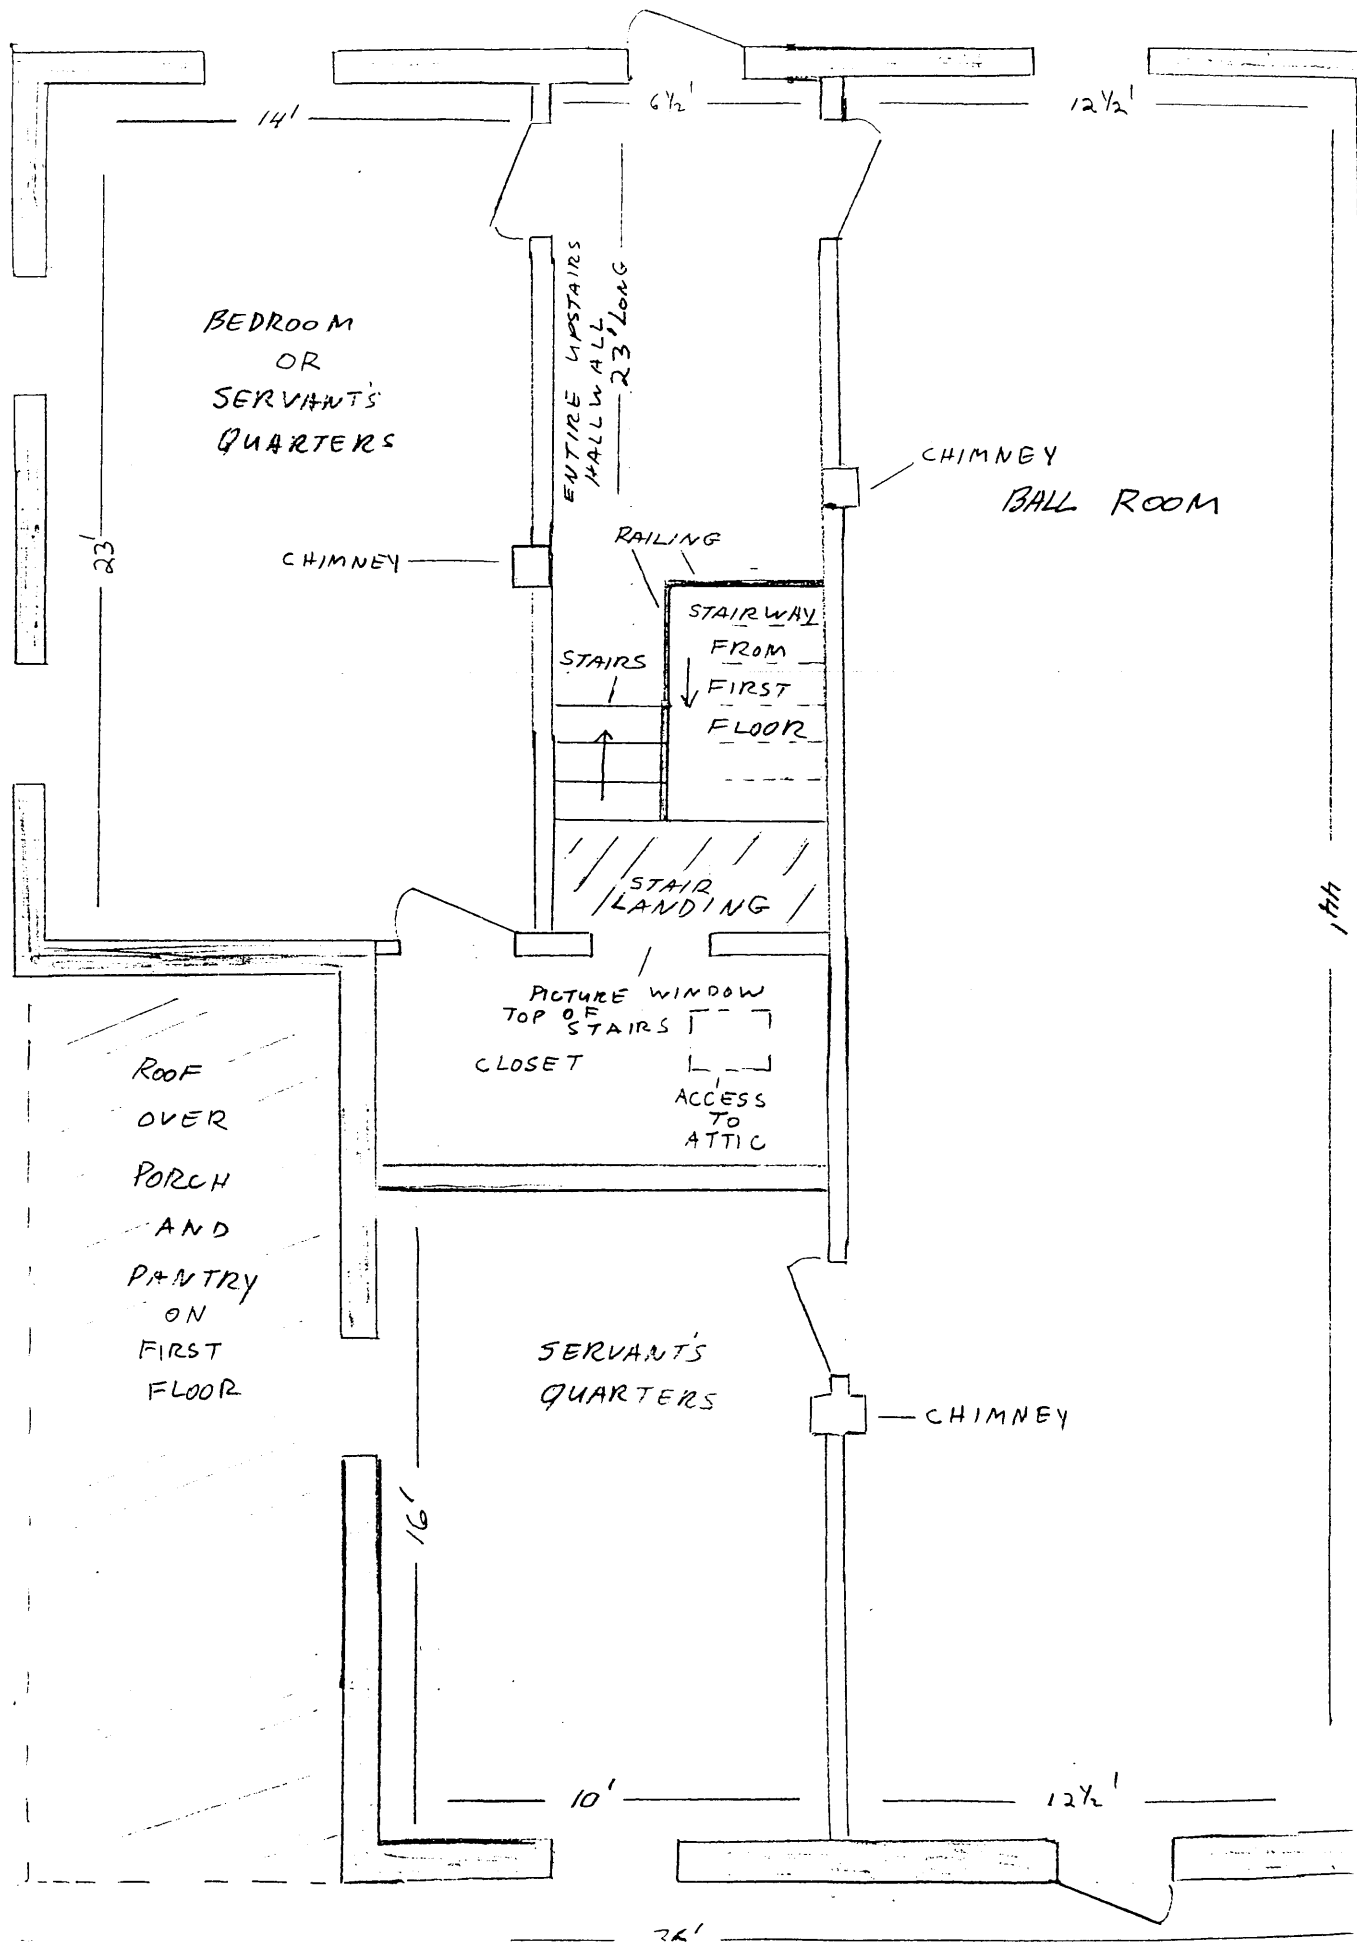
BEDROOM
OR
SERVANTS'
QUARTERS

CHIMNEY

A ballroom, two rooms reported to be servant's quarters, and a hallway are present on the second floor.

The chimney at the southwest area of the house rises vertically for two floors, then in the attic the brickwork laid at a forty-five degree angle, rises northeastward, and is supported by wooden beams. As this chimney reaches the roof crest, it rises vertically again. The chimney in the southeast part of the house rises vertically for two floors, then in the attic area, without external support bracing, angulates in corkscrew fashion, rising in a northeastward direction to reach the roof crest, then rises vertically again. The third chimney, in the northeastern part of the house appears to rise vertically throughout, to the roof crest. No fireplaces are in the house. The wood stoves that heated the rooms are missing.
