**National Register of Historic Places
Inventory—Nomination Form**

historic Meadow Brook Farm (preferred)

CARR-391

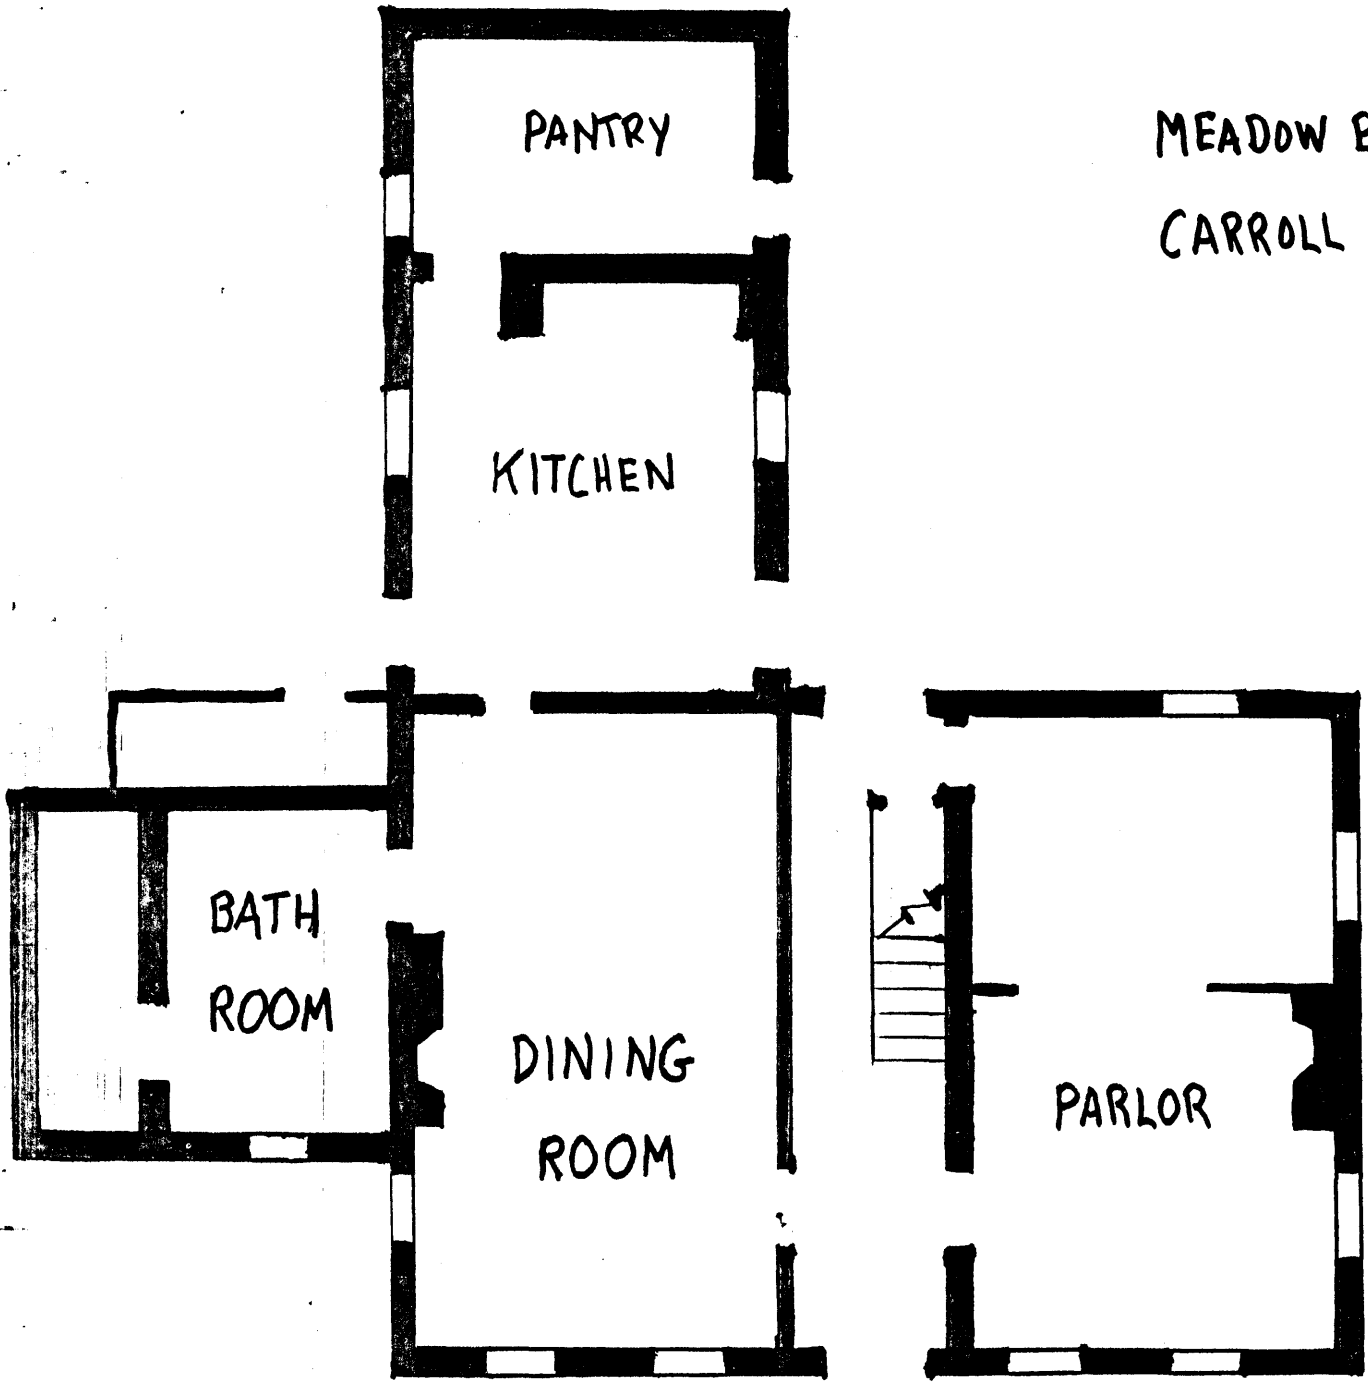
First Floor Plan
Not to Scale

The interior of the house contains a central stair hall with a three-room arrangement of the L-shaped plan. There is a parlor on the east side of the stair hall, a dining room on the west side of the stair hall, and a kitchen in the ell. The two additions, the bathhouse on the west side of the dining room and the pantry at the rear of the ell, provide service uses to the main house. The interior

The plan of the house and arrangement of farm buildings are also representative of this region's heritage. The house has an L-shaped plan with a two-bay long ell that has a double-tiered porch on the inner side. The ell housed the kitchen while the front two rooms were more formal separated by a central stair hall. The house-related outbuildings are arranged in a straight line on the west side of the house, close to the kitchen ell. The farm outbuildings are located on the northeast side of the house.

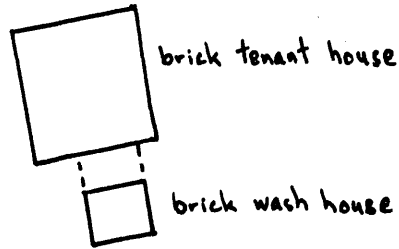
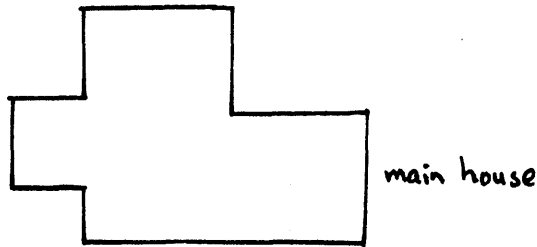
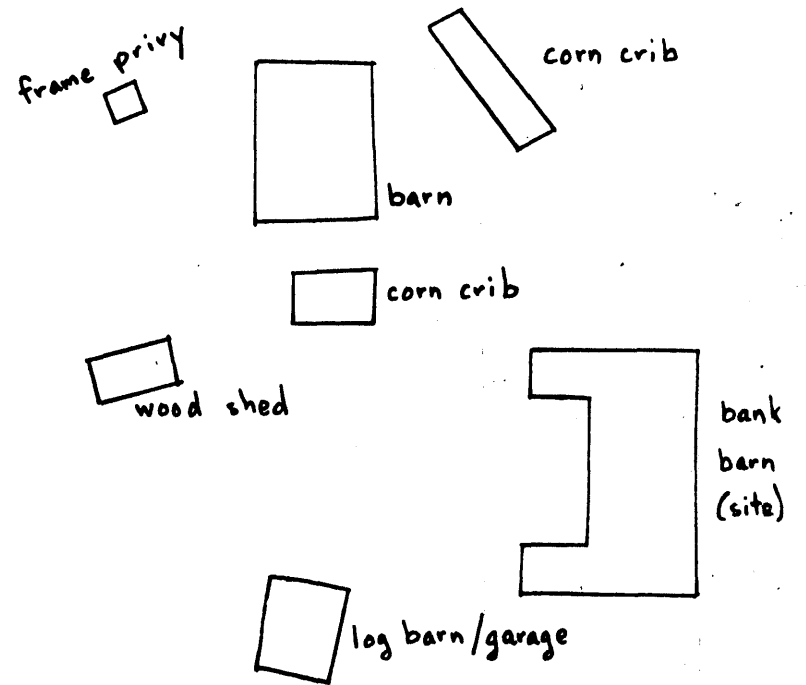
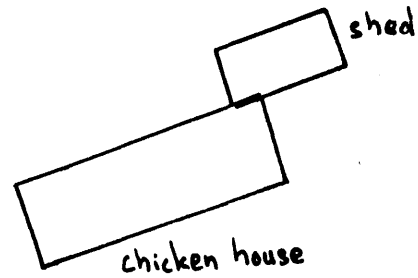
Site Plan
not to scale

brick wash house

brick smoke house

The property includes several significant outbuildings. On the west side of the main house is a row of outbuildings that includes a smokehouse, washhouse and privy. The smokehouse is a square-shaped brick structure with a hipped roof. Its entrance is on the east side of the structure where it has a batten door and hasp. The other three facades are unfenestrated but have a single slit opening. Inside the smokehouse is a small brick firestand and a central revolving post with arms which could be described as a "meat tree."

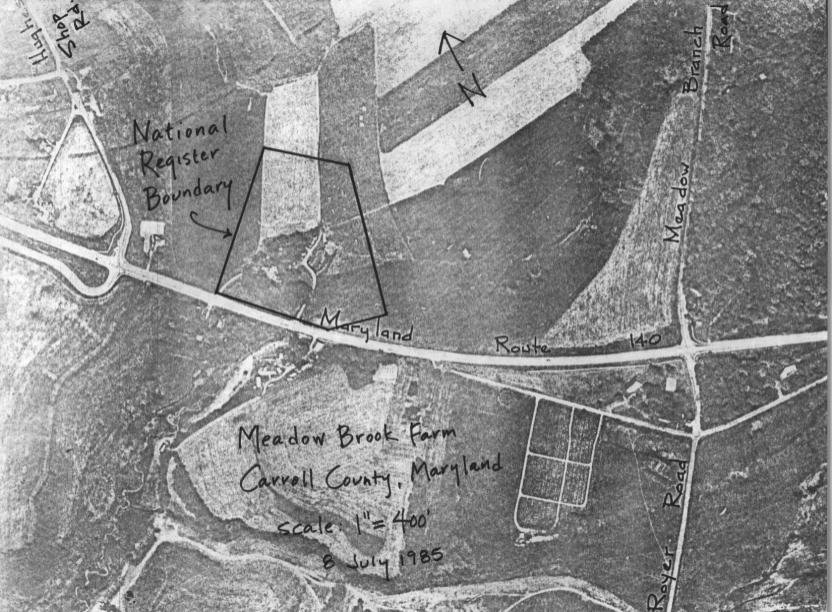
Meadow Brook Farm
Carroll County, Maryland

National
Register
Boundary

Scale: 1" = 400'

Beginning at a point on the western edge of the driveway to the property at its intersection with Maryland Route 140 (Taneytown Pike), and traveling northeast perpendicular to Taneytown Pike a distance of 800'; thence turning 83° and traveling southeast approximately 450' to the bed of a stream; thence turning 65° south and following the stream bed approximately 800' to its confluence with Meadow Branch; thence turning 90° west and following Meadow Branch 300' to its crossing of Maryland Route 140; thence turning 40° north-west and following the right-of-way of Maryland Route 140 600' to the point of beginning. Boundaries are depicted on the attached aerial photograph at a scale of 1"=400'.

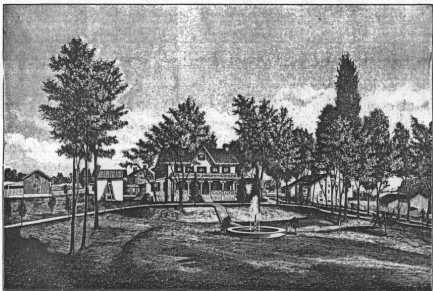
Illustration of MEADOW BROOK FARM, CARR-391

RESIDENCE OF SAMUEL ROOP, WESTMINSTER, GARROLL CO., MD.
