KENTUCKY HISTORIC RESOURCES  
Individual Inventory Form

Resource # 76  
Shelby County

1. Name of Resource: John Edward Crockett House		16. Date: Original Building 1848-50 [ 6 ] Addition ca. 1940 [ 3 ]	
2. Original Owner: John Edward Crockett		17. Style: Greek Revival [ 31 ]

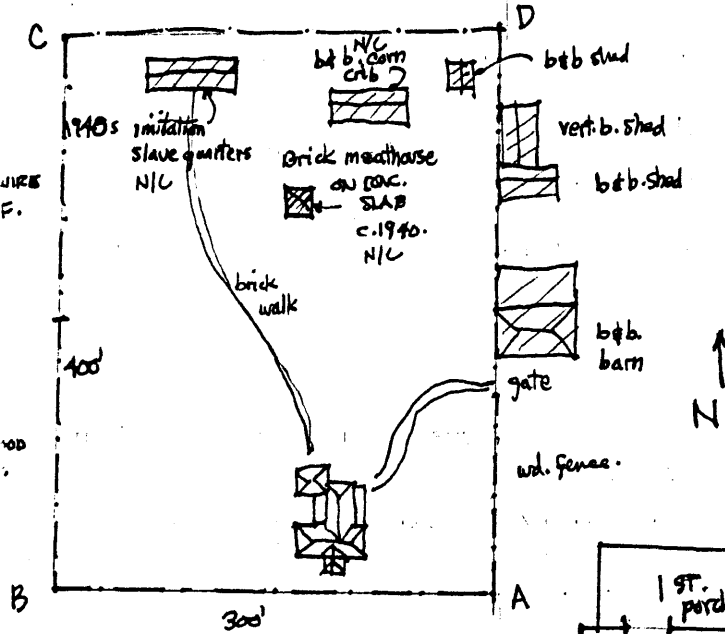
44. Site Plan (and boundary description and justification for N.R. sites):

Beginning at a point of intersection of two fences in the southeast corner of the yard (A) that is 80 feet east southeast of the southeastern corner of the house, 300 feet westward along the southern yard fence to its intersection with another fence (B); then 400 feet northward along west yard fence to its intersection with another fence (C); then 300 feet eastward along rear (northern) yard fence to its intersection with another fence (D); then 400 feet southward along east yard fence and western edges of sheds and barn to point of origin.

The boundaries were chosen to encompass the domestic related space as enclosed by fences. Although the four outbuildings within the area are modern and non-contributing, they occupy the location of earlier outbuildings and are incorporated within these boundaries to preserve their relationships to the house.

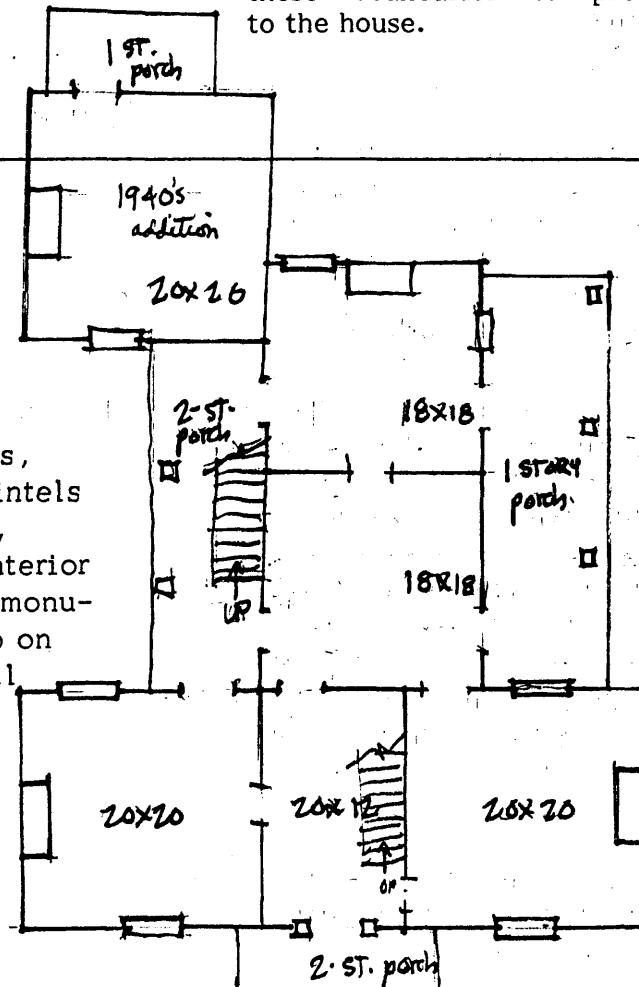
45. Description and House Plan:

2-story, 3-bay, brick, center-passage, single-pile plan, double-stretcher bond on principal (south) facade, pilasters divide bays, ashlar foundation, wooden lintels and sills, 6/6 sash, hipped, standing seam metal roof, interior end chimneys, deep frieze, monumental Greek Revival portico on tapering wood posts, original balcony at second floor, transom and sidelights at both first and second floor doors, 1-story shed-roofed porch along east side of ell, 5-course advance brick cornice painted white on east

side of ell, 2-story porch along west side of ell abuts an extremely sensitive ca. 1940 kitchen addition which replicates scale, materials, and details of original section, including corner pilasters, deep frieze, and hipped roof, 1-story porch on rear of kitchen addition.

Spiral stair in passage, eared door surrounds with projecting cornices in passage, eared door and window surrounds in east and west rooms, high molded baseboards, ceiling lowered in west room, plain Greek Revival pilaster and shelf mantels, north room of ell has elaborate federal mantel on paired colonnettes with sunbursts possibly inserted in ca. 1940 restoration.
