# National Register of Historic Places Registration Form

Historic name Miller, Henry, House  
Other names/site number N/A  
Name of related Multiple Property Listing N/A

Street & number 106 Cape Road N/A not for publication  
City or town Bloomfield N/A vicinity  
State Missouri Code MO County Stoddard Code 099 Zip code 63825

The Henry Miller House, circa 1843, is a two story, side gabled, wood frame I house with a one-story ell creating an “L” shaped footprint. Located at 106 Cape Road, Bloomfield, Missouri, the house has a medium pitch asphalt shingle roof with an exterior chimney on the east elevation and five evenly spaced windows on the second level of the façade (north elevation). The first level of the façade has seven openings; five windows located directly below the windows on the second level, and a door located between the first two windows on both the east and west ends of the façade. The original wood windows and doors on both levels of the north elevation are intact behind the plywood coverings. The house was used as a residence continually from the time it was constructed until approximately 1979 and has been vacant ever since. An addition extending the original o

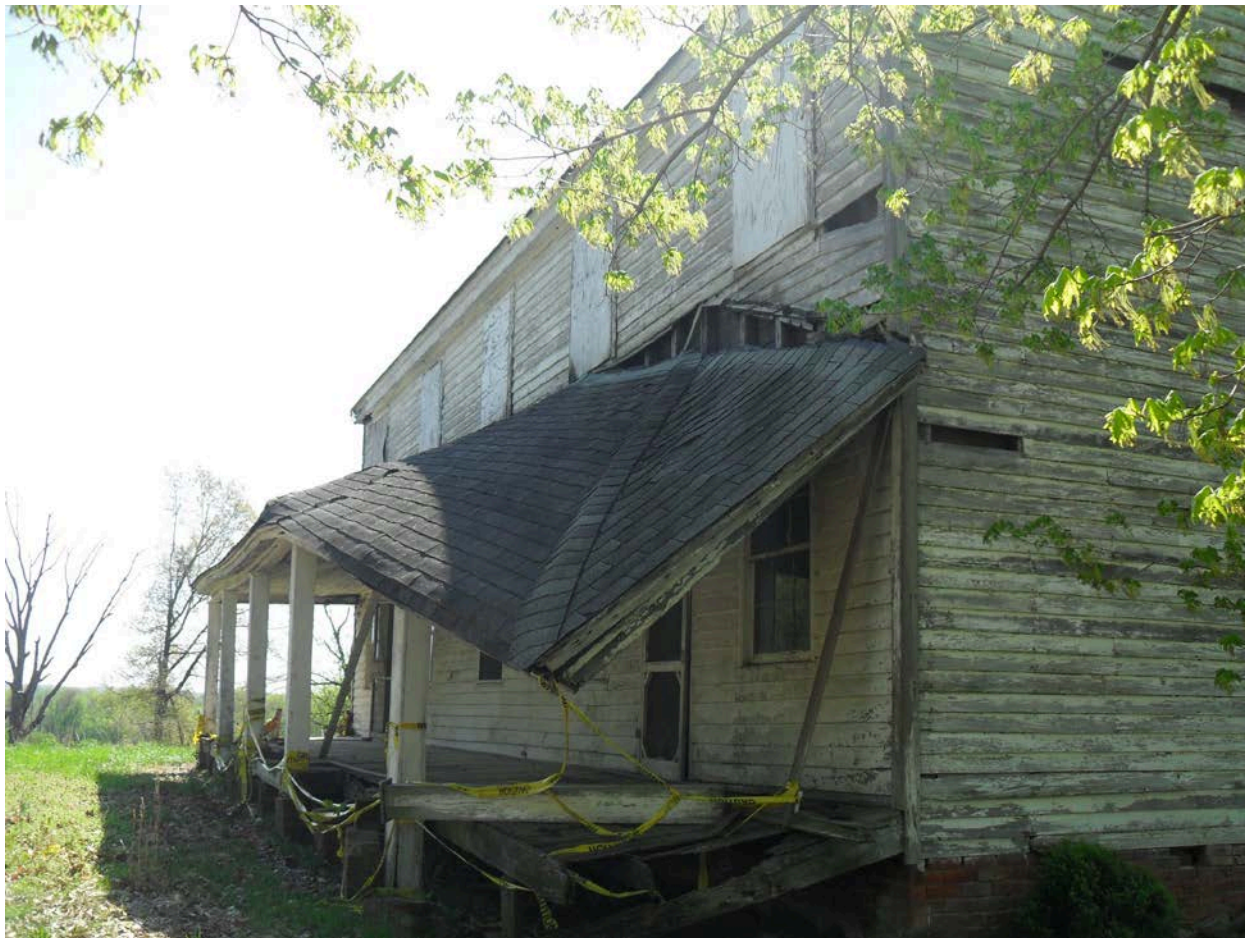
Figure 3

Henry Miller House, with front porch partially collapsed, April 2011

There are seven openings across the first level of the north façade (see photo 1). Five of the openings are six-over-six original wood sash windows and two original wood doors, one located at the eastern end and one located on the western end. On the second level of the façade, there are five window openings, containing original six-over-six wood sash windows. Currently, all façade openings are covered with plywood (see photo 8). Originally, a porch ran across the length of the north façade of the house with a small set of stairs at the eastern end. The porch rested on masonry piers constructed of modern brick with Portland cement mortar, likely added during changes to the foundation which occurred in the 1950s. The remainder of the porch was wood with a hipped roof supported by simple square pillars. The porch was removed in 2012 after the western end collapsed due to significant moisture damage (see Figures 3 and 4).<sup>2</sup>

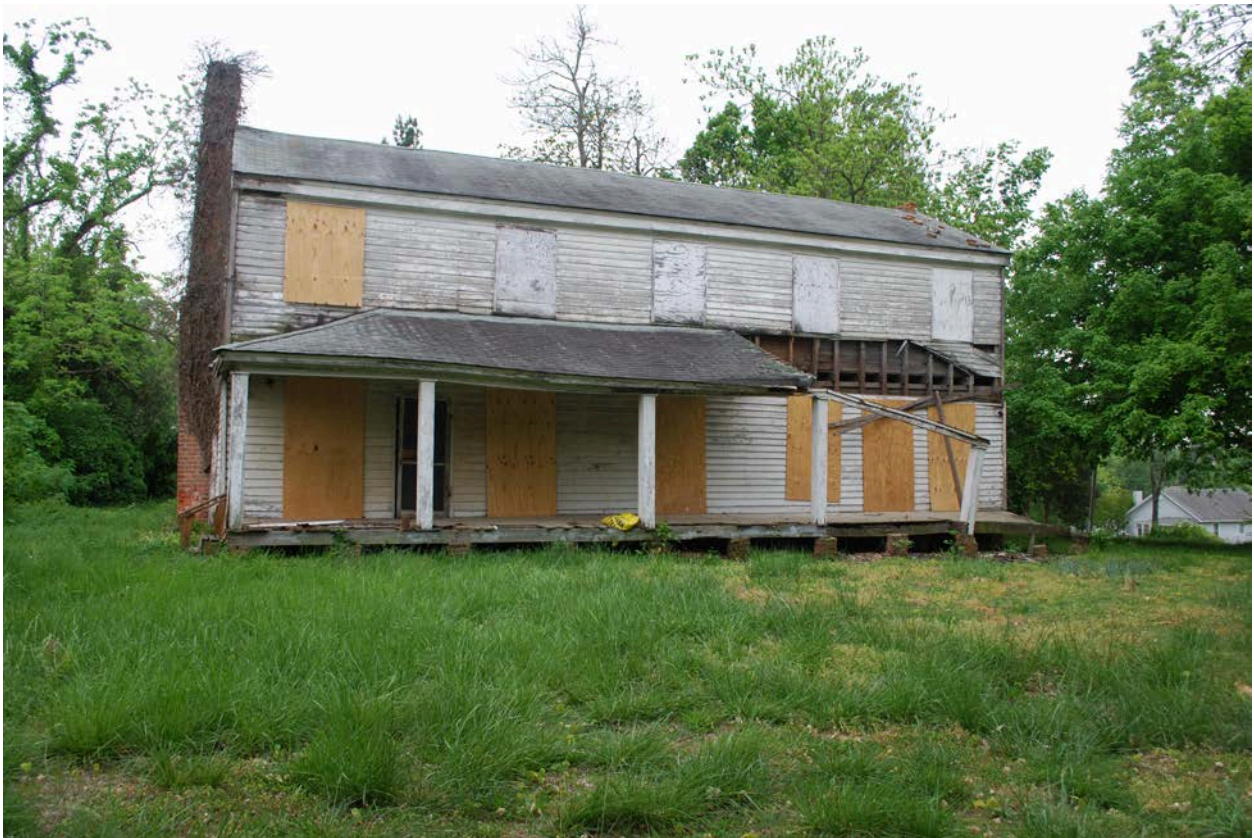
Figure 4

Henry Miller House, with front porch partially intact, April 2012

foundation has eroded in some locations and there are missing bricks. The front porch was removed in 2012 after the western end collapsed, threatening the house's façade. The back porch remains intact, however, the brick masonry piers and the wood pillars are in significant disrepair (see photo 6).

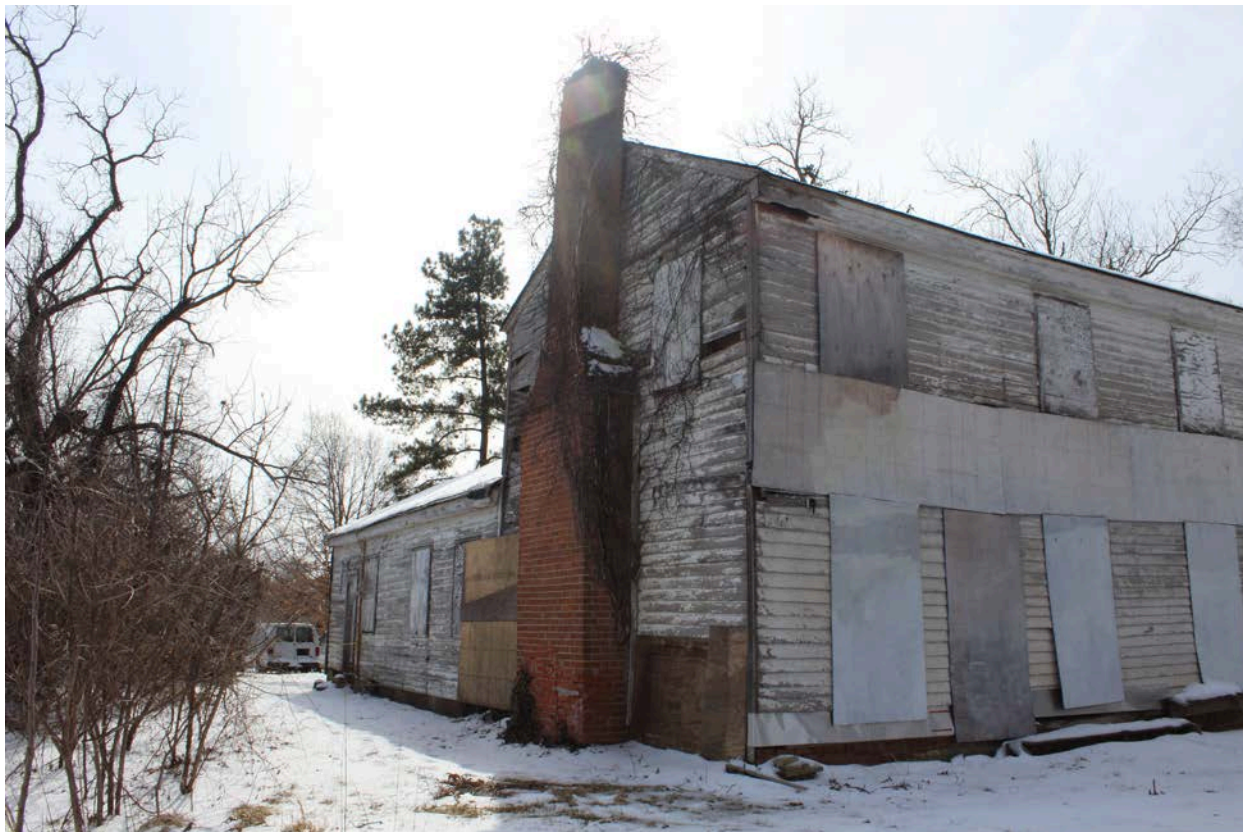
Figure 5

Henry Miller House, eastern elevation, February 2014

An external chimney is located on the eastern elevation of the main house (see photo 1 and Figure 5). There are three openings on the eastern elevation of the main house. One is located on the first floor on the south side of the chimney, and two are located on the second floor on either side of the chimney. Plywood currently covers the openings, but the original six-over-six wood sash window frames remain underneath. The eastern elevation of the ell is flush with the east elevation of the front portion of the home. The eastern elevation of the ell portion of the house contains four openings including three historic wood six-over-six sash windows, covered with plywood, on the north end of the elevation and a historic wood door on the south end.

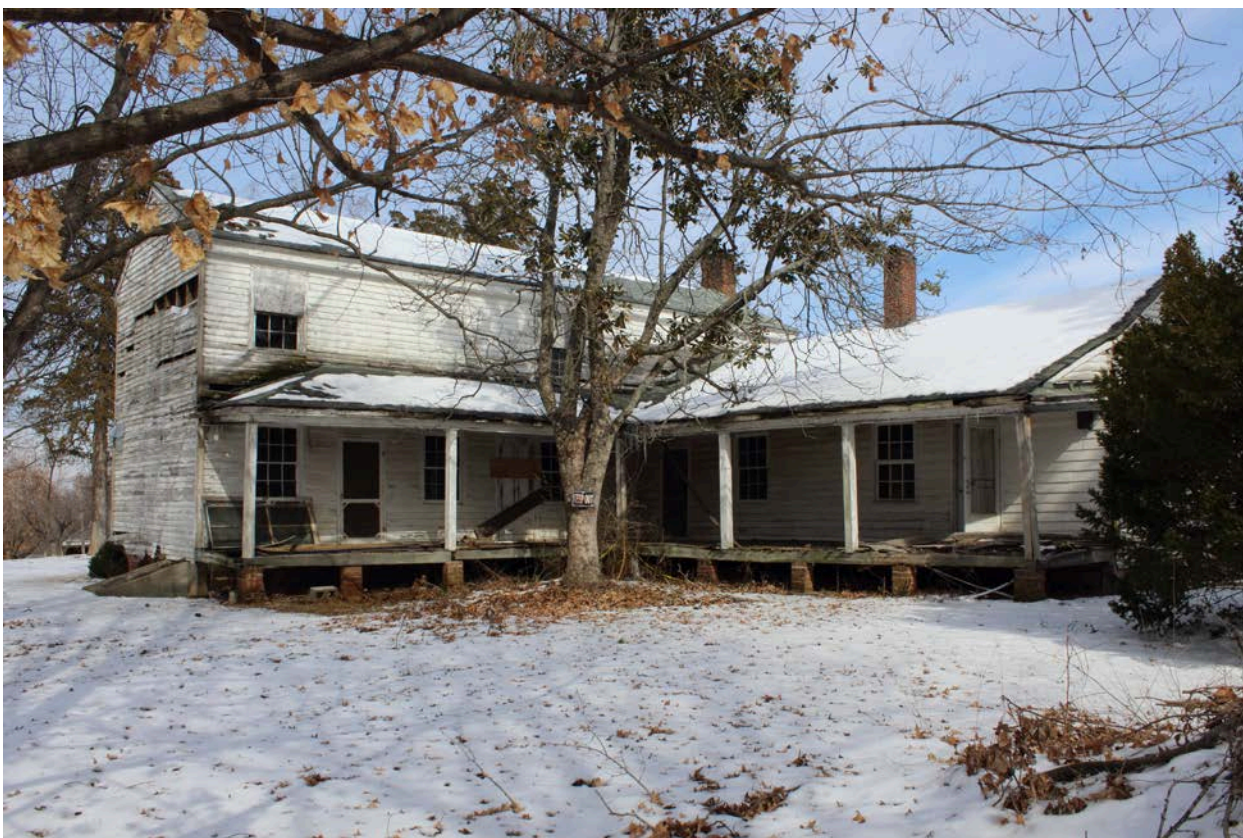
Figure 6

Henry Miller House, west and south elevations, February 2014

The western elevation of the main portion of the house contains no openings (see photo 2 and Figure 6). Evidence on the interior wall suggests an exterior chimney was likely located on this elevation as well, but it was removed at an unknown date (see photo 3). The 1910s remodeling is a likely alteration date because the exterior wood clapboard siding installed at that time is continuous across the western elevation<sup>3</sup>. Also located on the western elevation is a modern 1950s era Portland concrete entrance to a historic brick cellar (see photos 2 and 12).

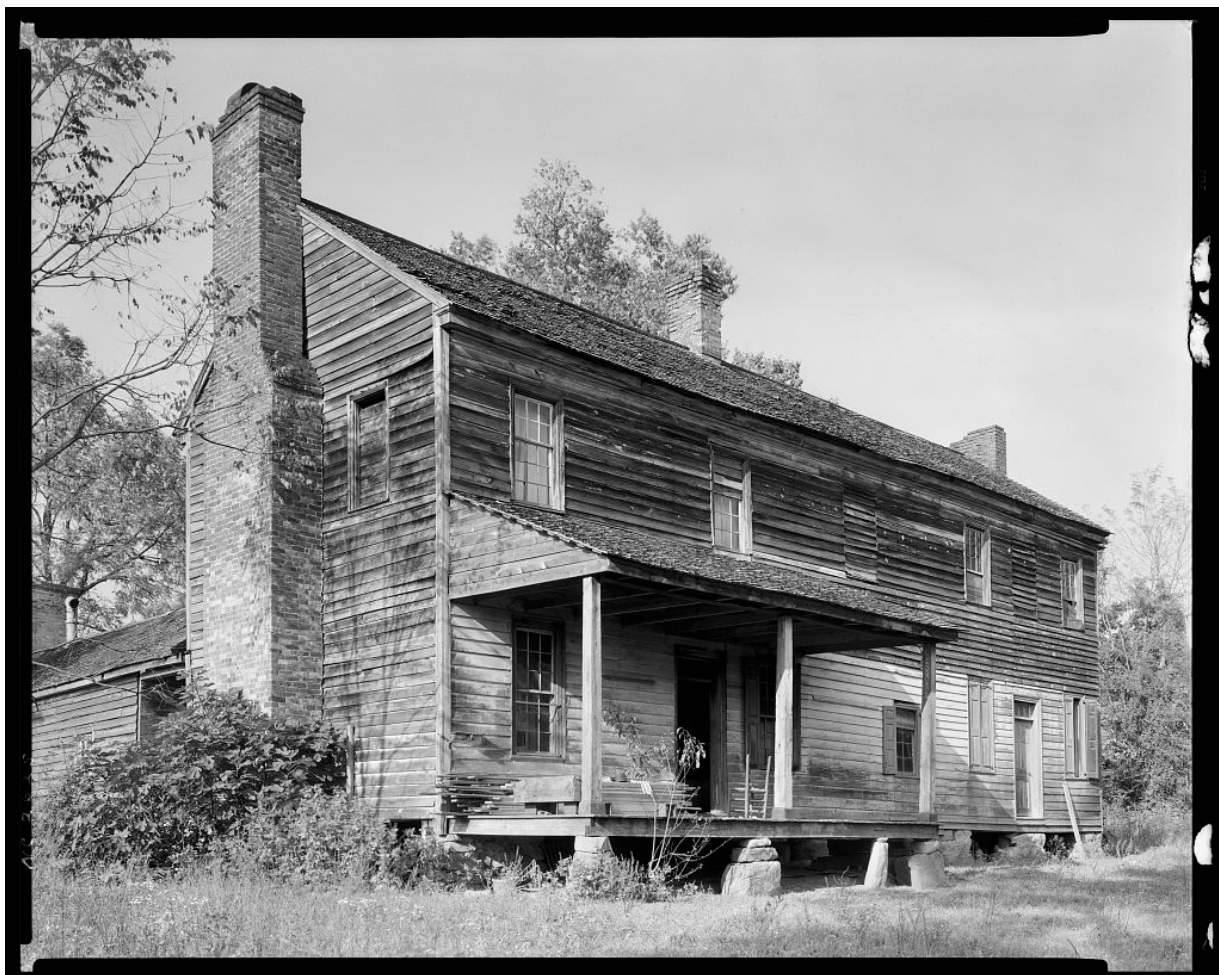
Figure 7

Vesuvius Furnace, HABS Photo, 1938

The Miller House bears a striking resemblance to Vesuvius Furnace, a house built nearly fifty years earlier in the region from which the Millers migrated. Several years prior to the Miller's departure from North Carolina General Joseph Graham constructed a prominent home in Lincoln County. General Graham began construction of the house in 1792, and is believed to have constructed the home in two sections. When completed it was an impressive structure, with many characteristics of the I house form.<sup>31</sup> Like the Miller House, though, Vesuvius Furnace has two doorways on either end of the façade and the fenestration pattern on the façade is similar (See Figure 7). Vesuvius Furnace is also dissimilar to other I houses because it does not have a central doorway, much like the Miller House. Originally Vesuvius Furnace had a porch similar to the one on the Miller House, but it was replaced in the 1950s by a two story, Mt. Vernon Style veranda porch (See Figure 8).<sup>32</sup>

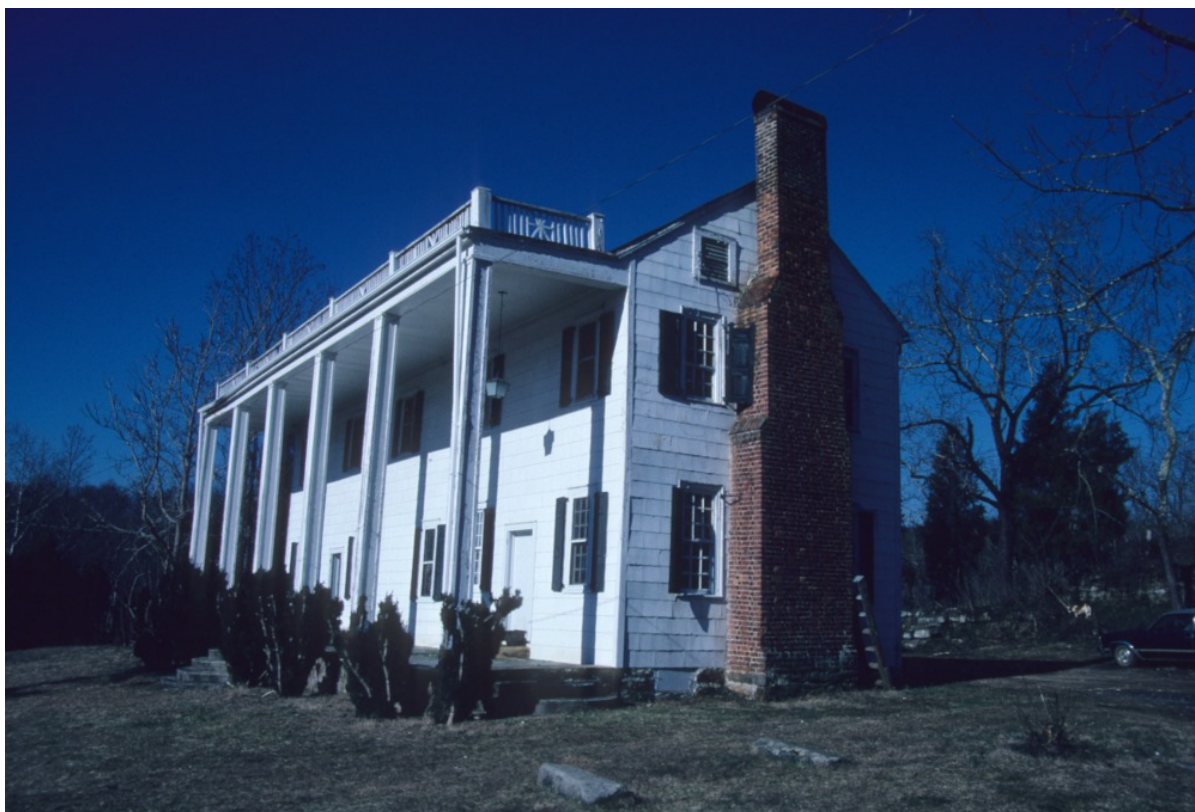
Figure 8

Vesuvius Furnace, 1988

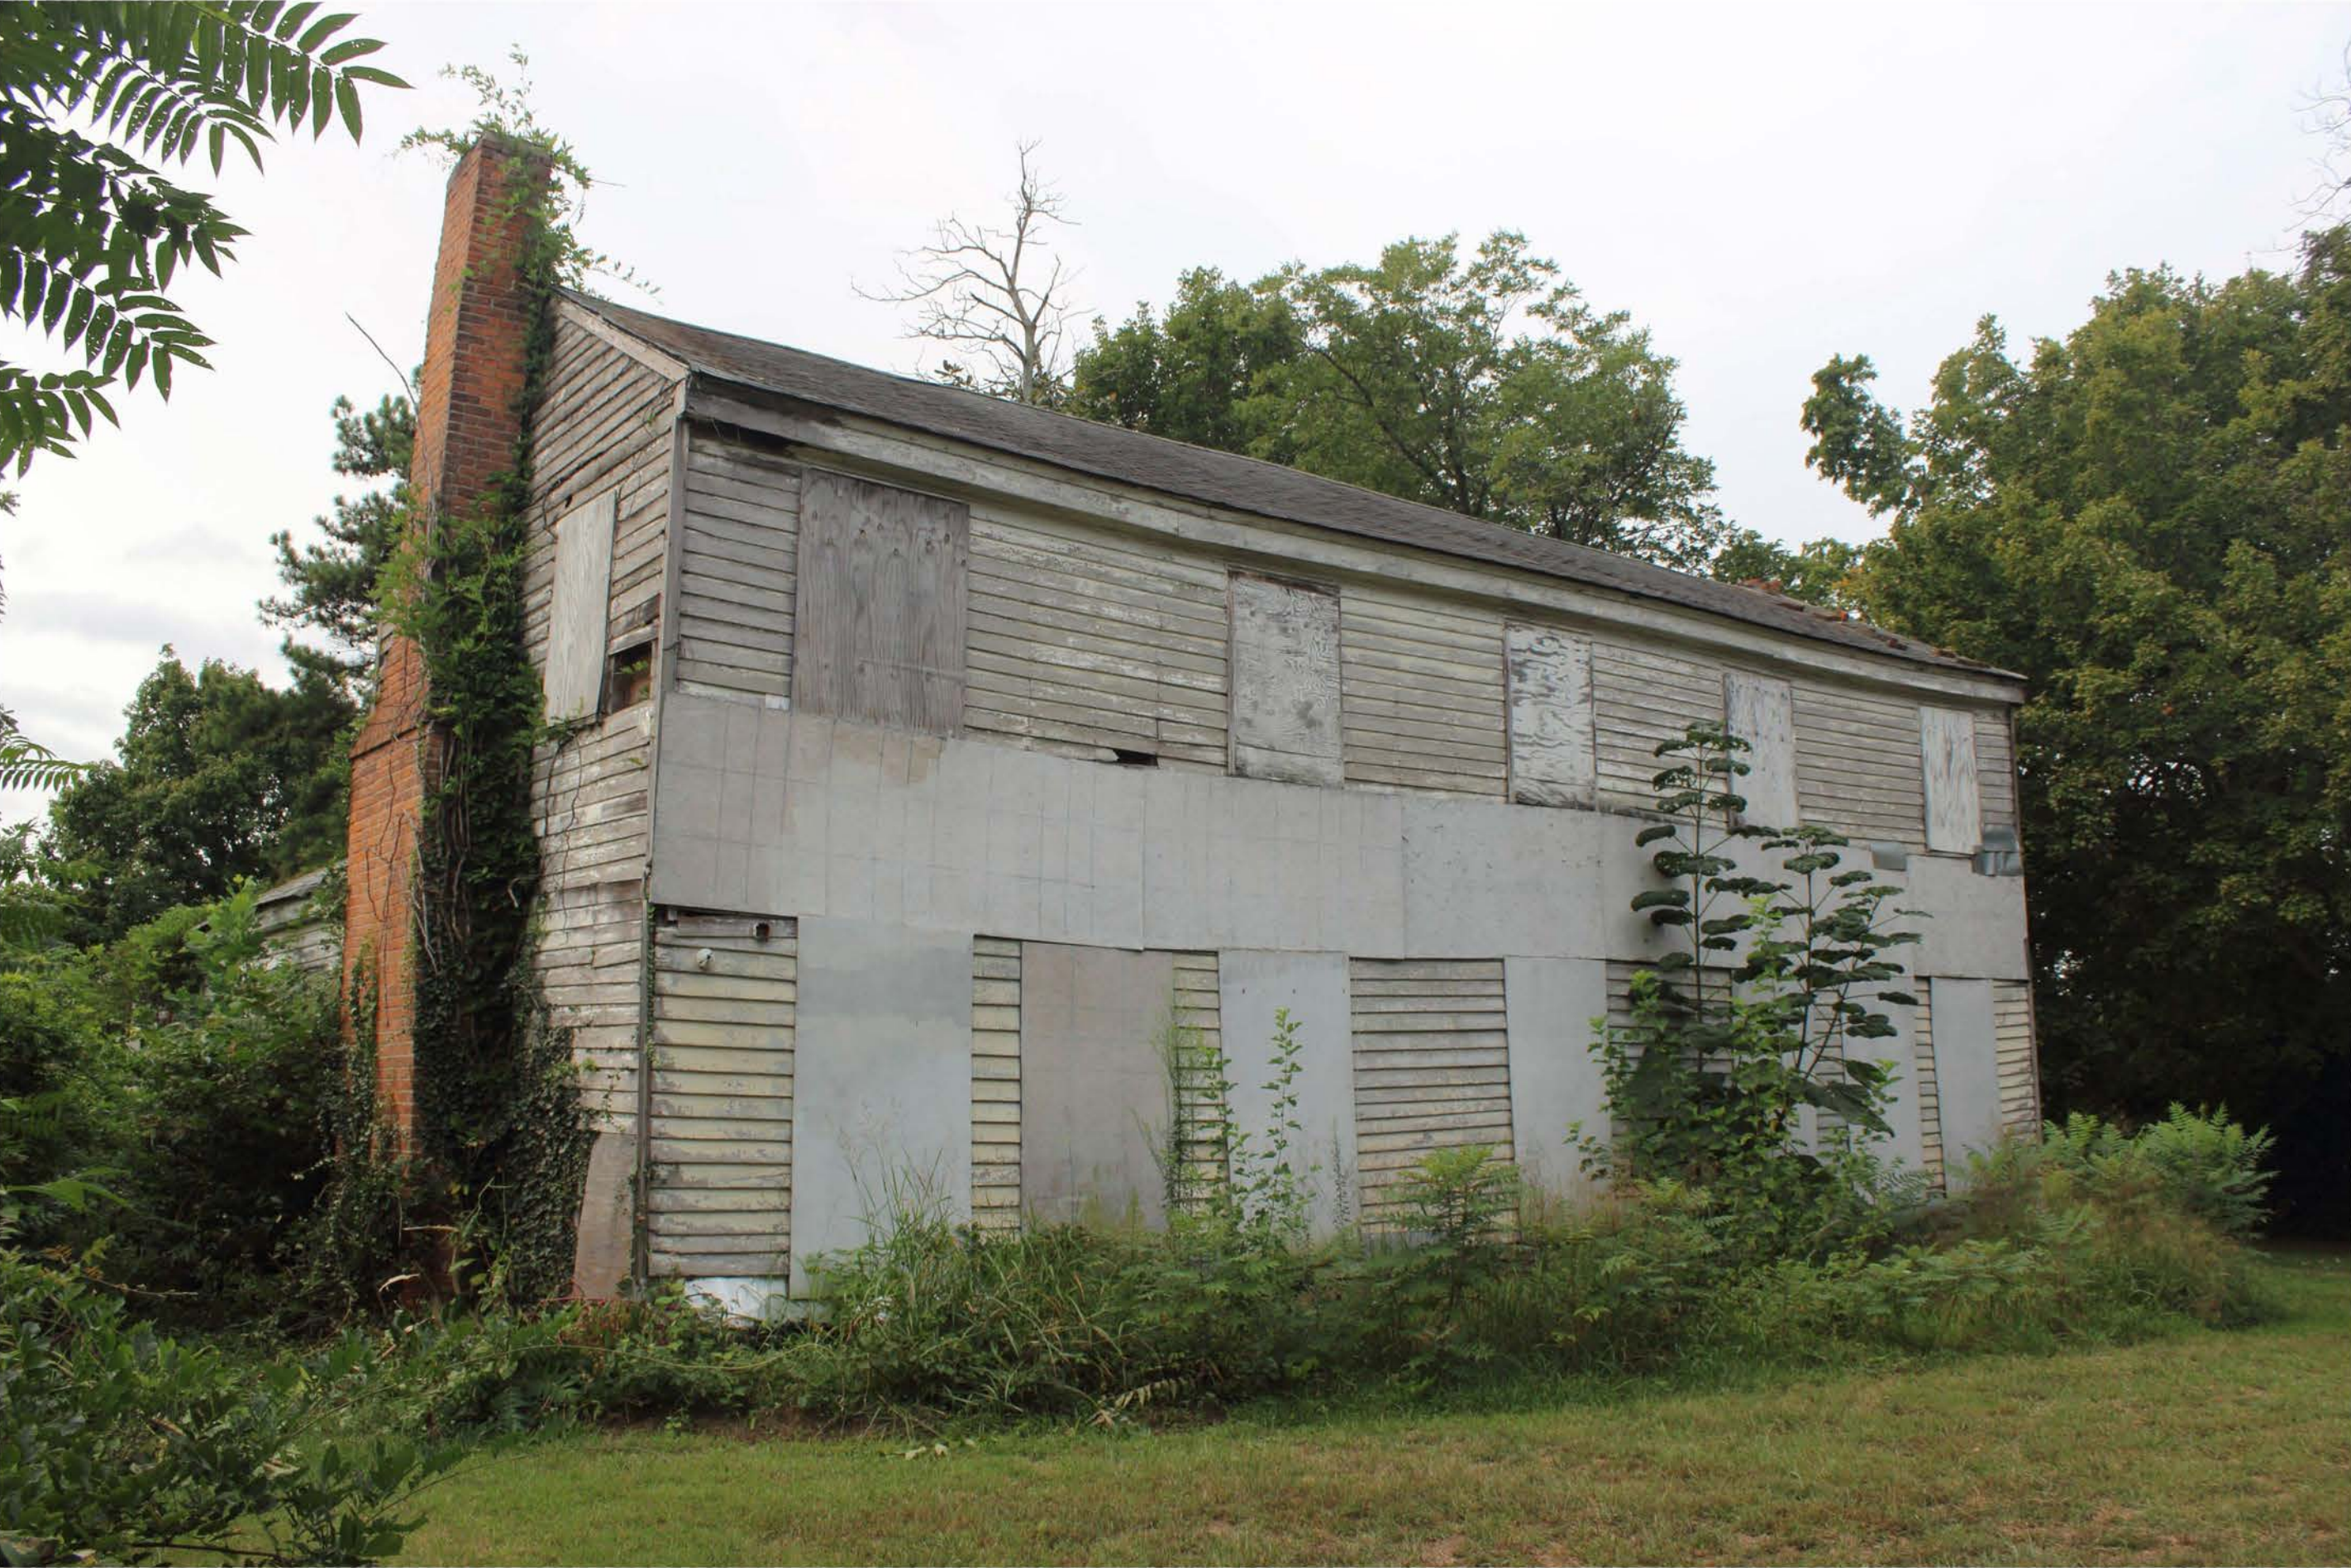
1 of 12: North façade and east elevation, facing south-west

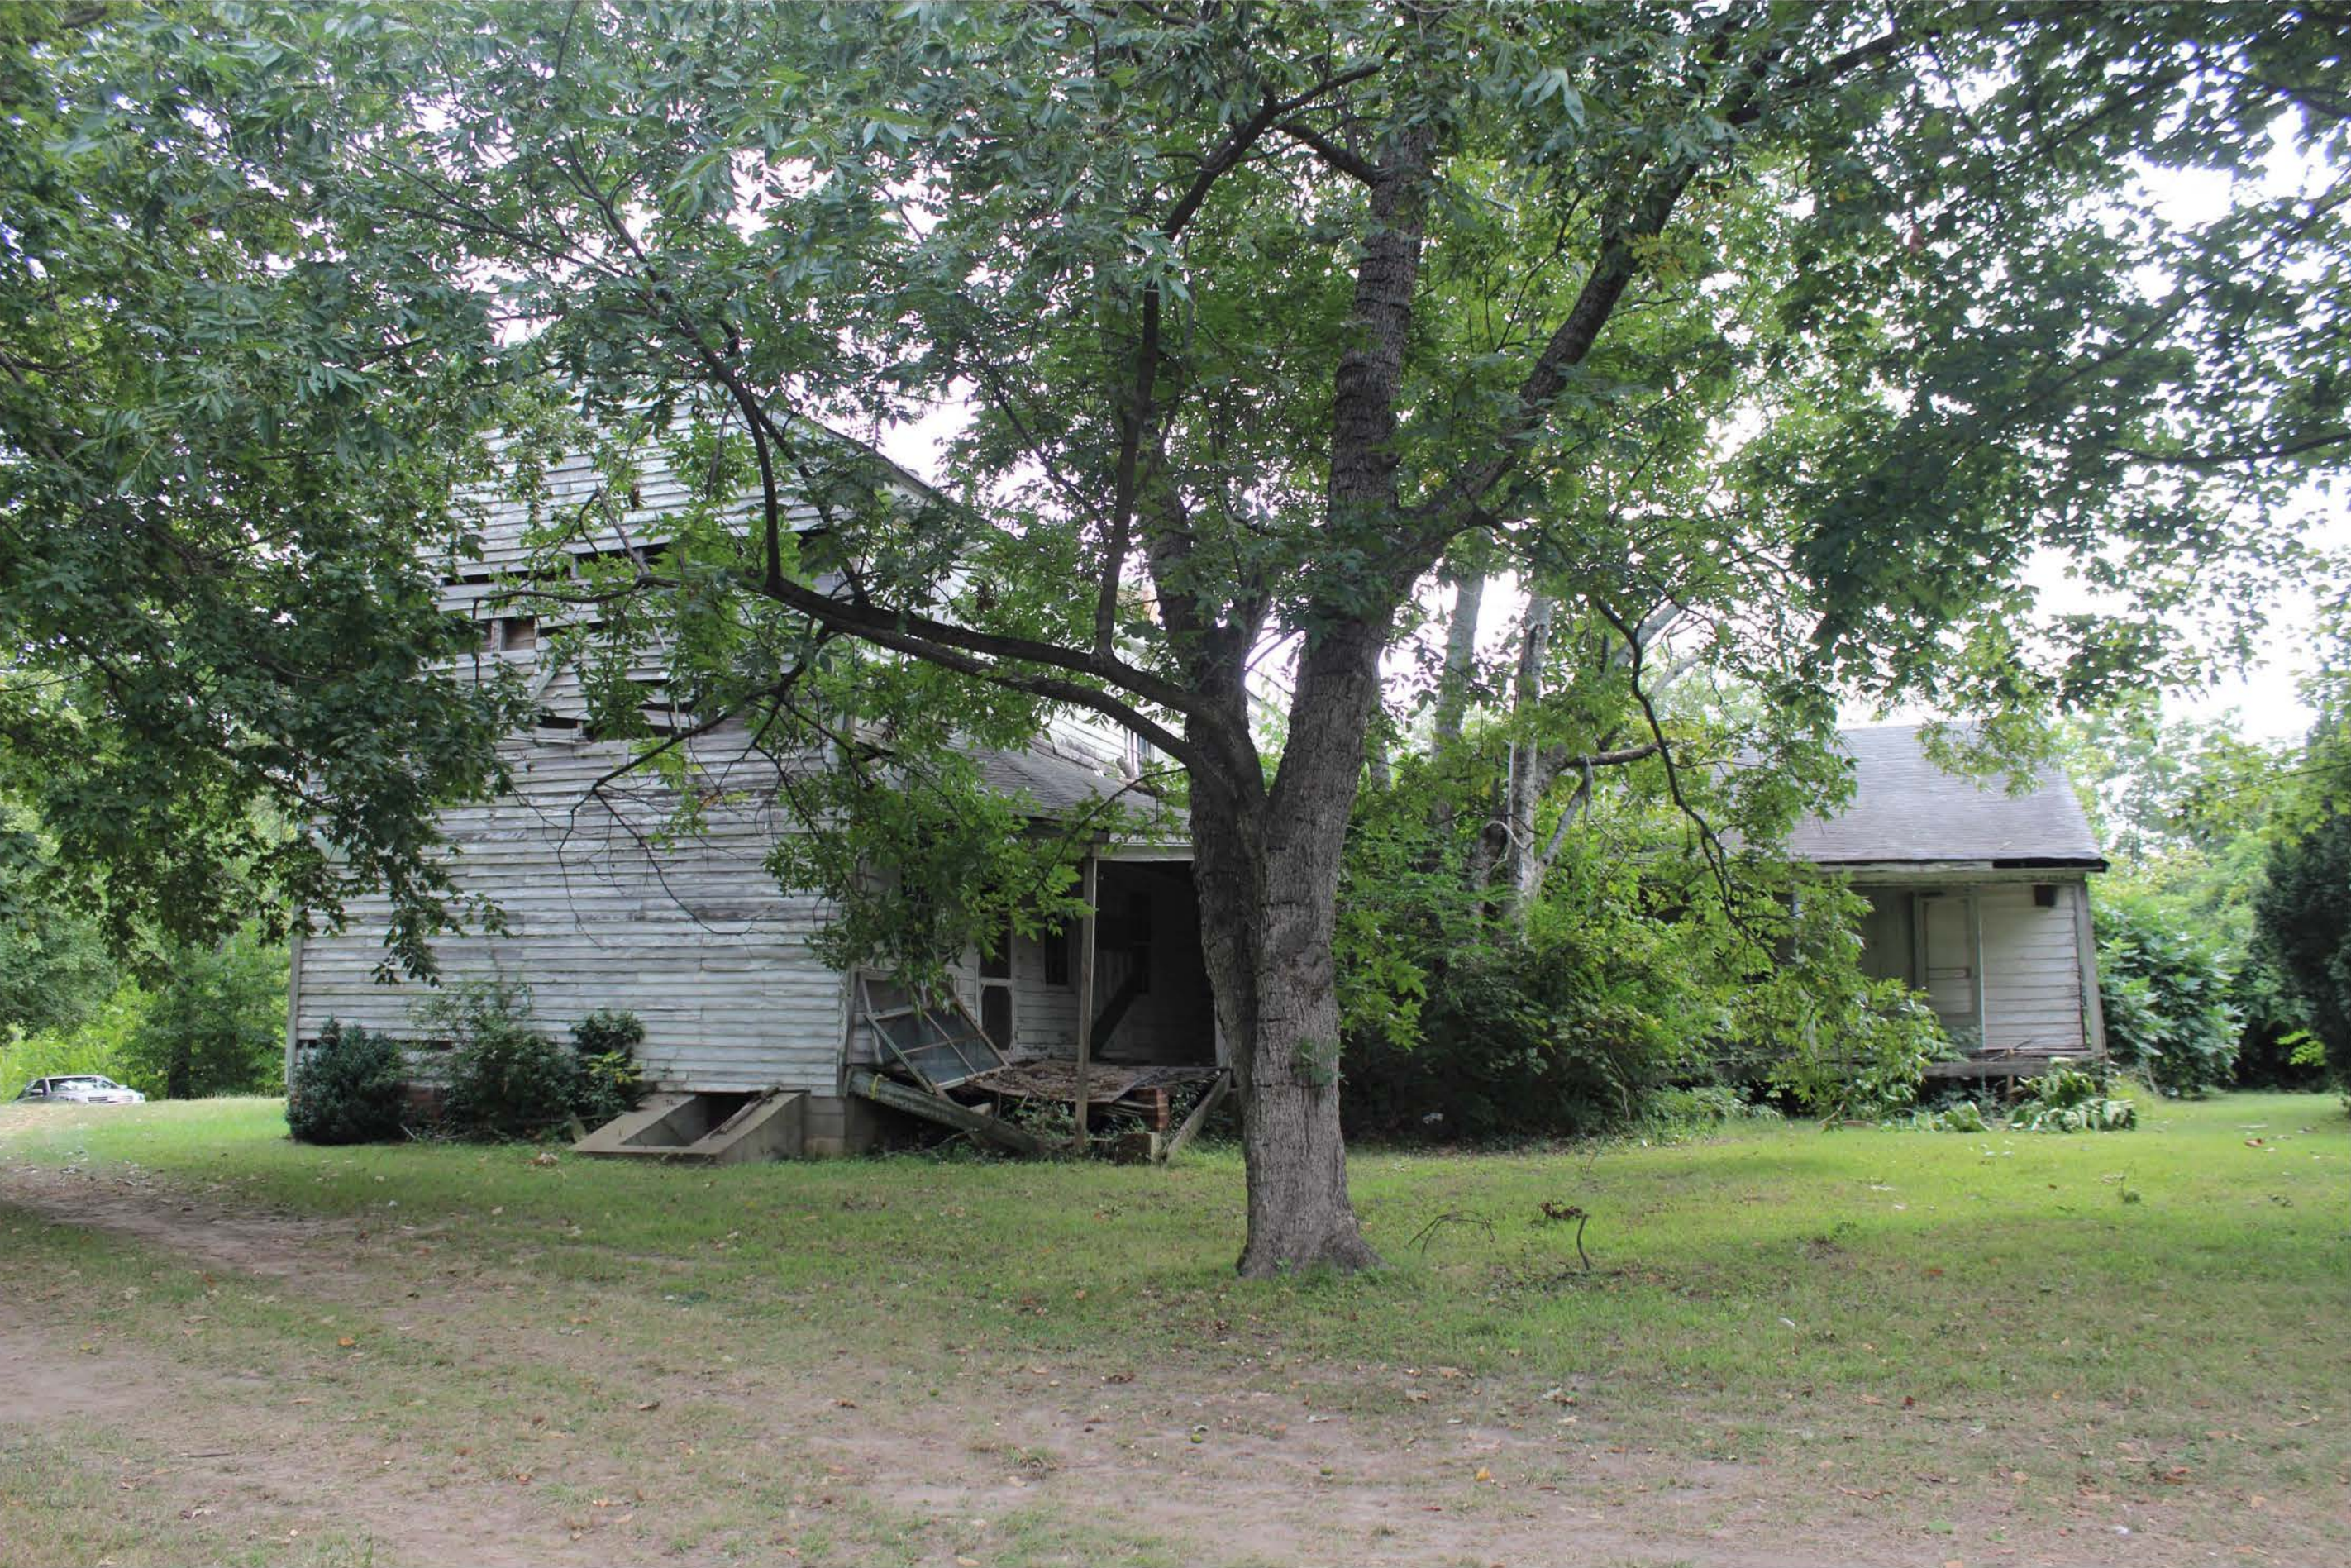
2 of 12: West elevation and south elevation), facing north-east

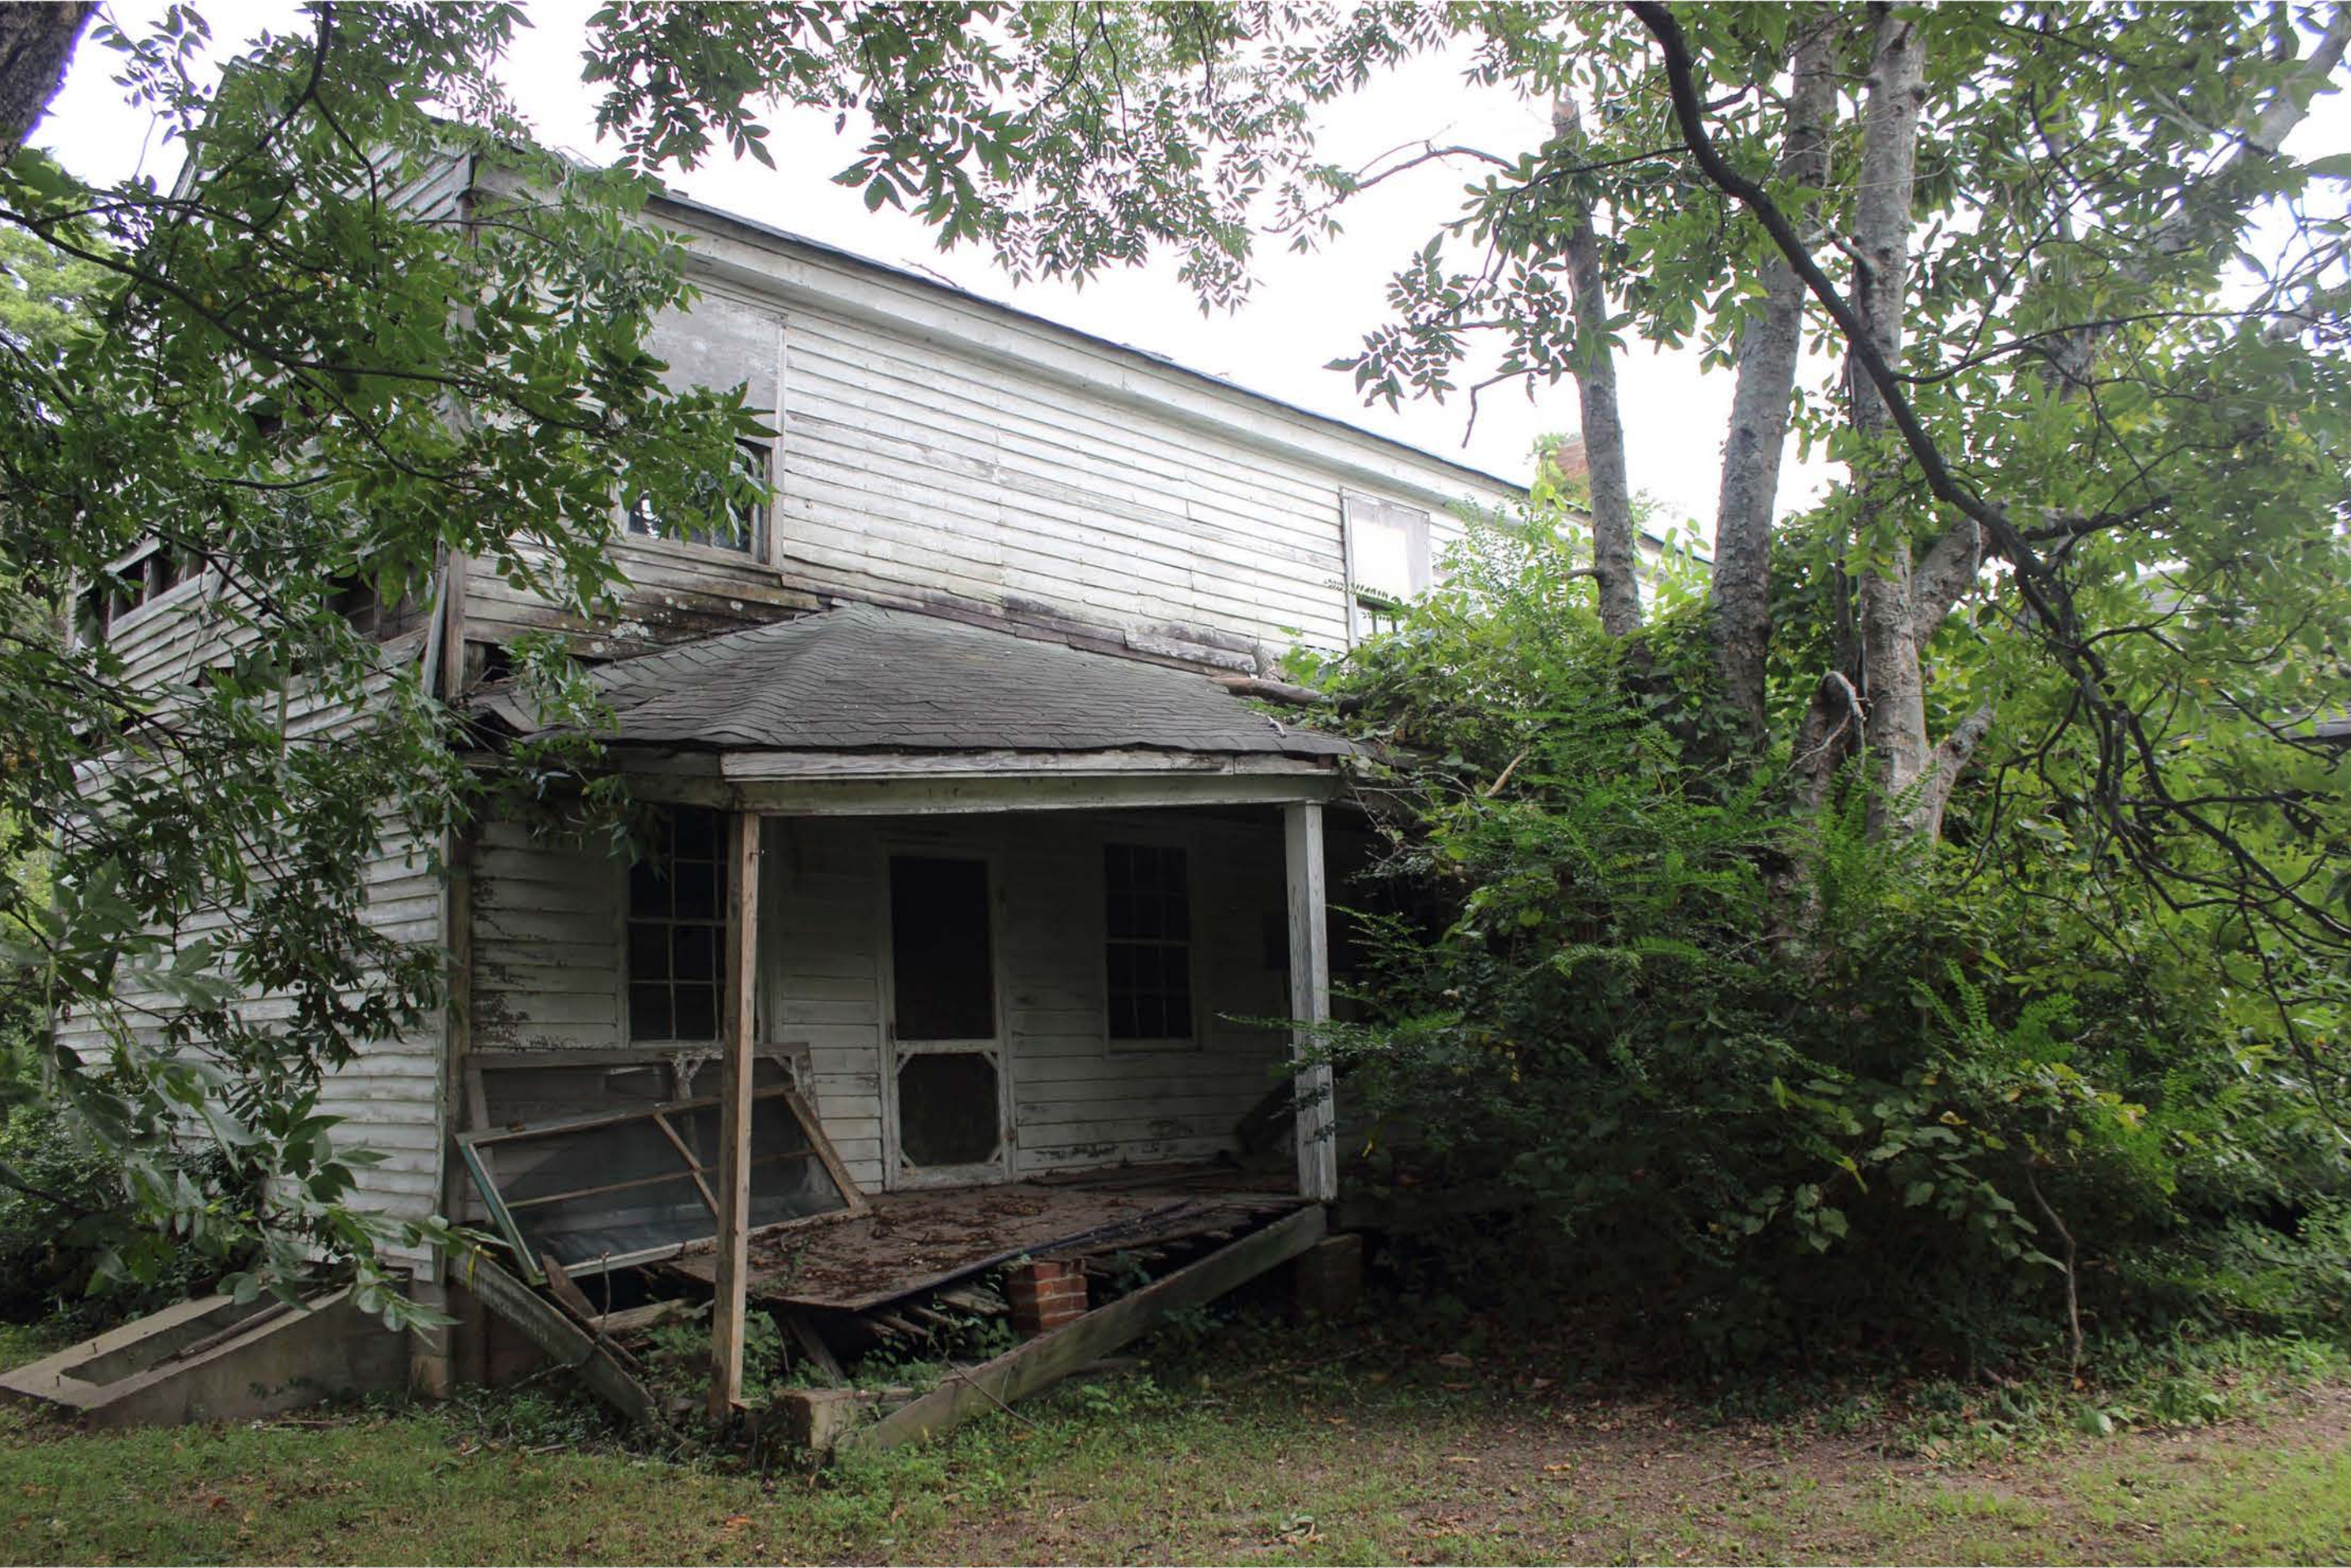
4 of 12: South elevation (two-story portion), facing north-east

The first level of the southern elevation of the main house is similar to the north façade, with the difference being the ell portion of the home is located on the east end (see photo 2 and Figure 6). There are five openings on the first floor (see photo 4). There are three historic wood six-over-six sash windows. There are two historic wood doors. One is located on the western end, between the two western most window placements, and one door is located in the center of the first floor and leads to a wood staircase to the second floor of the home (see figure 1). The second floor contains two historic wood six-over-six sash windows, one of which is partially covered by plywood.

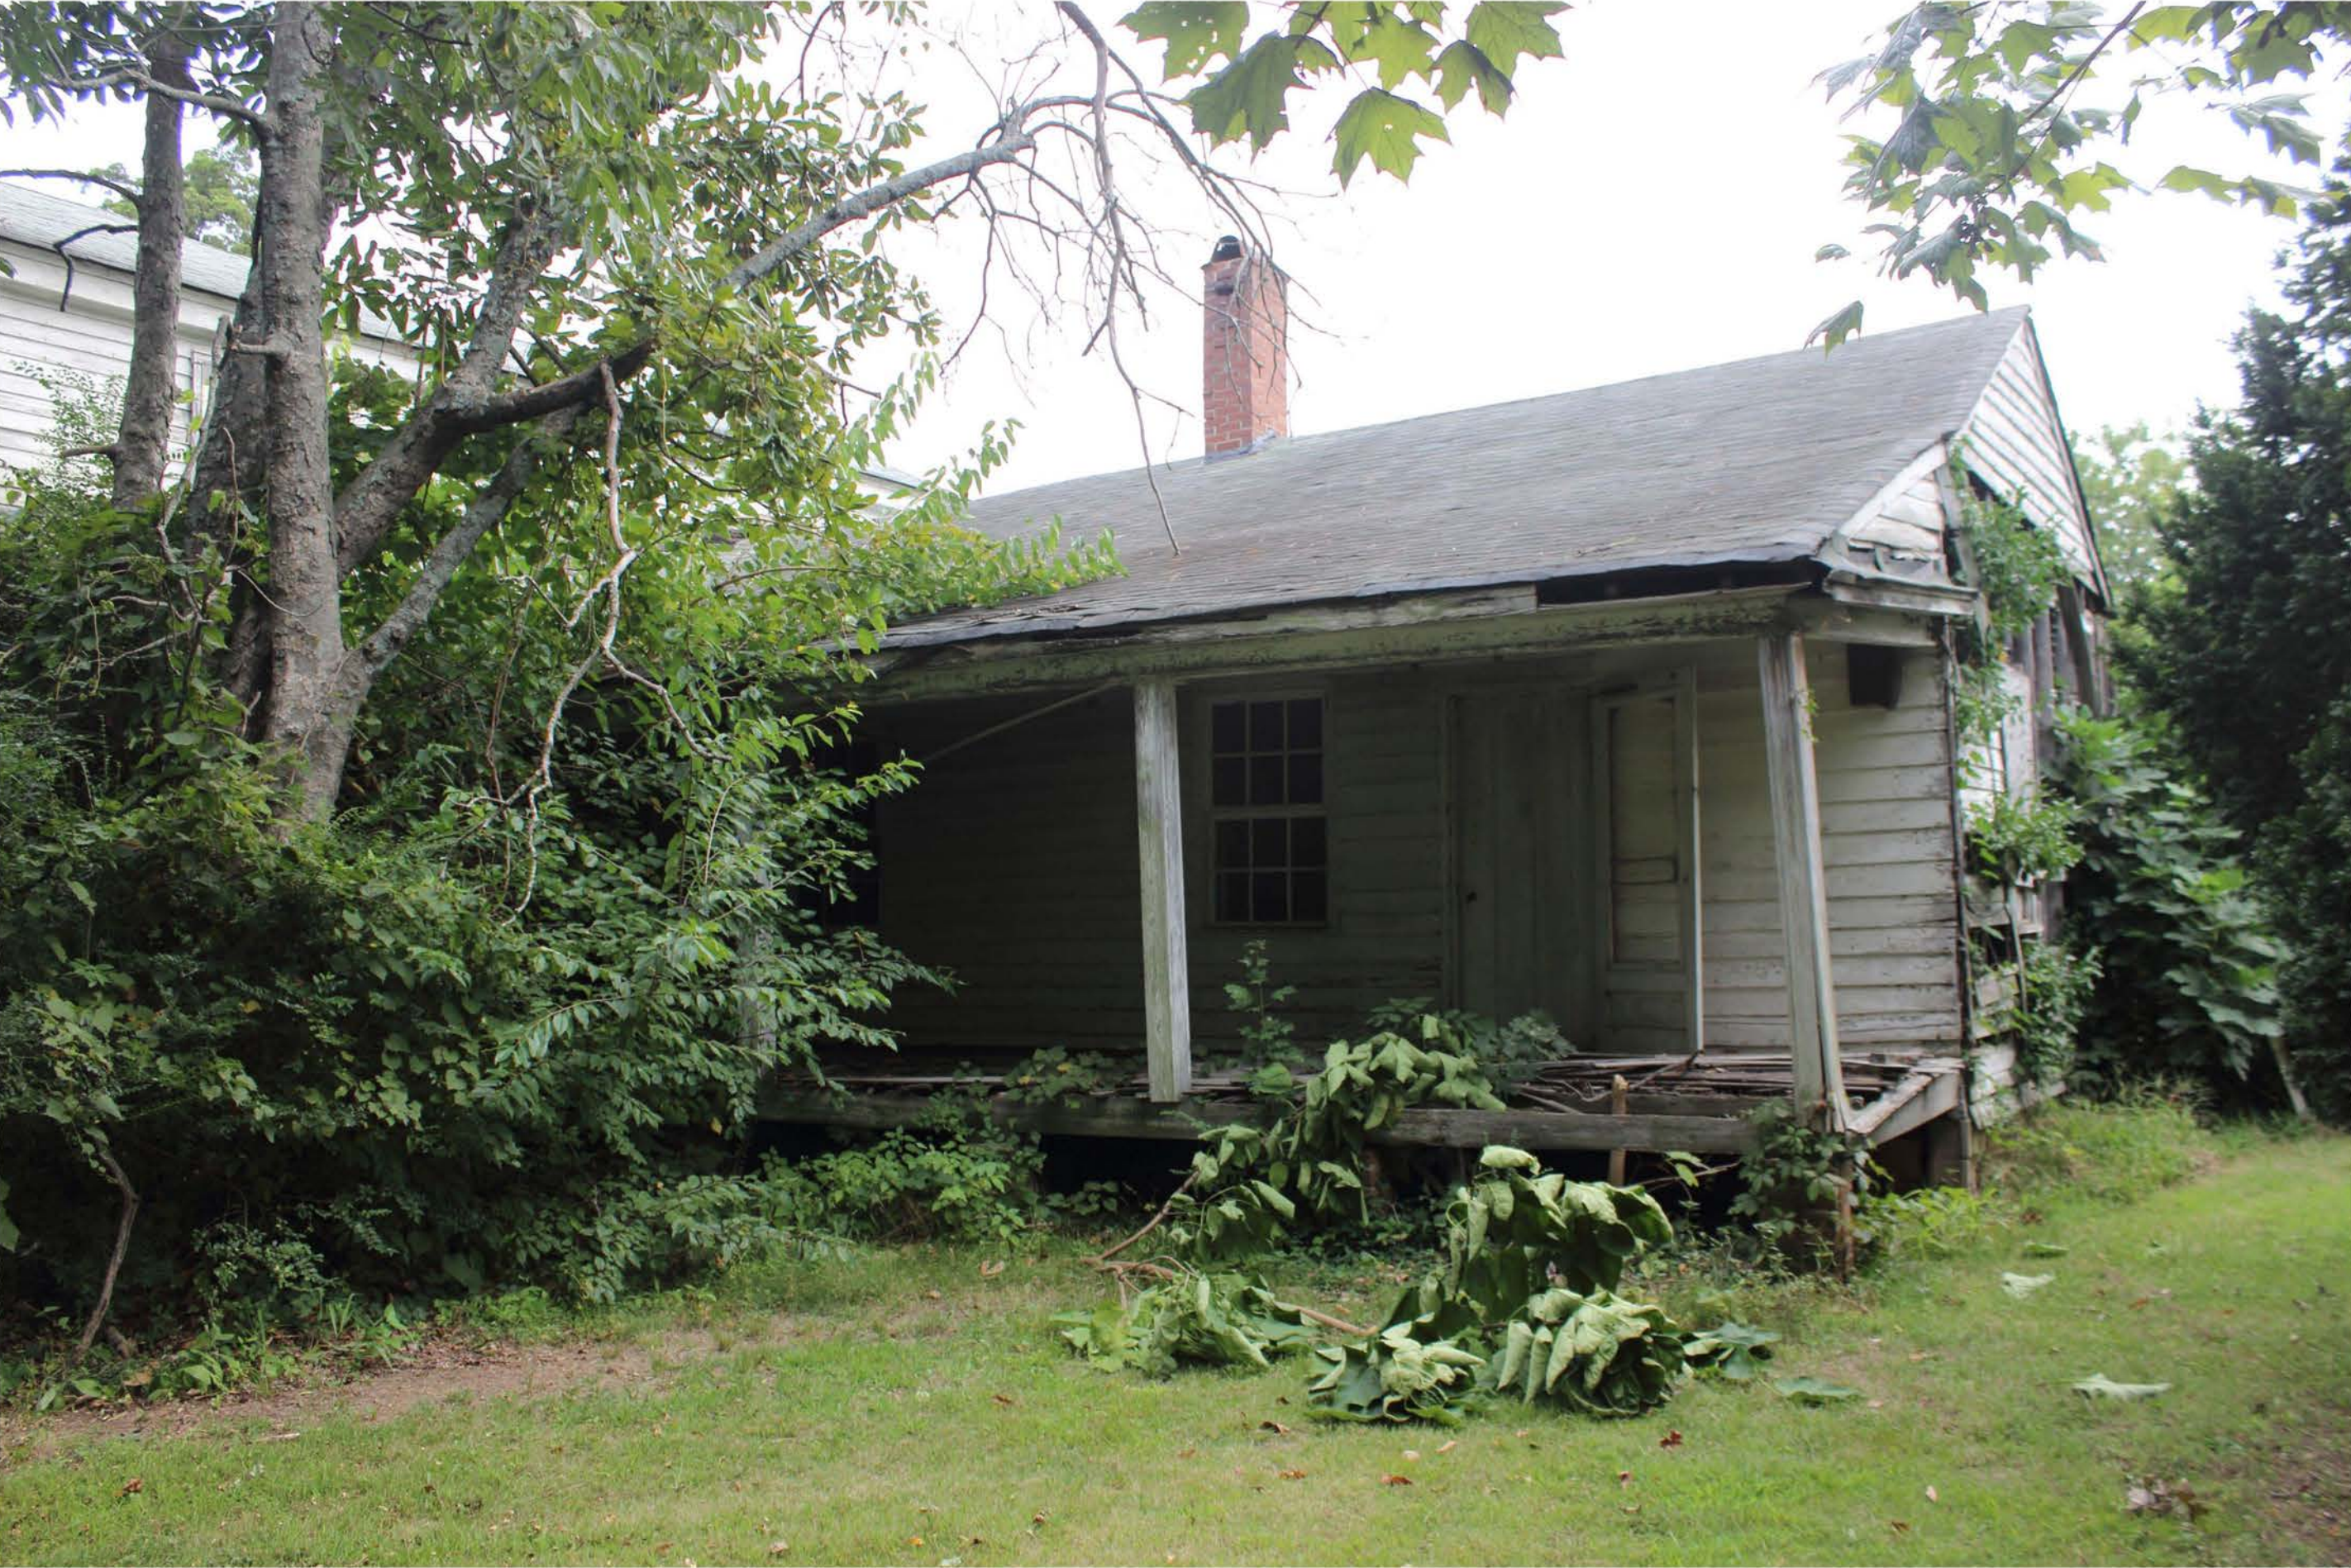
5 of 12: West elevation of ell, facing north-east

The western elevation of the ell portion of the home contains four openings (see photo 5). Two historic wood six-over-six sash windows are located in the center of the elevation. There is one original wood door located at the northern end in the original portion of the ell, a second door is located at the southern end, which opens to the kitchen added in circa 1910.
