# National Register of Historic Places Registration Form

Historic name Miller, Henry, House  
Other names/site number N/A  
Name of related Multiple Property Listing N/A

Street & number 106 Cape Road N/A not for publication  
City or town Bloomfield N/A vicinity  
State Missouri Code MO County Stoddard Code 099 Zip code 63825

The Henry Miller House, circa 1843, is a two story, side gabled, wood frame I house with a one-story ell creating an “L” shaped footprint. Located at 106 Cape Road, Bloomfield, Missouri, the house has a medium pitch asphalt shingle roof with an exterior chimney on the east elevation and five evenly spaced windows on the second level of the façade (north elevation). The first level of the façade has seven openings; five windows located directly below the windows on the second level, and a door located between the first two windows on both the east and west ends of the façade. The original wood windows and doors on both levels of the north elevation are intact behind the plywood coverings. The house was used as a residence continually from the time it was constructed until approximately 1979 and has been vacant ever since. An addition extending the original o

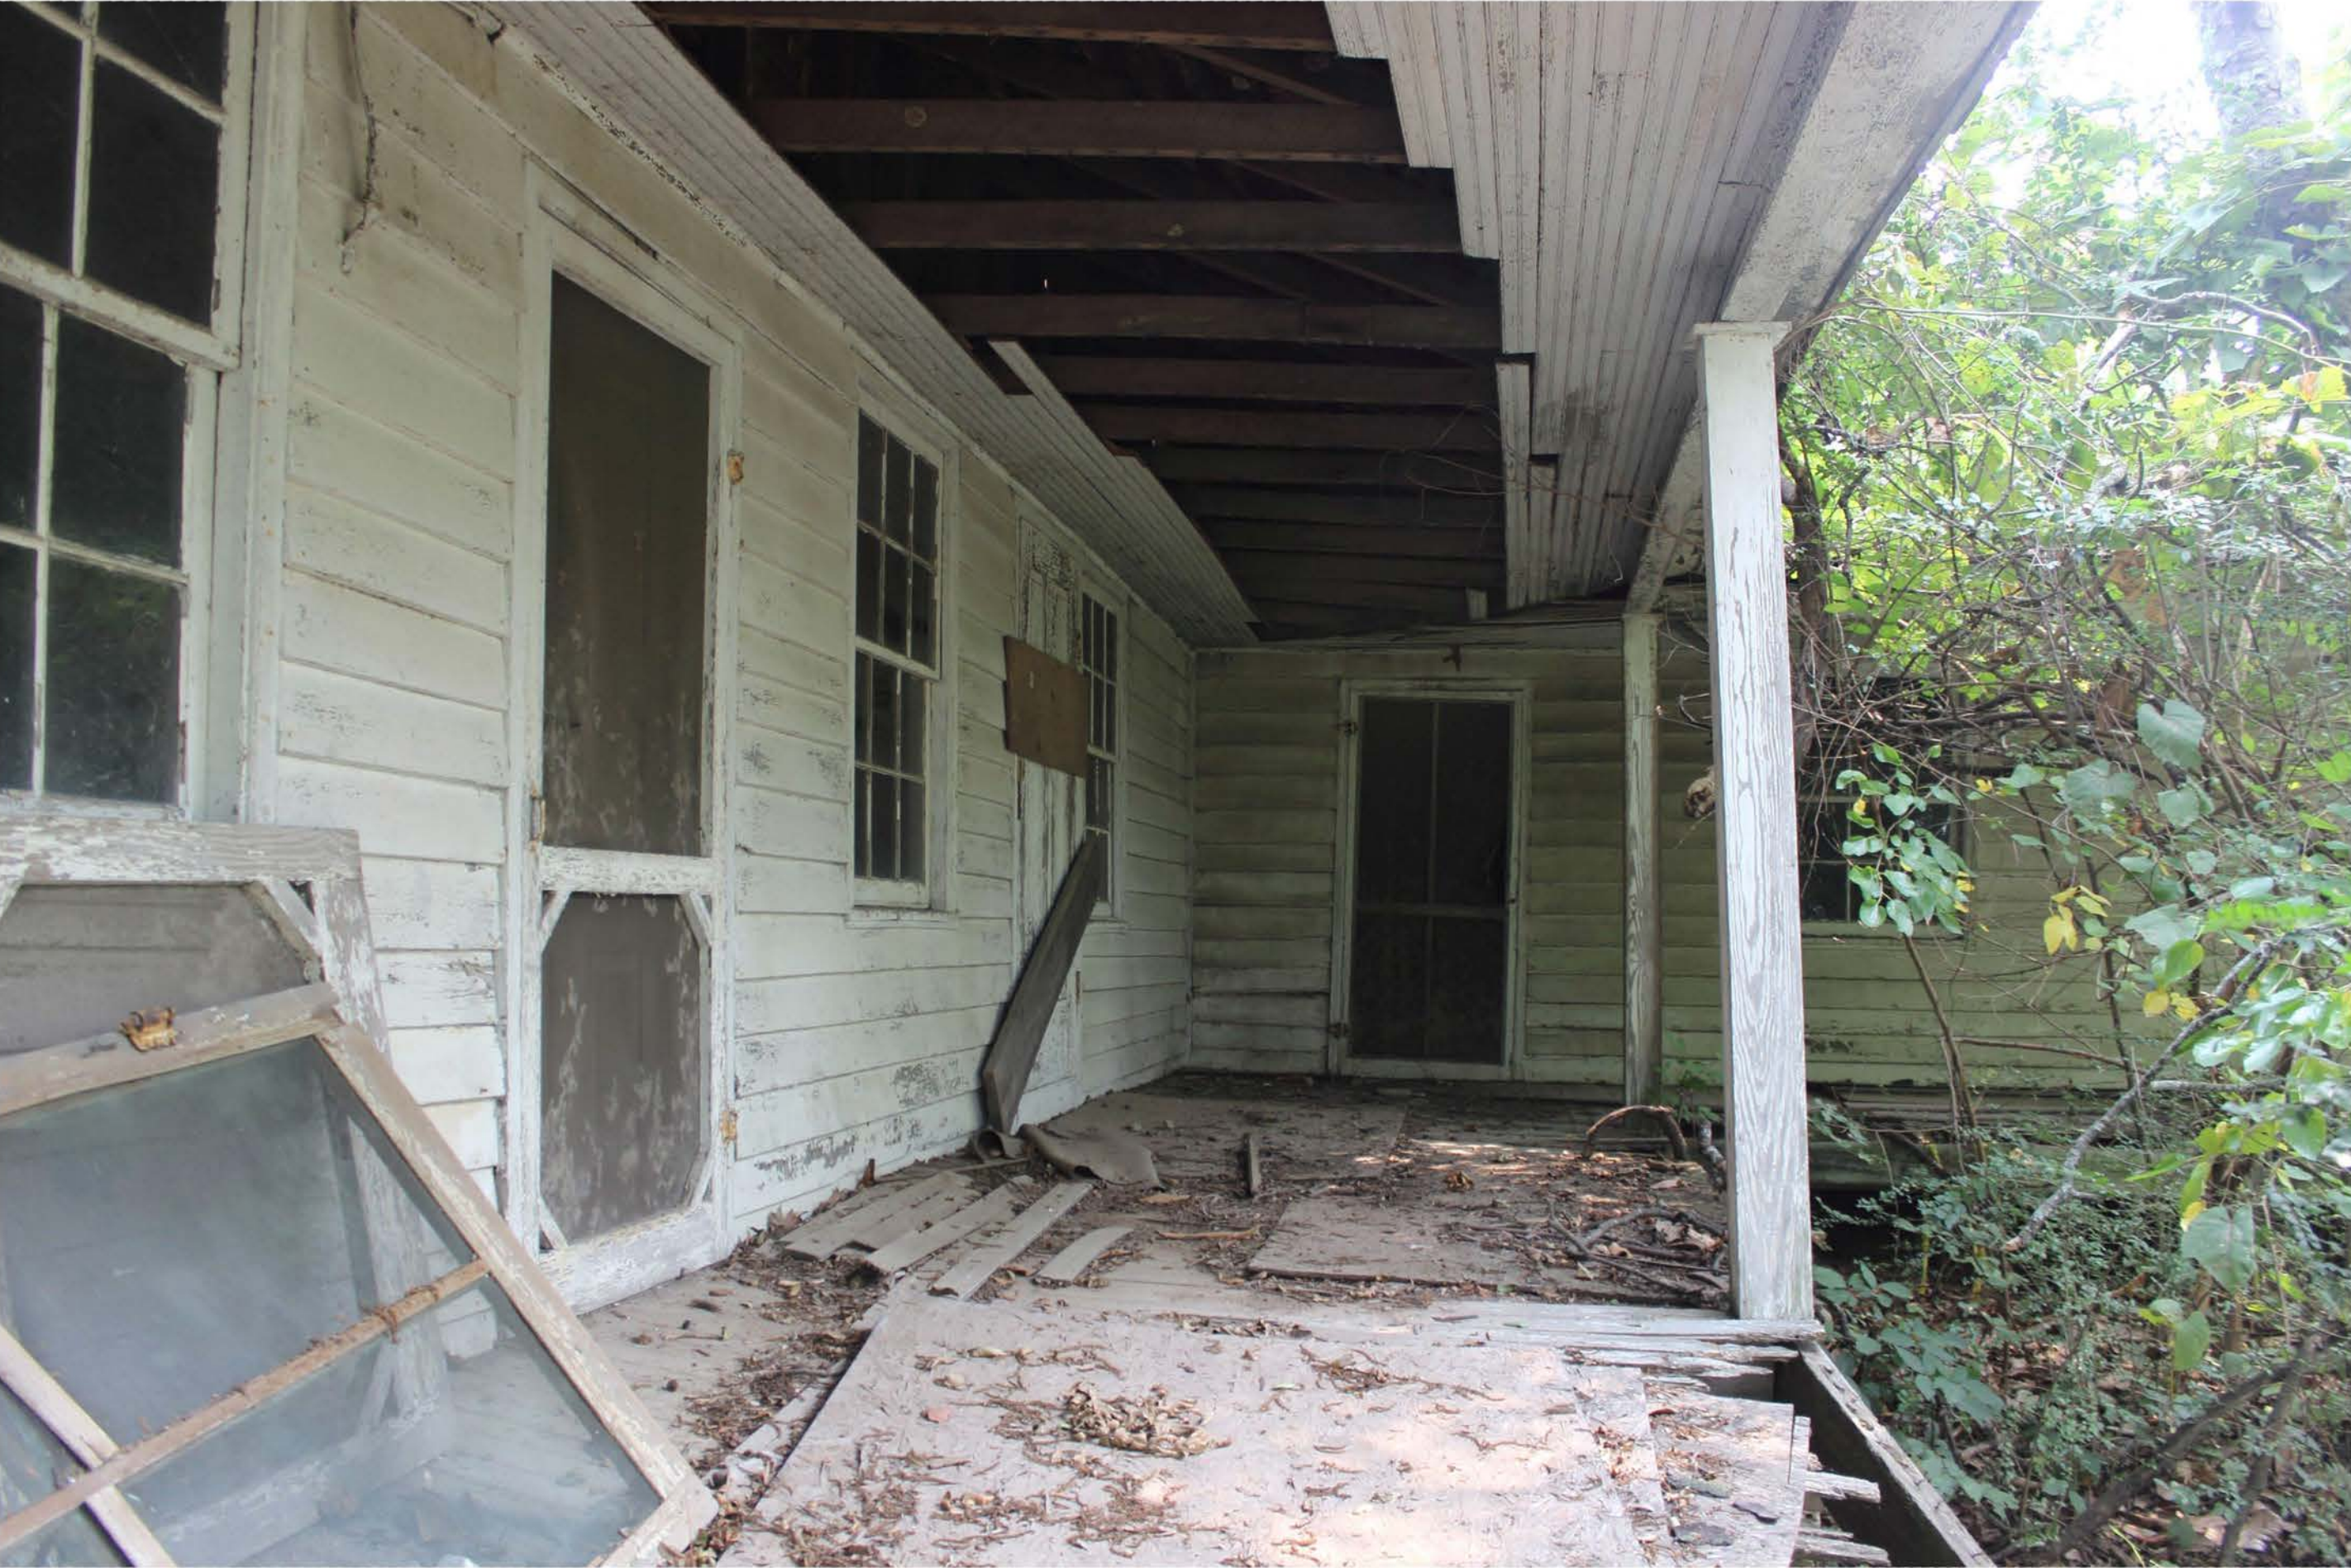
6 of 12: Rear porch, facing east

foundation has eroded in some locations and there are missing bricks. The front porch was removed in 2012 after the western end collapsed, threatening the house's façade. The back porch remains intact, however, the brick masonry piers and the wood pillars are in significant disrepair (see photo 6).

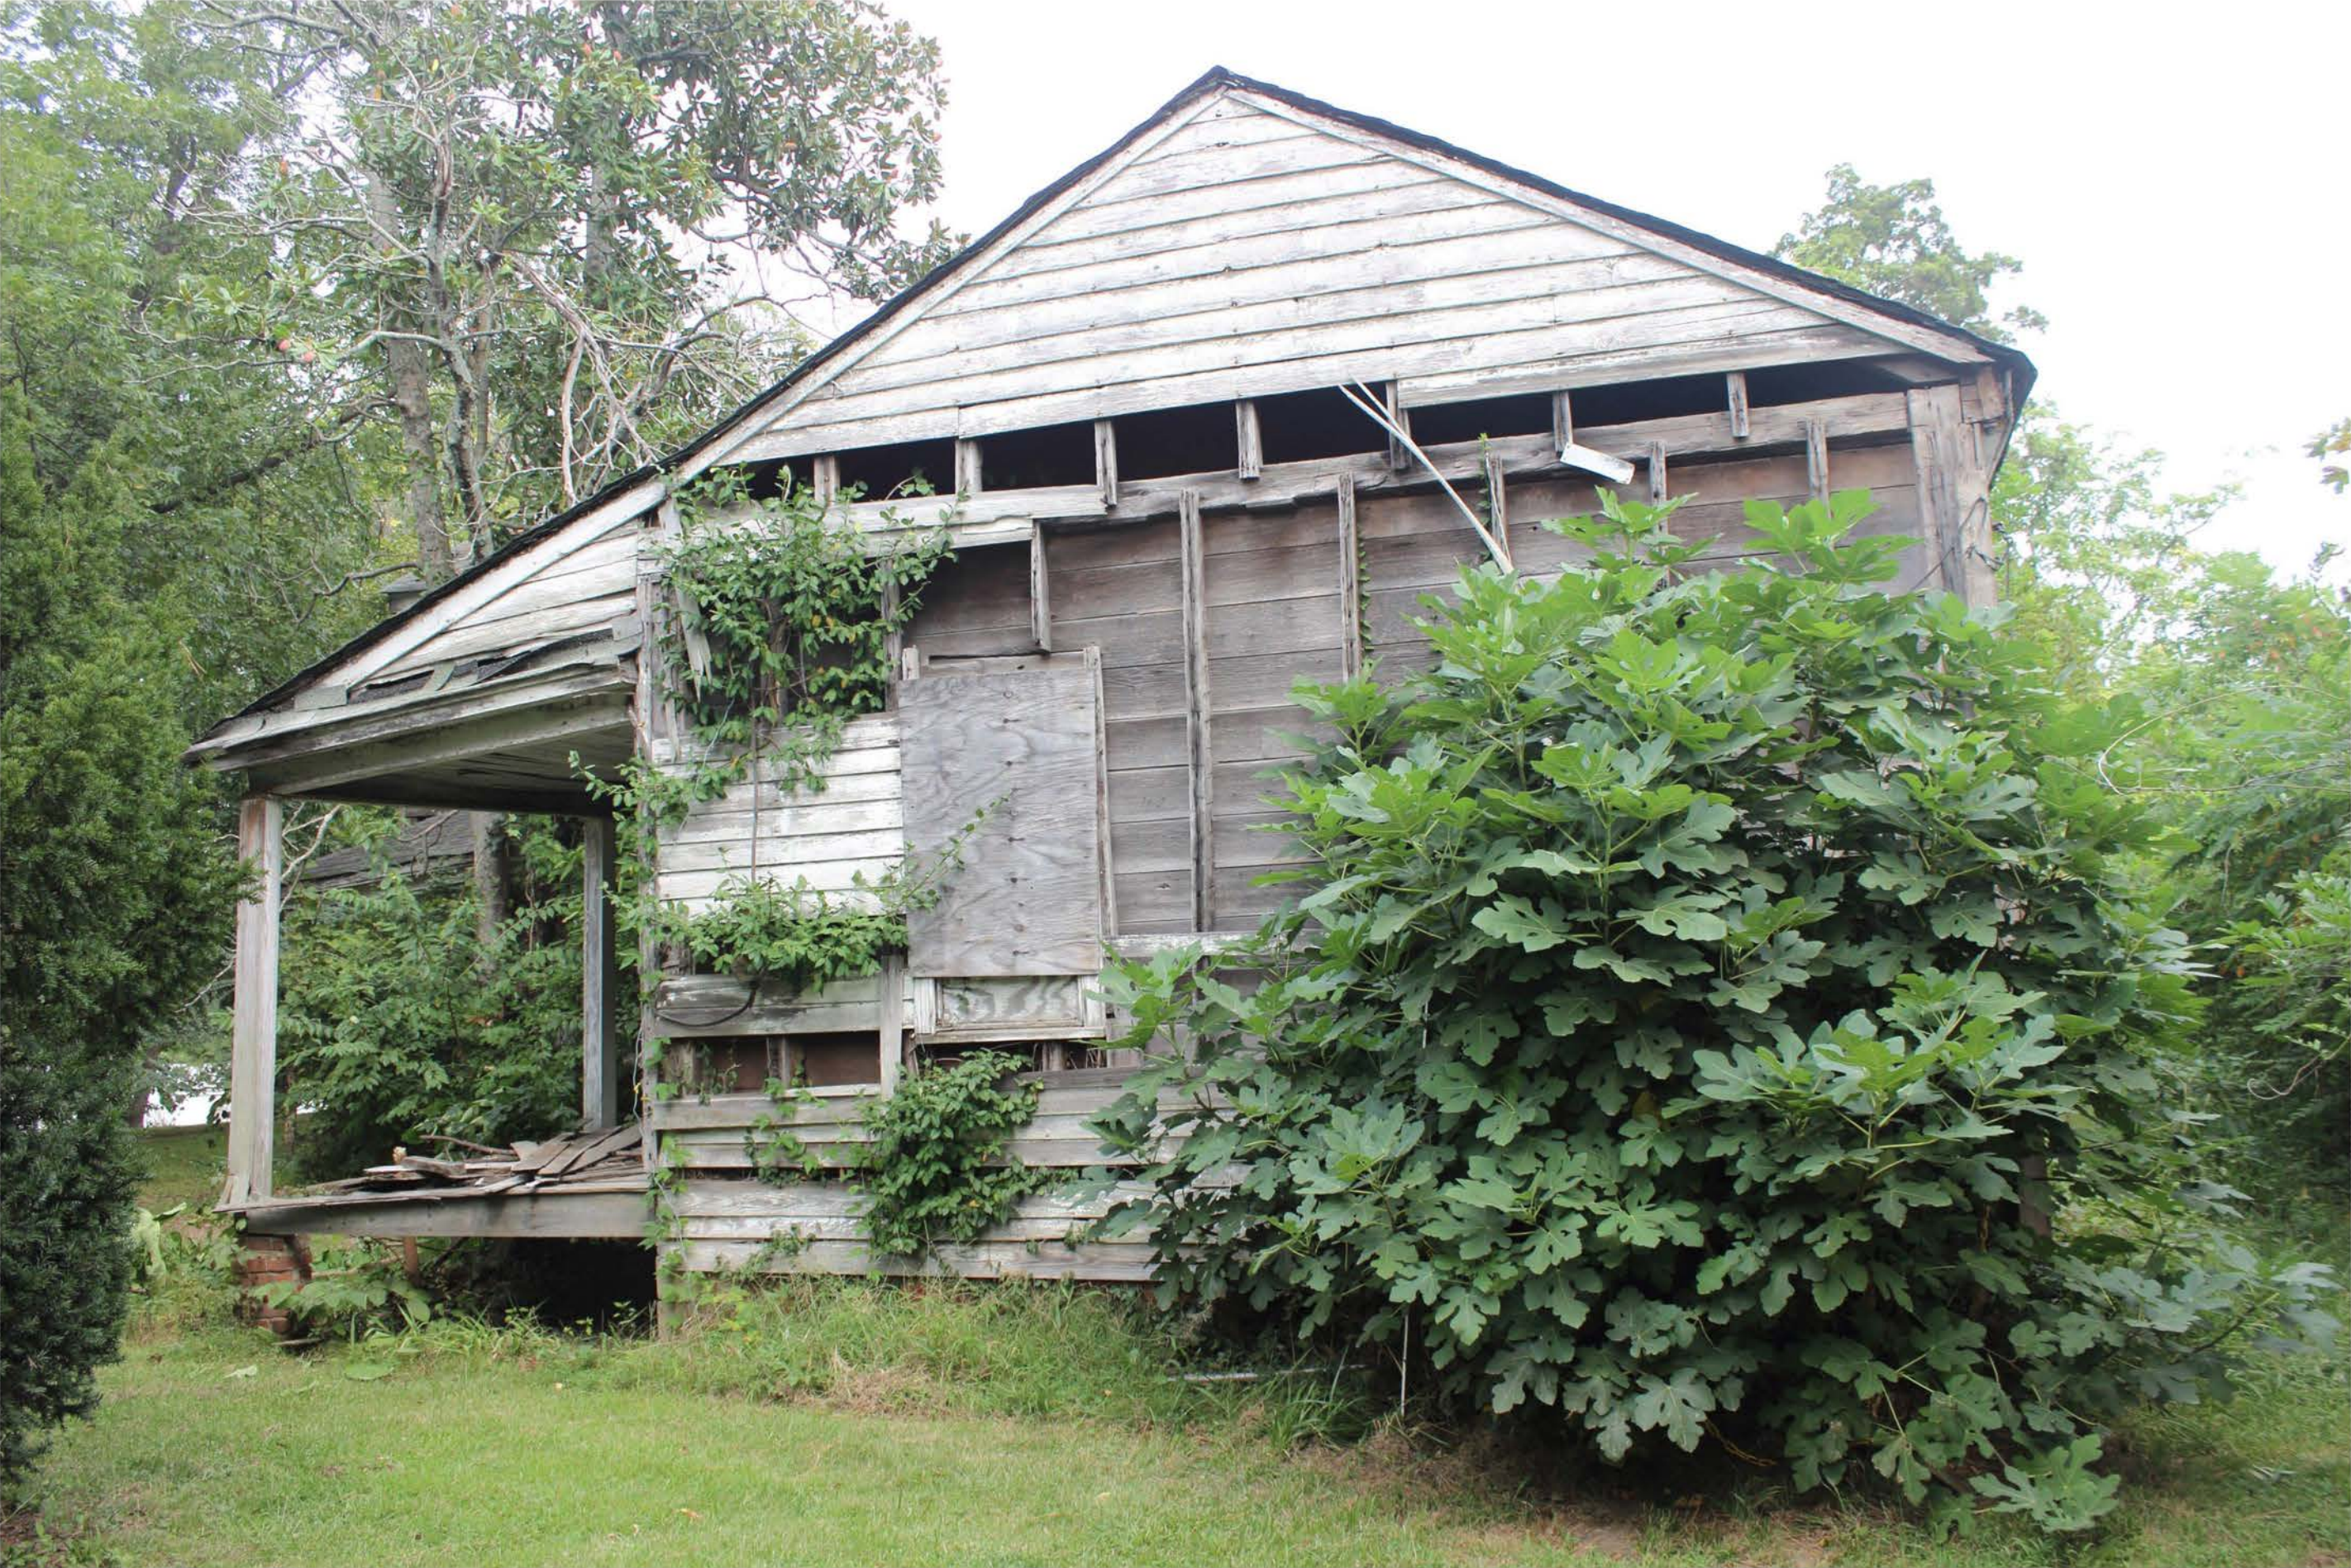
7 of 12: South elevation (ell), facing north

The exterior is in a substantial state of disrepair. Siding is missing in several locations, most prominently on the southern elevation of the ell portion (see photo 7). The mortar in the brick

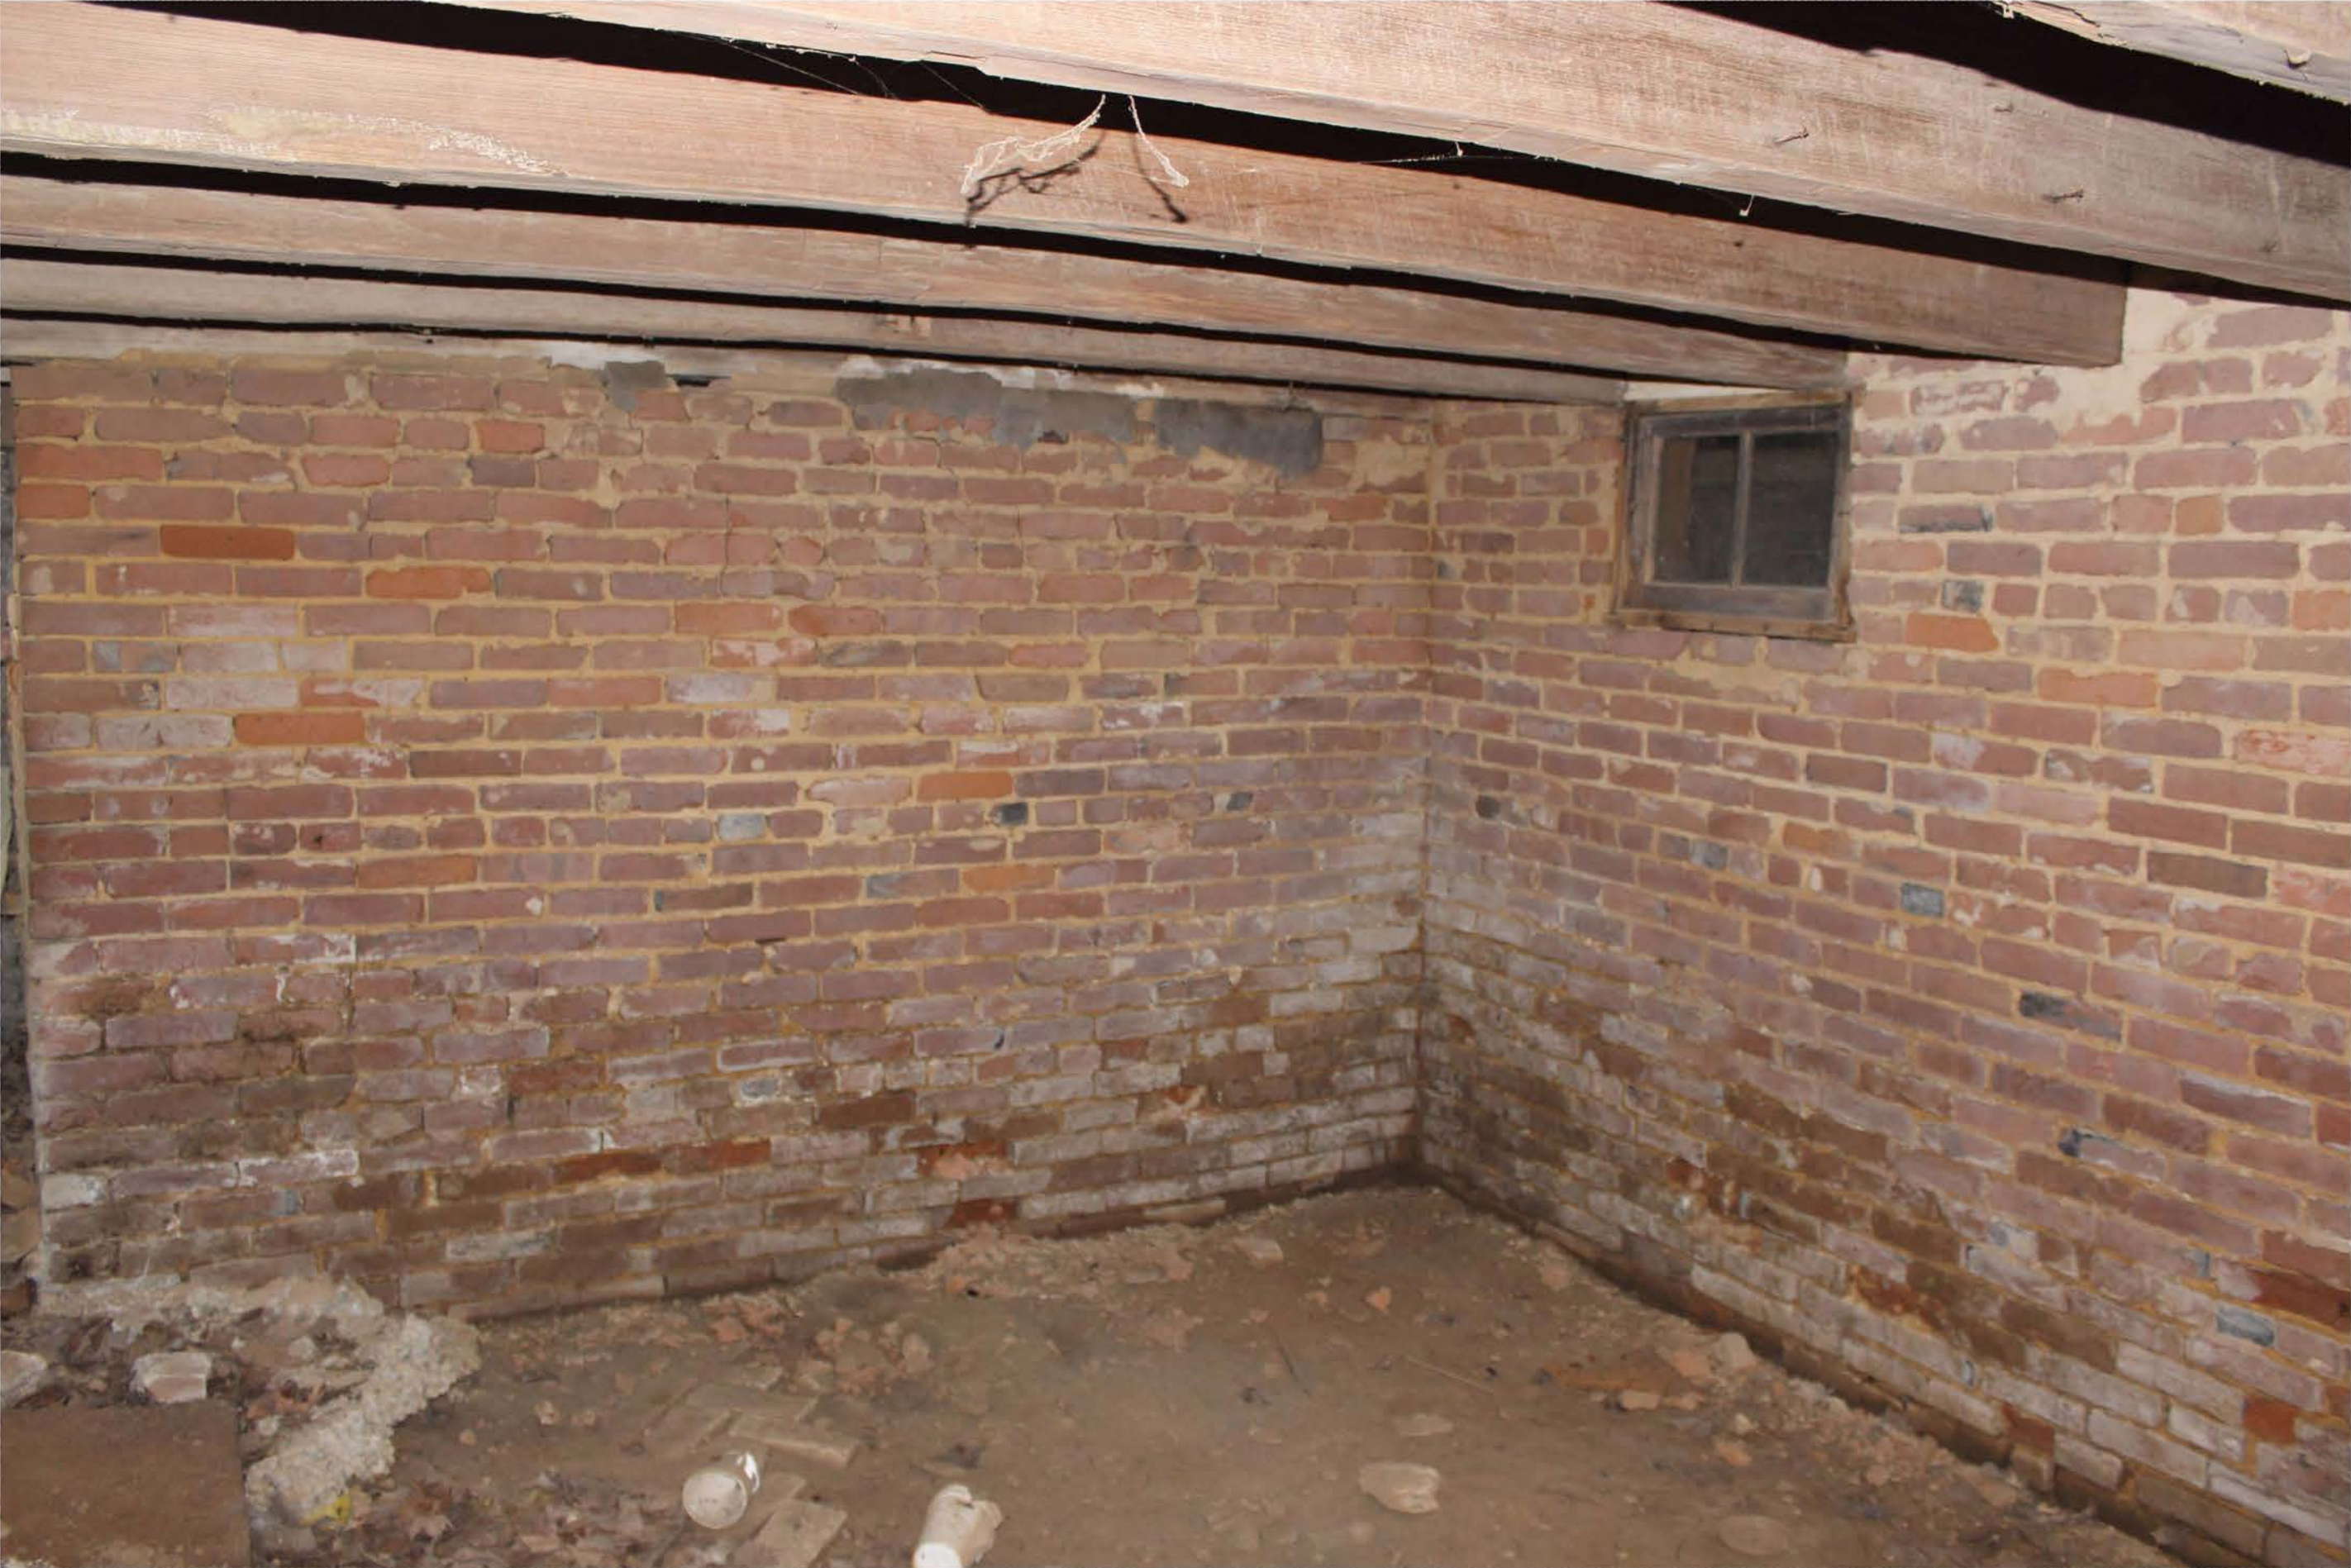
12 of 12: Interior of cellar, facing south-east

The cellar is constructed of brick and is original to the house (see photo 12). The entrance to the cellar, located on the western elevation of the house, was replaced most likely in the 1950s. The cellar is approximately 12 feet by 12 feet and 6 ½ feet high and has two openings for windows on both the north and south walls. The openings suggest that the original foundation to the house was open, which would allow the cellar to be properly ventilated. There are also remnants of brick flooring. There is some damage to the cellar: a large hole in the eastern wall and the southern wall has buckled. The original hand hewn cypress floor joists are visible from the cellar and are in excellent condition.
