# National Register of Historic Places Registration Form

Historic name Montgomery Veterans Administration Hospital Historic District  
Other names/site number Central Alabama Veterans Health Care System - West Campus / NA

United States Second Generation Veterans Hospitals

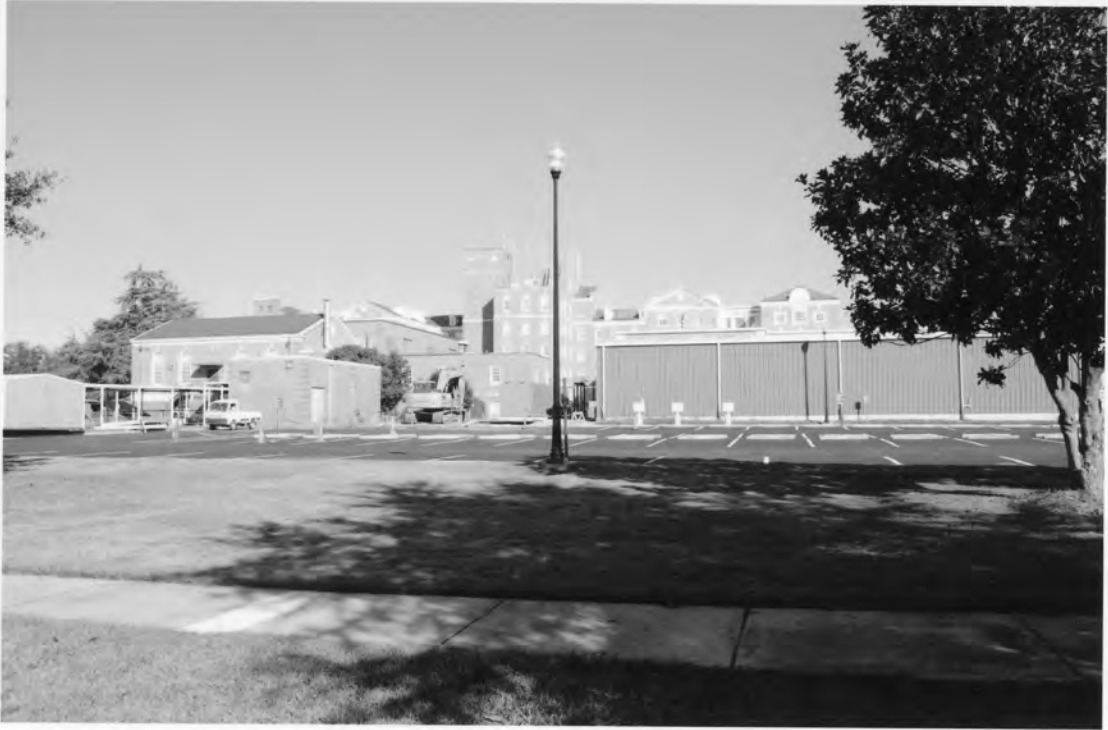
Al Montgomery county - 2nd Generation Veterans Hospital MPS - Montgomery VA Hospital - 0012

12. View to north-northwest with Resources 4, 44, 1, and 5.
13. View to southwest of original facade portion of Resource 1.
14. View to south of Resource 1 east return wing facade and addition.
