National Register of Historic Places Registration Form

historic name Barrio Anita
other names/site number Barrio Anita Historic District

Barrio Anita Historic District
 Name of Property

Pima County, Arizona
 County and State

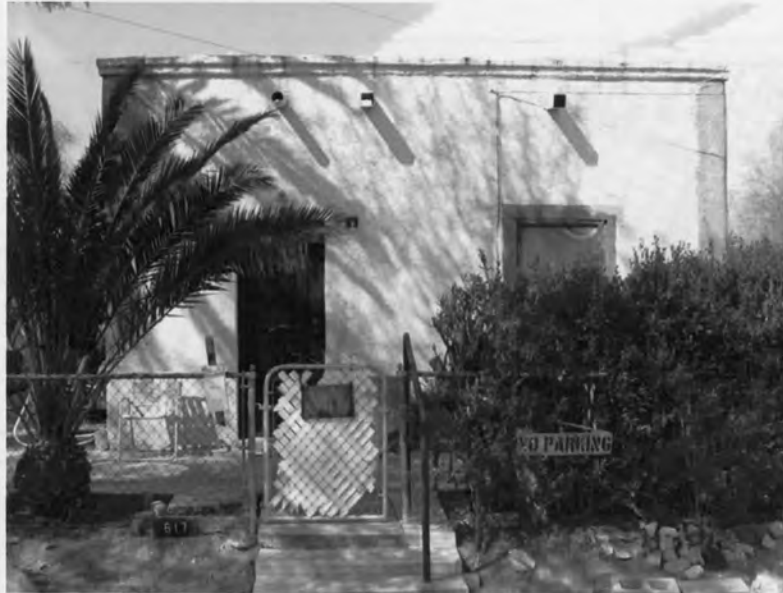
Photograph 1. 617 N. Brady Ave.; view west-southwest.

Most of the buildings constructed in Barrio Anita during its period of significance are a continuation of the Hispanic vernacular building tradition known regionally as Sonoran. (Until the United States' invasion of Mexico and the subsequent treaties of Guadalupe Hidalgo in 1848 and La Mesilla in 1854, what is now southern Arizona was northern Sonora.) The one-story dwellings are modest in size and scale, with simple massing. Adobe is the primary material for bearing walls. Flat roofs with parapets alternate with pitched roofs (in some instances, the latter were added to the former). Typical examples are 617 Brady (Photograph 1) and 515 Oury (Photograph 2).

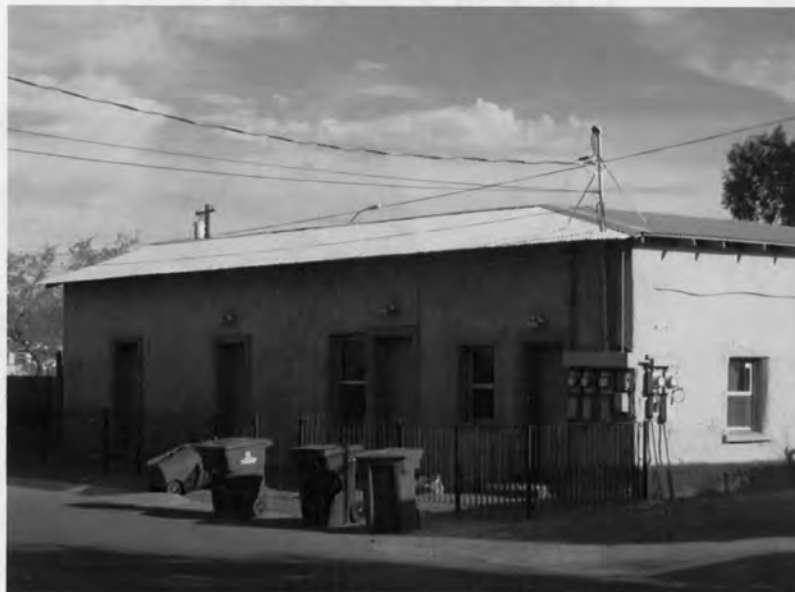
Photograph 2. 515 W. Oury St.; view southeast.

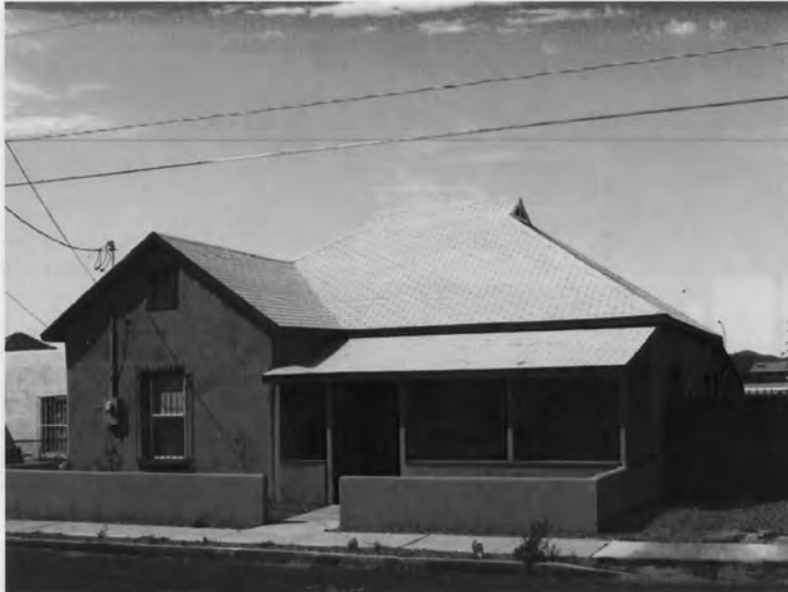
Photograph 3. 911 N. Anita Ave.; view southwest.

The Queen Anne style, as built in the barrio, is a simplified version that has a hipped roof with a lower cross-gabled wing on one side and a front porch, as seen at 911 Anita (Photograph 3). Dwellings in the American Territorial style are built of brick and typically have a hipped roof over a square or nearly square plan (Nequette and Jeffery 2002). The examples of the National Folk style belong to the gable-front and gable-front-and-wing families (McAlester and McAlester 1997); 657 Anita (Photograph 4) is an example of the former. After 1920, there are a few examples of the Craftsman/Bungalow style. These are front-gabled, with low-pitched roofs and integral front porches, as seen at 654 Anita (Photograph 5). All of these dwellings, with the exception of the single example of the American Territorial style, were built of adobe rather than brick.

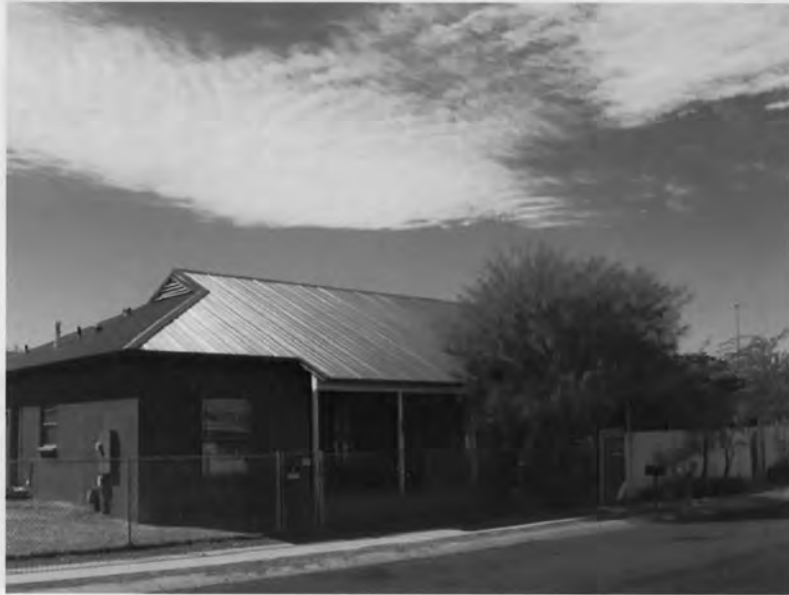
Photograph 13. 545-547 W. Shibell St.; view south.

Most of the barrio still possesses its distinctive architecture, streetscape, and housescapes. Examples of inappropriate alterations are relatively few. The City built a few incompatible federally funded dwellings in the 1970s and 1980s, but recent infill has been subject to design review to ensure that in terms of form, massing, and scale, new dwellings are appropriate for the historic character of the neighborhood. Their style can be classified as "Neo-Traditional"; a characteristic example is 545-547 Shibell (Photograph 13). As a result, Barrio Anita retains a high degree of integrity of design.

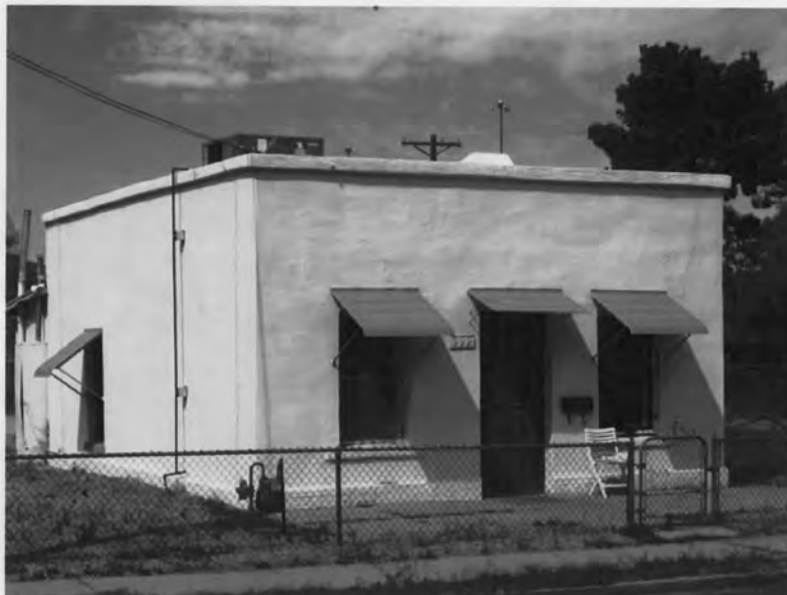
Photograph 17. 999 N. Anita Ave.; view west-northwest.

To document the survival of the Sonoran Tradition into this period, Husband (1988:17-30) uses a simplified typology of the basic forms: parapeted Sonoran and pitched-roof (hipped, side-gabled, or front-gabled) Sonoran. Typical examples are 999 Anita (Photograph 17), 700 Van Alstine (Photograph 18), 673 Anita (Photograph 19), and 519 Oury (Photograph 20). The last two were originally flat-roofed: the roof on 673 Anita was added sometime before 1919 and the roof on 519 Oury was added ca.1920. Sobin (1975, 1977) categorizes these "Transformed" Sonorans as a late nineteenth-century evolutionary type, but he acknowledges that the process continued throughout the early twentieth century. As pointed out in Section 7, changes over time were an inherent part of the adobe vernacular tradition. A particularly telling example of the transformation is 656 Anita (Photograph 21), where the *canales* (roof drains) of the original flat roof can be seen below the eaves of the hipped roof (added before 1919).

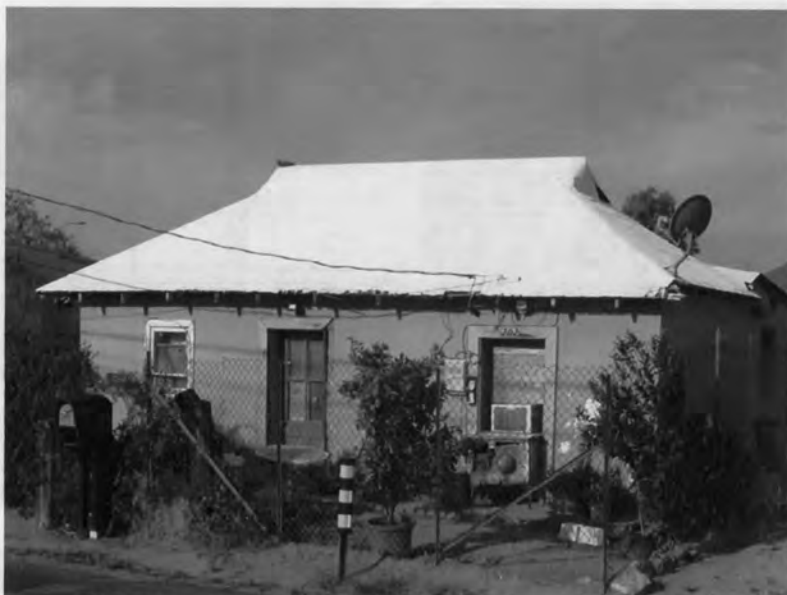
Photograph 18. 700 N. Van Alstine Ave.; view south-southwest.

With regard to the morphology of pitched roofs, hipped roofs tended to predominate in the earlier years, particularly the hipped roof with gabled vents (gable-on-hip) that was also a characteristic feature of Anglo-American dwellings at that time (Photograph 18). From the late 1910s, gabled roofs became more common, with a low pitch that indicates influence of Craftsman Bungalow models (Husband 1988).

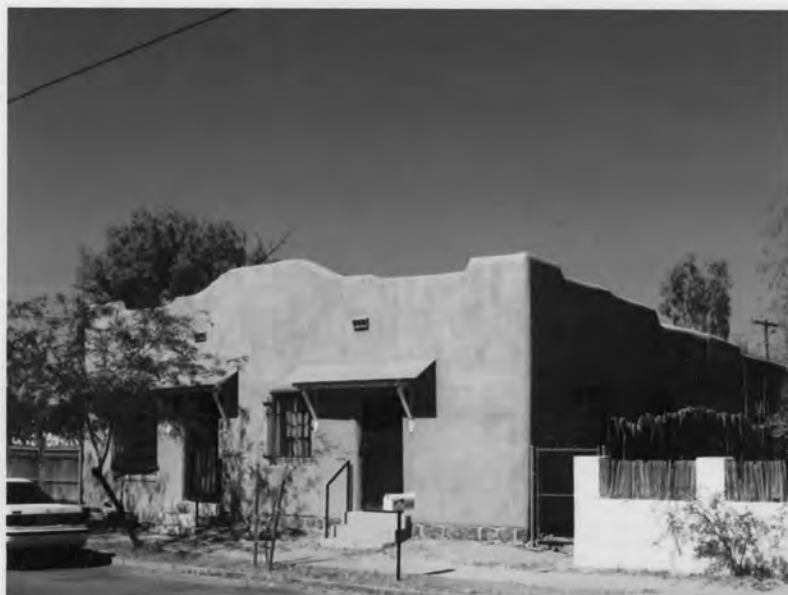
Photograph 22. 1000 N. Anita Ave.; view north-northeast.

By the mid-1910s, asphalt roofing was available, which obviated the disadvantages of the traditional earthen roof, while at the same time the influence of the Mission/Spanish Colonial Revival style filtered down to the barrios (as a fashion for flat-roofed parapeted dwellings, in a case of what could be called reverse osmosis). The result was a new generation of such dwellings, typically with stepped or curvilinear parapets, illustrated by 1000 Anita (Photograph 22).

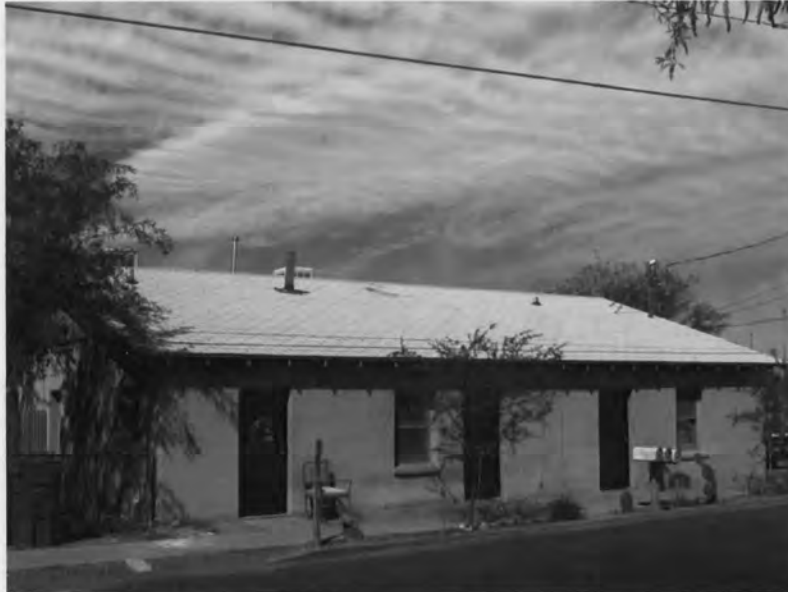
Photograph 23. 709-713 N. Anita Ave.; view west-northwest.

In its suburban form, the Sonoran row house was subject to incremental modular change in the traditional manner. The surviving examples of three-or-more-unit dwellings in Barrio Anita began with one or two units to which additional units were added incrementally. The only extant Sonoran row house in the barrio that had more than three units is 515 Oury (Photograph 2). In this case, the westernmost unit was built first, ca. 1900, and a second unit was added before 1919; in the 1930s (reflecting the straitened circumstances of the Depression era) these two units were subdivided, for a total of four units. A typical three-unit Sonoran row house is 709-713 Anita (Photograph 23); in this example, two units were built ca. 1925 and a third was added ca. 1930.

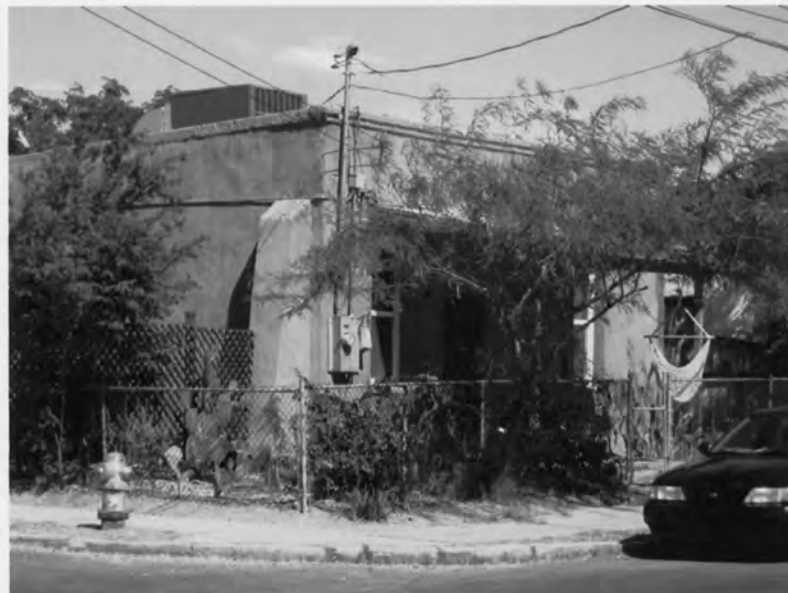
Photograph 24. 798 N. Contzen Ave.; view east-southeast.

Obviously, Barrio Anita's builders borrowed much from prevailing Anglo-American styles. Yet the basics of adobe construction are evident in the barrio's contributing dwellings, in the thickness of the walls and in elements such as buttresses added to provide structural support, as seen on the corner of 798 Contzen (Photograph 24). It is ironic that mock-buttresses added to brick walls for picturesque effect were a popular feature of "Spanish"-style dwellings in Tucson's Anglo-American suburbs.

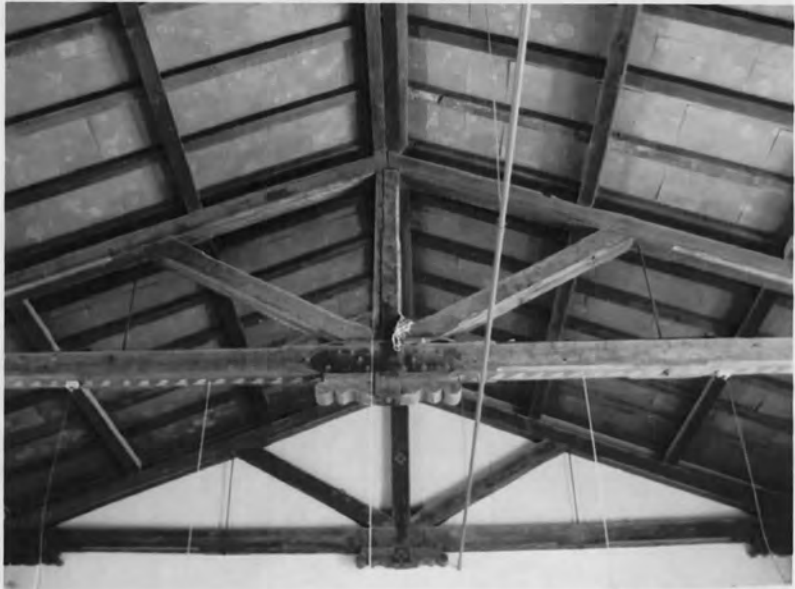
Photograph 25. Oury Center, 600 W. St. Mary's Rd.; interior, view north-northeast.

buildings were constructed of adobe because it was still a viable building tradition and its labor-intensive nature made it appropriate for work-relief projects (Henry 1991; Works Progress Administration 1936). The interior is particularly impressive, with its chip-carved polychrome roof timbers (Photograph 25). On the south, in a lower shed-roofed portion, are the library and kitchen.

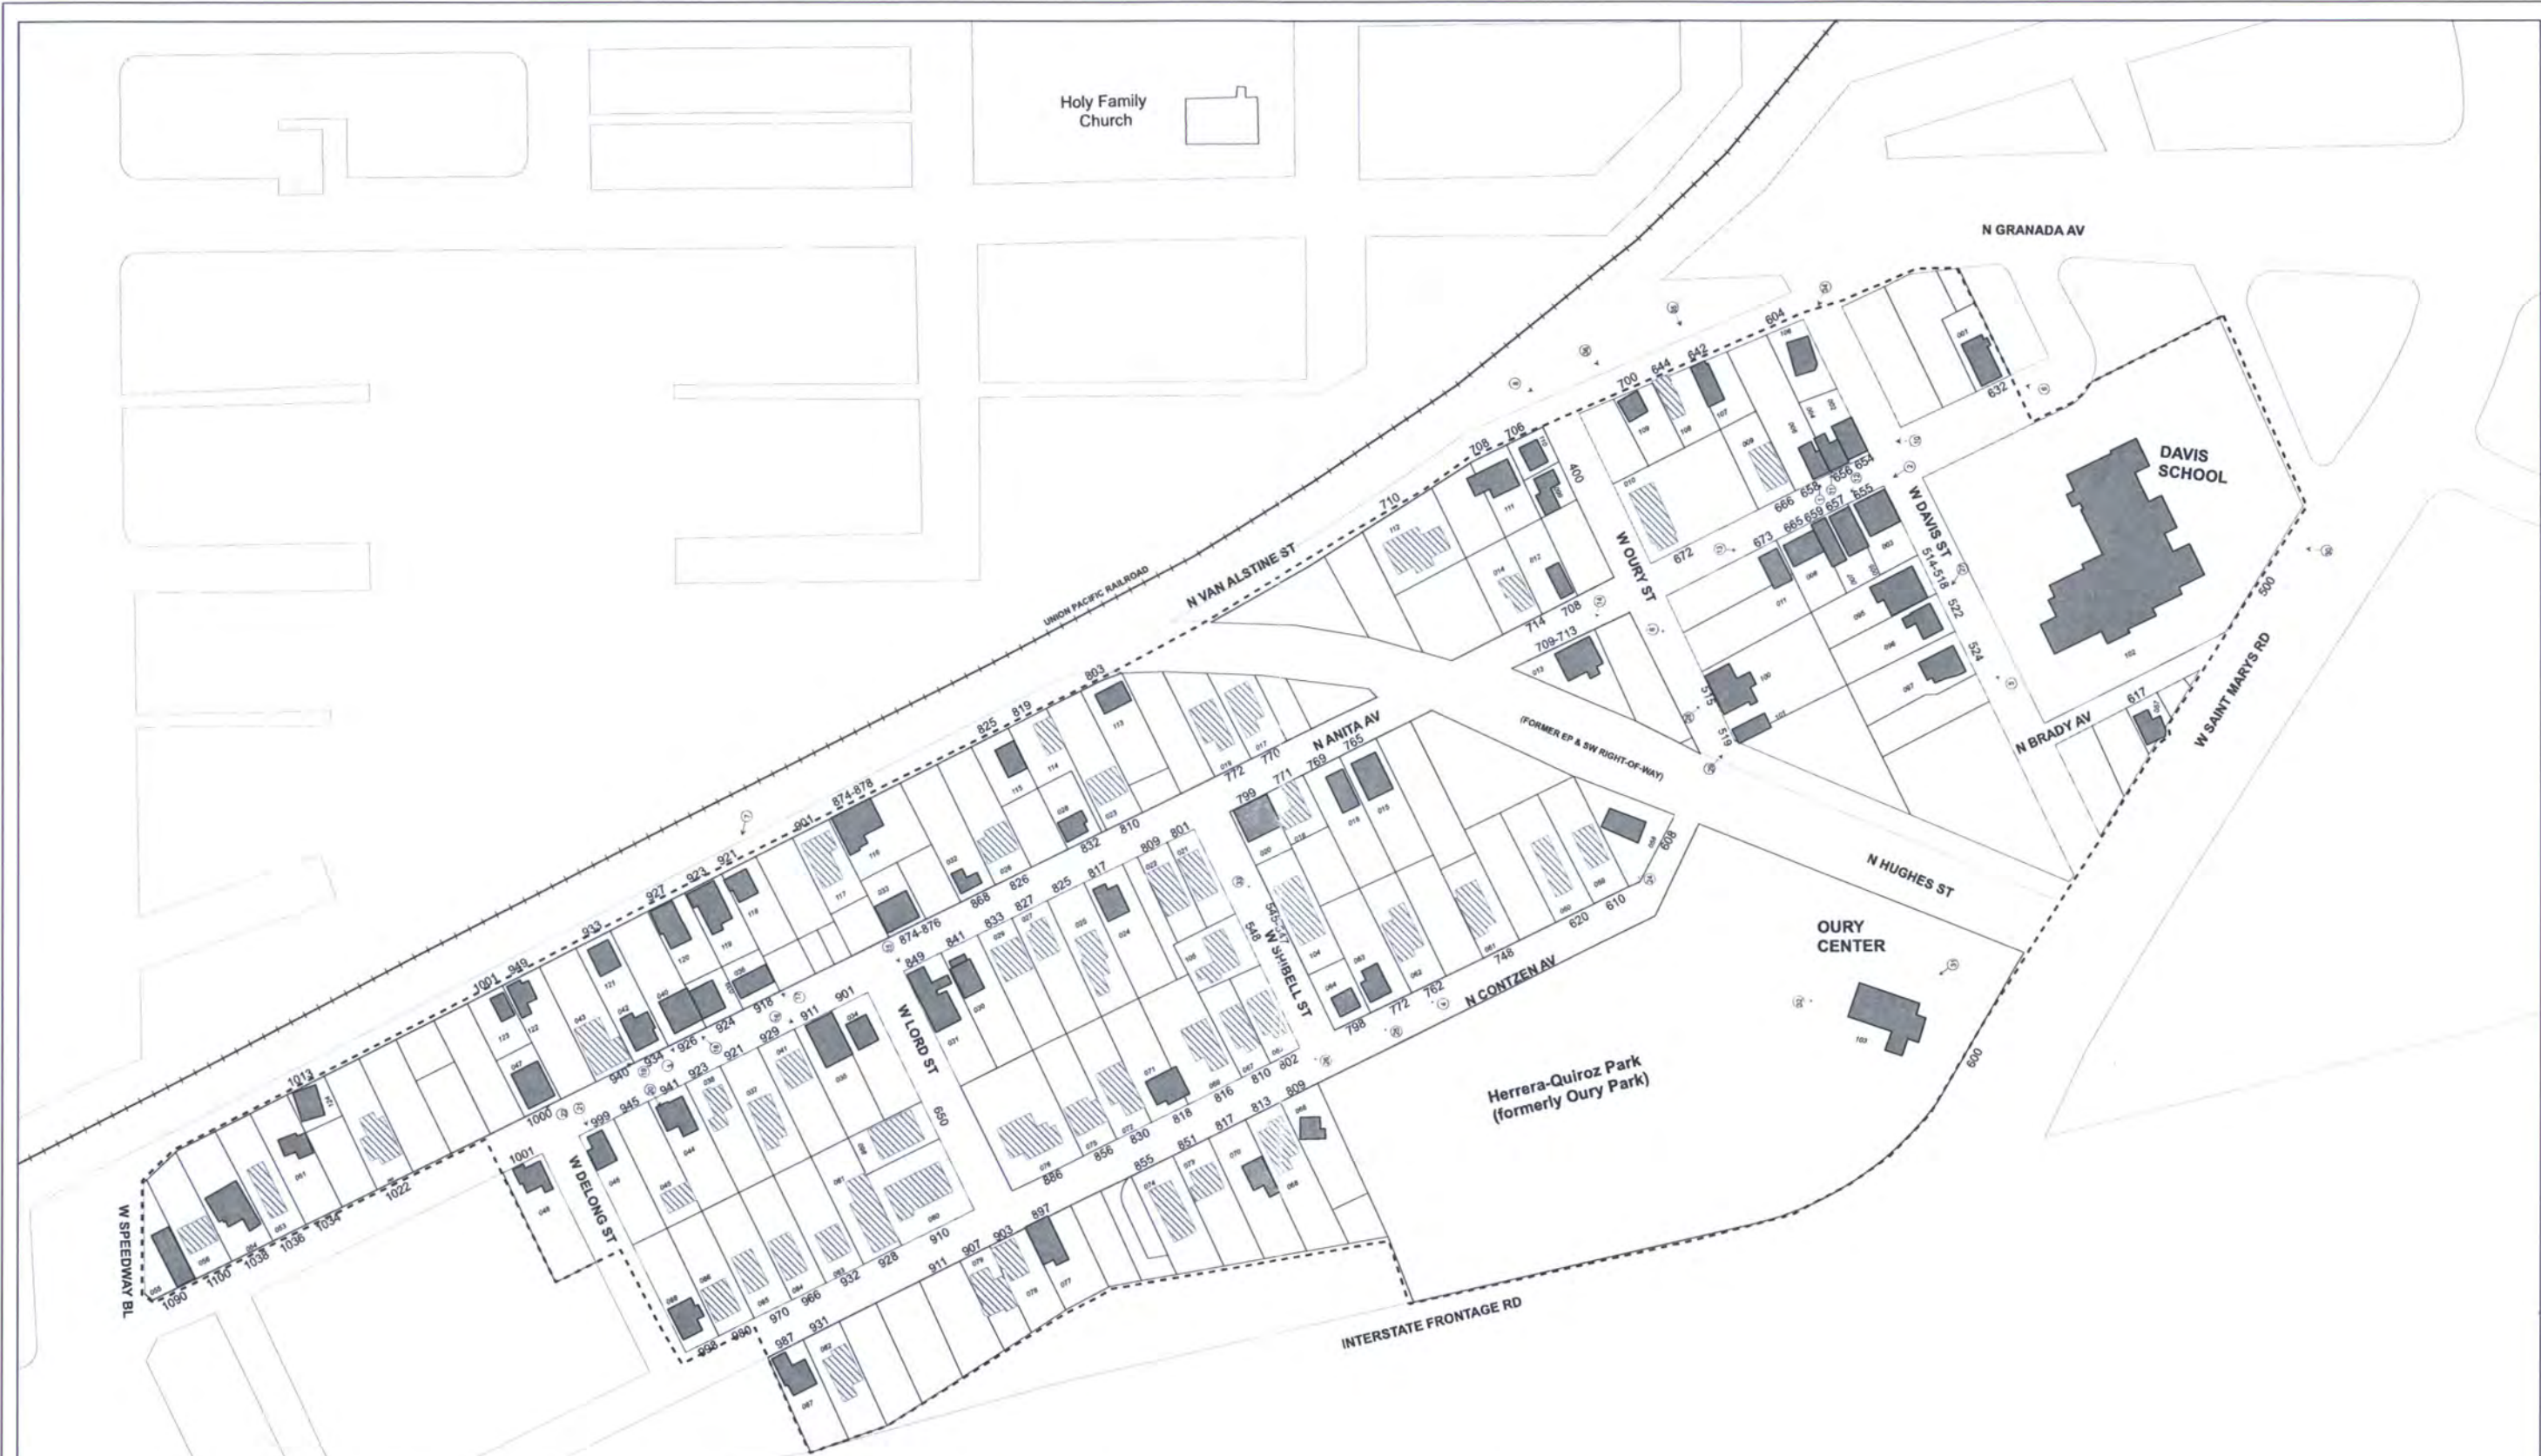
BARRIO ANITA HISTORIC DISTRICT

District Boundary
 Noncontributing Property
 Contributing Property
 001 Survey Site Number
○● Photo Vantage Point
0 50 100 200 Feet
↶
