**National Register of Historic Places
Inventory—Nomination Form**

historic Alberry Wasson Homeplace

ALBERRY WASSON HOMEPLACE
CLAIBORNE PARISH, LA

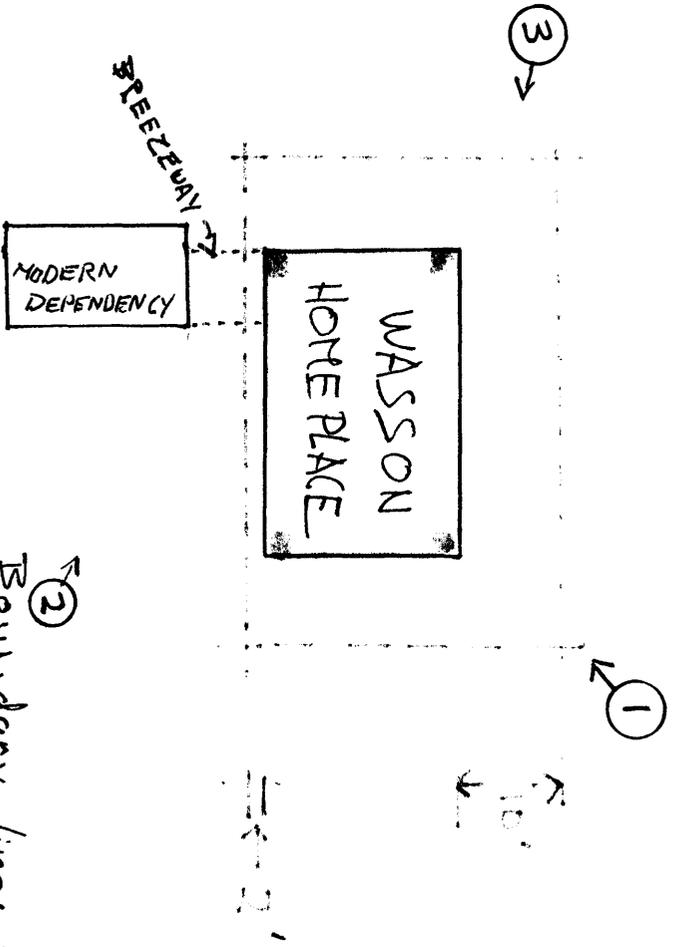
APPROX 1/8 ACRE

② Boundary lines parallel the house facades at distances shown.

Please refer to enclosed sketch map. The boundaries were chosen to discretely encompass the significant resource. The building was moved to its present location; hence there is no historic setting to recognize. The boundaries cut closely around the house to the rear in order to exclude a modern rear dependency which has been connected to the house by a breezeway. The dependency duplicates the appearance of the kind of late-nineteenth century kitchen dependency which was often appended to a house of this type via an open breezeway. In our opinion, the kitchen has not adversely affected the house's historical appearance because the original house stands forth.
