NOMINATION: Historic Resources of Challis (Partial Inventory: Architectural Properties)SITE NAME: Old Challis Historic District SITE # 1LOCATION: Block 36, Challis, IdahoOWNER'S NAME AND ADDRESS: See attached owners listQUADRANGLE AND SCALE: Challis 15 minute ACREAGE: less than oneVERBAL BOUNDARY DESCRIPTION: The Challis Historic District includes lots 1, 2, 3, and T-275 in block 36, Challis; see enclosed sketch map.UTM(S): 11/7,19,725/49,31,325DATE OR PERIOD: 1876-1890's EVALUATED LEVEL OF SIGNIFICANCE: localAREAS OF SIGNIFICANCE: architecture

NATIONAL REGISTER OF HISTORIC PLACES INVENTORY -- NOMINATION FORM

Old Challis Historic District, Site #1

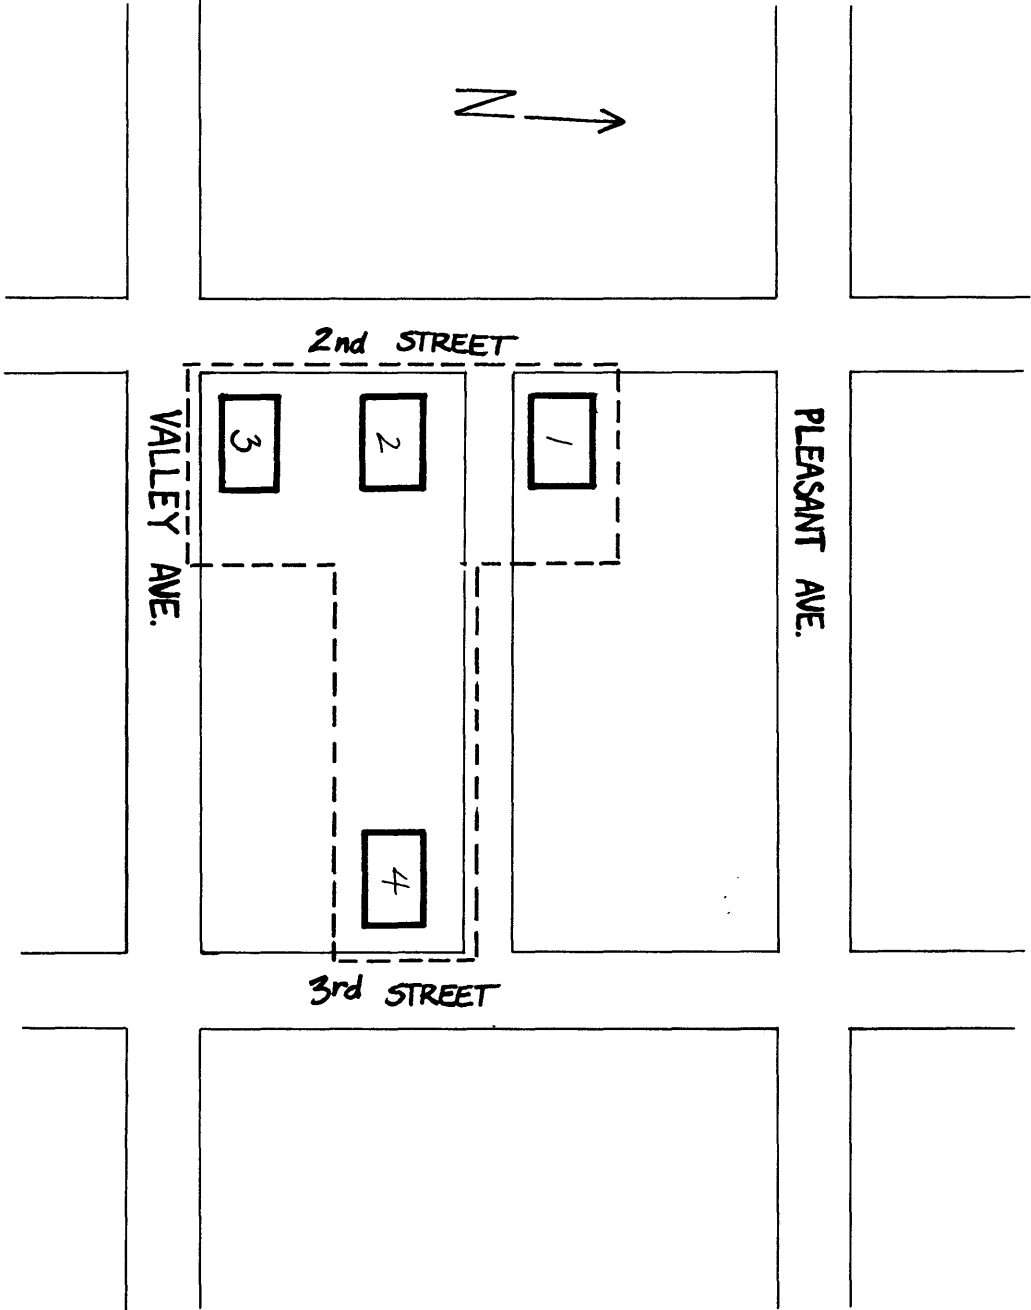
OLD CHALLIS

HISTORIC DISTRICT

CHALLIS, IDAHO

NOT TO SCALE - 1980

DISTRICT BOUNDARY - - - - -

The Old Challis Historic District includes three log houses and one board-and-batten house lying within a half block on the southern side of Challis in an area identified locally as the oldest section of town. The four buildings line Second and Third avenues and are separated by the interior of the half block, which is overgrown with period plantings. The buildings remain in fair condition and are potentially preservable for the interpretation of folk architecture. The district is surrounded by vacant lots, altered houses from the period under consideration, and much newer trailers and tract housing. There are no intrusions.
