National Register of Historic Places
Registration Form

1. Name of Property Arizona Hotel

Arizona Hotel
Pima County, Arizona

NARRATIVE DESCRIPTION

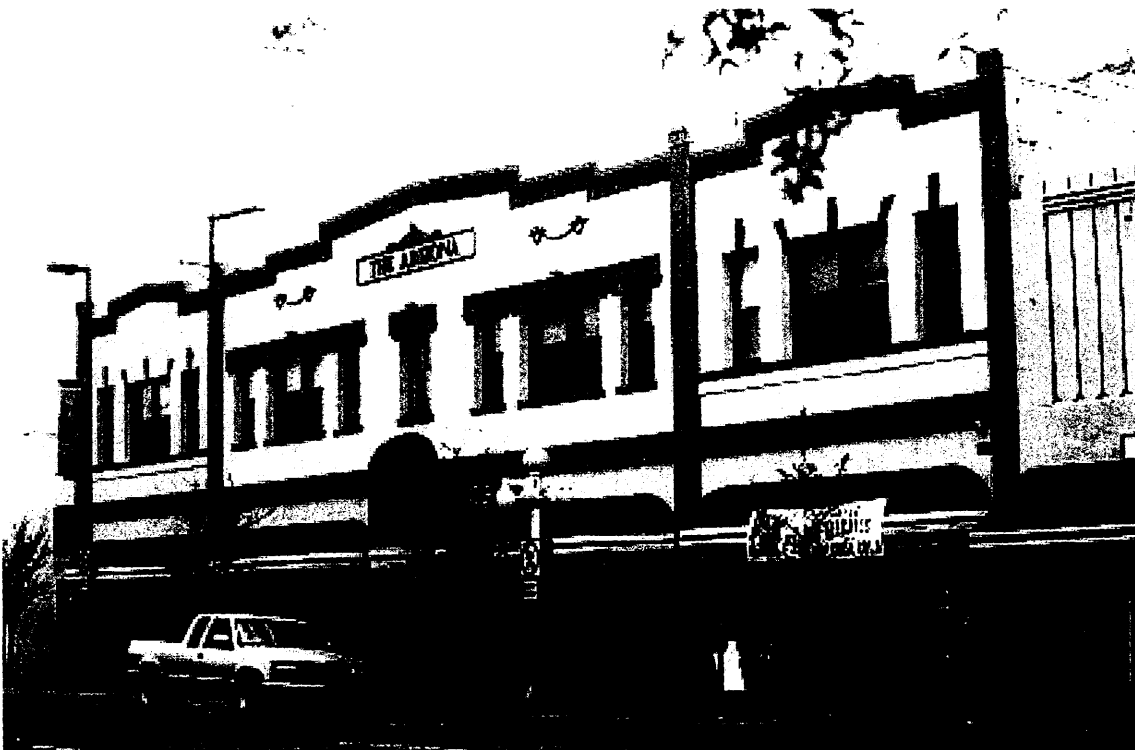
PHOTO #1: Sixth Avenue (east) façade; looking SW

The principal façade faces east and Sixth Avenue, and is composed in a restrained Neoclassical Revival style. The four-bay structural bay composition of the ground floor facade is transformed to a three-bay composition of the second story façade, with the central bay of the second story resting above the middle bays of the ground floor. The ground floor façade contains a series of storefront bays with recessed entries all glazed with plate glass framed with terracotta tile. Each of the storefronts and the hotel entrance have protruding fabric awnings that have been added in the last five years. The dominant second floor façade is symmetrical in design with three bays defined by decorative pilasters that extend to the ground and pediment centered on each bay. The wide central bay is marked by a single window in the center of the façade over the hotel entry and was once accentuated by a sheet metal and neon marquee with the name "Arizona Hotel". The single, central window is balanced by two sets of window ensembles, each with a paired window flanked by single windows. The central bay is also accentuated by its decorative features, including molded surrounds above the windows with ornamental keystone detail on the central and flanking window ensembles. Above the central window is the building name plate with a raised molding and letters spelling "The Arizona". Above each of the central bay window ensembles is a decorative swag. The secondary bays, at either end of the façade, are each defined by another window ensemble. These windows are accentuated by painted keystones above each of the ensemble's windows. The windows in the central bay have cast concrete sills while those of the secondary bays have corbelled sills. The top of the building is marked by a stepped parapet with a cap row and four cast concrete capped pilasters. Applied to each of the pilasters is a cast
