NATIONAL REGISTER OF HISTORIC PLACES REGISTRATION FORM

historic name: Horse Barn

other name/site number: HS-48

street & number: Bryce Canyon National Park

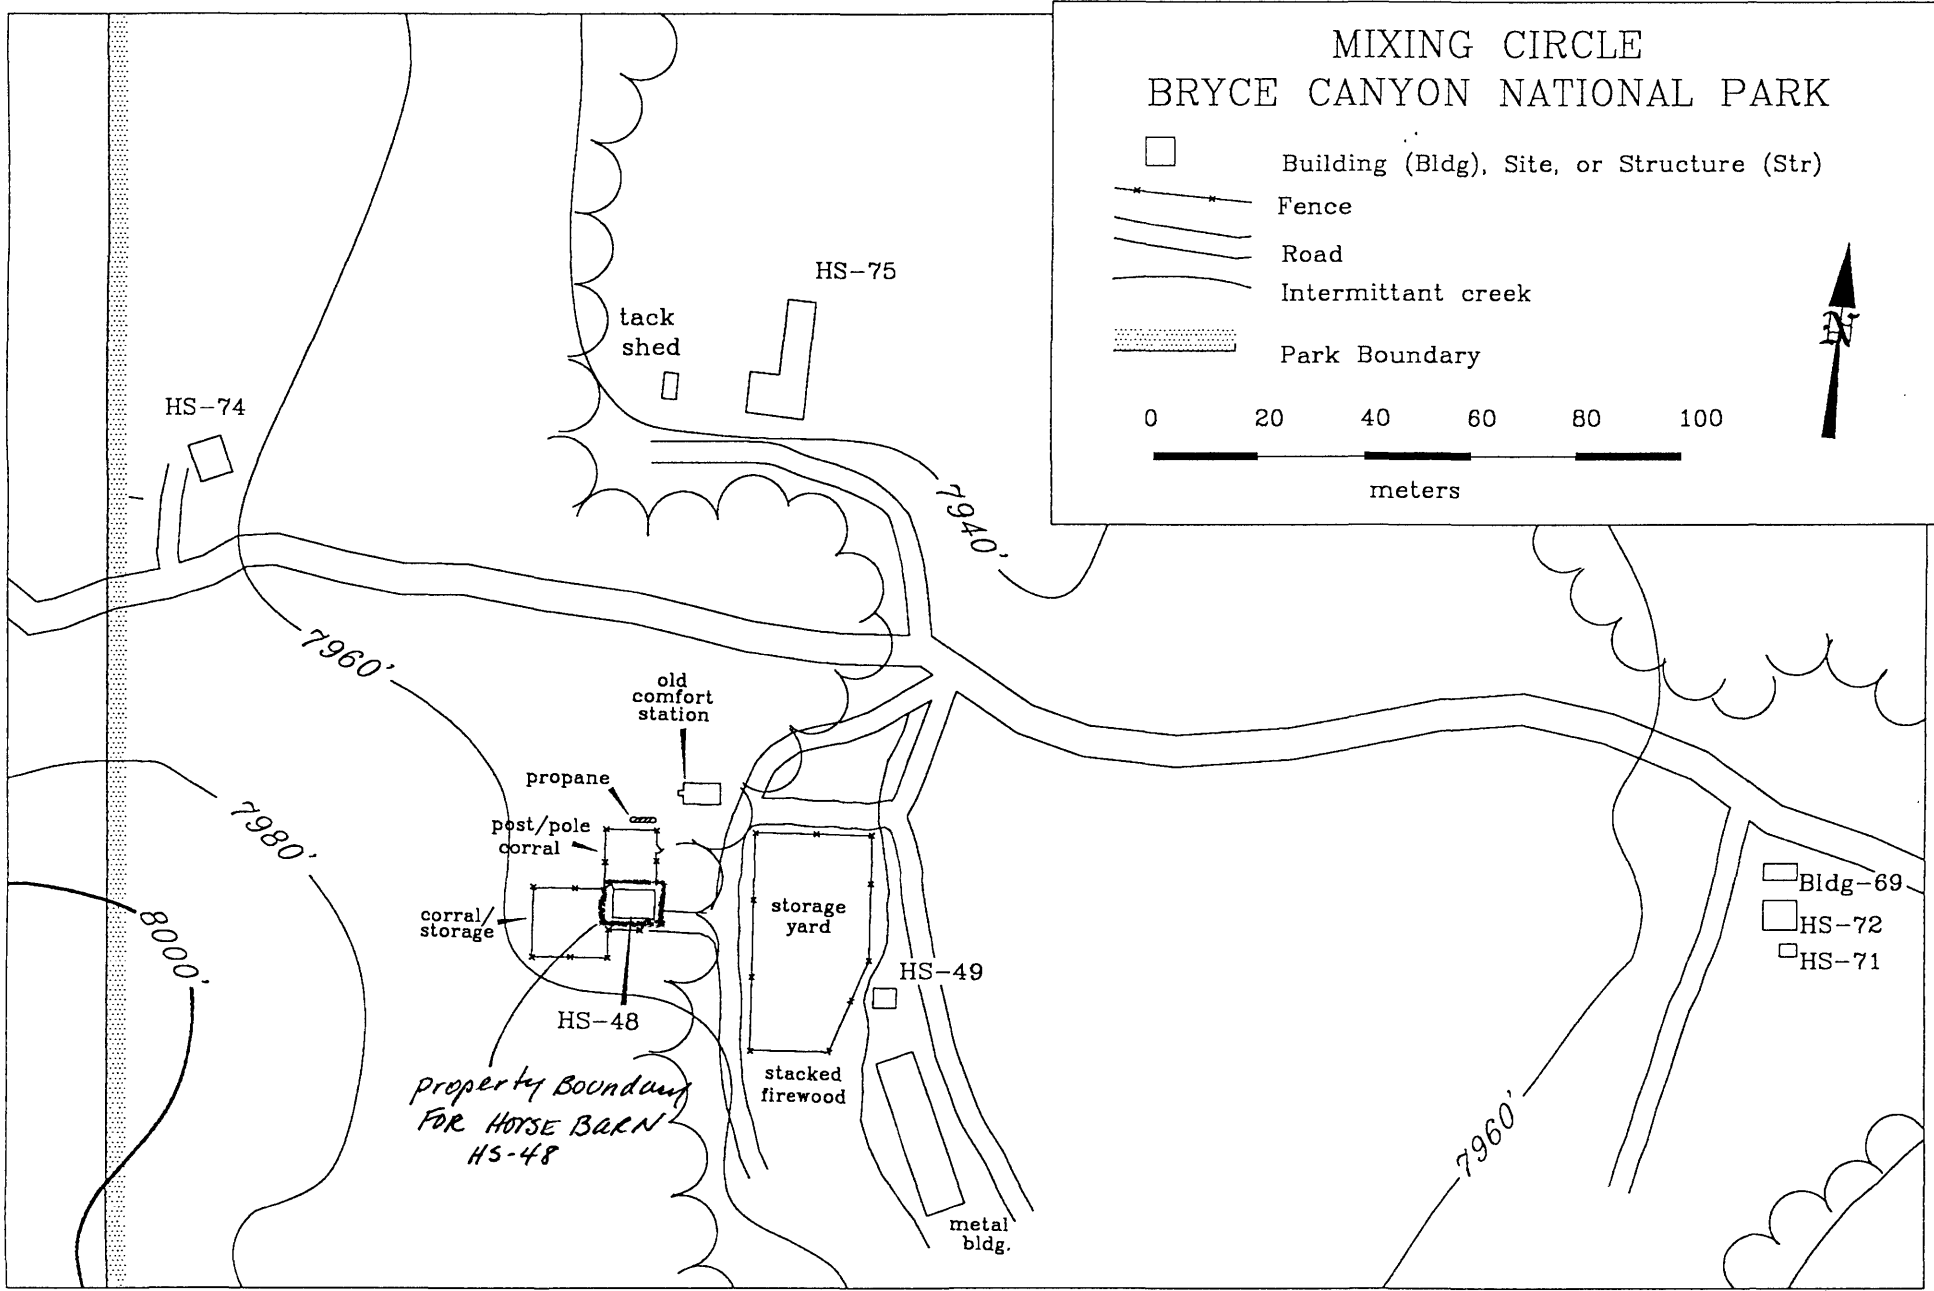
MIXING CIRCLE BRYCE CANYON NATIONAL PARK

The horse barn is located within the mixing circle. The mixing circle currently contains a collection of both National Park Service (NPS) and Utah Parks Company (UPC) buildings, moved to the area beginning in the 1950s.¹ The horse barn (constructed by the NPS) is located at the east edge of a low, timbered knoll -- at the west edge of the mixing circle. A system of pole corrals is located adjacent to the north and west sides.
