KENTUCKY HISTORIC RESOURCES
Individual Inventory Form

Resource # KE-3
Kenton County

1. Name of Resource:
Pleasant Run Stone House II

Resource # KE-3

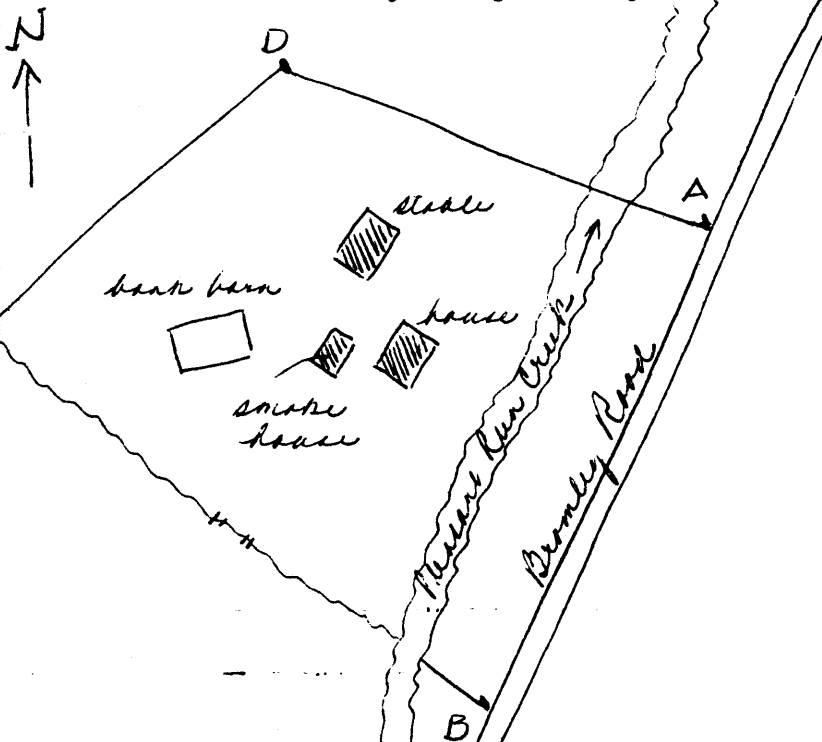
44. Site Plan (and boundary description and justification for N.R. sites):

Site enclosed A - B - C - D as shown, which is the present property line. A - B is on the road, and B - C is with a small branch.

Stone house, smokehouse and stable are contributing. Bank barn is non-contributing because of alterations.

3 contributing buildings
