National Register of Historic Places Registration Form

Historic name: James Farm

Other names/site number: Possums Rest, The William Russell House; DHR#053-0739

Street & number: 15021 Mountain Road

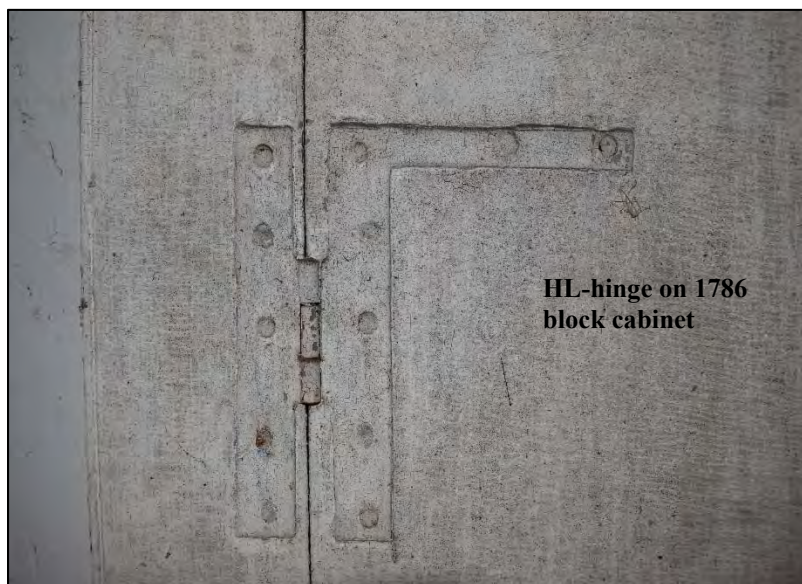
Figure 2: HL-Hinge, 1786 Block Cabinet

A large, full paneled chimneypiece with a simply molded mantel is located in the center of the main block's western wall. This suggests that the mantel was updated in the mid-to-late 19th century, as it does not match common designs and trends of the late-18th century. On either side of the fireplace are two built-in cabinet and storage spaces. The cabinet to the right, situated between the fireplace and an enclosed winder staircase, is accessed by opening a vertical-board door. The cabinet on the left is divided into two levels; the upper has wooden shelves, closed in by a wooden door with nine lights, while the lower portion is without shelving and is enclosed by a small, paneled wooden door. The enclosed staircase has a simple vertical plank door with original HL hinges. The presence of these original late-18th- to early-19th-century finishes, which are all still in excellent condition, adds to the dwelling's integrity and architectural importance. Original door hardware is found throughout the 18th- and 19th-century sections, including the original late-18th-century strap and HL-hinges situated on cabinets and doors, as shown below.

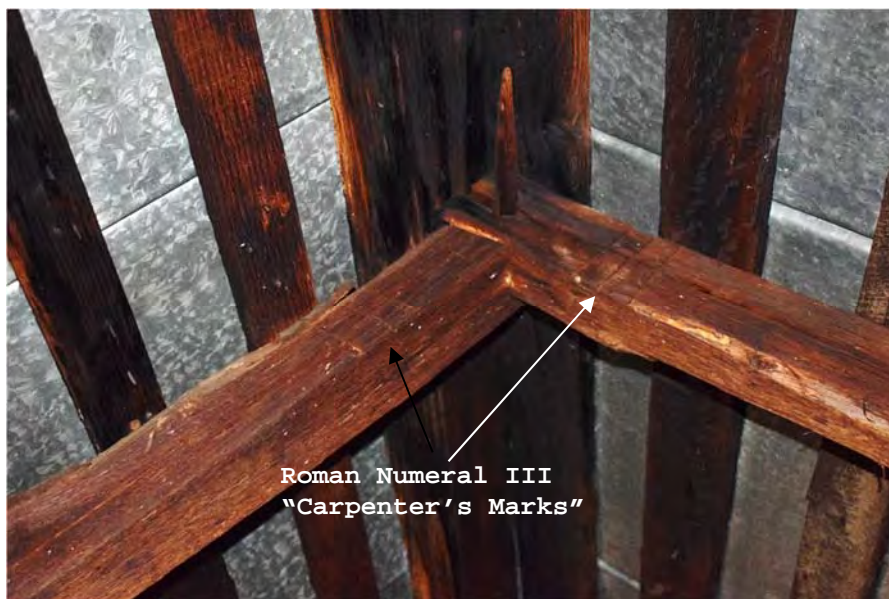
Figure 3: Attic Carpenter's Marks

The attic features wooden beams connected at the roof pitch to form the two side-gables. The beams are pegged with mortise-and-tenon joinery and feature “carpenter’s marks” in Roman numerals at their highest points. (Figure 3). The original interior stone chimneys are present and exposed on the western and eastern walls of the attic, with the eastern chimney being plastered over.

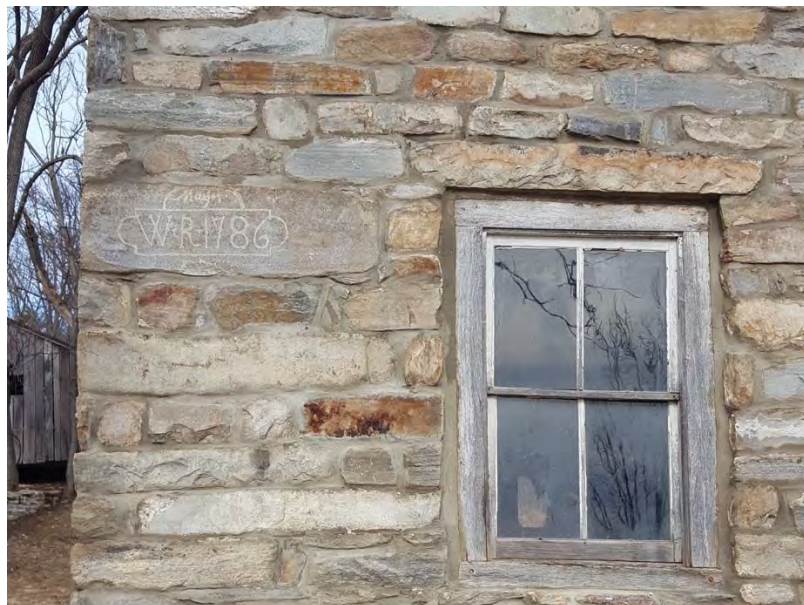
Figure 5: Date stone on façade of stone house, inscribed, “May 17 W.R. 1786.” Photo by author.
