# National Register of Historic Places Registration Form

Historic name: Hobart Commercial District

City or town: Hobart State: Indiana County: Lake

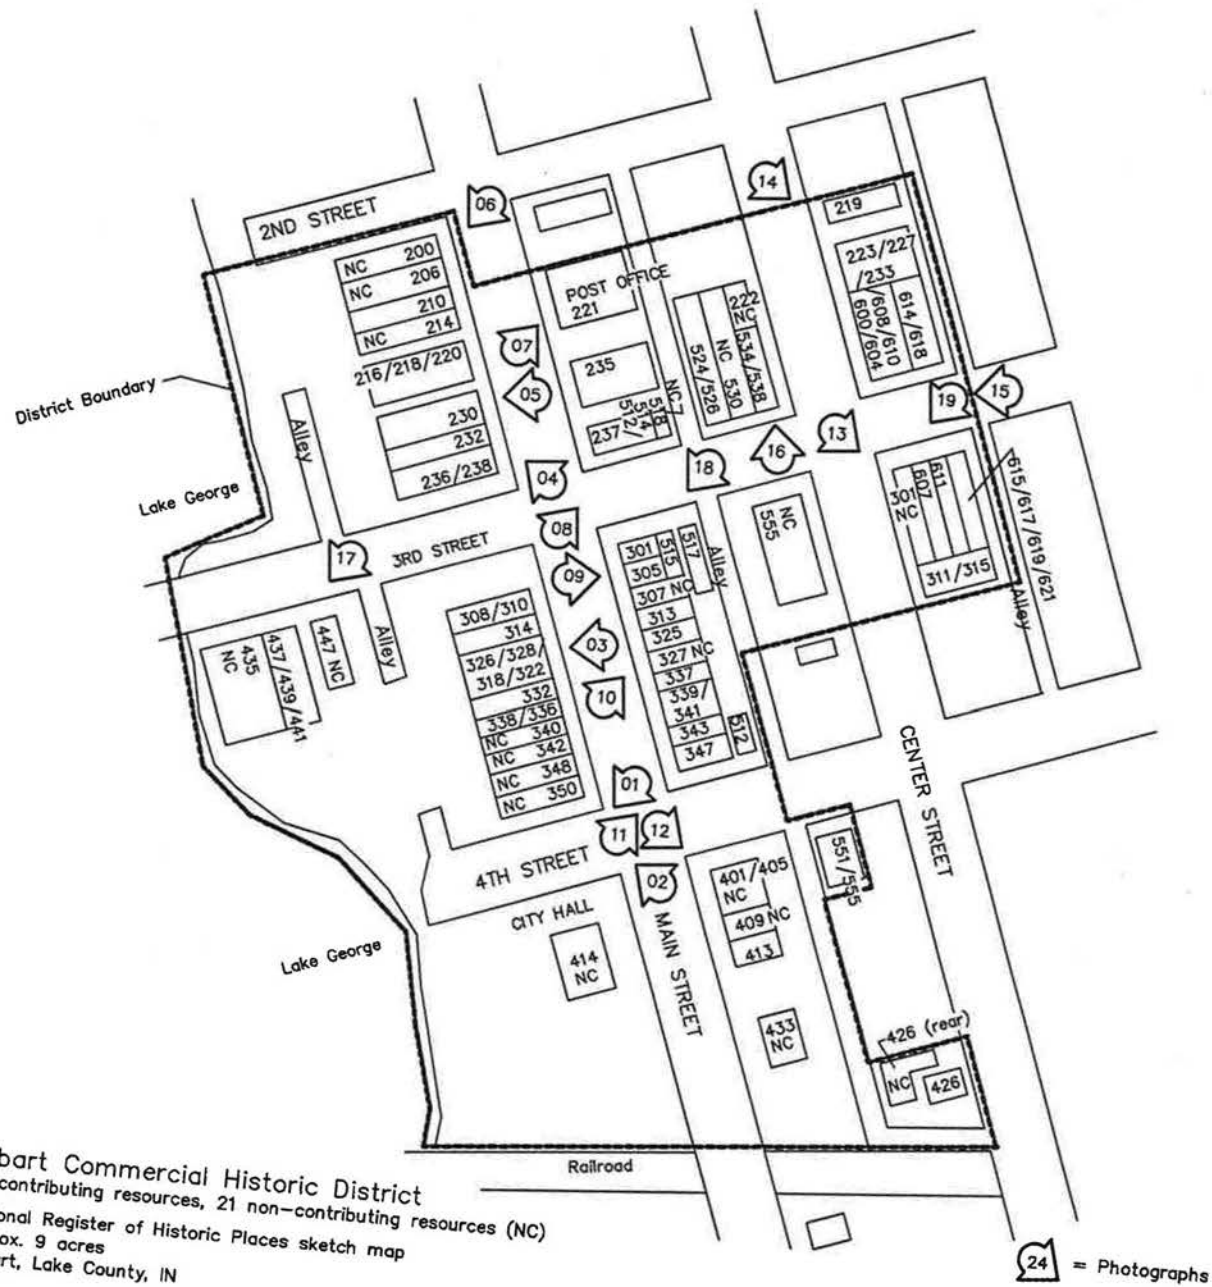
Hobart Commercial Historic District  
 38 contributing resources, 21 non-contributing resources (NC)  
 National Register of Historic Places sketch map  
 Approx. 9 acres  
 Hobart, Lake County, IN
