National Register of Historic Places Registration Form

historic name Beauchamp Building

street & number 395 North Third Avenue

city or town Stayton

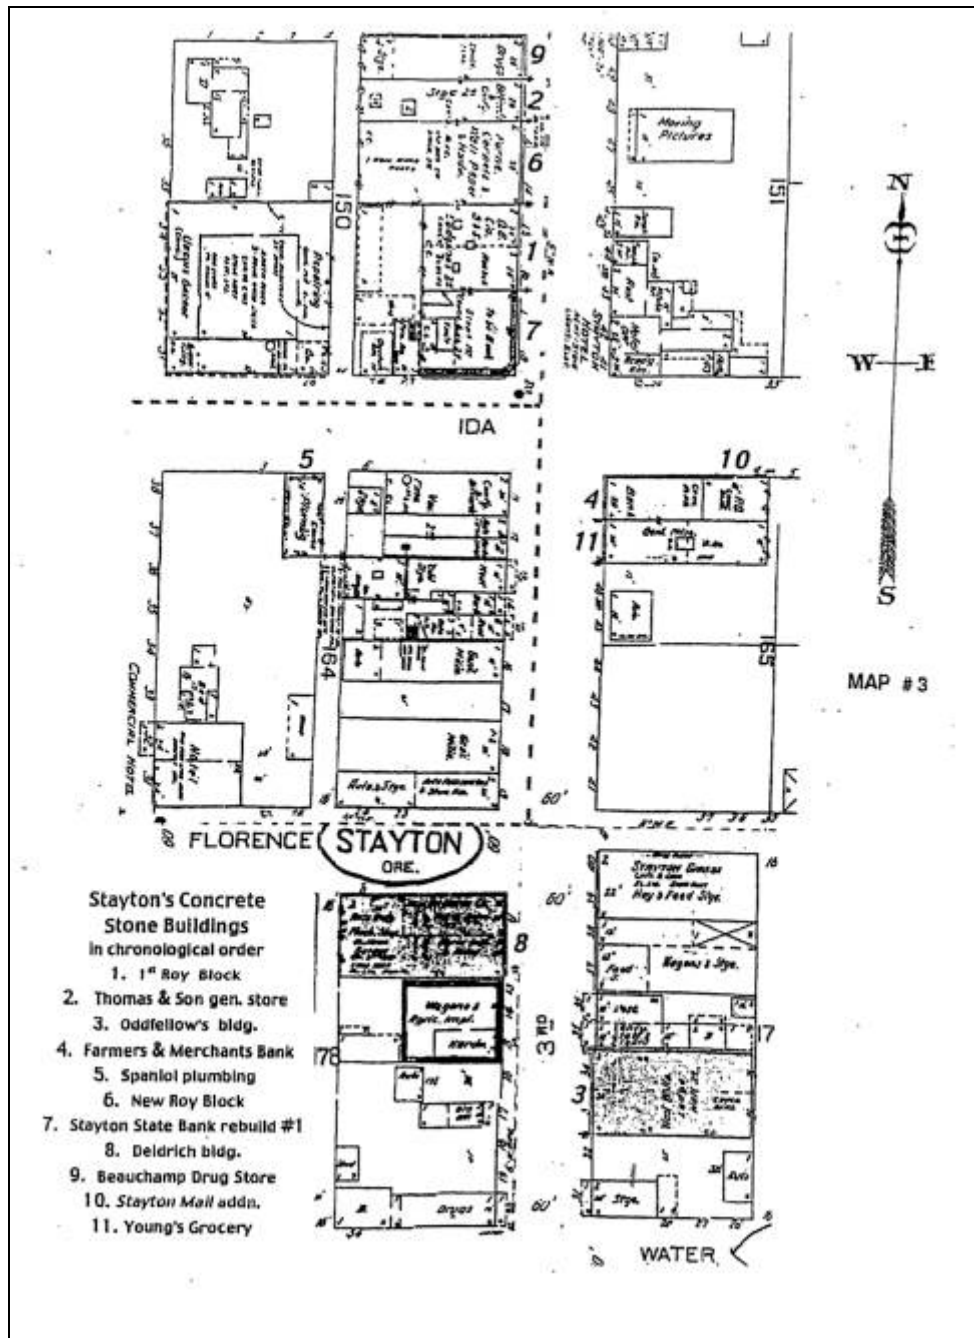
Figure 11: Map#2. Sanborn Fire Map 1913: The Beauchamp Building is labeled #9: Drugs: Dance Hall.

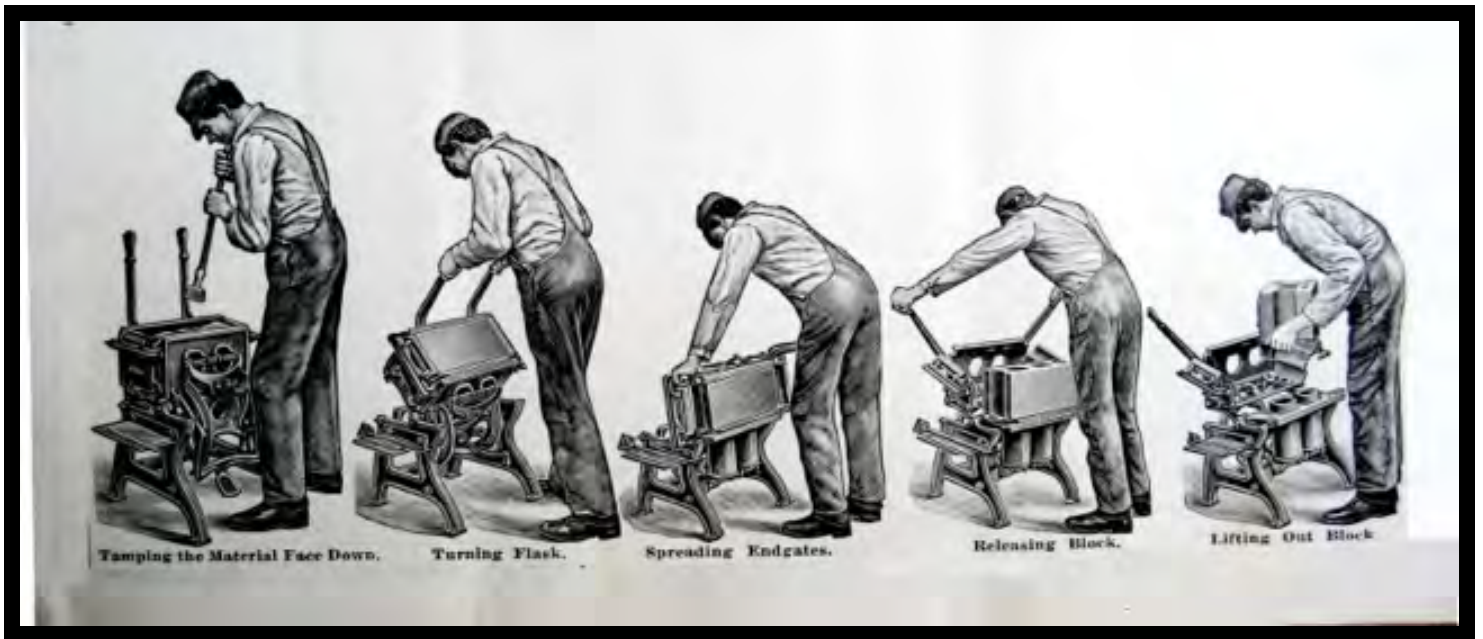
Figure 14: Sample of concrete block-making machinery popular in the early teens of the 1900s.

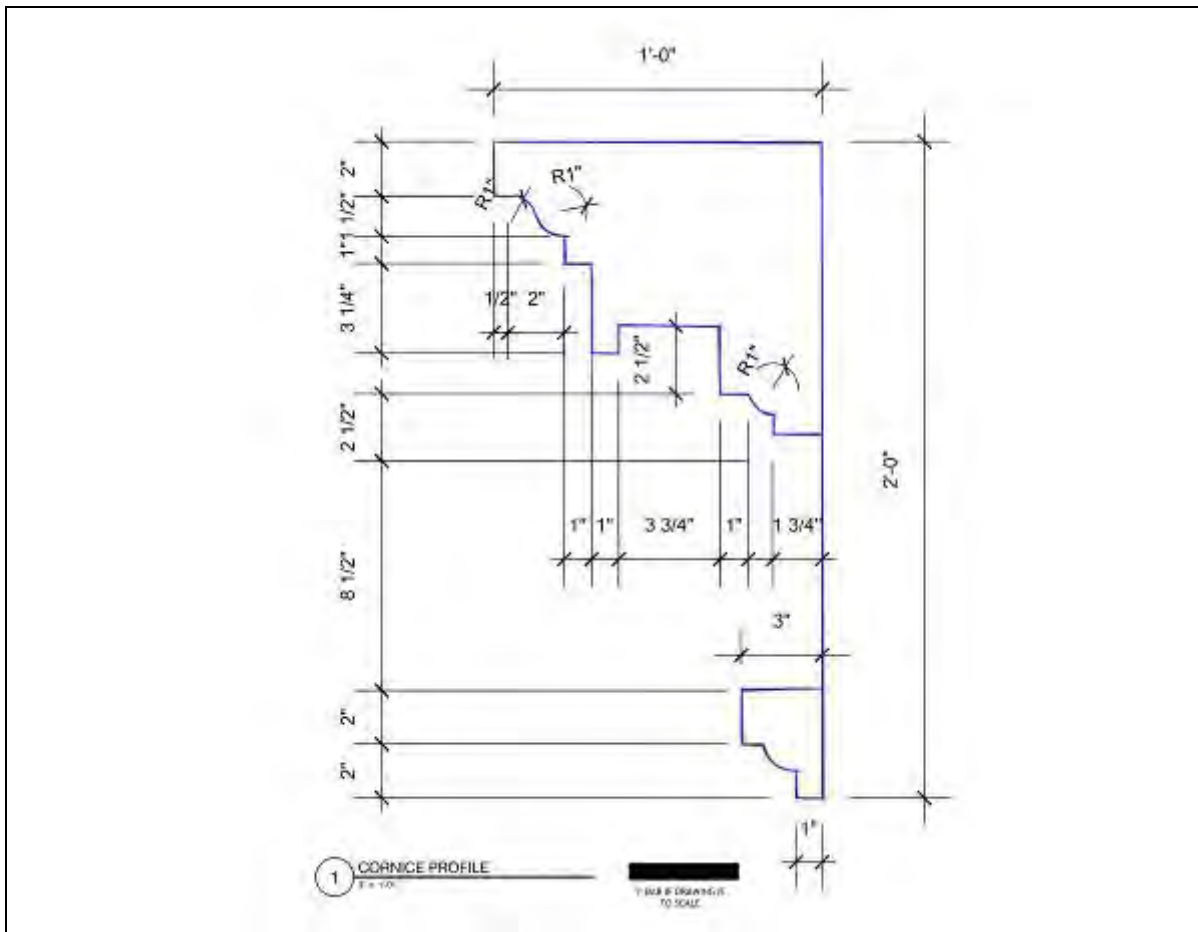
Figure 18: Cornice Drawing to be installed 2019.

The one embellishment missing is the tin cornice. The shape of the metal cornice is known only from historic pictures. It was installed as the building was laid, the three courses of block behind it are rougher than the rest and have open slots for supporting the cornice at regular intervals. It was three blocks high (twenty four inches) and protruded approximately twelve inches. Running twenty-five feet on the east elevation and one hundred feet on the north elevation, it directed water hitting the upper wall away from the dentil course and the steel behind it. A galvanized steel cornice, designed by an architect (see additional information) and

engineered to attach to the building (see additional information) will be reconstructed and installed in 2019. Galvanized steel was picked over fiberglass, as it will wear more like the tin than fiberglass ever could.

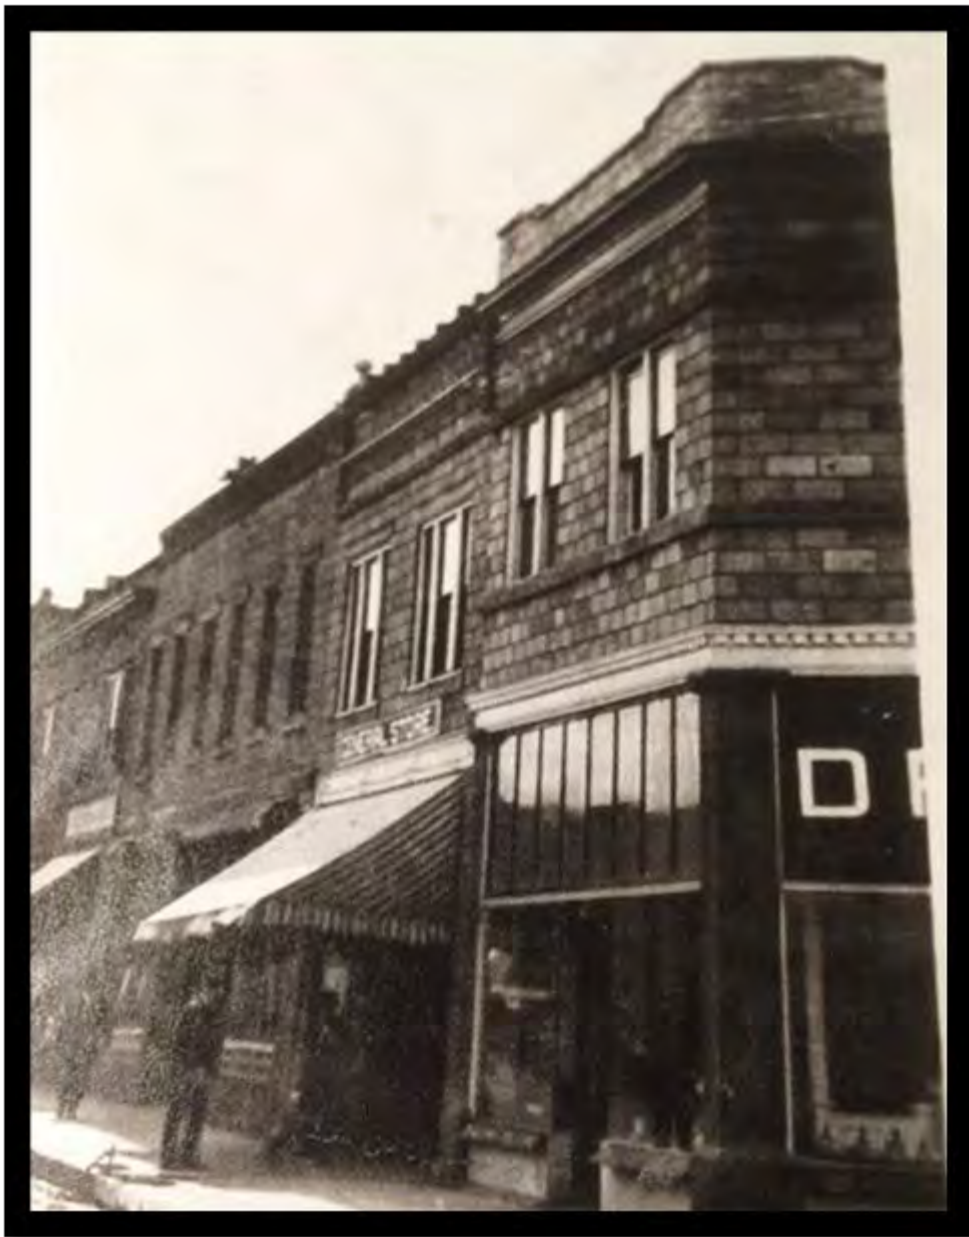
Figure 19: Photo showcasing the NE corner of the original Beauchamp Building exterior, as well as neighboring cast-block concrete buildings. Similar to the current building are the stepped parapet, concrete belt courses, dentil frieze and columns. The differences are also seen in the: color variation of concrete blocks, decorative tin cornice and original entry. View is to the south with a slight westerly angle.

The two-story Beauchamp Building's ground floor consists of plate glass windows under tall, luminous transom windows. The two exceptions to the glass are the west elevation in the alley, which is largely blank cast block, and a small section of cast block in the north elevation. Pairs of long modern I-beams, spanning up to twenty-three feet, rest on steel posts and reinforced concrete columns to carry the weight of the heavy upper block. The weight is transferred to the ground, allowing for the lavish use of glass on the ground floor. A frieze made of exterior fascia, a drip cap and a long row of dentils covers the I-beams. Taking advantage of the city view is a rhythm of paired, one-over-one windows inserted into concrete block on the second floor of the east, north and west elevations. On the upper east elevation there are two sets of windows and on the north there are six sets, with the last being a single one-over-one window. Two concrete bands, eight-inches high and protruding two-inches, cap the top and bottom of these window runs. Above the upper concrete band are eleven courses of unadorned concrete block, the middle three courses are the block that lay behind a sheet metal cornice that was removed (Compare Figure 19 and Photo 1).

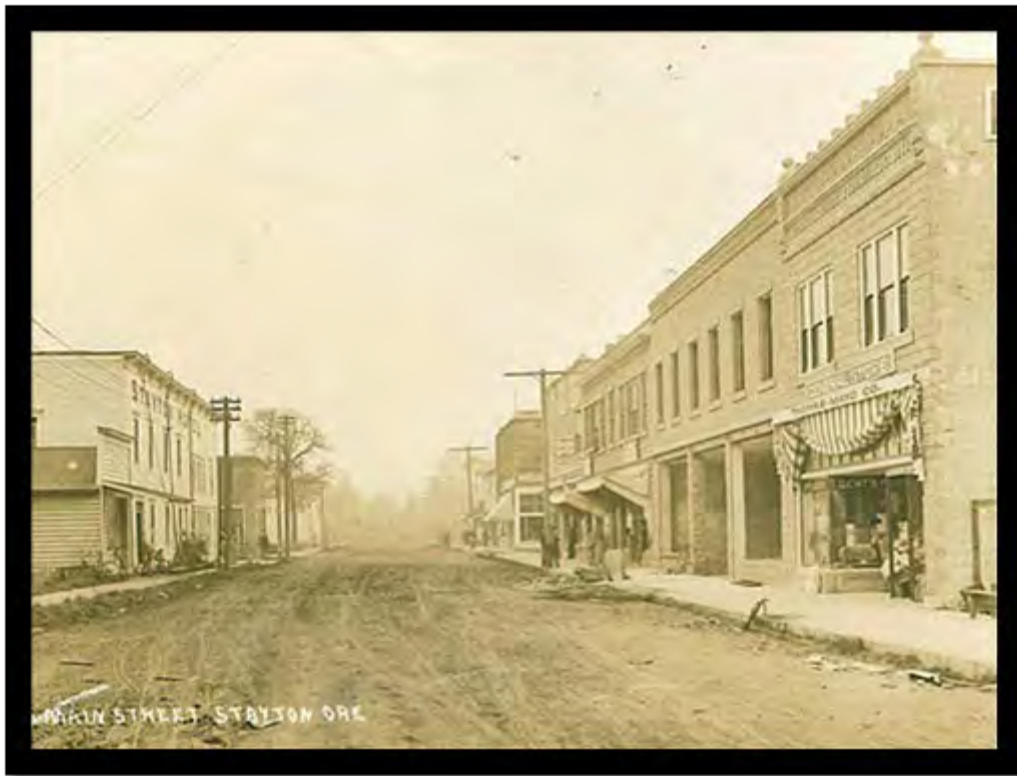
Figure 20: Historical 1912 reproduction photo showing a partial view of the future site of The Beauchamp Building, where the wheelbarrow is on the farthest right side of this image. The building with bunting is on the Thomas & Sons Building, which The Beauchamp Building abutted after construction. View is looking south near the intersection of High & Third Avenue.

- Figure 20:** Historical 1912 reproduction photo showing a partial view of the future site of The Beauchamp Building, where the wheelbarrow is on the farthest right side of this image. The building with bunting is on the Thomas & Sons Building, which The Beauchamp Building abutted after construction. View is looking south near the intersection of High & Third Avenue.

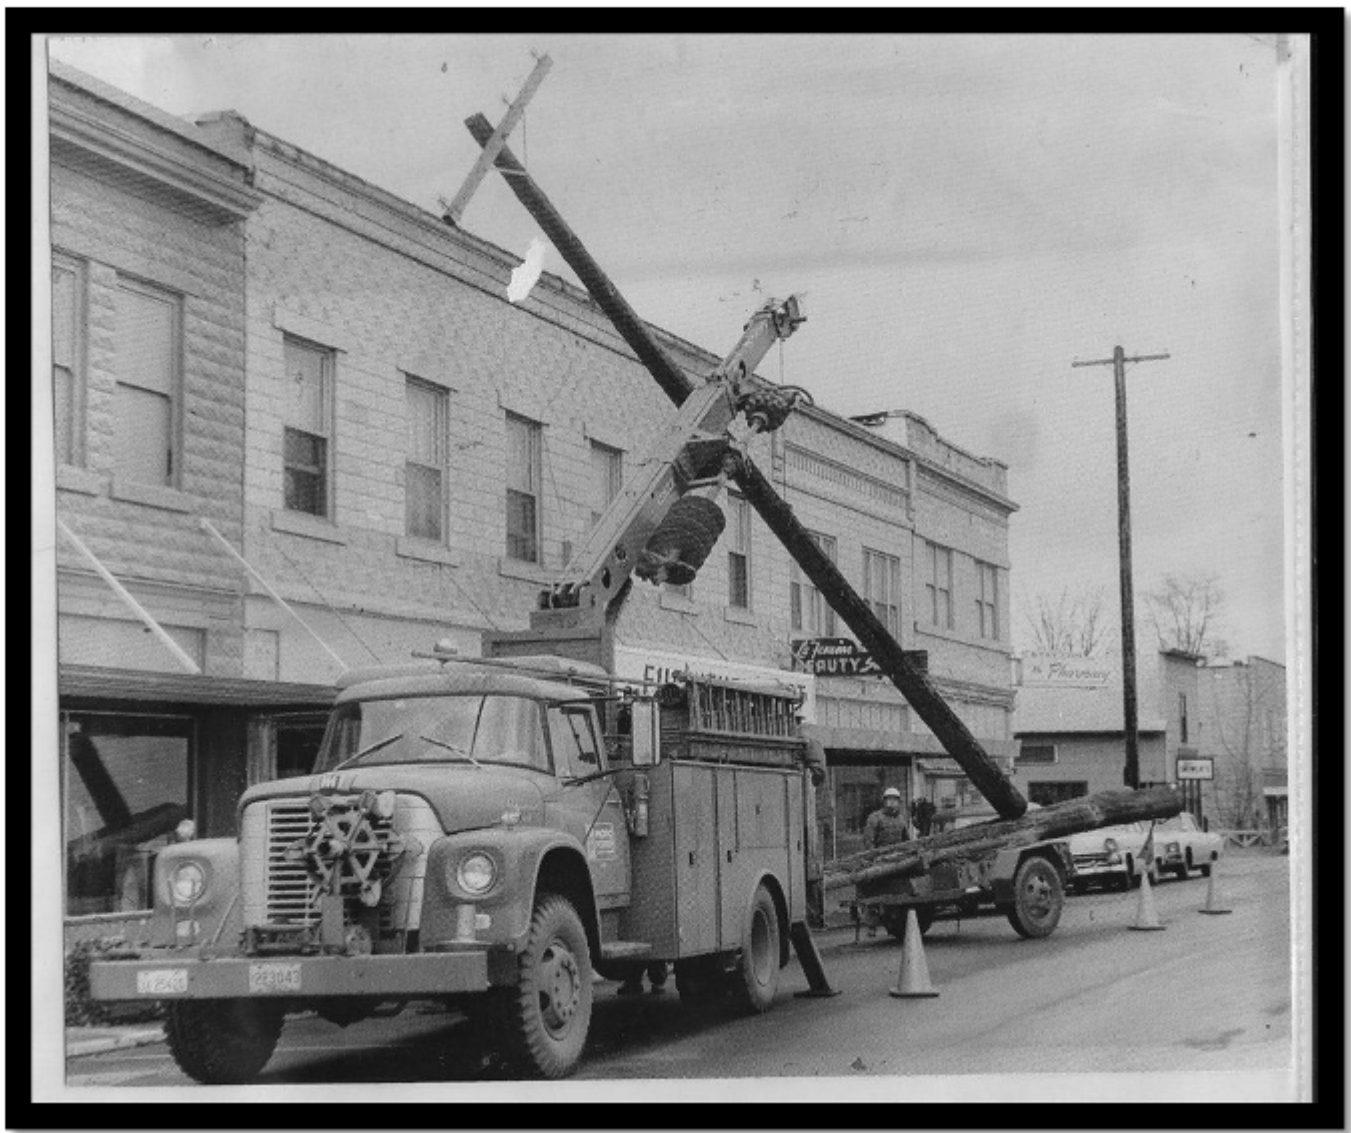
Figure 21: The Beauchamp Building and the three buildings to its South, of notice are the painted transoms. View is to the north along Third Avenue with a slight westerly angle.

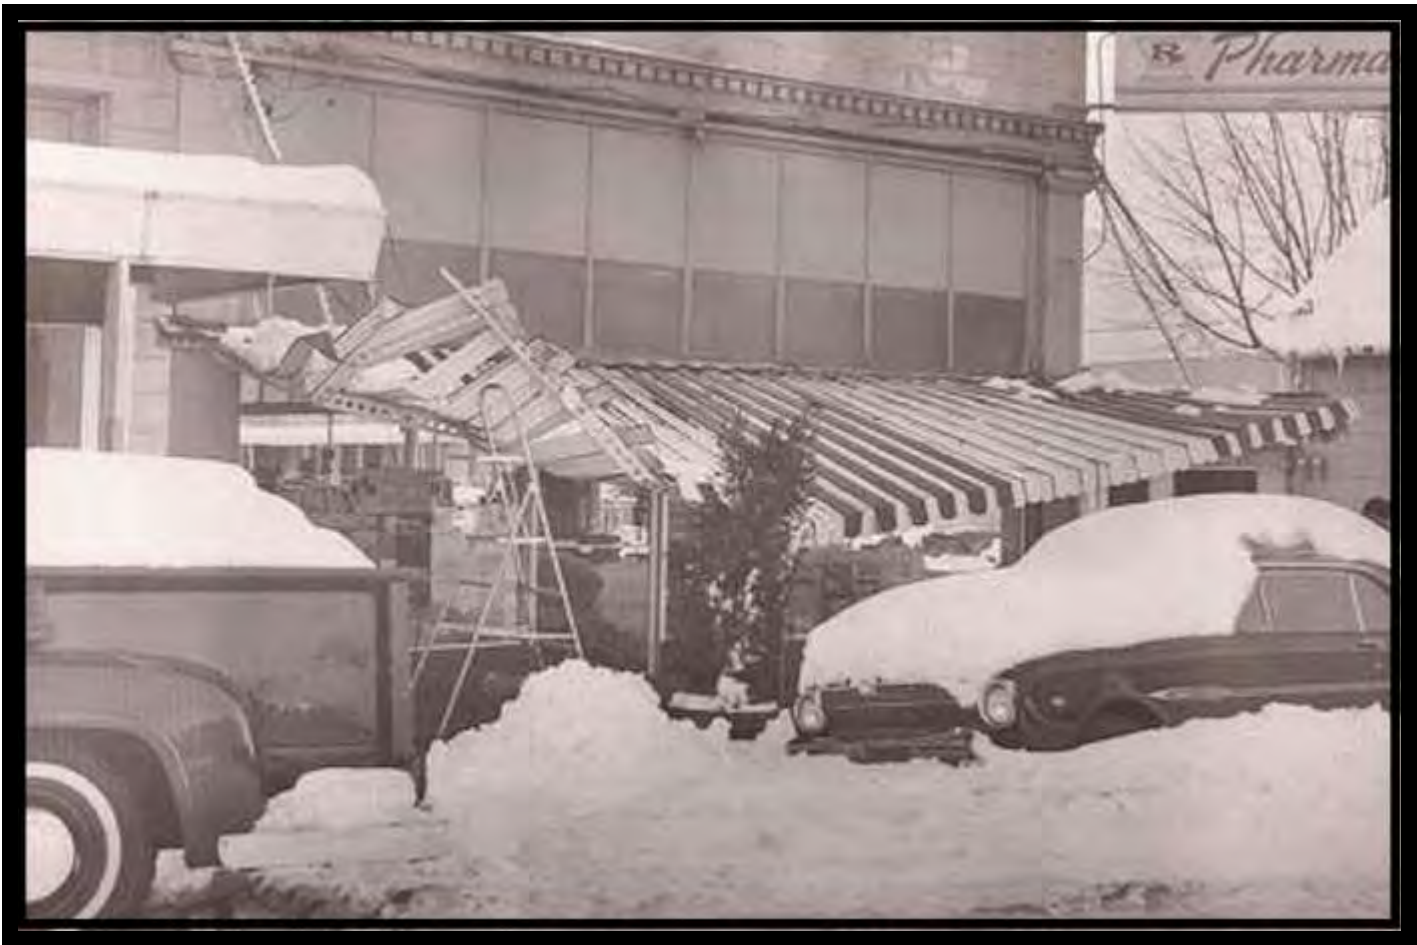
Figure 22: This photo shows the transoms painted and the dentil frieze sill in tact. View is the east side of Third Ave looking north, northwest.

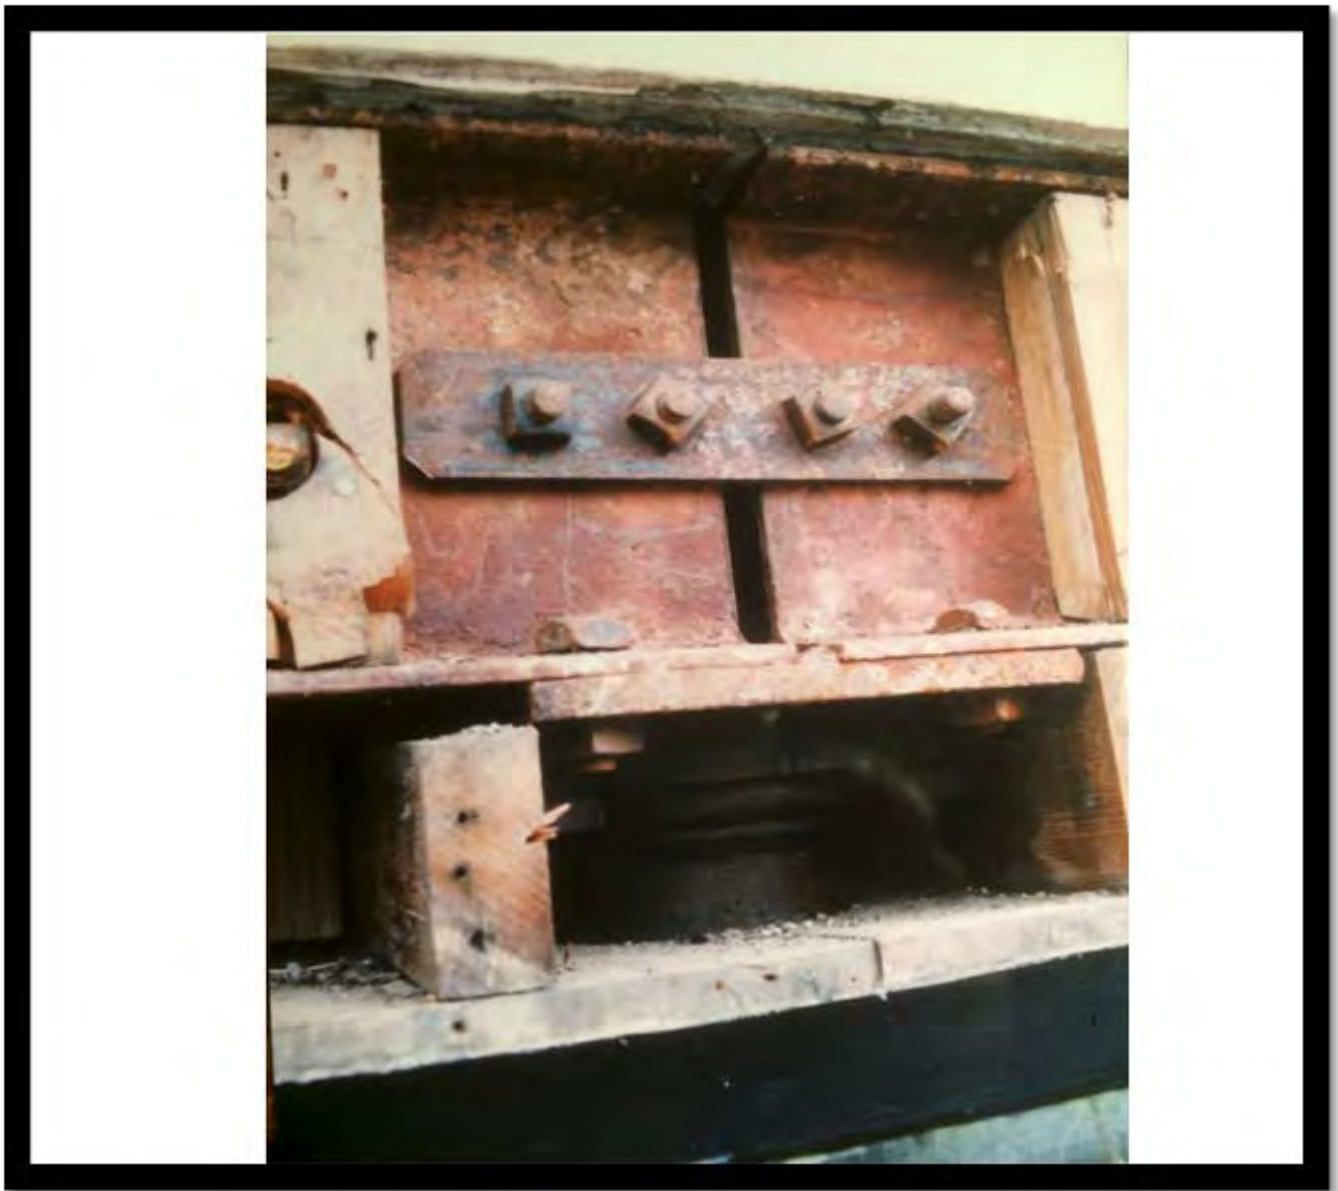
Figure 23: Captured during building 1997 renovation, steel "I" beams with flanges are riveted together in the middle and the bottom to connect and strengthen the beams. Below is one of the steel columns. View is looking south above transom windows of the east retail.

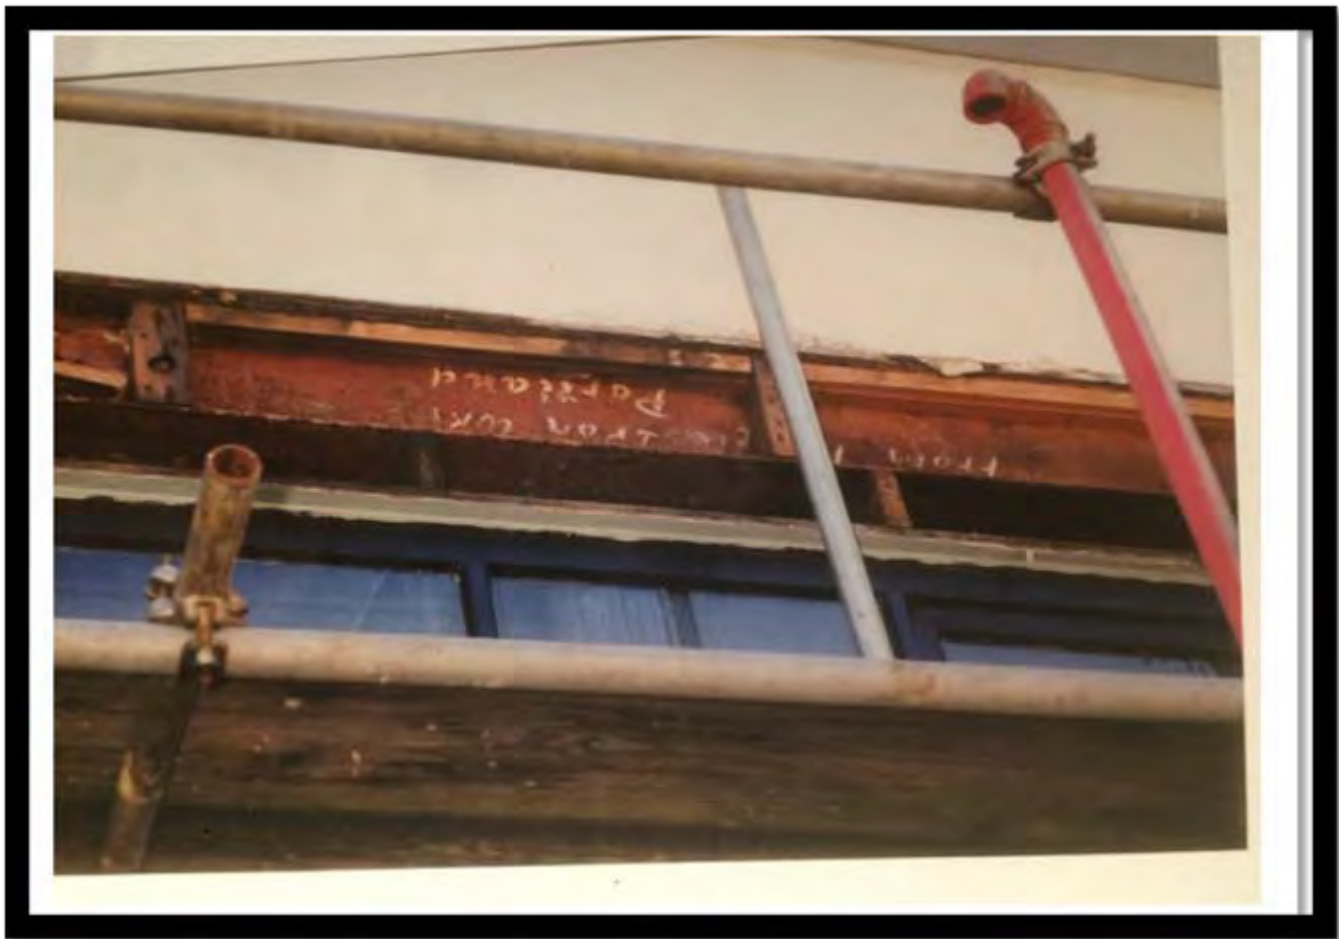
Figure 24: Uncovered during the 1997 renovation, on the north façade of the building, are the pairs of steel I-beams above transom windows. View is looking south.
