**National Register of Historic Places
Inventory—Nomination Form**

historic Church San Juan Bautista of Maricao *La Iglesia de San Juan Bautista*

street & number Baldorioty St., Town Plaza not for publication

city, town Maricao vicinity of

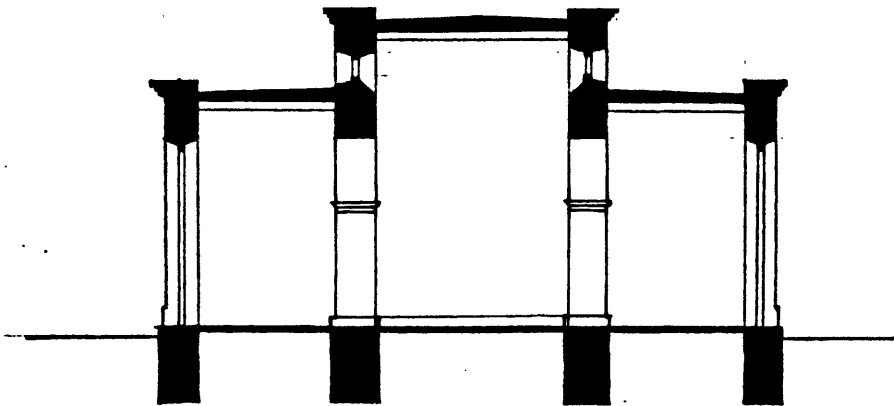
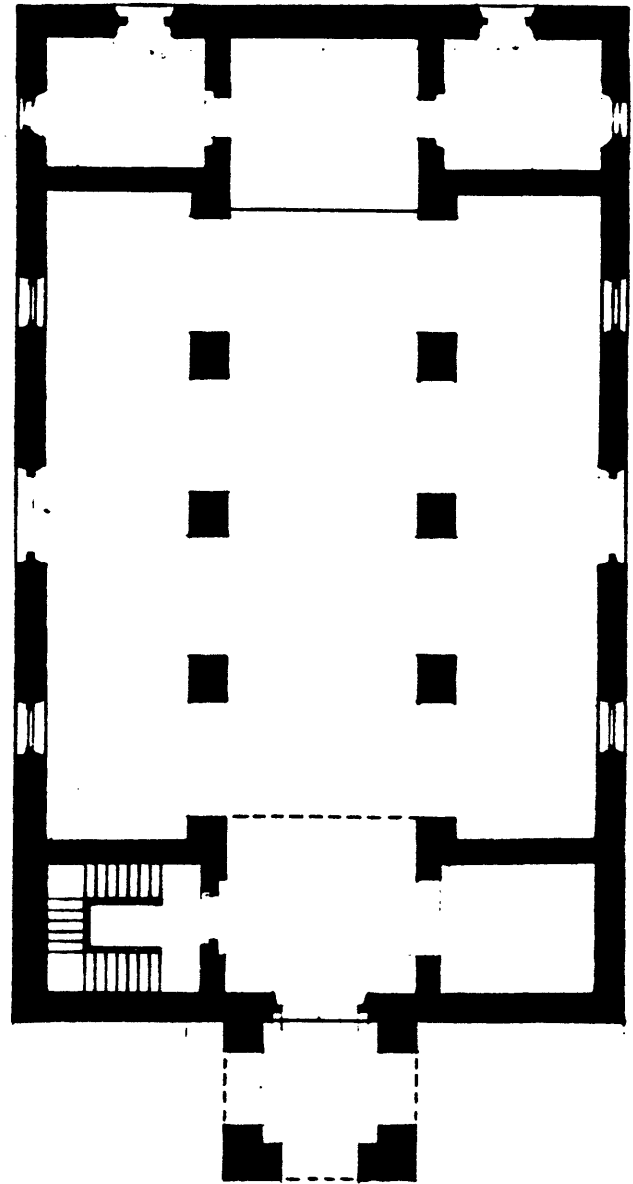
Church San Juan Bautista of Maricao

SCALE 1:200

- Diagram prepared by Arch. Thomas S. Marvel for the book Architecture of Parish Churches in Puerto Rico, unpublished.

The exterior was designed in the Gothic style and has pointed arches. However, the interior space is more traditional having rounded arches. The plan consists of a nave and two aisles. Open arcades (four arches each) resting on round columns with pronounced entasis divide the space. There are five bays plus the apse/sacristies and the entrance tower. The first bay is the vestibule or sotocoro. On the left, a modern metal spiral staircase leads to the new choir loft. The next four bays comprise the main space. The original wooden roof was substituted in 1965 by a metal joist structure covered with corrugated asbestos sheets. The side aisles culminate with two blind arches where statues have been placed. The square apse has a flat roof. Glass blocks illuminate the simple altar. Two arched doors give access to the sacristies. New terrazo has been installed on the floors.

The facade is dominated by a three level square bell tower. Steps lead up to the main entrance. The tower's first level functions as a portico. The second level has a round oculi and the third level has eight double arch windows, each topped with a pointed arch. The tower is crowned by a pyramidal concrete roof. Two pointed arch windows flank the tower and reflect the two inner aisles. There are four windows and one door on each side facade. Two doors on the rear facade permit direct access to the sacristies.
